**Flood Control Project Maintenance  
Levee Inspections**  
**LMA District Cover Sheet**  
**Spring 2011 Levee Inspection Results**

**Sutter Maintenance Yard Maintenance Area 0013**

**Levee Inspection Report By Mile - Spring 2011**

Waterway							Bank	Unit Miles	Inspection Start/End	Inspector
Unit No. 01 Cherokee Canal							Right	18.87	04/28/2011 04/28/2011	Bob Duffey
LMR No.	Levee Mile		Category	Item	Location *	Rating **	Action/Comment	GPS Latitude/Longitude		Issue No.
	Start	End						Start	End	Photo
1	0.76	0.78	Earthen Levee	Encroachments	LS	M	Equipment	39.587905 ° -121.700822 °	39.587505 ° -121.700880 °	12 Y
2	1.68	1.68	Earthen Levee	Encroachments	LS	C	Prunings	39.576092 ° -121.702808 °	39.576092 ° -121.702808 °	1 Y
3	6.51	7.09	Earthen Levee	Encroachments	LS	PO	Agricultural Ditch	39.508928 ° -121.714842 °	39.501438 ° -121.719715 °	3 Y
4	6.63	6.63	Earthen Levee	Encroachments	LS	M	Material	39.507337 ° -121.715693 °	39.507337 ° -121.715693 °	2 Y
5	9.84	9.87	Earthen Levee	Trim / Thin Trees	LS	M	Trim trees to at least five feet above ground level.	39.467170 ° -121.743887 °	39.466860 ° -121.744108 °	5 Y
6	9.89	9.89	Earthen Levee	Encroachments	LS	M	Equipment	39.466577 ° -121.744275

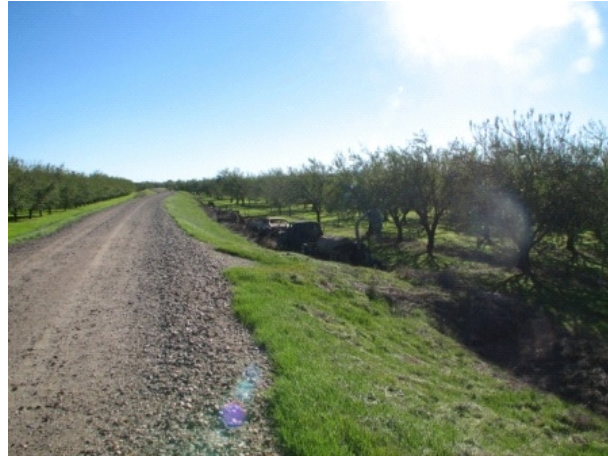
Levee Mile Report Line	1
Start Levee Mile	0.76
End Levee Mile	0.78
Location	Land Side
Category	Earthen Levee
Item	Encroachments

View of the equipment along the landside toe of the levee.

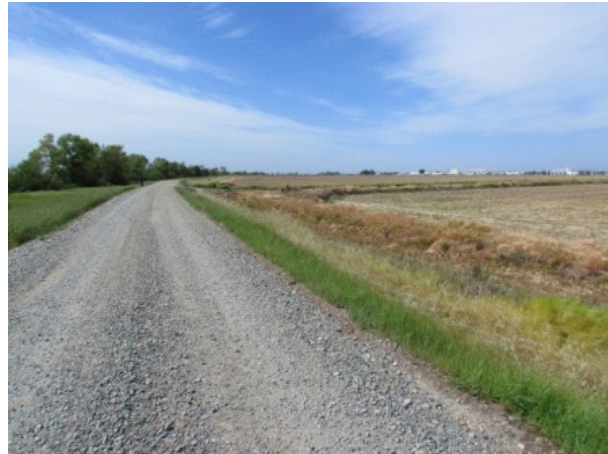
Levee Mile Report Line	3
Start Levee Mile	6.51
End Levee Mile	7.09
Location	Land Side
Category	Earthen Levee
Item	Encroachments

View of the AG ditch along the toe.

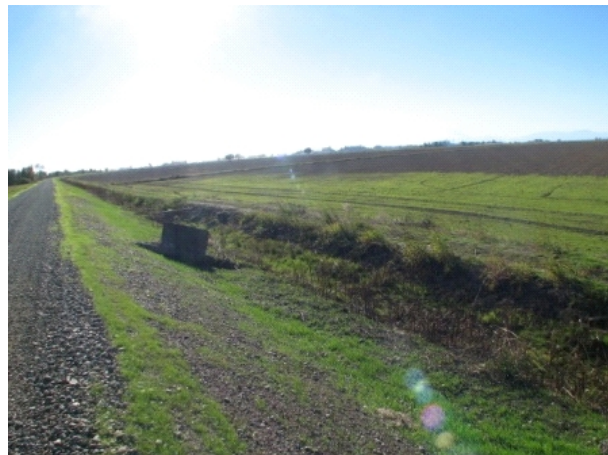
Levee Mile Report Line	4
Start Levee Mile	6.63
End Levee Mile	6.63
Location	Land Side
Category	Earthen Levee
Item	Encroachments

View of a concrete block along the toe.

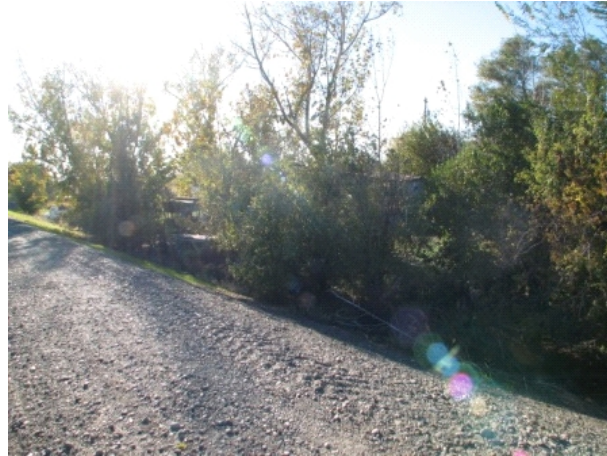
Levee Mile Report Line	5
Start Levee Mile	9.84
End Levee Mile	9.87
Location	Land Side
Category	Earthen Levee
Item	Trim / Thin Trees

View of trees that need to be trimmed along the toe.

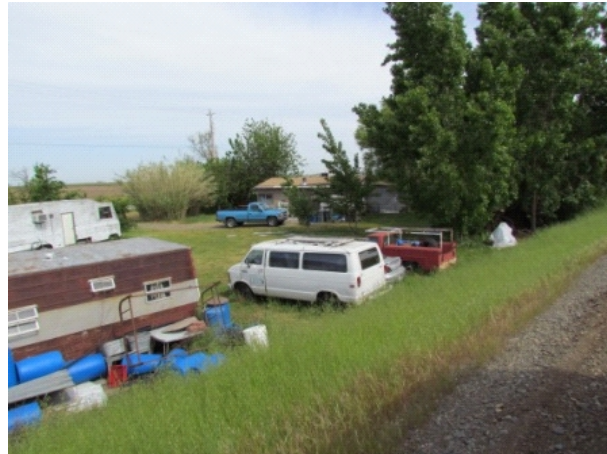
Levee Mile Report Line	6
Start Levee Mile	9.89
End Levee Mile	9.89
Location	Land Side
Category	Earthen Levee
Item	Encroachments

View of vehicles & trailers along the toe.

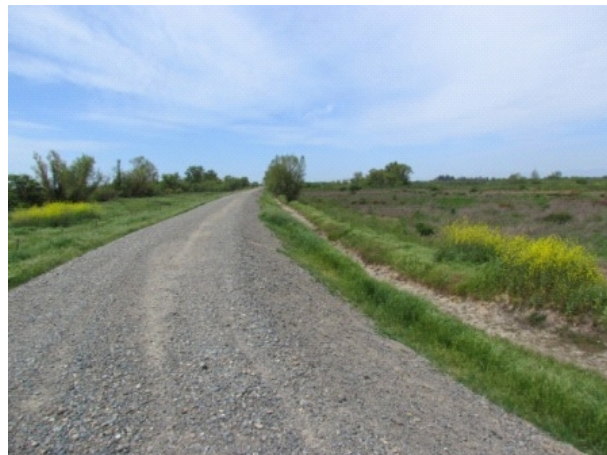
Levee Mile Report Line	8
Start Levee Mile	16.45
End Levee Mile	17.42
Location	Land Side
Category	Earthen Levee
Item	Encroachments

View of the Ag ditch along the toe.

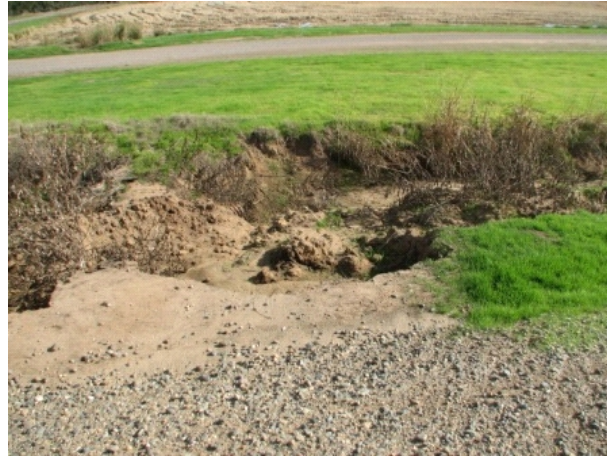
Levee Mile Report Line	2
Start Levee Mile	0.58
End Levee Mile	0.58
Location	Land Side
Category	Earthen Levee
Item	Erosion / Bank Caving

View of erosion along the levee toe.

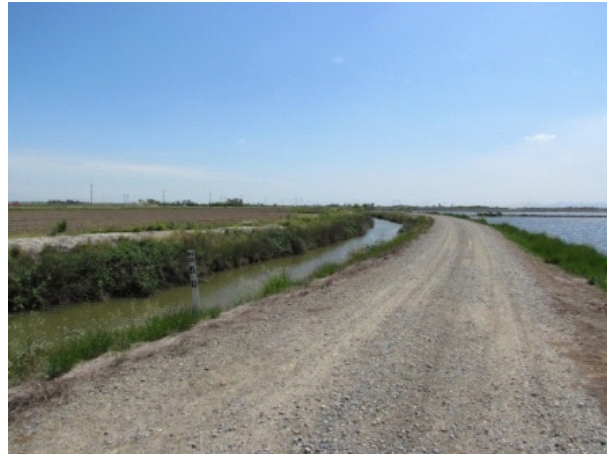
Levee Mile Report Line	3
Start Levee Mile	4.58
End Levee Mile	5.00
Location	Water Side
Category	Earthen Levee
Item	Encroachments

View of AG ditch along the toe.

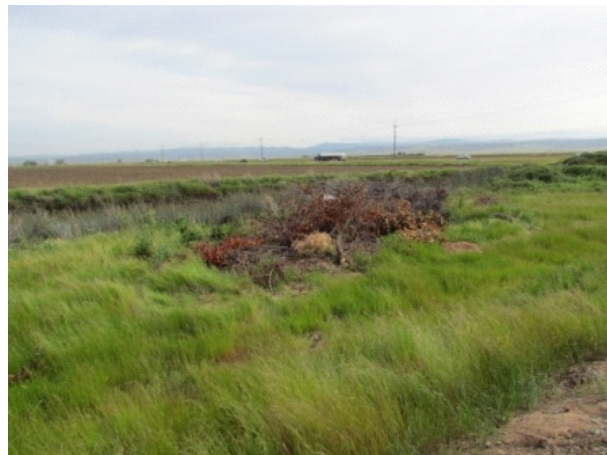
Levee Mile Report Line	5
Start Levee Mile	5.15
End Levee Mile	5.15
Location	Water Side
Category	Earthen Levee
Item	Encroachments

View of pruning & debris.

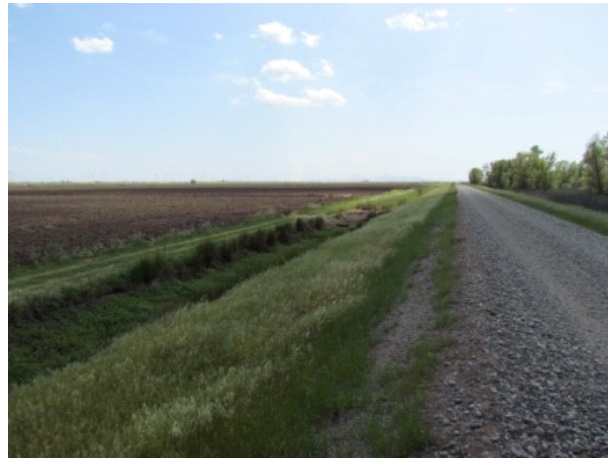
Levee Mile Report Line	6
Start Levee Mile	6.23
End Levee Mile	7.62
Location	Land Side
Category	Earthen Levee
Item	Encroachments
View of the AG ditch along the toe.	
rduffey_s_20110429_323.jpg

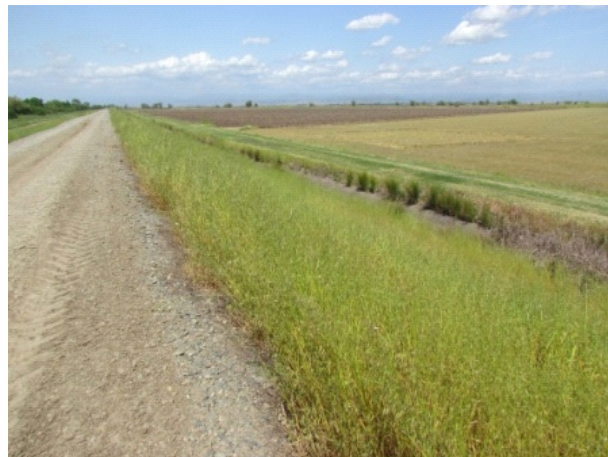
Levee Mile Report Line	7
Start Levee Mile	10.14
End Levee Mile	10.64
Location	Land Side
Category	Earthen Levee
Item	Encroachments
View of the AG ditch along the toe.	
rduffey_s_20110429_324.jpg

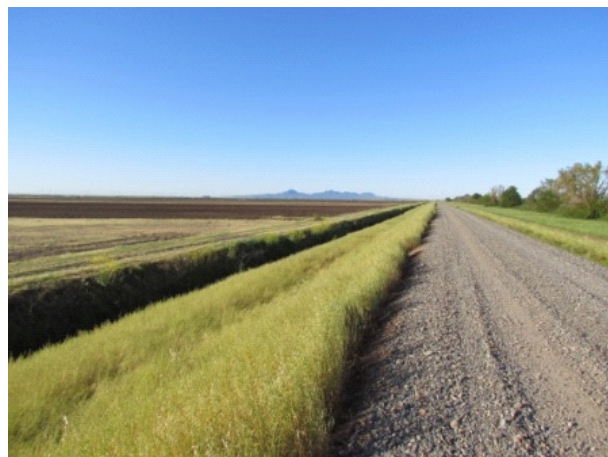
Levee Mile Report Line	8
Start Levee Mile	10.70
End Levee Mile	11.79
Location	Land Side
Category	Earthen Levee
Item	Encroachments
View of the AG ditch along the toe.	
rduffey_s_20110429_325.jpg

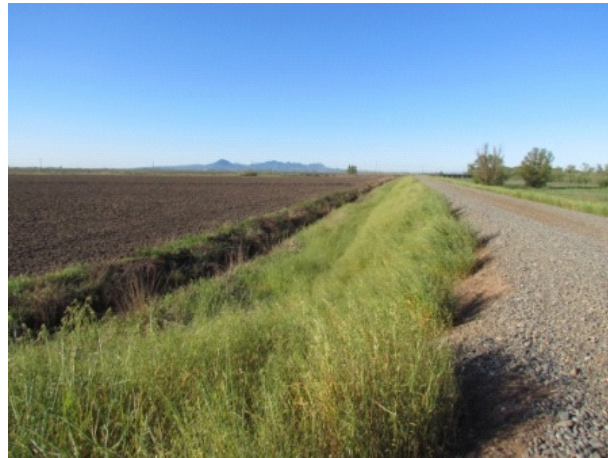
Levee Mile Report Line	9
Start Levee Mile	13.55
End Levee Mile	14.10
Location	Land Side
Category	Earthen Levee
Item	Encroachments

View of the AG ditch along the toe.

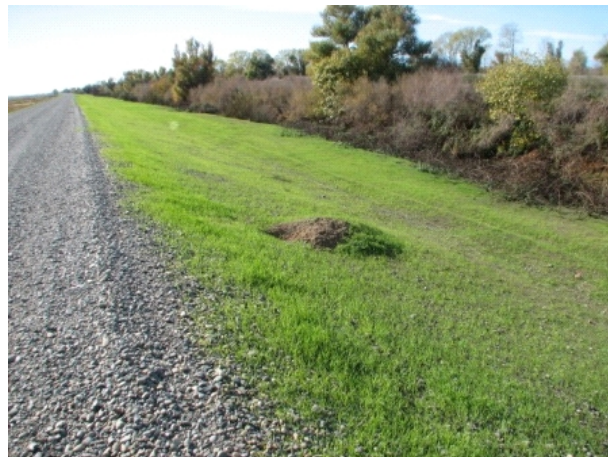
Levee Mile Report Line	11
Start Levee Mile	15.28
End Levee Mile	15.28
Location	Water Side
Category	Earthen Levee
Item	Animal Control

View of a squirrel hole along the slope.

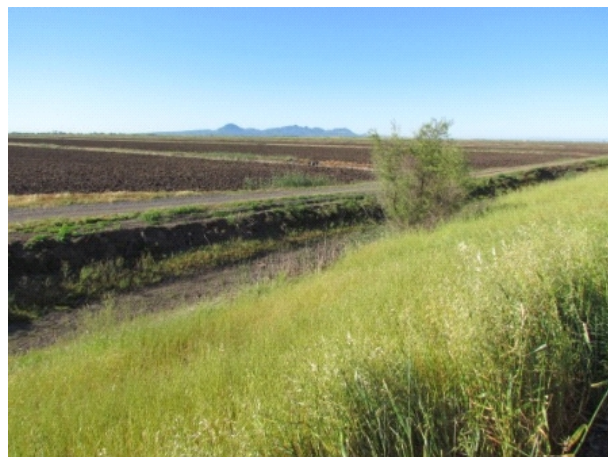
Levee Mile Report Line	12
Start Levee Mile	17.05
End Levee Mile	18.93
Location	Land Side
Category	Earthen Levee
Item	Encroachments

View of the AG ditch along the toe.

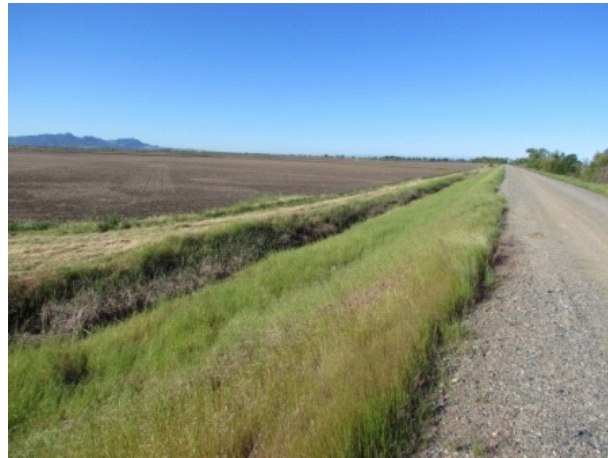
Levee Mile Report Line	14
Start Levee Mile	19.58
End Levee Mile	20.15
Location	Land Side
Category	Earthen Levee
Item	Encroachments

View of the AG ditch along the toe.

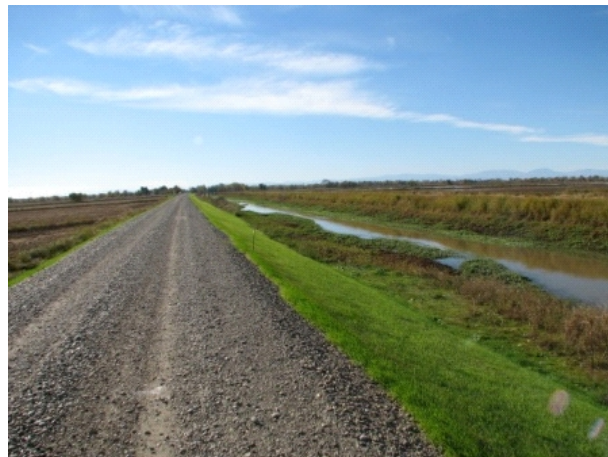
Levee Mile Report Line	16
Start Levee Mile	21.72
End Levee Mile	22.08
Location	Water Side
Category	Earthen Levee
Item	Erosion / Bank Caving

View of erosion along the toe.

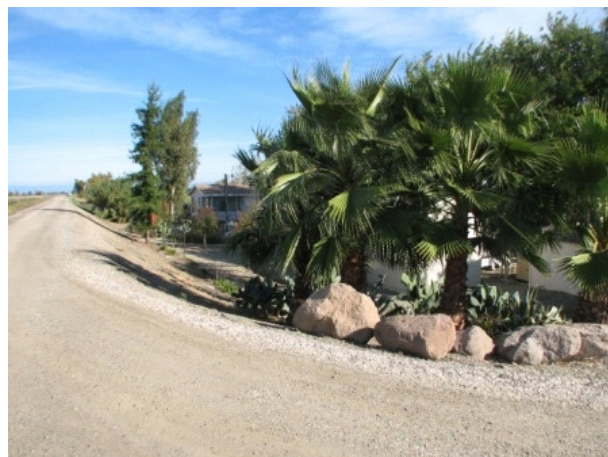
Levee Mile Report Line	17
Start Levee Mile	22.38
End Levee Mile	22.38
Location	Land Side
Category	Earthen Levee
Item	Encroachments

View of landscape along the toe.

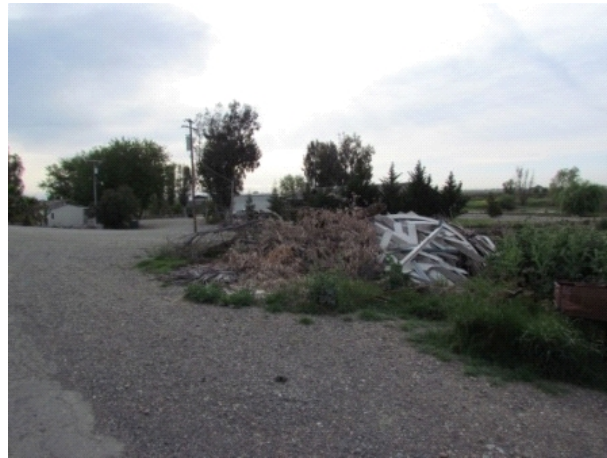
Levee Mile Report Line	18
Start Levee Mile	22.42
End Levee Mile	22.42
Location	Land Side
Category	Earthen Levee
Item	Encroachments

View of the debris & prunings.

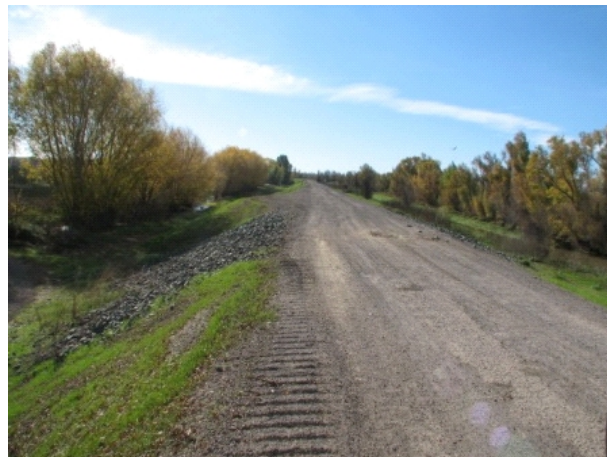
Levee Mile Report Line	19
Start Levee Mile	22.69
End Levee Mile	22.69
Location	Land Side
Category	Earthen Levee
Item	Erosion / Bank Caving

View of the erosion along the landside slope.

LMR No.	Levee Mile		Category	Item	* Location	** Rating	Action/Comment	GPS Latitude/Longitude		Issue No. Photo
	Start	End						Start	End	
19	22.69	22.69	Earthen Levee	Erosion / Bank Caving	LS	U	Schedule repair of erosion site prior to the next inspection.	39.357348 ° -121.876848 °	39.357348 ° -121.876848 °	3 Y
20	22.75	22.79	Earthen Levee	Erosion / Bank Caving	LS	U	Schedule repair of erosion site prior to the next inspection.	39.357180 ° -121.877755 °	39.356848 ° -121.878467 °	6 Y
21	22.83	22.85	Earthen Levee	Erosion / Bank Caving	WS	M	Note and monitor erosion site.	39.356498 ° -121.879030 °	39.356303 ° -121.879417 °	7 Y
22	22.83	22.83	Earthen Levee	Erosion / Bank Caving	LS	U	Schedule repair of erosion site prior to the next inspection.	39.356457 ° -121.879178 °	39.356457 ° -121.879178 °	2 Y

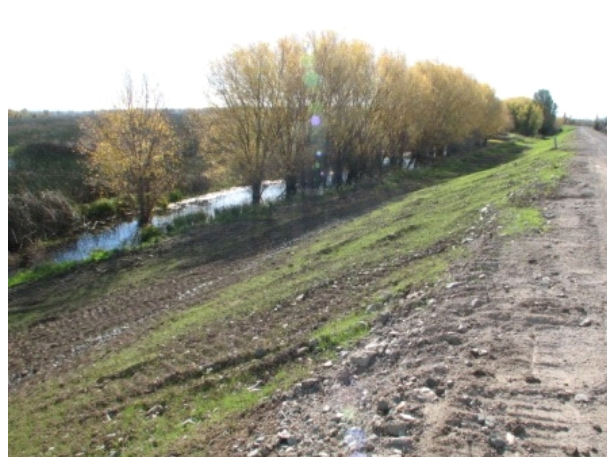
Levee Mile Report Line	20
Start Levee Mile	22.75
End Levee Mile	22.79
Location	Land Side
Category	Earthen Levee
Item	Erosion / Bank Caving

View of the erosion along the landside slope cause by a telephone company underground line.

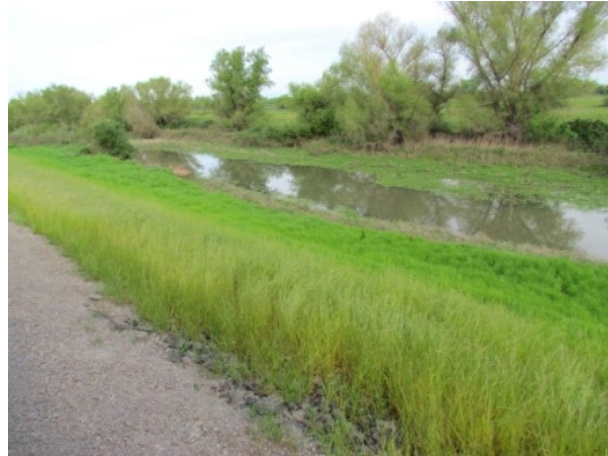
Levee Mile Report Line	21
Start Levee Mile	22.83
End Levee Mile	22.85
Location	Water Side
Category	Earthen Levee
Item	Erosion / Bank Caving

View of the along the canal.

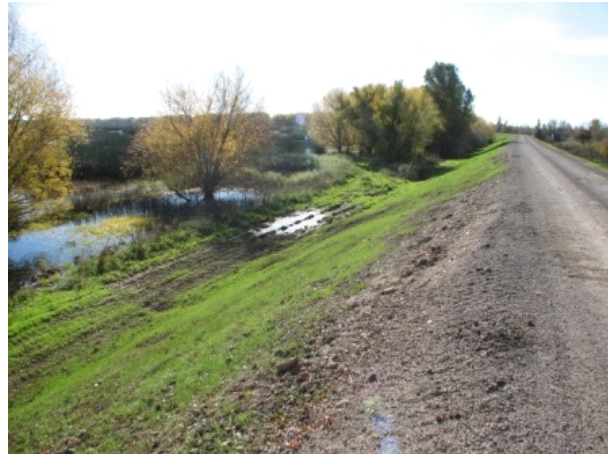
Levee Mile Report Line	22
Start Levee Mile	22.83
End Levee Mile	22.83
Location	Land Side
Category	Earthen Levee
Item	Erosion / Bank Caving

View of the erosion on the landside slope of the levee.
