**Flood Control Project Maintenance  
Levee Inspections****LMA District Cover Sheet****Spring 2012 Levee Inspection Results****Sutter Maintenance Yard Maintenance Area 0013**

**Levee Inspection Report By Mile - Spring 2012**

**Sutter Maintenance Yard Maintenance Area 0013**

Waterway					Bank	Unit Miles	Inspection Start/End	Inspector
Unit No. 01 Cherokee Canal					Right	18.87	04/18/2012 04/18/2012	Bob Duffey

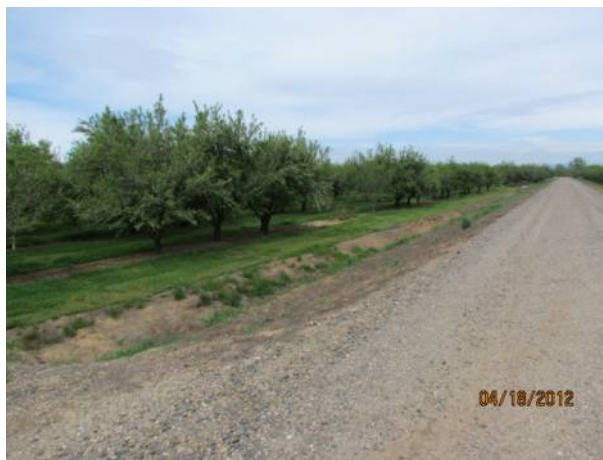
rduffey\_s\_20120430\_604.jpg

Levee Mile Report Line	4
Start Levee Mile	0.66
End Levee Mile	1.20
Location	Land Side
Category	Earthen Levee
Item	Encroachments

View of the ag ditch along the toe of the levee.

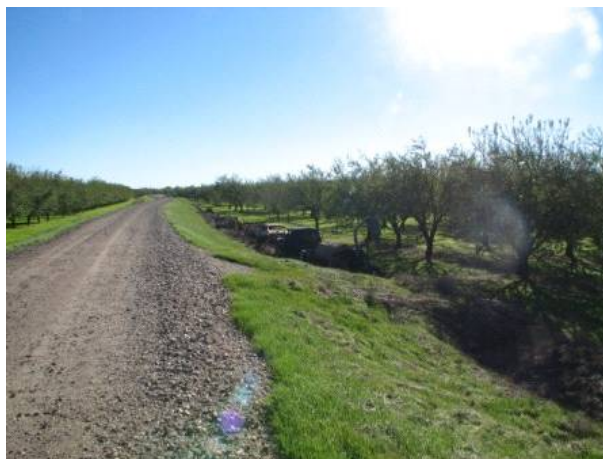
rduffey\_s\_20120312\_328.jpg

Levee Mile Report Line	5
Start Levee Mile	0.76
End Levee Mile	0.78
Location	Land Side
Category	Earthen Levee
Item	Encroachments

View of the equipment along the landside toe of the levee.

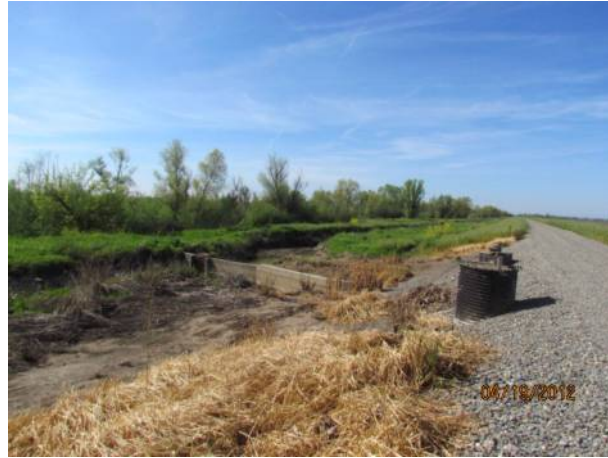
rduffey\_s\_20120430\_608.jpg

Levee Mile Report Line	10
Start Levee Mile	11.19
End Levee Mile	11.81
Location	Water Side
Category	Earthen Levee
Item	Erosion / Bank Caving

View of the ag ditch and erosion along the toe of the levee.

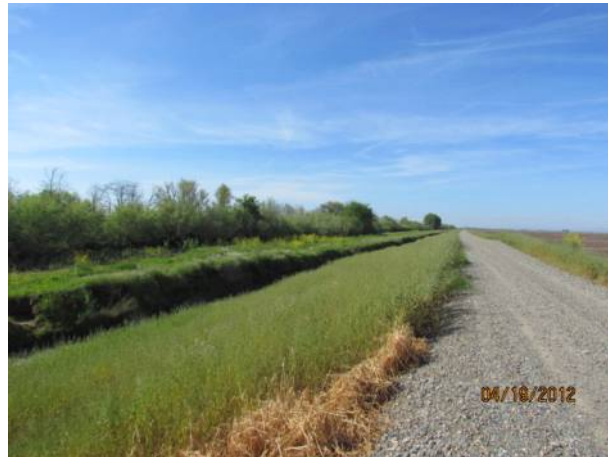
rduffey\_s\_20120430\_607.jpg

Levee Mile Report Line	11
Start Levee Mile	11.20
End Levee Mile	13.47
Location	Water Side
Category	Earthen Levee
Item	Encroachments

View of the ag ditch along the toe of the levee.

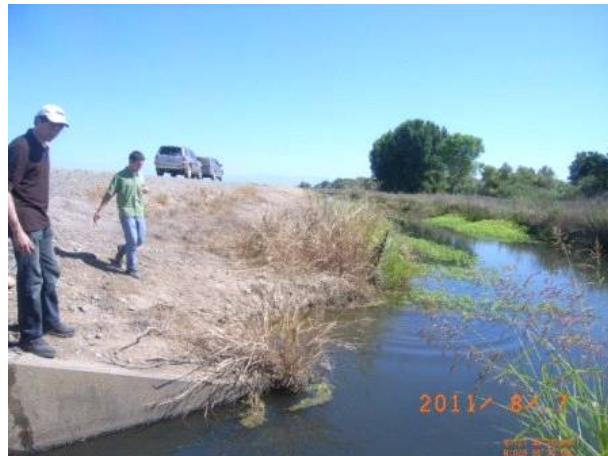
USACE 2011 Photo #1

12	11.75	11.76	Supplemental	USACE Erosion Survey	WS	M Ma	Inspector Comments: 2011: Small erosion pocket, likely caused by the irrigation diversion structure. [2011 Site ID: CHK_11-7_R]	39.442821 ° -121.759851 °	39.442738 ° -121.759908 °	11 Y
DWR ID: DWR_MA0013_01_s_2012_11										
13	14.42	14.42	Earthen Levee	Encroachments	LS	M Ma	GA : Garbage	39.412752 ° -121.788662 °	39.412752 ° -121.788662 °	4 Y
DWR ID: DWR_MA0013_01_s_2012_4										
14	14.46	14.46	Earthen Levee	Animal Control	LS	A/W Ma	A3 : No rodents visible, but rodent burrows visible; need to backfill and compact or grout burrows.	39.412328 ° -121.789342 °	39.412328 ° -121.789342 °	1 Y
DWR ID: DWR_MA0013_01_s_2012_1

Levee Mile Report Line	12
Start Levee Mile	11.75
End Levee Mile	11.76
Location	Water Side
Category	Supplemental
Item	USACE Erosion Survey

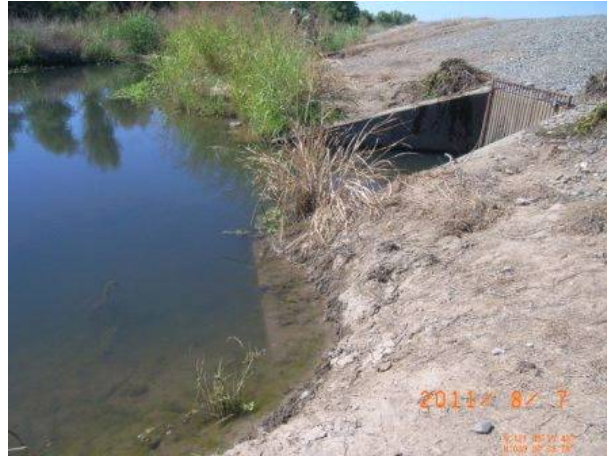
USACE 2011 Photo #2

Levee Mile Report Line	12
Start Levee Mile	11.75
End Levee Mile	11.76
Location	Water Side
Category	Supplemental
Item	USACE Erosion Survey

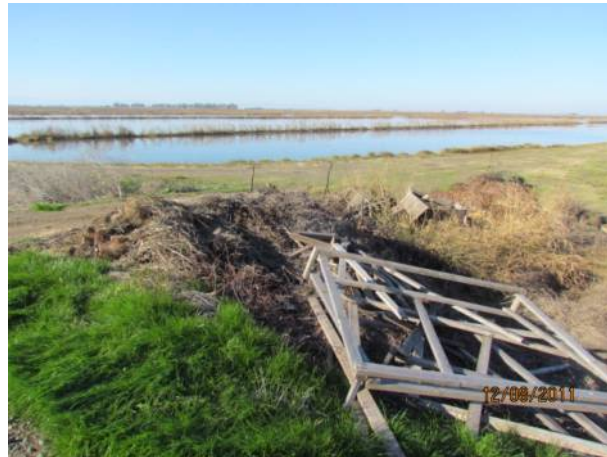
rduffey\_s\_20120312\_322.jpg

Levee Mile Report Line	13
Start Levee Mile	14.42
End Levee Mile	14.42
Location	Land Side
Category	Earthen Levee
Item	Encroachments

View of garbage along the L/S slope.

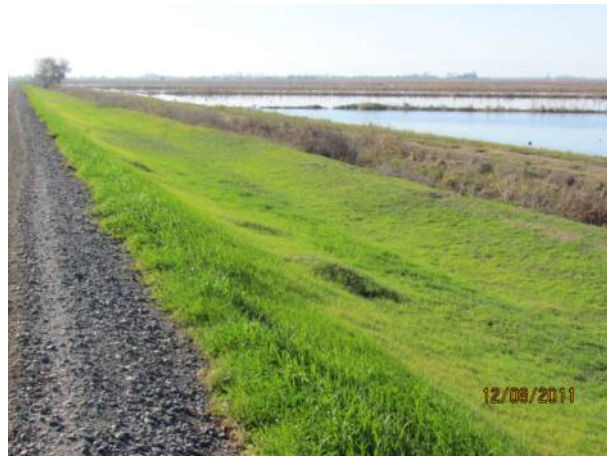
rduffey\_s\_20120312\_319.jpg

Levee Mile Report Line	14
Start Levee Mile	14.46
End Levee Mile	14.46
Location	Land Side
Category	Earthen Levee
Item	Animal Control

View of rodent holes along the L/S slope.

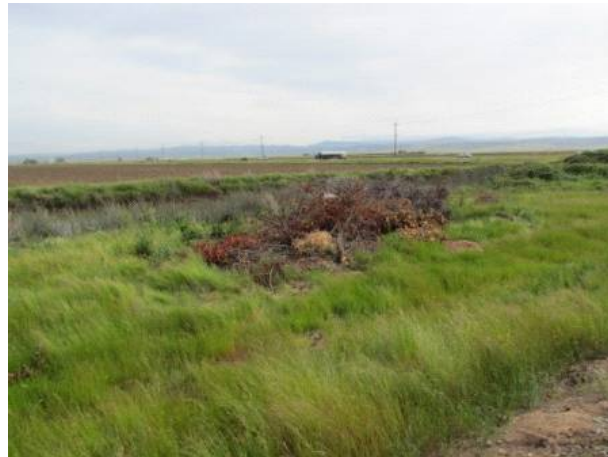
rduffey\_s\_20120312\_332.jpg

Levee Mile Report Line	4
Start Levee Mile	5.15
End Levee Mile	5.15
Location	Water Side
Category	Earthen Levee
Item	Encroachments

View of pruning & debris.

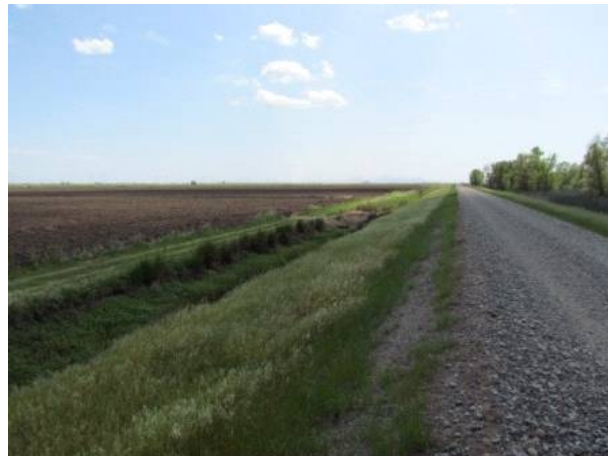
rduffey\_s\_20120312\_334.jpg

Levee Mile Report Line	5
Start Levee Mile	6.23
End Levee Mile	7.62
Location	Land Side
Category	Earthen Levee
Item	Encroachments

View of the AG ditch along the toe.

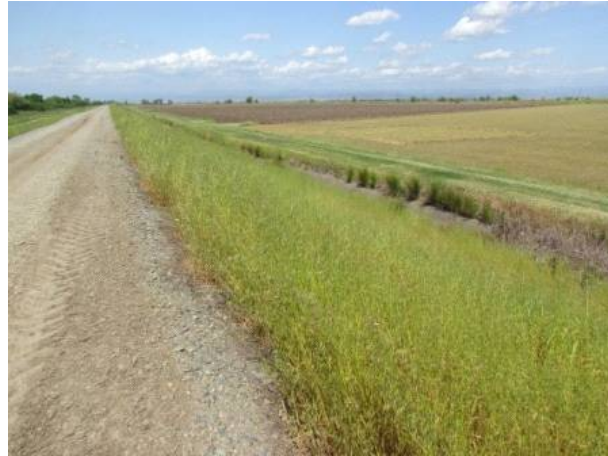
rduffey\_s\_20120312\_335.jpg

Levee Mile Report Line	6
Start Levee Mile	10.14
End Levee Mile	10.64
Location	Land Side
Category	Earthen Levee
Item	Encroachments

View of the AG ditch along the toe.

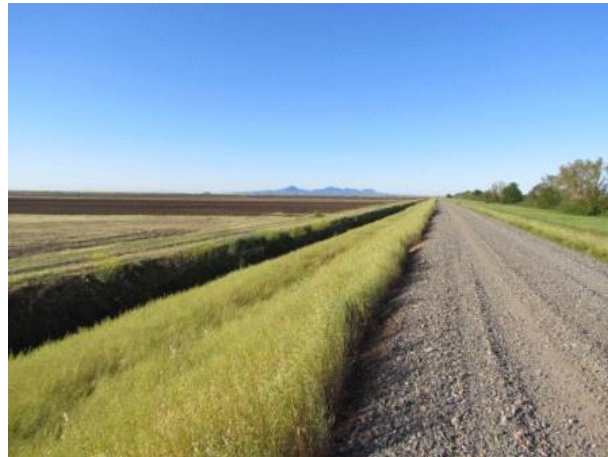
rduffey\_s\_20120312\_337.jpg

Levee Mile Report Line	7
Start Levee Mile	10.70
End Levee Mile	11.79
Location	Land Side
Category	Earthen Levee
Item	Encroachments

View of the AG ditch along the toe.

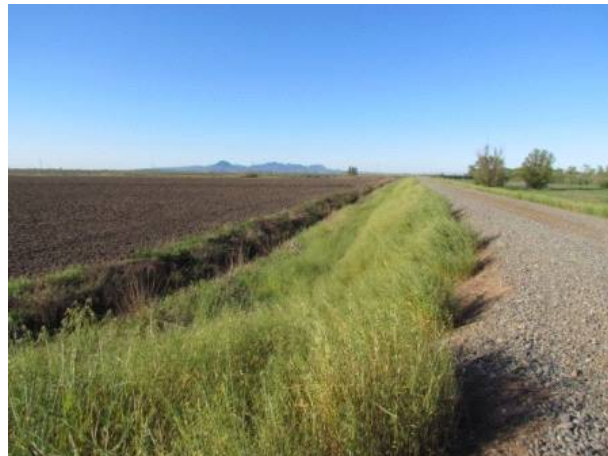
rduffey\_s\_20120312\_338.jpg

Levee Mile Report Line	8
Start Levee Mile	13.55
End Levee Mile	14.10
Location	Land Side
Category	Earthen Levee
Item	Encroachments

View of the AG ditch along the toe.

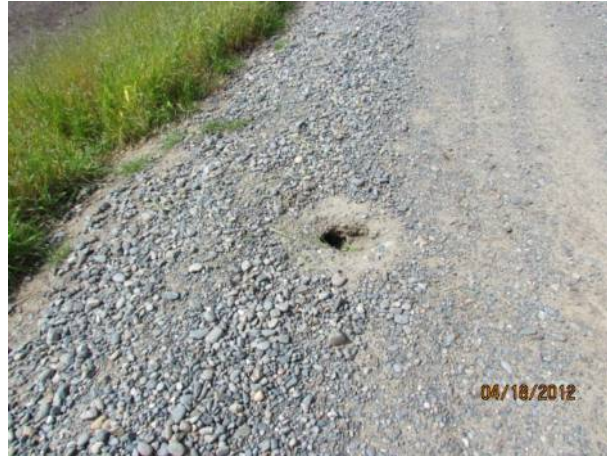
rduffey\_s\_20120430\_603.jpg

Levee Mile Report Line	10
Start Levee Mile	14.90
End Levee Mile	14.90
Location	Land Side
Category	Earthen Levee
Item	Animal Control

View of the rodent hole along the crown of the levee.

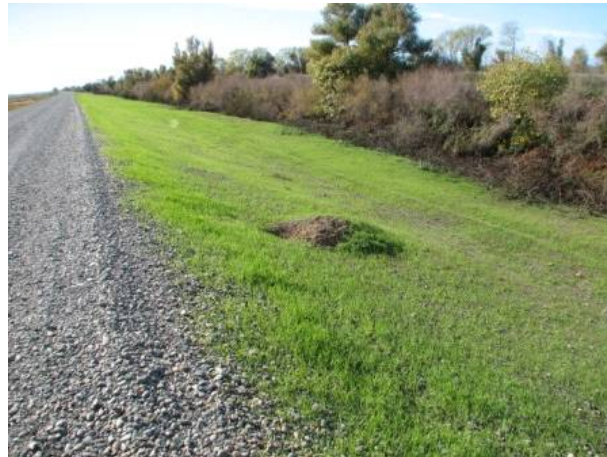
rduffey\_s\_20120312\_336.jpg

Levee Mile Report Line	11
Start Levee Mile	15.28
End Levee Mile	15.28
Location	Water Side
Category	Earthen Levee
Item	Animal Control

View of a squirrel hole along the slope.

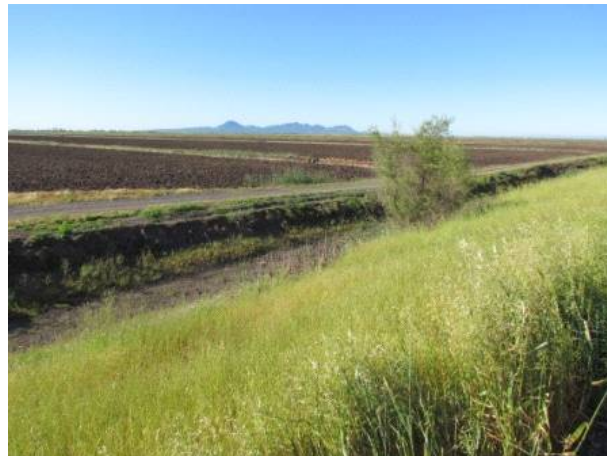
rduffey\_s\_20120312\_339.jpg

Levee Mile Report Line	12
Start Levee Mile	17.05
End Levee Mile	18.93
Location	Land Side
Category	Earthen Levee
Item	Encroachments

View of the AG ditch along the toe.

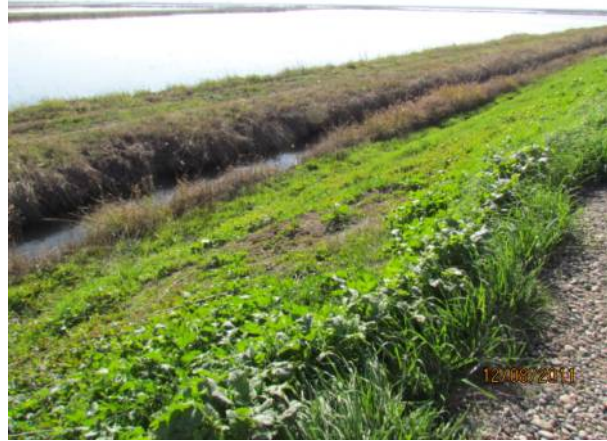
rduffey\_s\_20120312\_333.jpg

Levee Mile Report Line	13
Start Levee Mile	18.13
End Levee Mile	18.13
Location	Land Side
Category	Earthen Levee
Item	Animal Control

View of the rodent holes along the L/S slope.

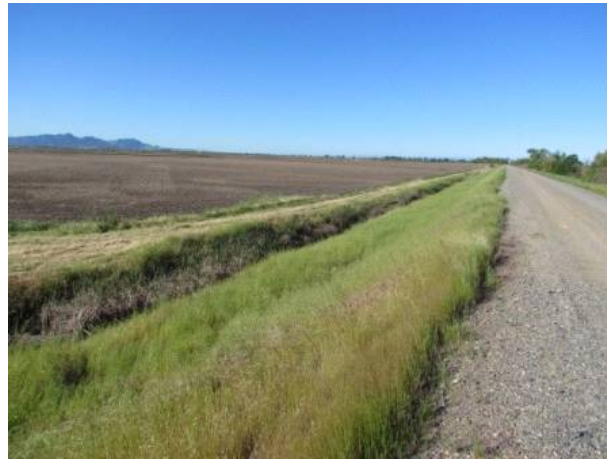
rduffey\_s\_20120312\_340.jpg

Levee Mile Report Line	14
Start Levee Mile	19.58
End Levee Mile	20.15
Location	Land Side
Category	Earthen Levee
Item	Encroachments

View of the AG ditch along the toe.

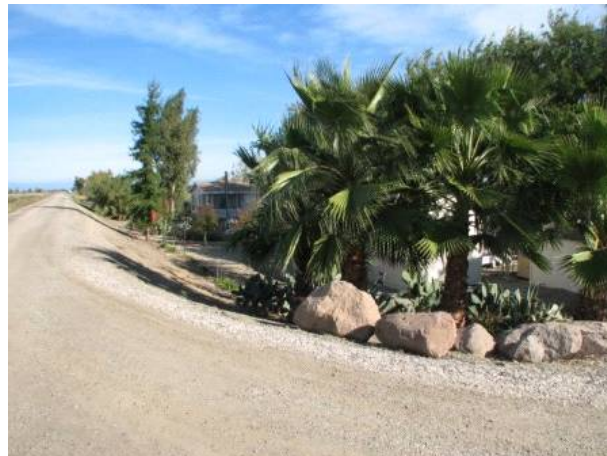
rduffey\_s\_20120312\_329.jpg

Levee Mile Report Line	15
Start Levee Mile	22.38
End Levee Mile	22.38
Location	Land Side
Category	Earthen Levee
Item	Vegetation

View of landscaping along the toe.

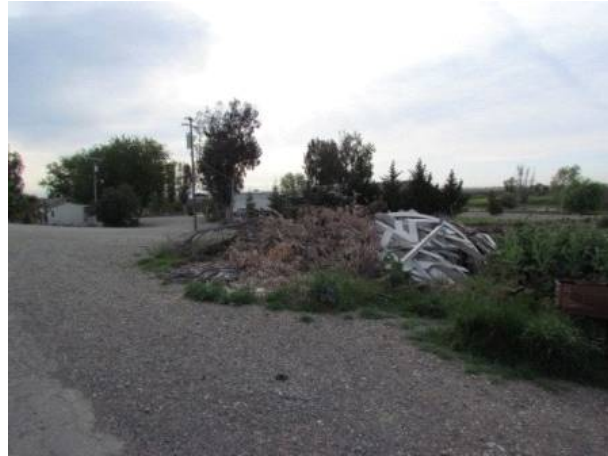
rduffey\_s\_20120312\_331.jpg

Levee Mile Report Line	16
Start Levee Mile	22.42
End Levee Mile	22.42
Location	Land Side
Category	Earthen Levee
Item	Encroachments

View of the debris & prunings.

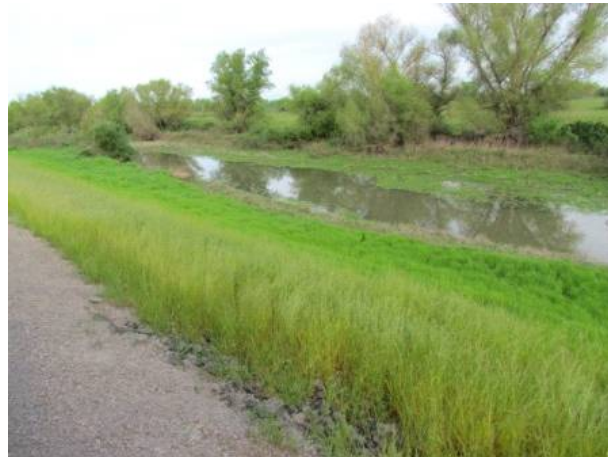
rduffey\_s\_20120312\_330.jpg

Levee Mile Report Line	17
Start Levee Mile	22.83
End Levee Mile	22.85
Location	Water Side
Category	Earthen Levee
Item	Erosion / Bank Caving

View of the along the canal.

LMR No.	Levee Mile		Category	Item	Location *	Rating ** +	Action/Comment	GPS Latitude/Longitude		Issue No. Photo
	Start	End						Start	End	
17	22.83	22.85	Earthen Levee	Erosion / Bank Caving	WS	M Ma	E1 : Note and monitor erosion site.	39.356498 ° -121.879030 °	39.356303 ° -121.879417 °	7 Y
DWR ID: DWR_MA0013_02_s_ 2012_7
