**Flood Control Project Maintenance
Levee Inspections****LMA District Cover Sheet****Spring 2013 Levee Inspection Results****Sutter Maintenance Yard Maintenance Area 0013**

Levee Inspection Report By Mile - Spring 2013

Sutter Maintenance Yard Maintenance Area 0013

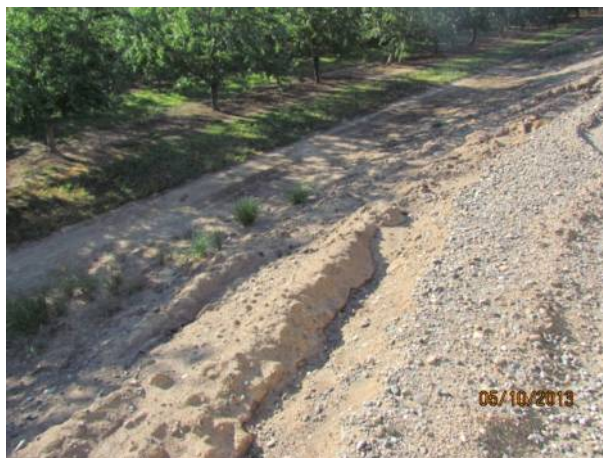
Levee Mile Report Line	4
Start Levee Mile	0.60
End Levee Mile	0.60
Location	Water Side
Category	
Item	Slope Stability

View of the vehicle erosion along the waterside slope.

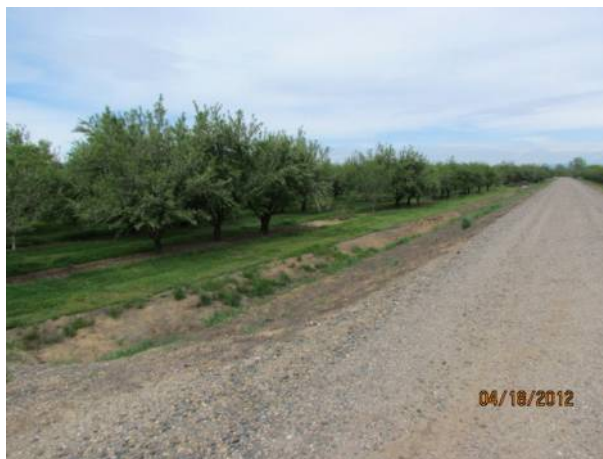
Levee Mile Report Line	5
Start Levee Mile	0.66
End Levee Mile	1.20
Location	Land Side
Category	
Item	Encroachments

View of the agricultural ditch along the toe of the levee.

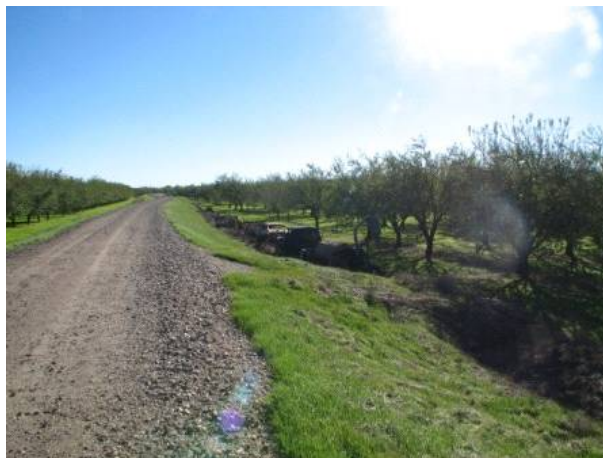
Levee Mile Report Line	6
Start Levee Mile	0.76
End Levee Mile	0.78
Location	Land Side
Category	
Item	Encroachments

View of the equipment along the landside toe of the levee.

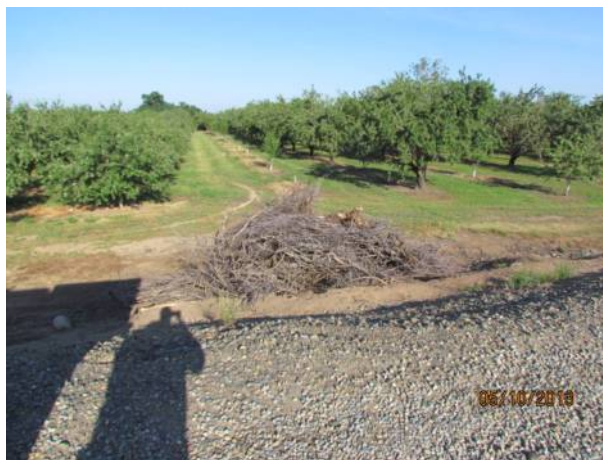
Levee Mile Report Line	7
Start Levee Mile	0.97
End Levee Mile	0.97
Location	Land Side
Category	
Item	Encroachments

View of the prunings along the landside toe.

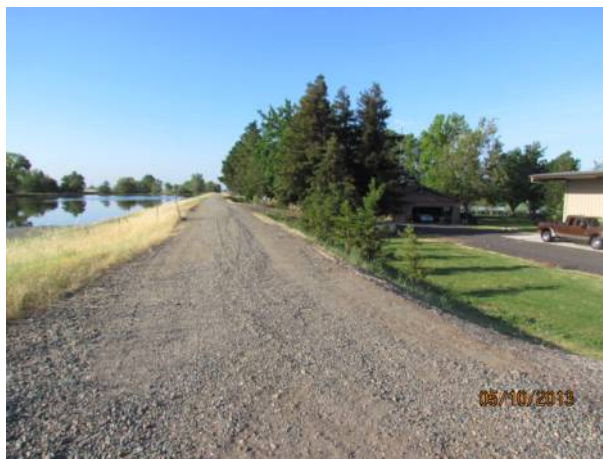
Levee Mile Report Line	8
Start Levee Mile	4.13
End Levee Mile	4.20
Location	Land Side
Category	
Item	Encroachments

View of the redwood trees along the slope of the levee.

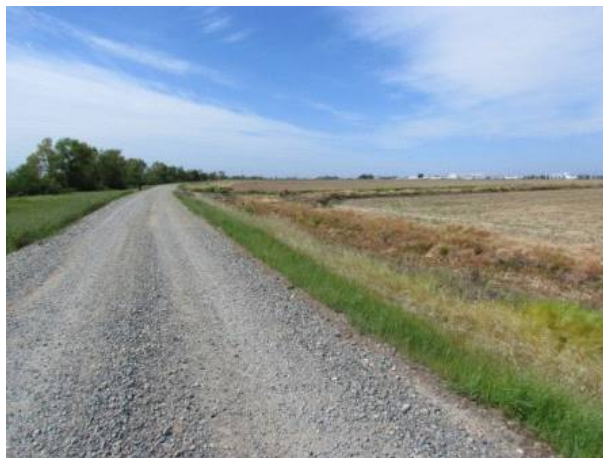
Levee Mile Report Line	9
Start Levee Mile	6.51
End Levee Mile	7.09
Location	Land Side
Category	
Item	Encroachments

View of the agricultural ditch along the toe.

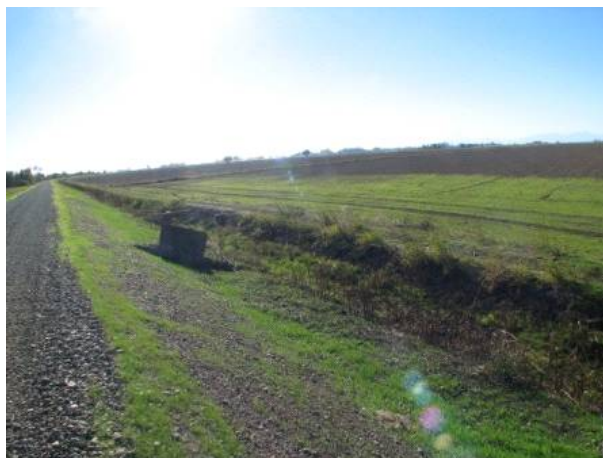
Levee Mile Report Line	10
Start Levee Mile	6.63
End Levee Mile	6.63
Location	Land Side
Category	
Item	Encroachments

View of a concrete block along the toe.

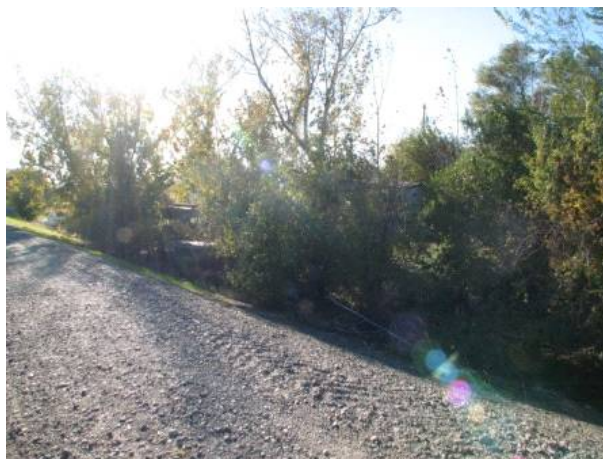
Levee Mile Report Line	11
Start Levee Mile	9.84
End Levee Mile	9.87
Location	Land Side
Category	
Item	Trim / Thin Trees

View of trees that need to be trimmed along the toe.

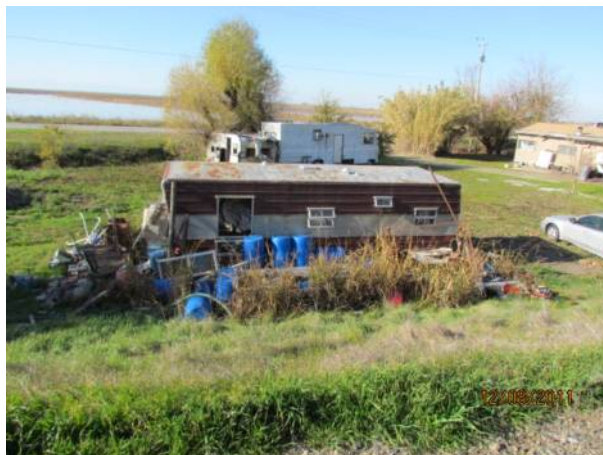
Levee Mile Report Line	12
Start Levee Mile	9.89
End Levee Mile	9.89
Location	Land Side
Category	
Item	Encroachments

View of a trailer & material along the L/S toe.

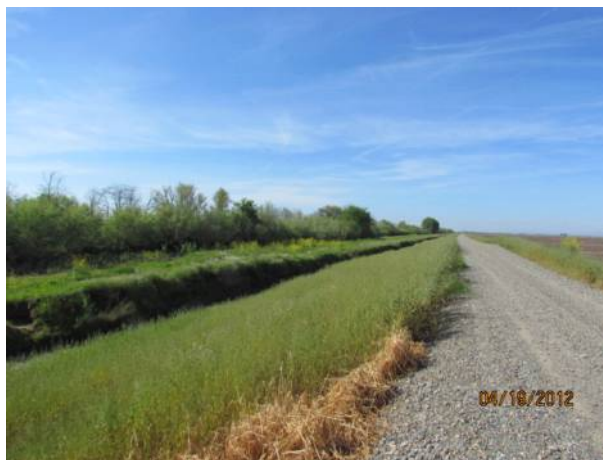
Levee Mile Report Line	13
Start Levee Mile	11.20
End Levee Mile	13.47
Location	Water Side
Category	
Item	Encroachments

View of the agricultural ditch along the toe of the levee.

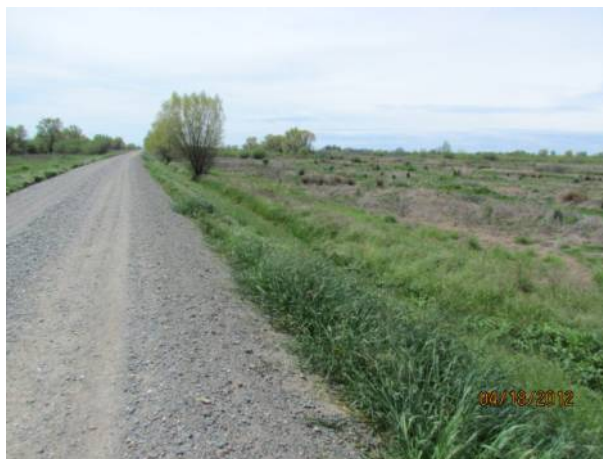
Levee Mile Report Line	16
Start Levee Mile	16.45
End Levee Mile	17.42
Location	Land Side
Category	
Item	Encroachments

View of the ag along the toe of the levee.

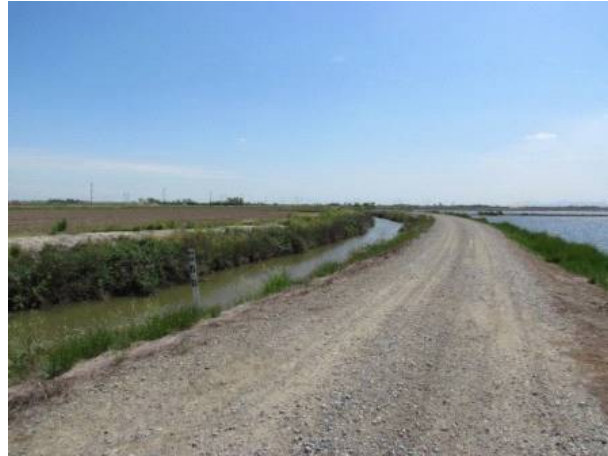
Levee Mile Report Line	2
Start Levee Mile	4.58
End Levee Mile	5.00
Location	Water Side
Category	
Item	Encroachments

View of agricultural ditch along the toe.

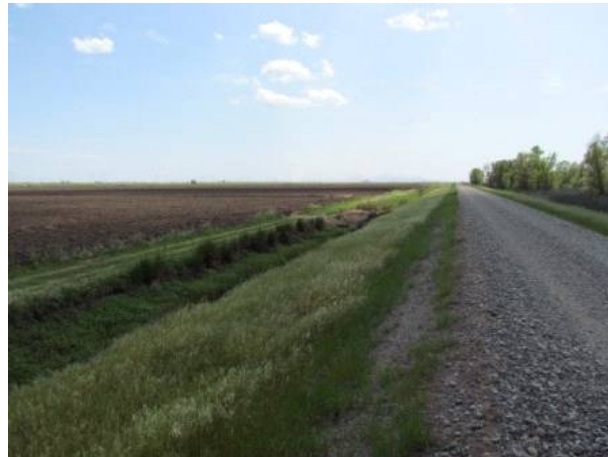
Levee Mile Report Line	4
Start Levee Mile	6.23
End Levee Mile	7.62
Location	Land Side
Category	
Item	Encroachments

View of the agricultural ditch along the toe.

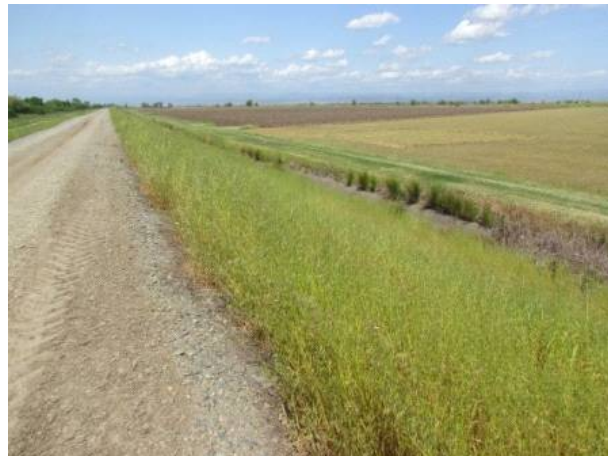
Levee Mile Report Line	5
Start Levee Mile	10.14
End Levee Mile	10.64
Location	Land Side
Category	
Item	Encroachments

View of the agricultural ditch along the toe.

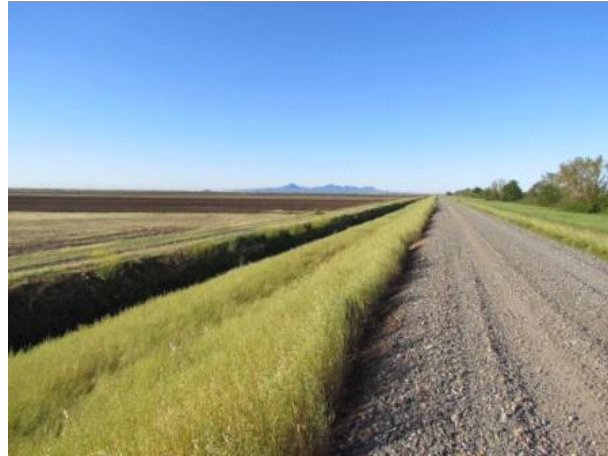
Levee Mile Report Line	6
Start Levee Mile	10.70
End Levee Mile	11.79
Location	Land Side
Category	
Item	Encroachments
View of the agricultural ditch along the toe.	
rduffey_s_20130225_115.jpg

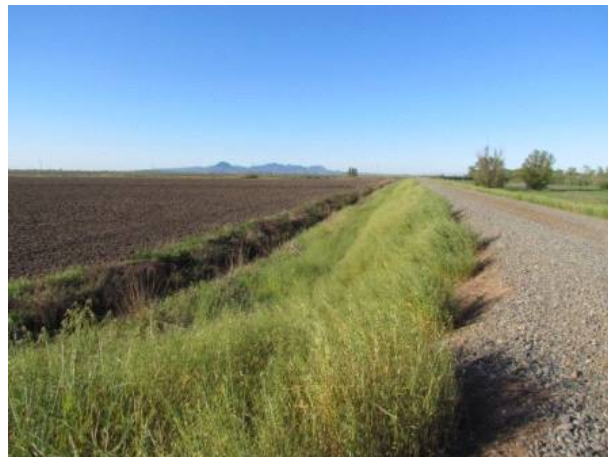
Levee Mile Report Line	7
Start Levee Mile	13.55
End Levee Mile	14.10
Location	Land Side
Category	
Item	Encroachments
View of the agricultural ditch along the toe.	
rduffey_s_20130225_116.jpg

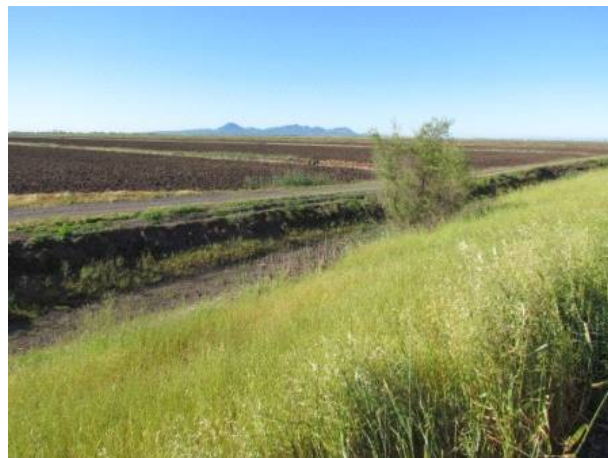
Levee Mile Report Line	8
Start Levee Mile	17.05
End Levee Mile	18.93
Location	Land Side
Category	
Item	Encroachments
View of the agricultural ditch along the toe.	
rduffey_s_20130225_117.jpg

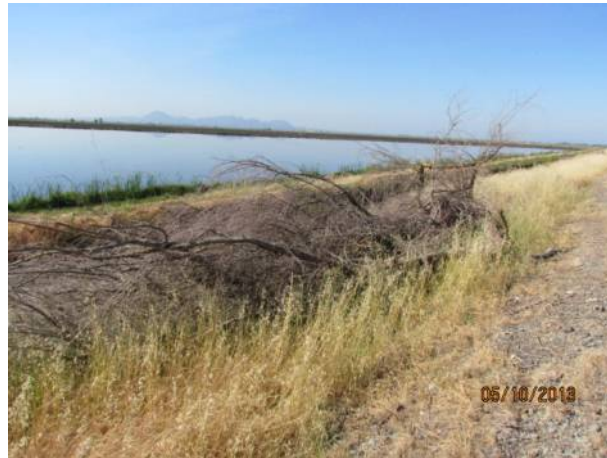
Levee Mile Report Line	9
Start Levee Mile	17.55
End Levee Mile	17.66
Location	Land Side
Category	
Item	Encroachments

View of the prunings along the landside slope.

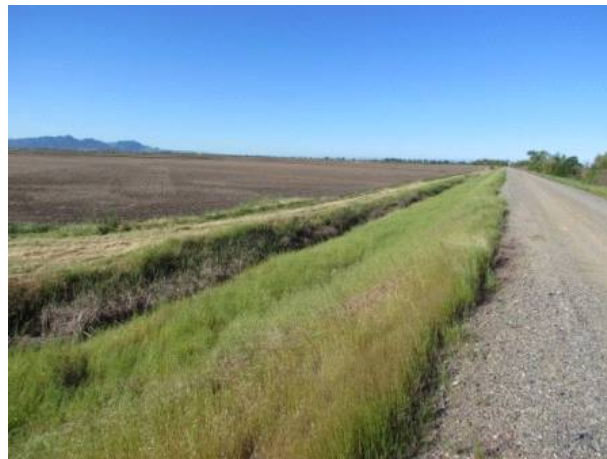
Levee Mile Report Line	10
Start Levee Mile	19.58
End Levee Mile	20.15
Location	Land Side
Category	
Item	Encroachments

View of the agricultural ditch along the toe.

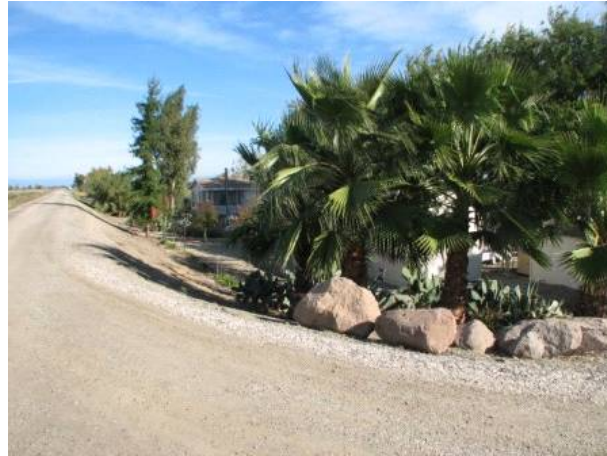
Levee Mile Report Line	12
Start Levee Mile	22.38
End Levee Mile	22.38
Location	Land Side
Category	
Item	Vegetation

View of landscaping along the toe.

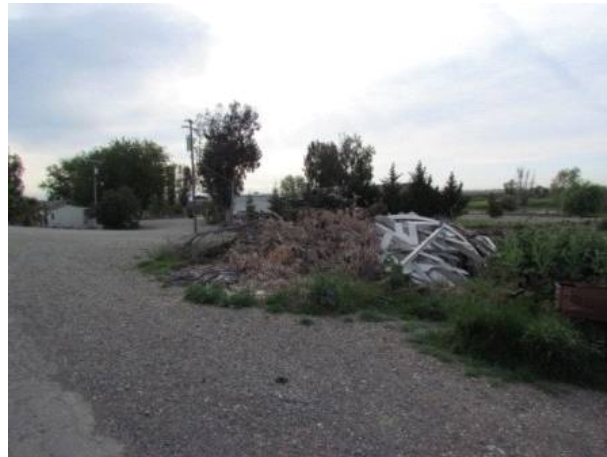
Levee Mile Report Line	13
Start Levee Mile	22.42
End Levee Mile	22.42
Location	Land Side
Category	
Item	Encroachments

View of the debris & prunings.

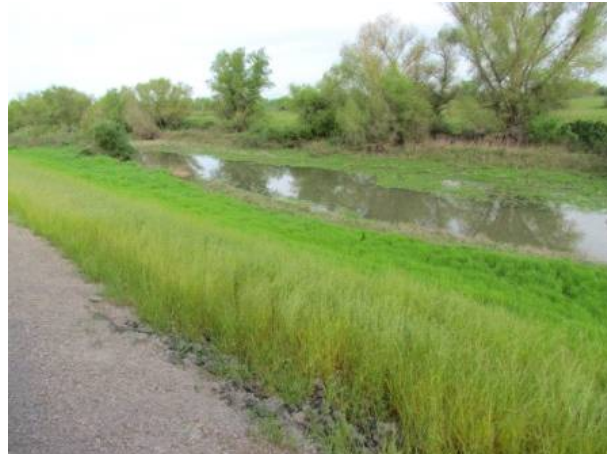
Levee Mile Report Line	14
Start Levee Mile	22.83
End Levee Mile	22.85
Location	Water Side
Category	
Item	Erosion / Bank Caving

View of the along the canal.
