**Flood Control Project Maintenance  
Levee Inspections****LMA District Cover Sheet****Spring 2014 Levee Inspection Results****Sutter Maintenance Yard Maintenance Area 0013**

**Spring 2014 Levee Inspection Results**

**Sutter Maintenance Yard Maintenance Area 0013**

Waterway			Bank	Unit Miles
Unit No. 01 Cherokee Canal			Right	18.87
	Spring (March - May)	Summer (June - August)	(September - November) Fall	Winter (December - February)
Unit Maintenance Rating (Fall Only)				
Date of Inspection	03/20/2014 - 03/20/2014			
DWR Inspector	Bob Duffey			
Accompanied By	Jason Cooper Sutter Maintenance Yard

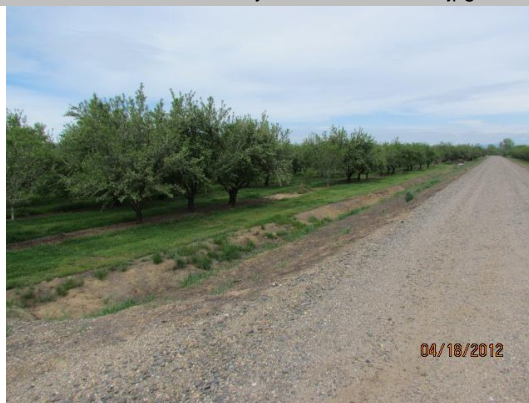
Photo 1 of 1 : rduffey\_s\_20140304\_446.jpg

LM Start	0.60	Rating **	M	Issue No.	19
LM End	0.60	Issue Type +	Ma	Location *	WS
Category	Earthen Levee			GPS Latitude/Longitude	
				Start	End
Item	Slope Stability			39.590173 °	39.590173 °
				-121.700617 °	-121.700617 °
DWR ID	DWR_MA0013_01_s _ 2013_19				
Action/Comments					
Repair the levee slope damaged by vehicle traffic and prevent access where possible.

View of the vehicle erosion along the waterside slope.

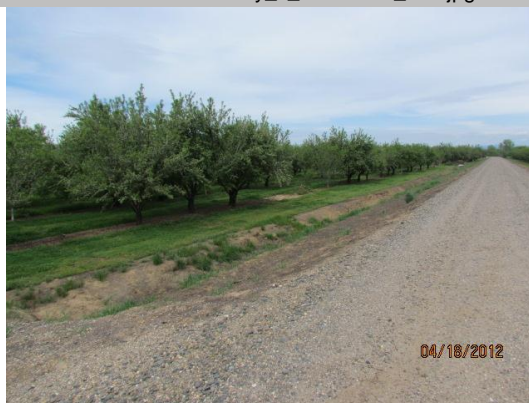
Photo 1 of 1 : rduffey\_s\_20140304\_443.jpg

LM Start	0.66	Rating **	M	Issue No.	14
LM End	1.20	Issue Type +	En	Location *	LS
Category	Earthen Levee			GPS Latitude/Longitude	
				Start	End
Item	Encroachments			39.589272 °	39.581472 °
				-121.700599 °	-121.700518 °
DWR ID	DWR_MA0013_01_s _ 2012_14				
Action/Comments					
Ditch

View of the agricultural ditch along the toe of the levee.

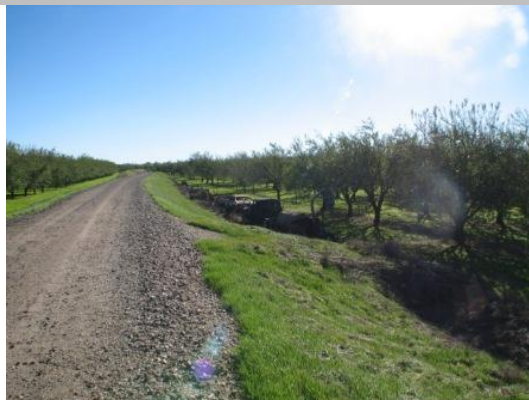
Photo 1 of 1 : rduffey\_s\_20140304\_442.jpg

LM Start	0.76	Rating **	M	Issue No.	12
LM End	0.78	Issue Type +	Ma	Location *	LS
Category	Earthen Levee			GPS Latitude/Longitude	
				Start	End
Item	Encroachments			39.587905 °	39.587505 °
				-121.700822 °	-121.700880 °
DWR ID	DWR_MA0013_01_s _ 2012_12				
Action/Comments					
Equipment

View of the equipment along the landside toe of the levee.

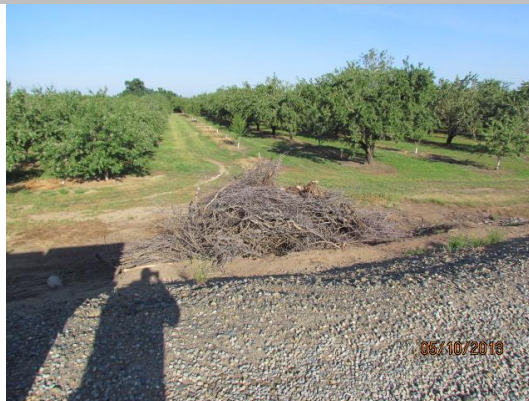
Photo 1 of 1 : rduffey\_s\_20140304\_447.jpg

View of the prunings along the landside toe.

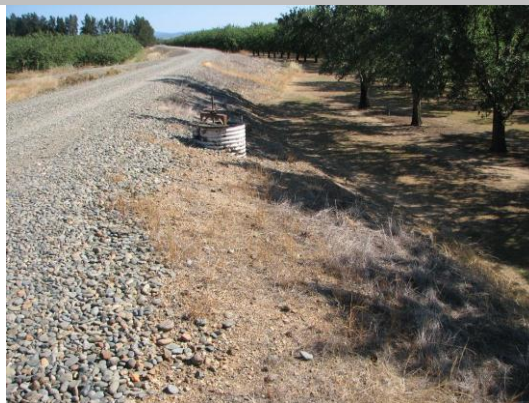
Photo 1 of 1 : UCIP\_4429.jpg

LM Start	1.70	Rating **	M	Issue No.	4
LM End	1.70	Issue Type +	En	Location *	LS
Category	Supplemental			GPS Latitude/Longitude	
				Start	End
Item	DWR UCIP Field Study			39.575816 °	39.575816 °
				-121.702900 °	-121.702900 °
DWR ID	DWR_MA0013_01_s _ 2014_4				
Action/Comments

Inspector Comments: FS\_ID:25107  
 EP\_NO: N/A  
 Repair Type:  
 Crossing Status:  
 UCIP Comments: Crossing has 4-inch pipe inside blocking positive closure/notify landowner to remove prior to flood season. LS crossing is blocked about 50% by sediment build up. Burrow activity present on LS near crossing/15/2013 Same as last inspection12/2/2013 Same as last inspection.  
 FIELD\_STRUCT\_DESC: 24-inch corrugated metal irrigation pipe through the levee, 7.6 feet below the crown. Slide gate in corrugated metal pipe riser on the waterward slope. Concrete headwall on the landward side. 36-inch concrete standpipe in the channel with 2 piles to deflect debris (USACE-1960). This entry matches the Drainage or Irrigation Structure referenced in O&M manual (HLM 1.69).  
 FS Date: 12/10/2013 7:32:16 AM

WS view looking upstream.

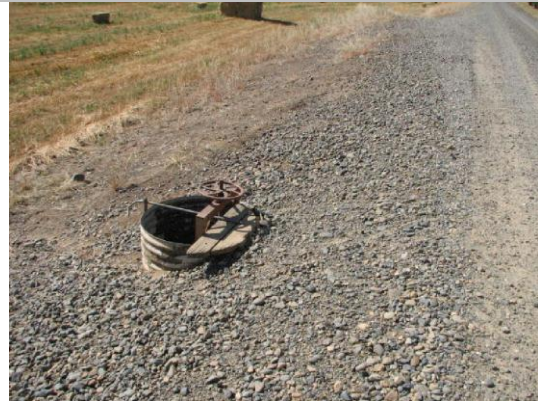
Photo 1 of 1 : UCIP\_4434.jpg

LM Start	2.36	Rating **	M	Issue No.	21
LM End	2.36	Issue Type +	En	Location *	LS
Category	Supplemental			GPS Latitude/Longitude	
				Start	End
Item	DWR UCIP Field Study			39.566434 °	39.566434 °
				-121.703750 °	-121.703750 °
DWR ID	DWR_MA0013_01_s_2014_21				
Action/Comments					
Inspector Comments: FS_ID:25108					
EP_NO: N/A					
Repair Type:					
Crossing Status:					
UCIP Comments: Non functional crossing due to LS headwall buried.					
This crossing was listed in the USACE Periodic Inspection report as					
Corp's inspect ID#USACE_CESPK_M13D_2011_p_0119 for no inlet or					
outlet visible7/15/2013 Same as last inspection12/2/2013 Same					
as last inspection.					
FIELD_STRUCT_DESC: 24-inch corrugated metal irrigation pipe					
through the levee 7.8 feet below the crown. Slide gate in corrugated					
metal pipe riser on the waterward slope. Pipe continues across					
channel. Concrete "U" headwall on the landward side. (USACE-1960).

Corrugated riser located on WS slope.

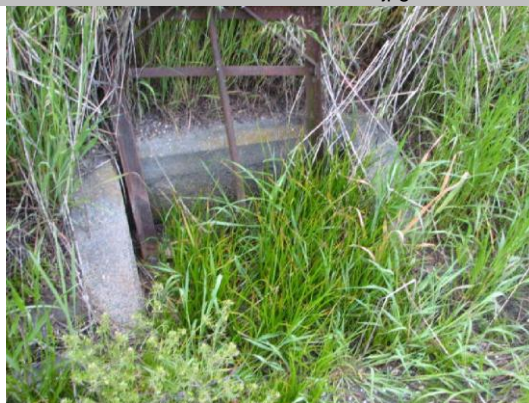
Photo 1 of 1 : UCIP\_4437.jpg

LM Start	3.80	Rating **	M	Issue No.	23
LM End	3.80	Issue Type +	En	Location *	LS
Category	Supplemental			GPS Latitude/Longitude	
				Start	End
Item	DWR UCIP Field Study			39.546317 °	39.546317 °
				-121.707510 °	-121.707510 °
DWR ID	DWR_MA0013_01_s_2014_23				
Action/Comments					
Inspector Comments: FS_ID:25115					
EP_NO: N/A					
Repair Type:					
Crossing Status:					
UCIP Comments: LS slide gate covered with silt. Slide gate is bent.					
Crossing appears not be in use. Limited inspection on WS and LS					
slope due to dense vegetation. Need photos of cleared					
slope 7/15/2013 Slopes have been cleared of vegetation and are in					
good condition. LS screw gate is still bent and silted over 12/2/2013					
Same as last inspection.					
FIELD_STRUCT_DESC: 24-inch corrugated metal drainpipe through					
the levee, 7.9 feet below the crown. Flap gate on the waterward end.					
Screw gate on the landward end. Concrete "U" headwalls on both ends

LS slide gate covered with silt. Slide gate is bent.

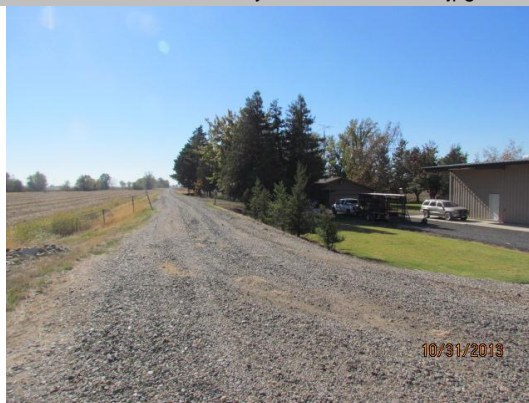
Photo 1 of 1 : rduffey\_s\_20140304\_445.jpg

LM Start	4.13	Rating **	M	Issue No.	18
LM End	4.20	Issue Type +	En	Location *	LS
Category	Earthen Levee			GPS Latitude/Longitude	
				Start	End
Item	Encroachments			39.541660 °	39.540651 °
				-121.707408 °	-121.707404 °
DWR ID	DWR_MA0013_01_s_2013_18				
Action/Comments					
Tree or limb

View of the redwood trees along the landside slope.

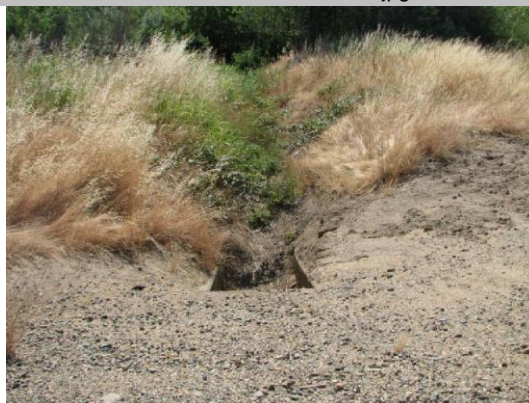
Photo 1 of 1 : UCIP\_4447.jpg

LM Start	4.42	Rating **	M	Issue No.	24
LM End	4.42	Issue Type +	En	Location *	LS
Category	Supplemental			GPS Latitude/Longitude	
				Start	End
Item	DWR UCIP Field Study			39.537516 °	39.537516 °
				-121.707580 °	-121.707580 °
DWR ID	DWR_MA0013_01_s_2014_24				
Action/Comments					
Inspector Comments: FS_ID:25117					
EP_NO: N/A					
Repair Type:					
Crossing Status:					
UCIP Comments: Minor debris on landside inlet. This crossing was listed in the USACE Periodic Inspection report as Corp's inspect ID#USACE_CESPK_M13D_2011_p_0189 for sediment and grass blocking WS and LS 7/15/2013 Same as last inspection 12/2/2013 Same as last inspection.					
FIELD_STRUCT_DESC: 36-inch corrugated metal drainpipe through the levee, 9.1 feet below The crown. Flap gate on the waterward end. Slide gate on landward end. Concrete "U" headwalls on both ends (USACE-1960). This entry matches the Drainage or Irrigation Structure referenced in O&M manual (HLM 4.43).

View of WS slope and toe.

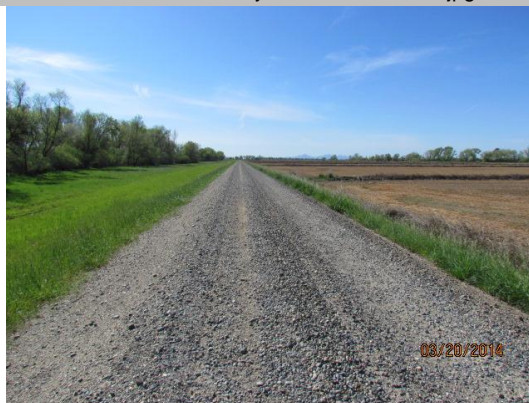
Photo 1 of 1 : rduffey\_s\_20140428\_236.jpg

LM Start	4.55	Rating **	A	Issue No.	43
LM End	4.55	Issue Type +	Ma	Location *	LS
Category	Earthen Levee			GPS Latitude/Longitude	
				Start	End
Item	Vegetation			39.535629 °	39.535629 °
				-121.707708 °	-121.707708 °
DWR ID	DWR_MA0013_01_s_2014_43				
Action/Comments					
Control annual grass and weeds on the levee slopes and easements.

View of native grasses on both slopes.

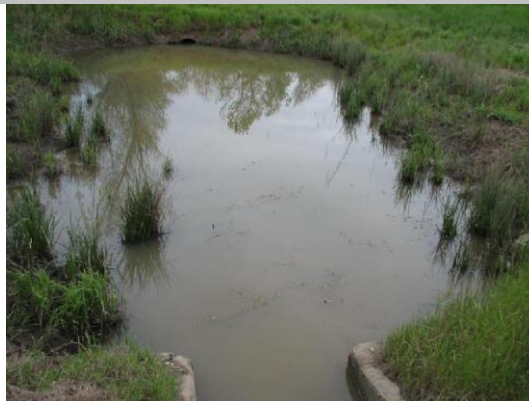
Photo 1 of 1 : UCIP\_4451.jpg

Action/Comments					
Inspector Comments: FS_ID:25119					
EP_NO: N/A					
Repair Type:					
Crossing Status:					
UCIP Comments: Minor vegetation on LS slope. This crossing was listed in the USACE Periodic Inspection report as Corp's inspect ID#USACE_CESPK_M13D_2011_p_0204 for restriction view of gate 7/15/2013 Same as last inspection 12/2/2013 Same as last inspection.					
FIELD_STRUCT_DESC: 24-inch corrugated metal drainpipe through the levee, 8.4 feet below the crown. Flap gate on the waterward end. Slide gate on the landward end. Concrete "U" headwalls on both ends (USACE-1960). This entry matches the Drainage or Irrigation Structure referenced in O&M manual (HLM 5.43).					
FS Date: 12/10/2013 8:01:26 AM

View of outlet cleared of vegetation.

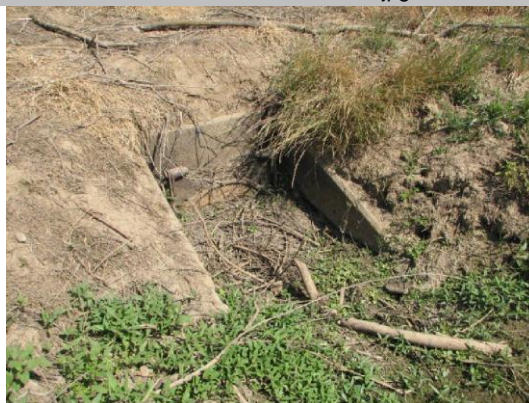
Photo 1 of 1 : UCIP\_4454.jpg

LM Start	5.72	Rating **	M	Issue No.	26
LM End	5.72	Issue Type +	En	Location *	LS
Category	Supplemental			GPS Latitude/Longitude	
				Start	End
Item	DWR UCIP Field Study			39.519212 °	39.519212 °
				-121.709030 °	-121.709030 °
DWR ID	DWR_MA0013_01_s _ 2014_26				
Action/Comments					
Inspector Comments: FS_ID:25125					
EP_NO: N/A					
Repair Type:					
Crossing Status:					
UCIP Comments: High sedimentation build up at WS and LS headwall. Limited inspection due to dense vegetation on WS and LS slope. Need photo of cleared WS and LS slopes. This crossing was listed in the USACE Periodic Inspection report as Corp's inspect ID# USACE_CESPK_M13D_2011_p_0210 for WS gate submerged 7/15/2013 Slopes have been cleared of vegetation and are in good condition. WS headwall and flapgate are fully covered in debris and not visible. Need to clear 2/2/2013 Same as last inspection.					
FIELD_STRUCT_DESC: 24-inch corrugated metal drainpipe through the levee, 9.2 feet below the crown. Flap gate on the waterward end. Concrete "U" headwalls on both ends (USACE-1960). This entry matches the Drainage or Irrigation Structure referenced in O&M manual (HLM 5.73).

View of WS flap gate buried.

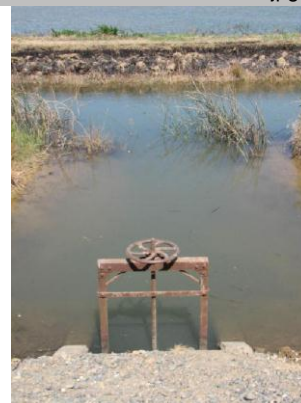
Photo 1 of 1 : UCIP\_4465.jpg

Action/Comments					
Inspector Comments: FS_ID:25126					
EP_NO: N/A					
Repair Type:					
Crossing Status:					
UCIP Comments: Burrow activity near crossing; burrow holes present on LS/15/2013 Same as last inspection12/2/2013 Same as last inspection.					
FIELD_STRUCT_DESC: 24-inch corrugated metal drainpipe through the levee, 6.2 feet below the crown. Flap gate on the waterward end. Slide gate on the landward end. Concrete "U" headwalls on both ends (USACE-1960). This entry matches the Drainage or Irrigation Structure referenced in O&M manual (HLM 5.97).					
FS Date: 12/10/2013 8:30:02 AM

View of LS slide gate.

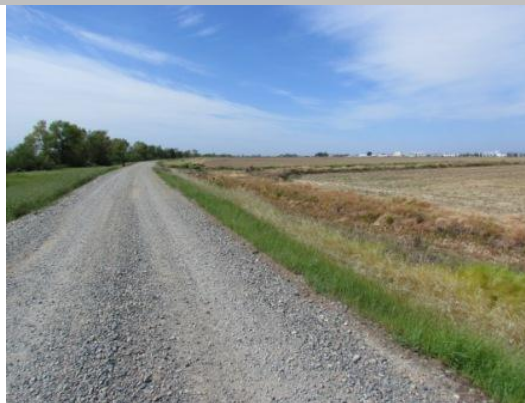
Photo 1 of 1 : rduffey\_s\_20140304\_438.jpg

LM Start	6.51	Rating **	M	Issue No.	3
LM End	7.09	Issue Type +	En	Location *	LS
Category	Earthen Levee			GPS Latitude/Longitude	
				Start	End
Item	Encroachments			39.508928 °	39.501438 °
				-121.714842 °	-121.719715 °
DWR ID	DWR_MA0013_01_s_2012_3				
Action/Comments					
Ditch

View of the agricultural ditch along the toe.

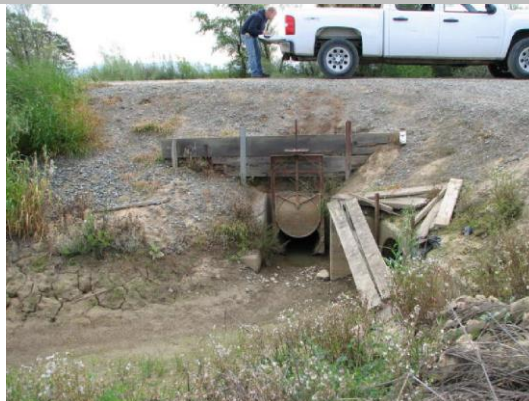
Photo 1 of 1 : UCIP\_4473.jpg

LM Start	6.55	Rating **	M	Issue No.	29
LM End	6.55	Issue Type +	En	Location *	LS
Category	Supplemental			GPS Latitude/Longitude	
				Start	End
Item	DWR UCIP Field Study			39.508309 °	39.508309 °
				-121.715100 °	-121.715100 °
DWR ID	DWR_MA0013_01_s _ 2014_29				
Action/Comments					
Inspector Comments: FS_ID:25128					
EP_NO: 5200B					
Repair Type:					
Crossing Status:					
UCIP Comments: Hole behind flashboards against slide gate on LS slope (Health and Safety Issue). Limited inspection on WS slope due to dense vegetation. Need photo of cleared slope on WS 3/15/2013 WS slope has been cleared of vegetation and is in good condition. Hole is still present behind flash boards on LS 2/2/2013 Same as last inspection.					
FIELD_STRUCT_DESC: 1 of 10 items under Board Order 5200, 5200A, and 5200B: 24-inch corrugated metal drainpipe through the levee, 7.8 feet below the crown. Flap gate on the waterward end. Slide gate on the landward end. Concrete head wall on both ends (Board Order 5200B-1965). This entry matches the Drainage or Irrigation Structure referenced in O&M manual (HLM 6.56).

View of LS slide gate. Levee section missing behind boards.

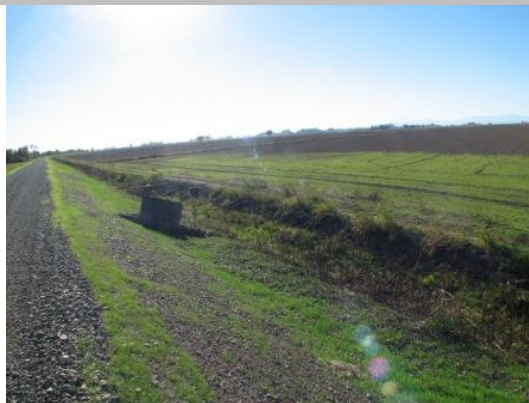
Photo 1 of 1 : rduffey\_s\_20140304\_437.jpg

LM Start	6.63	Rating **	M	Issue No.	2
LM End	6.63	Issue Type +	Ma	Location *	LS
Category	Earthen Levee			GPS Latitude/Longitude	
				Start	End
Item	Encroachments			39.507337 °	39.507337 °
				-121.715693 °	-121.715693 °
DWR ID	DWR_MA0013_01_s_2012_2				
Action/Comments					
Material

View of a concrete block along the toe.

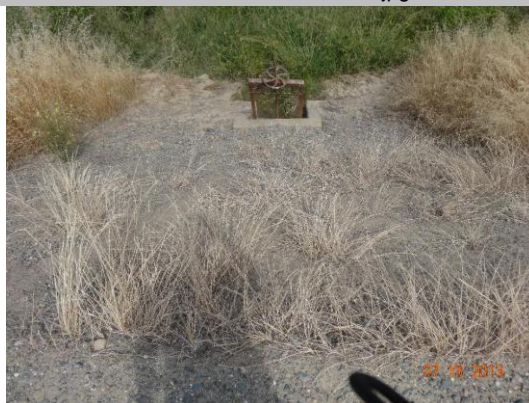
Photo 1 of 1 : UCIP\_4490.jpg

UCIP Comments: LMA's inspection sheet of 2011 indicates settlement and visible corrosion. Damage/severe corrosion on screw gate where it bolts to headwall. No visible signs of settlement due to high vegetation cover. Limited inspection on WS and LS slopes due to dense vegetation. Need photos of cleared slopes for this crossing 7/15/2013. Slopes have been cleared of vegetation and are in good condition.

There were no apparent signs of settling. LS screw gate is still damaged 2/2/2013 Same as last inspection.

LS slope cleared of vegetation

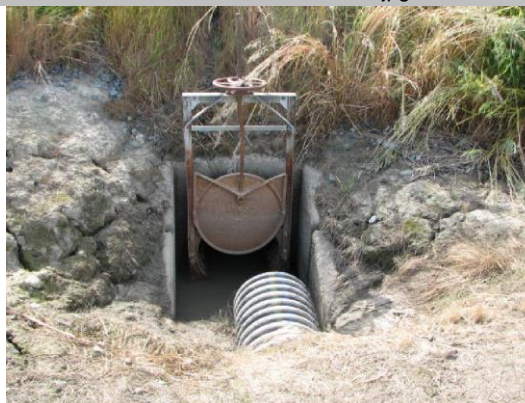
Photo 1 of 1 : UCIP\_4492.jpg

Action/Comments					
Inspector Comments: FS_ID:25136					
EP_NO: N/A					
Repair Type:					
Crossing Status:					
UCIP Comments: LS slide gate stem is bent and needs to be replaced. Limited inspection on WS and LS slope due to dense vegetation. Need photos of cleared slopes during next inspection. Confirmed flap gate on WS. This crossing was listed in the USACE Periodic Inspection report as Corp's inspect ID#USACE_CESPK_M13D_2011_p_0244 for submerged WS gate/15/2013 Slopes have been cleared of vegetation and are in good condition. LS screw gate stem is still bent 2/2/2013 Same as last inspection.					
FIELD_STRUCT_DESC: 24-inch corrugated metal drainpipe through the levee, 11.2 feet below the crown. Flap gate on the waterward end. Slide gate on the landward end. Concrete "U" headwall on both ends (USACE-1960). This entry matches the Drainage or Irrigation Structure referenced in O&M manual (HLM 7.34).

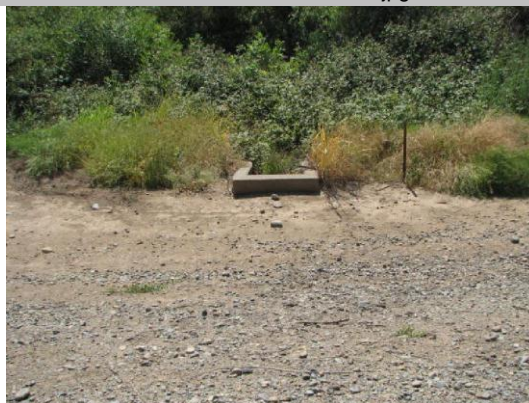
Photo 1 of 1 : UCIP\_4513.jpg

Action/Comments					
Inspector Comments: FS_ID:25145					
EP_NO: N/A					
Repair Type:					
Crossing Status:					
UCIP Comments: Sediment build up against flashboards. Flashboards are in use on landside of levee 7/15/2013 Same as last inspection 12/3/2013 Same as last inspection.					
FIELD_STRUCT_DESC: 24-inch corrugated metal drainpipe through the levee, 8.2 feet below the crown. Flap gate on the waterward end. Concrete "U" headwalls on both ends (USACE-1960). Flashboards should be present on the landward side. This entry matches the Drainage or Irrigation Structure referenced in O&M manual (HLM 8.12).					
FS Date: 12/10/2013 9:03:31 AM

View of WS slope and toe.

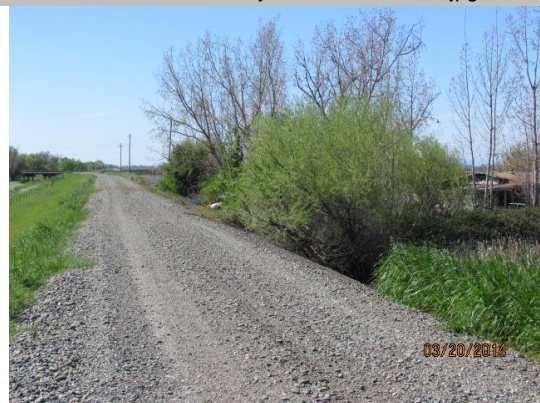
Photo 1 of 1 : rduffey\_s\_20140428\_237.jpg

LM Start	9.84	Rating **	M	Issue No.	5
LM End	9.87	Issue Type +	Ma	Location *	LS
Category	Earthen Levee			GPS Latitude/Longitude	
				Start	End
Item	Trim / Thin Trees			39.467170 °	39.466860 °
				-121.743887 °	-121.744108 °
DWR ID	DWR_MA0013_01_s _ 2012_5				
Action/Comments					
Trim trees to at least five feet above ground level.

Trim the trees along the landside slope and toe.

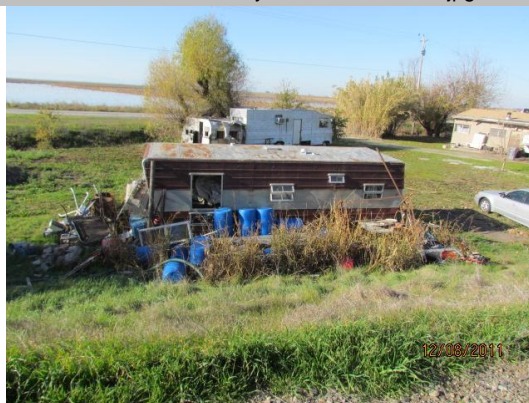
Photo 1 of 1 : rduffey\_s\_20140304\_441.jpg

View of a trailer &amp; material along the L/S toe.

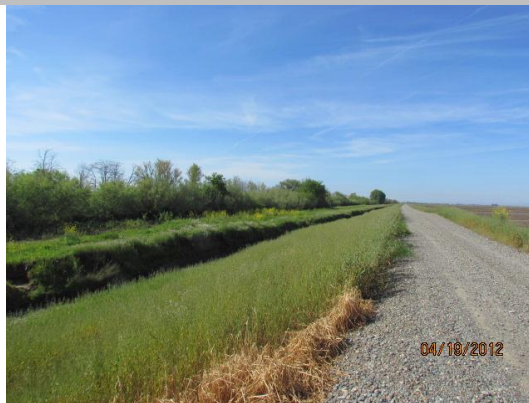
Photo 1 of 1 : rduffey\_s\_20140304\_444.jpg

LM Start	11.20	Rating **	M	Issue No.	17
LM End	13.47	Issue Type +	En	Location *	WS
Category	Earthen Levee			GPS Latitude/Longitude	
				Start	End
Item	Encroachments			39.449777 °	39.421255 °
				-121.755103 °	-121.774893 °
DWR ID	DWR_MA0013_01_s_2012_17				
Action/Comments					
Ditch

View of the agricultural ditch along the toe of the levee.

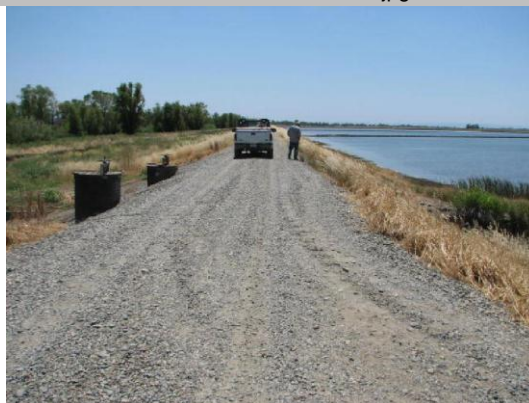
Photo 1 of 1 : UCIP\_4529.jpg

UCIP Comments: Limited inspection on WS and LS slope due to dense vegetation. WS outlet of pipe not found. Need photos of cleared WS and LS slopes. Determine if WS outlet daylight after WS slope is cleared 7/15/2013 Slopes have been cleared of vegetation and are in good condition. Still no sign of WS end of pipe 4/2/2013 Same as last inspection.

Overview of levee crown at crossing looking downstream.

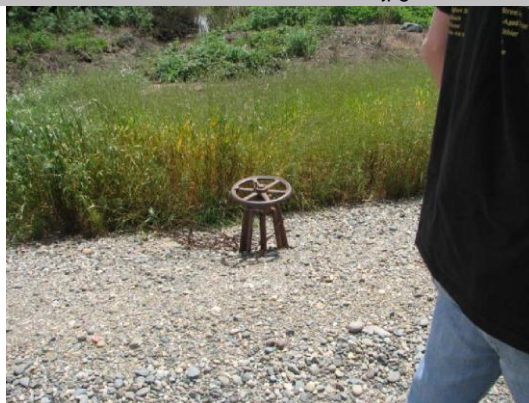
Photo 1 of 1 : UCIP\_4536.jpg

LM Start	13.97	Rating **	M	Issue No.	39
LM End	13.97	Issue Type +	En	Location *	WS
Category	Supplemental			GPS Latitude/Longitude	
				Start	End
Item	DWR UCIP Field Study			39.416756 °	39.416756 °
				-121.782060 °	-121.782060 °
DWR ID	DWR_MA0013_01_s_2014_39				
Action/Comments					
Inspector Comments: FS_ID:25167					
EP_NO: N/A					
Repair Type:					
Crossing Status:					
UCIP Comments: Non-functional crossing-buried slide gate on WS.					
Limited inspection on WS and LS slope/toe due to dense vegetation.					
Need photo of cleared WS & LS slopes or toe. This crossing is listed in					
the USACE periodic inspection report as Corp's Inspection ID#					
USACE_CESPK_M13D_2011_p_0352 for abandoned gate on WS					
slope 7/15/2013 Same as last inspection 12/3/2013 Same as last					
inspection.					
FIELD_STRUCT_DESC: Abandoned 12 inch steel drainpipe through					
the levee, 3 feet below the crown. Gate valve on the waterward slope.

Buried slide gate on the WS slope.

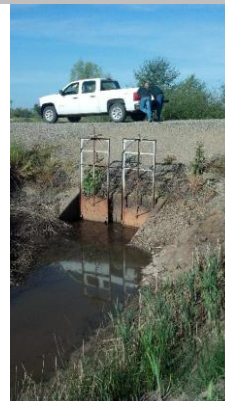
Photo 1 of 1 : UCIP\_4578.jpg

Headwall and screw gates (2) located on land side of levee. Missing handle on screw gate 1 of 2.

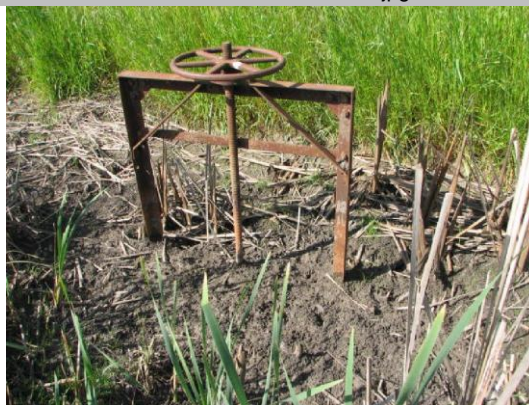
Photo 1 of 1 : UCIP\_4590.jpg

LS slide gate shown is buried in sediment.

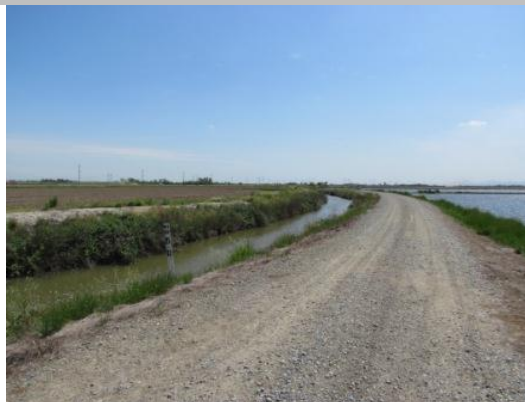
Photo 1 of 1 : rduffey\_s\_20140304\_479.jpg

View of agricultural ditch along the toe.

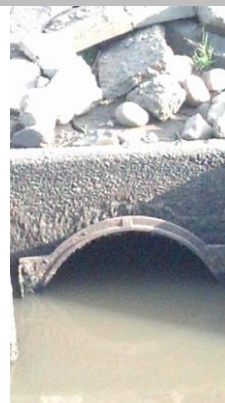
Photo 1 of 1 : UCIP\_4625.jpg

Headwall and damaged/missing screw gate on land side of levee

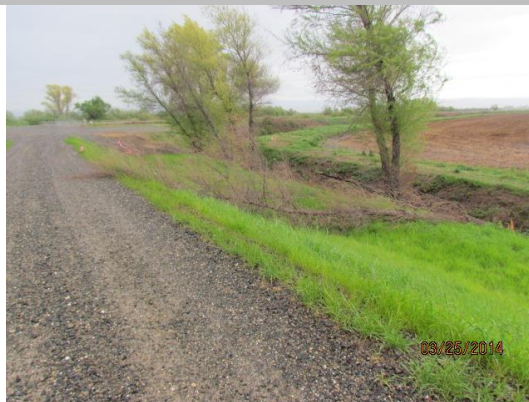
Photo 1 of 1 : rduffey\_s\_20140428\_215.jpg

View of the tree limbs on the landside slope and toe.

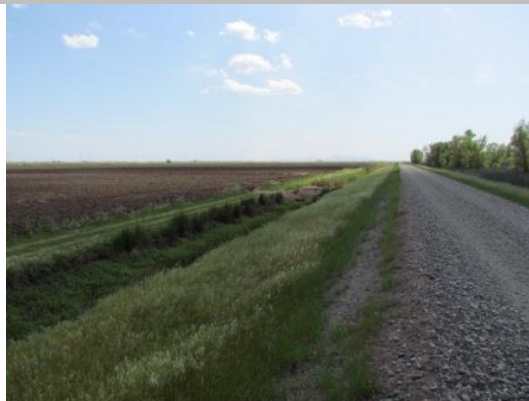
Photo 1 of 1 : rduffey\_s\_20140304\_473.jpg

View of the agricultural ditch along the toe.

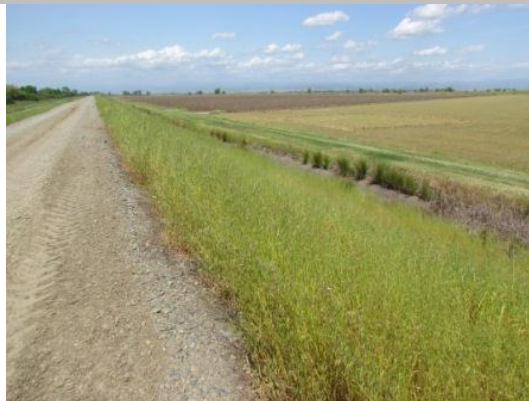
Photo 1 of 1 : rduffey\_s\_20140304\_474.jpg

View of the agricultural ditch along the toe.

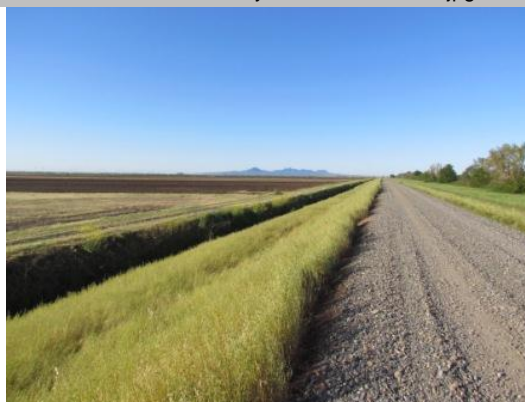
Photo 1 of 1 : rduffey\_s\_20140304\_475.jpg

View of the agricultural ditch along the toe.

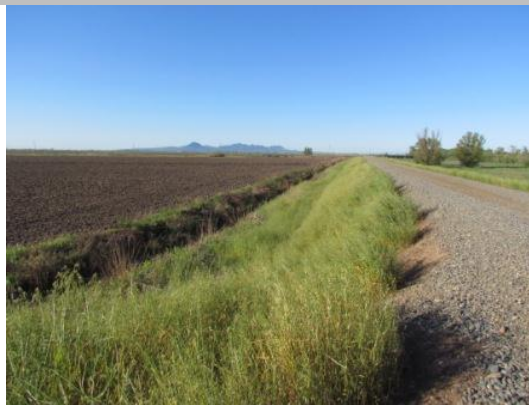
Photo 1 of 1 : rduffey\_s\_20140304\_476.jpg

View of the agricultural ditch along the toe.

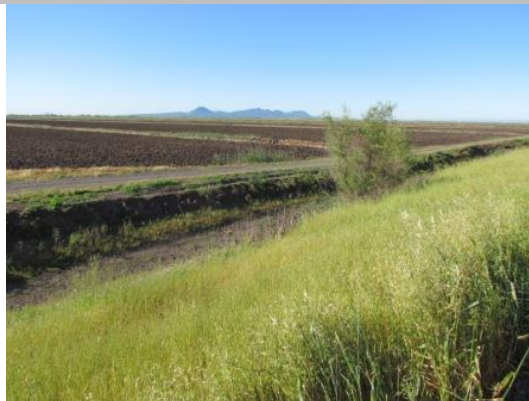
Photo 1 of 1 : rduffey\_s\_20140304\_477.jpg

View of the agricultural ditch along the toe.

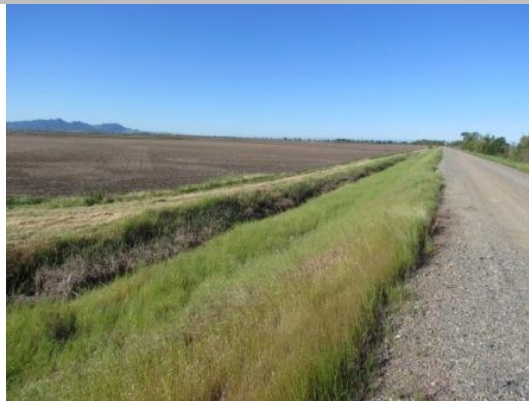
Photo 1 of 1 : rduffey\_s\_20140304\_478.jpg

View of the agricultural ditch along the toe.

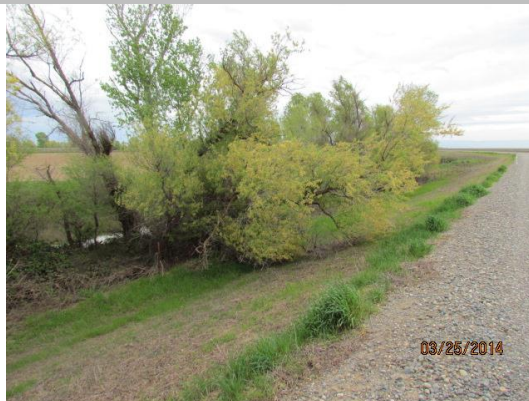
Photo 1 of 1 : rduffey\_s\_20140428\_218.jpg

View of the tree limbs along the waterside slope and toe.

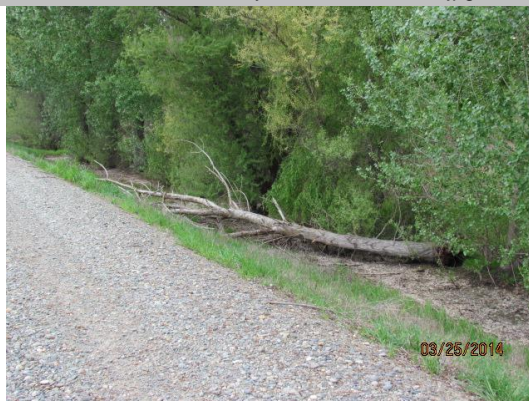
Photo 1 of 1 : rduffey\_s\_20140428\_219.jpg

View of the tree limbs along the waterside toe.

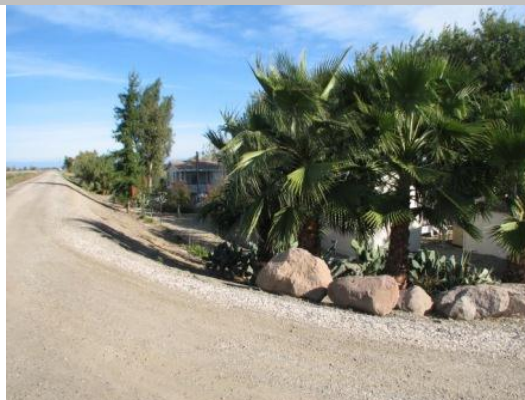
Photo 1 of 1 : rduffey\_s\_20140304\_468.jpg

View of landscaping along the toe.

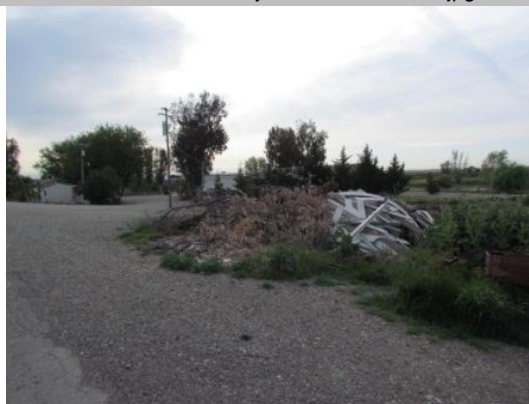
Photo 1 of 1 : rduffey\_s\_20140304\_472.jpg

View of the debris &amp; prunings.

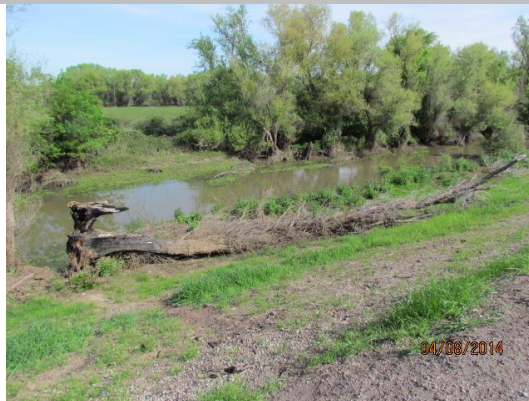
Photo 1 of 1 : rduffey\_s\_20140428\_220.jpg

View of the tree limbs along the waterside slope and toe.
