**Flood Control Project Maintenance
Levee Inspections****LMA District Cover Sheet****Spring 2015 Levee Inspection Results****Sutter Maintenance Yard Maintenance Area 0013**

Spring 2015 Levee Inspection Results

Sutter Maintenance Yard Maintenance Area 0013

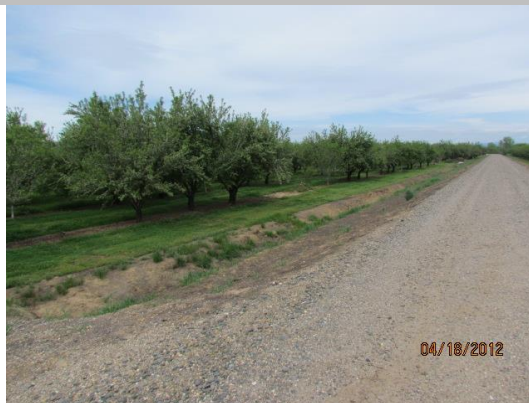
Photo 1 of 1 : SP_2015_MA0013_300_19_20150310_00009.jpg

LM Start	0.57	Rating **	M	Issue No.	19
LM End	0.57	Issue Type +	Ma	Location *	WS
Category	Earthen Levee			GPS Latitude/Longitude	
				Start	End
Item	Slope Stability			39.590173 °	39.590173 °
				-121.700617 °	-121.700617 °
DWR ID	DWR_MA0013_01_s_2013_19				
Action/Comments					
Repair the levee slope damaged by vehicle traffic and prevent access where possible.

View of the vehicle erosion along the waterside slope.

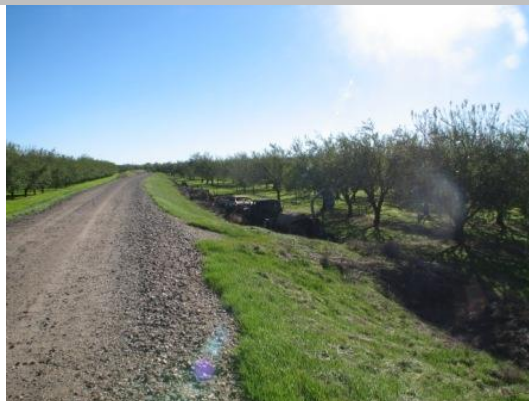
Photo 1 of 1 : SP_2015_MA0013_300_12_20150310_00006.jpg

View of the equipment along the landside toe of the levee.

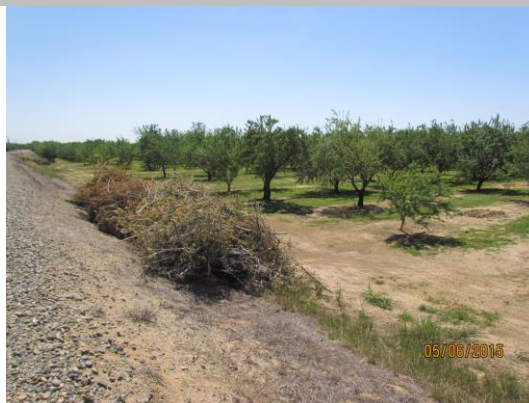
Photo 1 of 1 : SP_2015_MA0013_300_44_20150519_00014.jpg

LM Start	0.87	Rating **	M	Issue No.	44
LM End	0.87	Issue Type +	En	Location *	LS
Category	Earthen Levee			GPS Latitude/Longitude	
				Start	End
Item	Encroachments			39.585857 °	39.585857 °
				-121.700540 °	-121.700540 °
DWR ID	DWR_MA0013_01_s _ 2015_44				
Action/Comments					
Prunings					
Inspector Comments: Remove the prunings from the landside slope.

View of the prunings along the landside slope.

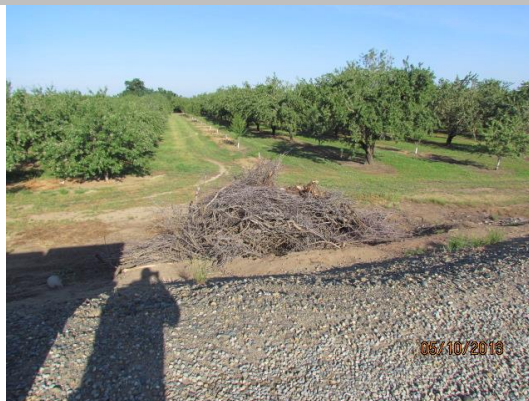
Photo 1 of 1 : SP_2015_MA0013_300_20_20150310_00010.jpg

LM Start	0.94	Rating **	M	Issue No.	20
LM End	0.94	Issue Type +	En	Location *	LS
Category	Earthen Levee			GPS Latitude/Longitude	
				Start	End
Item	Encroachments			39.584885 °	39.584885 °
				-121.700487 °	-121.700487 °
DWR ID	DWR_MA0013_01_s _ 2013_20				
Action/Comments					
Prunings

View of the prunings along the landside toe.

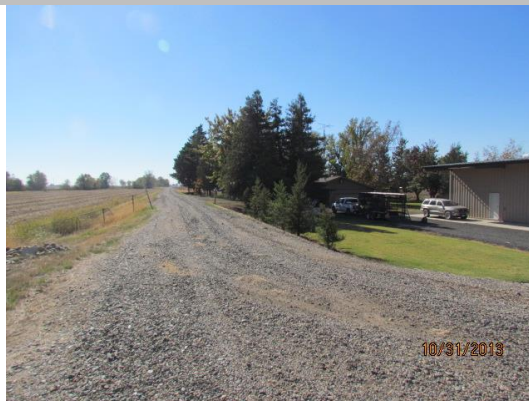
Photo 1 of 1 : SP_2015_MA0013_300_18_20150310_00008.jpg

View of the redwood trees along the landside slope.

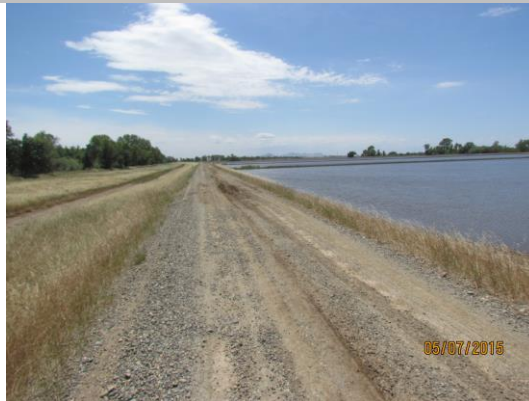
Photo 1 of 1 : SP_2015_MA0013_300_47_20150519_00016.jpg

LM Start	4.45	Rating **	M	Issue No.	47
LM End	5.35	Issue Type +	Ma	Location *	CR
Category	Earthen Levee			GPS Latitude/Longitude	
				Start	End
Item	Crown Surface / Depressions / Rutting			39.536017 °	39.523020 °
				-121.707705 °	-121.707577 °
DWR ID	DWR_MA0013_01_s_2015_47				
Action/Comments					
Repair depressions or ruts in the crown or slope.					
Inspector Comments: Repair the ruts in the crown roadway.

View of the ruts in the crown roadway.

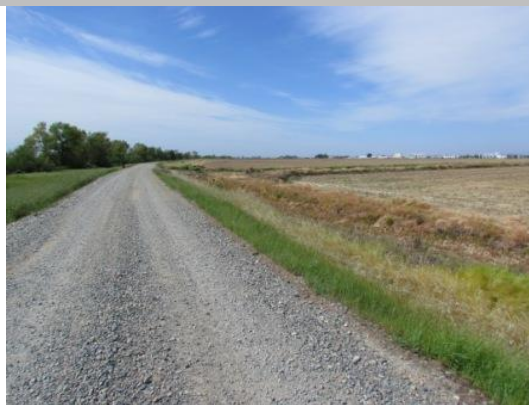
Photo 1 of 1 : SP_2015_MA0013_300_3_20150310_00002.jpg

Action/Comments					
Ditch

View of the agricultural ditch along the toe.

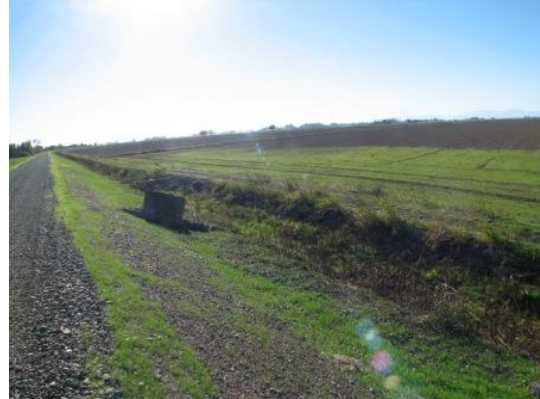
Photo 1 of 1 : SP_2015_MA0013_300_2_20150310_00001.jpg

View of a concrete block along the toe.

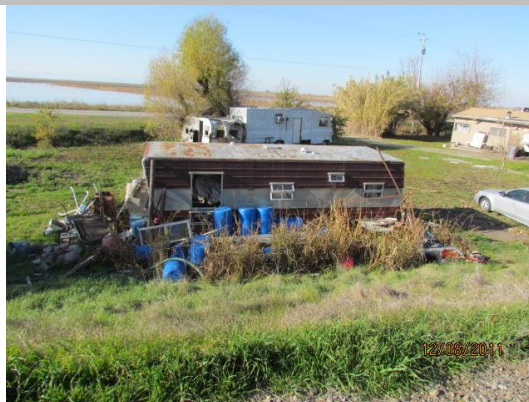
Photo 1 of 1 : SP_2015_MA0013_300_10_20150310_00005.jpg

LM Start	9.74	Rating **	M	Issue No.	10
LM End	9.74	Issue Type +	Ma	Location *	LS
Category	Earthen Levee			GPS Latitude/Longitude	
				Start	End
Item	Encroachments			39.466635 °	39.466635 °
				-121.744228 °	-121.744228 °
DWR ID	DWR_MA0013_01_f_2013_10				
Action/Comments					
Material

View of a trailer & material along the L/S toe.

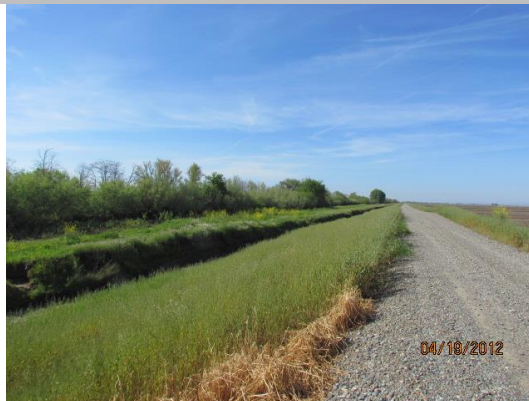
Photo 1 of 1 : SP_2015_MA0013_300_17_20150310_00007.jpg

View of the agricultural ditch along the toe of the levee.

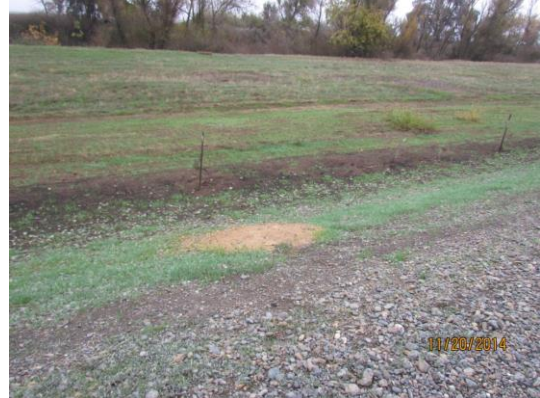
Photo 1 of 1 : SP_2015_MA0013_300_45_20150310_00012.jpg

View of the rodent hole on the waterside slope.

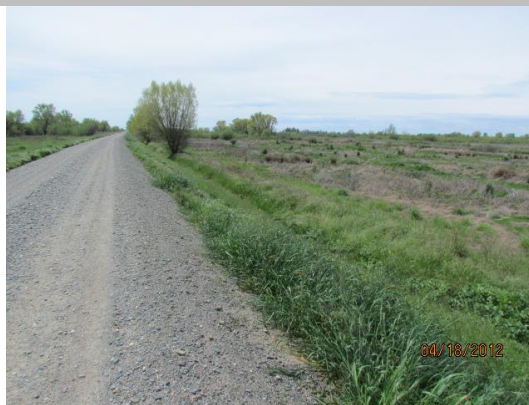
Photo 1 of 1 : SP_2015_MA0013_300_7_20150310_00004.jpg

View of the agricultural along the toe of the levee.

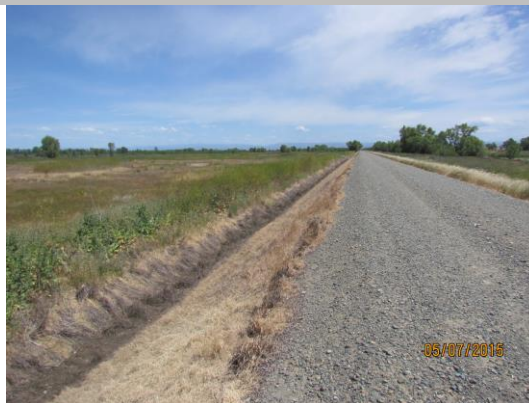
Photo 1 of 1 : SP_2015_MA0013_300_46_20150519_00015.jpg

View of no vegetation on the landside slope.

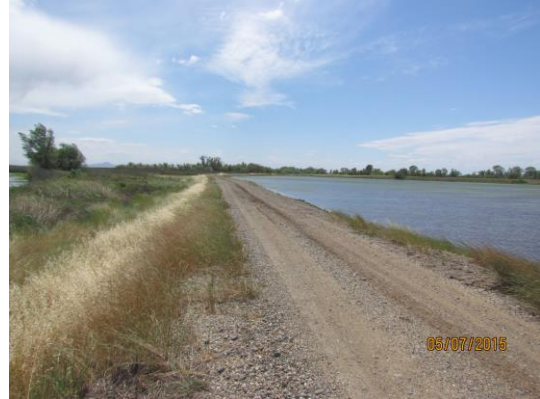
Photo 1 of 1 : SP_2015_MA0013_301_59_20150519_00023.jpg

View of the ruts in the crown roadway.

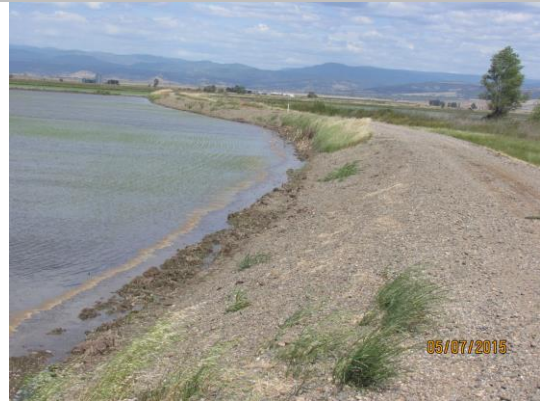
Photo 1 of 1 : SP_2015_MA0013_301_58_20150519_00022.jpg

LM Start	3.90	Rating **	M	Issue No.	58
LM End	4.04	Issue Type +	Ma	Location *	LS
Category	Earthen Levee			GPS Latitude/Longitude	
				Start	End
Item	Erosion / Bank Caving			39.524973 °	39.526697 °
				-121.701005 °	-121.699677 °
DWR ID	DWR_MA0013_02_s_2015_58				
Action/Comments					
Schedule repair of erosion site prior to the next inspection.					
Inspector Comments: Repaire the landside slope erosion.

View of the landside slope erosion that was caused by the water overtopping the levee.

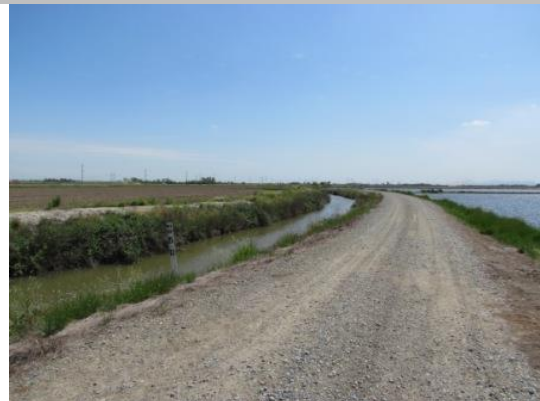
Photo 1 of 1 : SP_2015_MA0013_301_911_20150310_00014.jpg

LM Start	5.00	Rating **	M	Issue No.	911
LM End	5.09	Issue Type +	En	Location *	WS
Category	Earthen Levee			GPS Latitude/Longitude	
				Start	End
Item	Encroachments			39.537468 °	39.526858 °
				-121.690882 °	-121.689360 °
DWR ID	DWR_MA0013_02_s_2012_911				
Action/Comments					
Ditch

View of agricultural ditch along the toe.

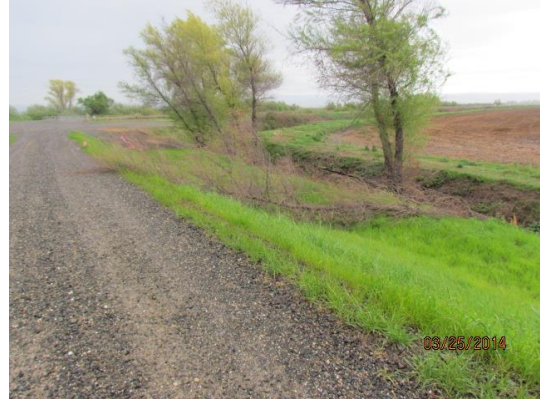
Photo 1 of 1 : SP_2015_MA0013_301_55_20150310_00013.jpg

View of the tree limbs on the landside slope and toe.

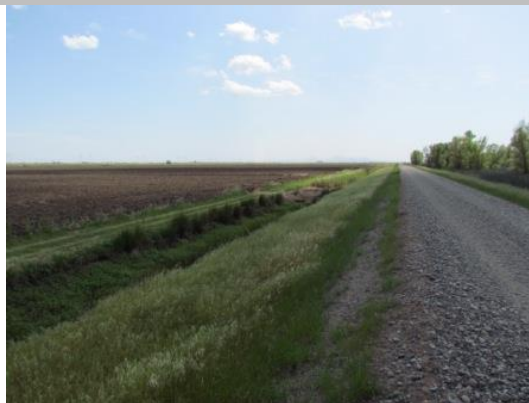
Photo 1 of 1 : SP_2015_MA0013_301_12_20150310_00005.jpg

View of the agricultural ditch along the toe.

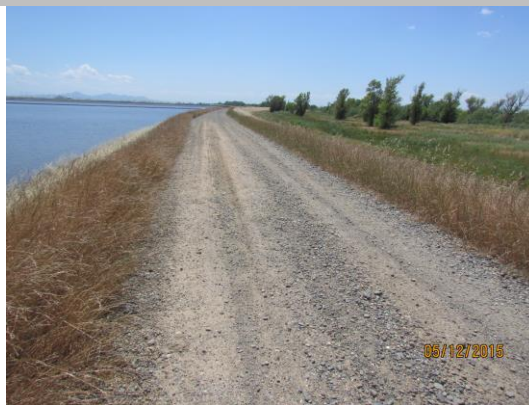
Photo 1 of 1 : SP_2015_MA0013_301_60_20150518_00015.jpg

View of the ruts in the crown roadway.

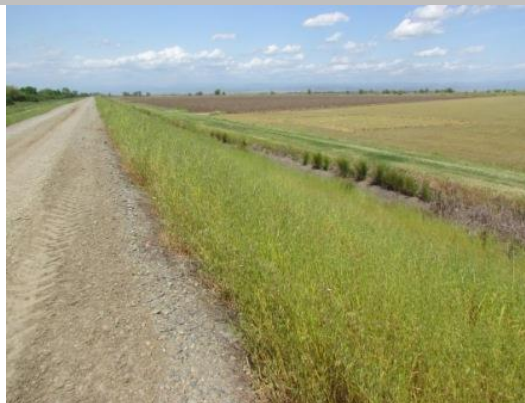
Photo 1 of 1 : SP_2015_MA0013_301_13_20150310_00006.jpg

View of the agricultural ditch along the toe.

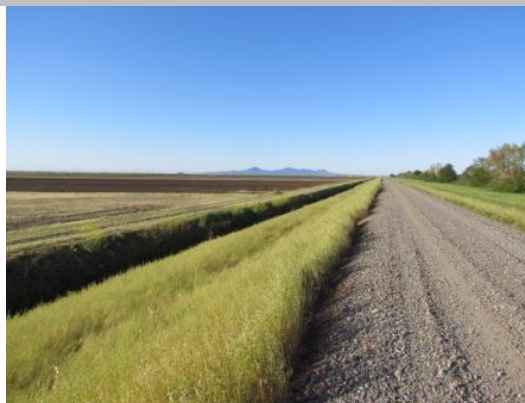
Photo 1 of 1 : SP_2015_MA0013_301_18_20150310_00007.jpg

LM Start	10.59	Rating **	M	Issue No.	18
LM End	11.66	Issue Type +	En	Location *	LS
Category	Earthen Levee			GPS Latitude/Longitude	
				Start	End
Item	Encroachments			39.464305 °	39.450333 °
				-121.744172 °	-121.753157 °
DWR ID	DWR_MA0013_02_s_2012_18				
Action/Comments					
Ditch

View of the agricultural ditch along the toe.

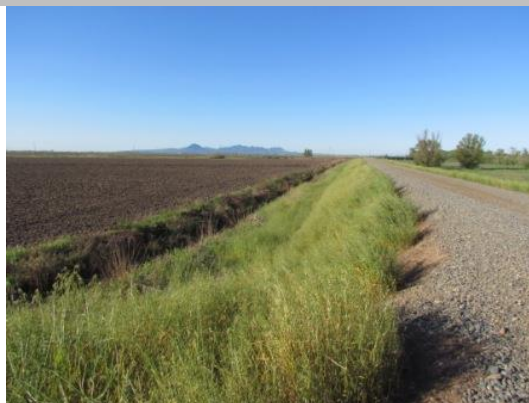
Photo 1 of 1 : SP_2015_MA0013_301_19_20150310_00008.jpg

Action/Comments					
Ditch

View of the agricultural ditch along the toe.

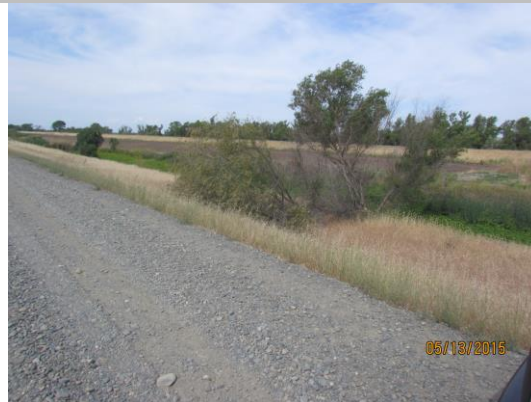
Photo 1 of 1 : SP_2015_MA0013_301_61_20150518_00016.jpg

View of the tree along the waterside toe and slope.

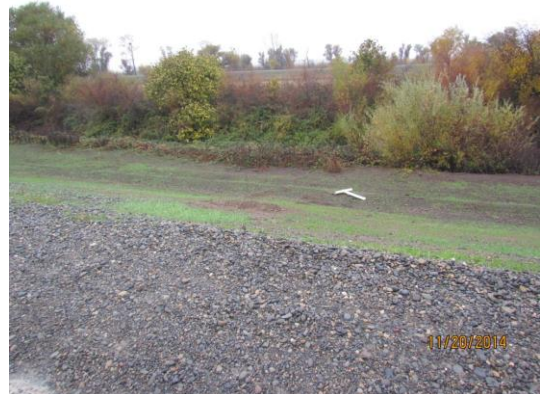
Photo 1 of 1 : SP_2015_MA0013_301_54_20150310_00012.jpg

View of the rodent holes and bait station along the waterside slope.

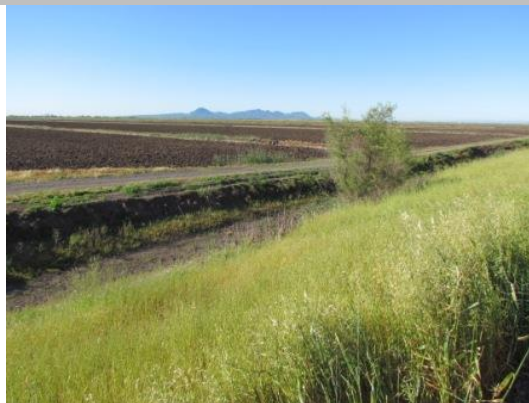
Photo 1 of 1 : SP_2015_MA0013_301_20_20150310_00009.jpg

View of the agricultural ditch along the toe.

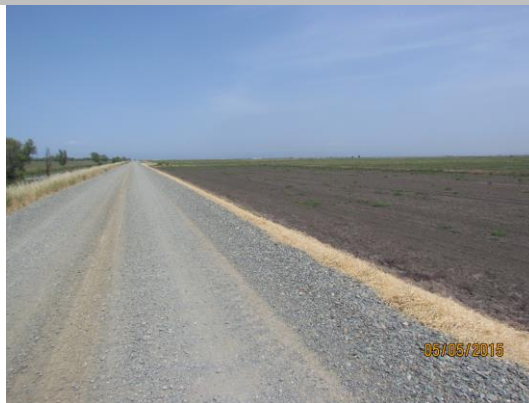
Photo 1 of 1 : SP_2015_MA0013_301_56_20150519_00021.jpg

View of no vegetation on the landside slope.

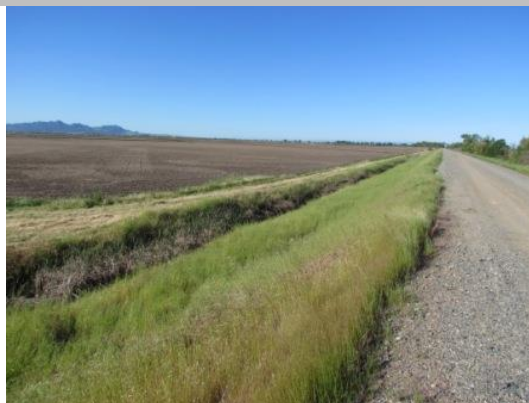
Photo 1 of 1 : SP_2015_MA0013_301_21_20150310_00010.jpg

LM Start	19.37	Rating **	M	Issue No.	21
LM End	19.92	Issue Type +	En	Location *	LS
Category	Earthen Levee			GPS Latitude/Longitude	
				Start	End
Item	Encroachments			39.383252 °	39.378192 °
				-121.830565 °	-121.838543 °
DWR ID	DWR_MA0013_02_s_2012_21				
Action/Comments					
Ditch

View of the agricultural ditch along the toe.

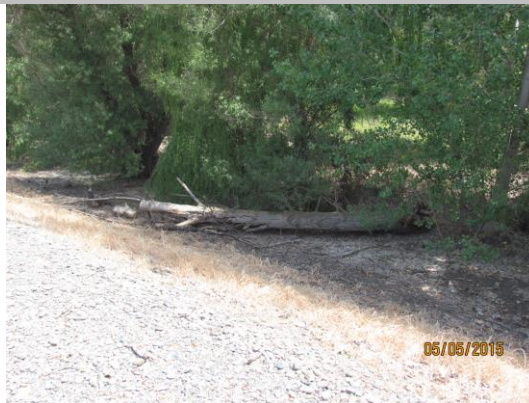
Photo 1 of 1 : SP_2015_MA0013_301_51_20150519_00017.jpg

View of the tree limbs along the landside toe.

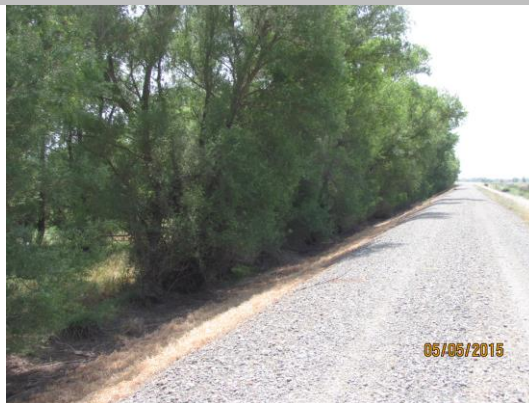
Photo 1 of 1 : SP_2015_MA0013_301_6_20150519_00019.jpg

LM Start	20.48	Rating **	M	Issue No.	6
LM End	20.75	Issue Type +	Ma	Location *	LS
Category	Earthen Levee			GPS Latitude/Longitude	
				Start	End
Item	Trim / Thin Trees			39.372724 °	39.370732 °
				-121.846022 °	-121.850282 °
DWR ID	DWR_MA0013_02_s_2013_6				
Action/Comments					
Trim trees to at least five feet above ground level.					
Inspector Comments: Trim the trees 5 feet to allow visibility.

Trim the trees 5 feet to allow visibility along the landside slope.

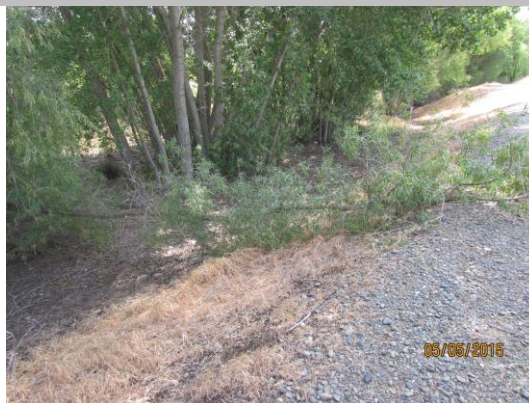
Photo 1 of 1 : SP_2015_MA0013_301_52_20150519_00018.jpg

LM Start	20.65	Rating **	M	Issue No.	52
LM End	20.65	Issue Type +	En	Location *	LS
Category	Earthen Levee			GPS Latitude/Longitude	
				Start	End
Item	Encroachments			39.371433 °	39.371433 °
				-121.848753 °	-121.848753 °
DWR ID	DWR_MA0013_02_s_2014_52				
Action/Comments					
Tree or limb					
Inspector Comments: Remove the tree limbs from the landside slope and toe.

View of the trees limbs along the landside slope and toe.

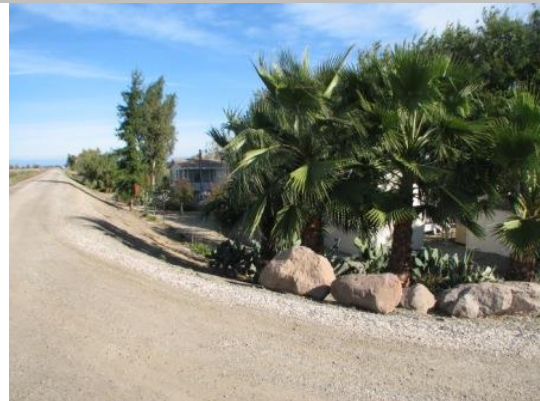
Photo 1 of 1 : SP_2015_MA0013_301_4_20150310_00001.jpg

Action/Comments					
Landscaping

View of landscaping along the toe.

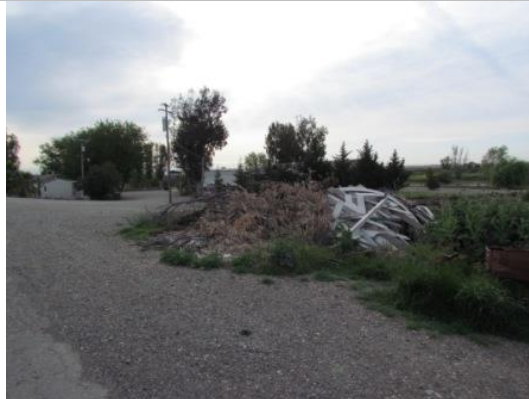
Photo 1 of 1 : SP_2015_MA0013_301_8_20150310_00004.jpg

View of the debris & prunings.

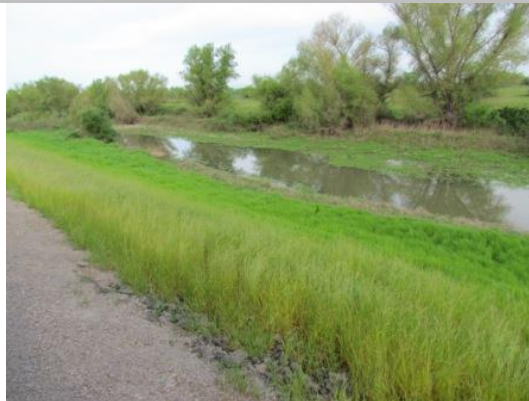
Photo 1 of 1 : SP_2015_MA0013_301_7_20150310_00003.jpg

View of the erosion along the canal.
