**Flood Control Project Maintenance
Levee Inspections****LMA District Cover Sheet****Spring 2016 Levee Inspection Results****Sutter Maintenance Yard Maintenance Area 0013**

Spring 2016 Levee Inspection Results

Sutter Maintenance Yard Maintenance Area 0013

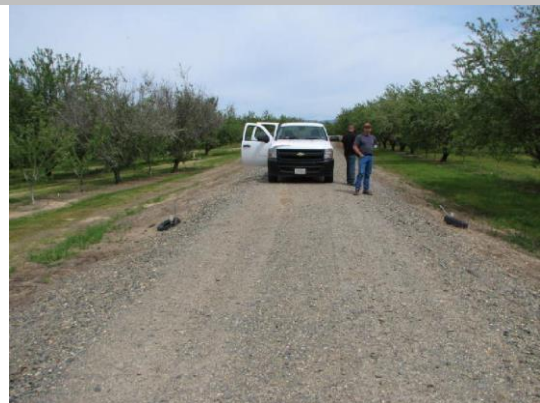
Photo 1 of 2 : UCIP_SP_2016_48018_66680.jpg

Overview of the crossing.

Comment Code						
Inspector Comment						
FS_ID:48018 DS_ID:16327 EP_NO: 6135 Repair Type: Urgent Crossing Status: Found UCIP Comments: 4/28/2016 8-inch pipe was running water but was leaking at a weld joint on the LS slope. Pipe appears to have been dug out by the landowner but unsure if repairs are being made yet. (see photo 5)7/14/2015 Pipe end is still welded solid.5/21/2014 Same as last inspection.12/2/2013 Same as last inspection.7/10/2013 Same as last inspection. FIELD_STRUCT_DESC: 8-inch steel pipe through the levee 2.8 feet below the crown. Permit requirements are as follow: during the flood season the 5 inch irrigation pipe will be removed and a plate bolted over the waterside (WS) end of the 8 inch. Pipe section is completely buried. Current configuration does not allow for 5 inch irrigation pipe to slide pipe through. 8 inch pipe is welded solid. (Permit No. 6135-1968, George Washington) FS Date: 5/4/2016 7:18:00 AM

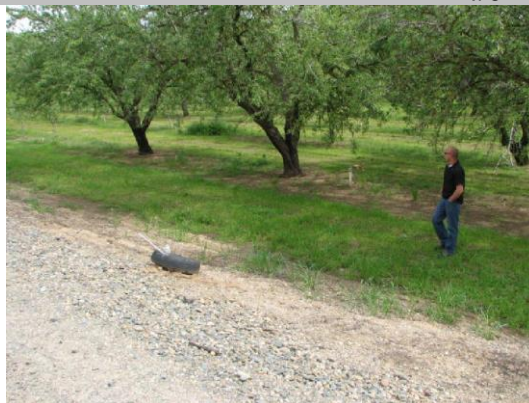
Photo 2 of 2 : UCIP_SP_2016_48018_66683.jpg

Air Vent located on WS.

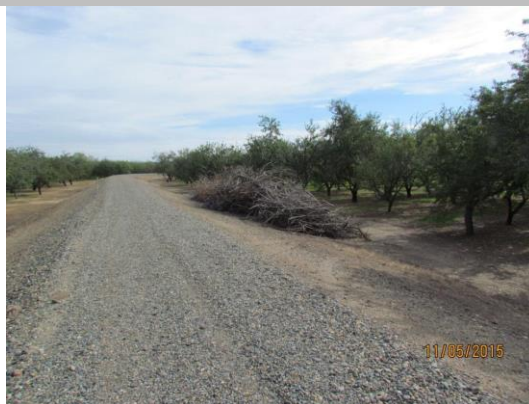
Photo 1 of 1 : SP_2016_MA0013_300_43_20160316_00010.jpg

LM Start	0.45	Rating **	M	Issue No.	43
LM End	0.45	Issue Type +	En	Location *	LS
Category	Earthen Levee			GPS Latitude/Longitude	
				Start	End
Item	Encroachments			39.591237 °	39.591237 °
				-121.702015 °	-121.702015 °
DWR ID	DWR_MA0013_01_f_2015_43				
Comment Code					
PR : Prunings					
Inspector Comment					
Remove the prunings from the landside slope.

View of the prunings along the landside slope.

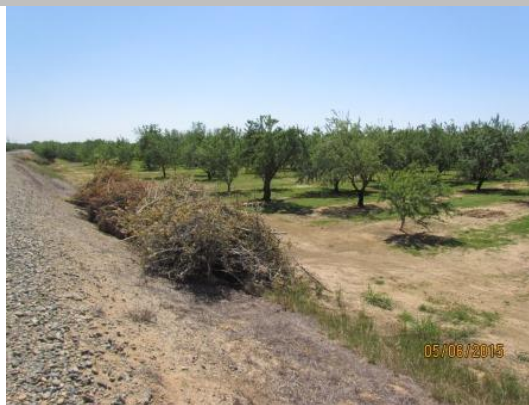
Photo 1 of 1 : SP_2016_MA0013_300_44_20160316_00011.jpg

View of the prunings along the landside slope.

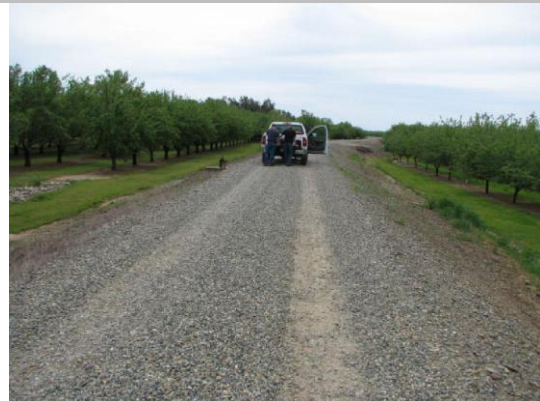
Photo 1 of 2 : UCIP_SP_2016_48017_66695.jpg

Comment Code					
Inspector Comment					
FS_ID:48017 DS_ID:16831 EP_NO: N/A Repair Type: Urgent Crossing Status: Found UCIP Comments: 4/28/2016 Landowner appears to have removed the WS headwall and pipe to make room for planting more orchard trees. LS pipe end was full of water as it has no where to drain to anymore. Changing to urgent listing but it currently does not affect the levee integrity. (see photos 8, 9, & 10)7/14/2015 Crossing appears in good condition. No noticeable issues to report.5/21/2014 Same as last inspection.12/2/2013 Pipe section was dug up and repaired. Crossing is now in good condition. 4/17/2012 Pipe collapse on WS 10 feet from toe, needs repair. From WS, sediment is visible inside pipe. FIELD_STRUCT_DESC: 36-inch irrigation corrugated metal pipe through the levee, 7.8 feet below crown. Slide gate in corrugated metal pipe riser on the waterside (WS) slope. Concrete "U" headwalls on both ends (USACE-1962) This entry matches the Drainage or Irrigation Structure referenced in O&M manual (HLM 1.62). FS Date: 5/4/2016 8:07:00 AM

Overview of levee crown at crossing looking downstream.

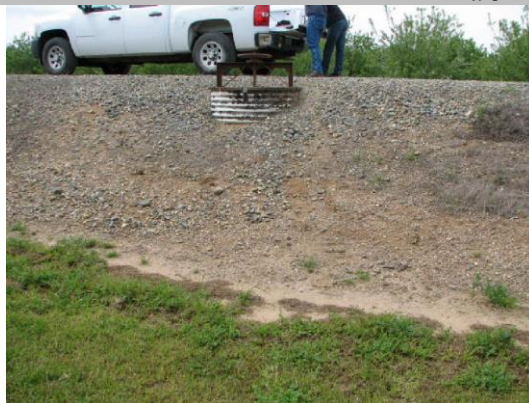
Photo 2 of 2 : UCIP_SP_2016_48017_66699.jpg

Comment Code					
Inspector Comment					
FS_ID:48017 DS_ID:16831 EP_NO: N/A Repair Type: Urgent Crossing Status: Found UCIP Comments: 4/28/2016 Landowner appears to have removed the WS headwall and pipe to make room for planting more orchard trees. LS pipe end was full of water as it has no where to drain to anymore. Changing to urgent listing but it currently does not affect the levee integrity. (see photos 8, 9, & 10)7/14/2015 Crossing appears in good condition. No noticeable issues to report.5/21/2014 Same as last inspection.12/2/2013 Pipe section was dug up and repaired. Crossing is now in good condition. 4/17/2012 Pipe collapse on WS 10 feet from toe, needs repair. From WS, sediment is visible inside pipe. FIELD_STRUCT_DESC: 36-inch irrigation corrugated metal pipe through the levee, 7.8 feet below crown. Slide gate in corrugated metal pipe riser on the waterside (WS) slope. Concrete "U" headwalls on both ends (USACE-1962) This entry matches the Drainage or Irrigation Structure referenced in O&M manual (HLM 1.62). FS Date: 5/4/2016 8:07:00 AM

Corrugated metal riser with slide gate located on WS slope.

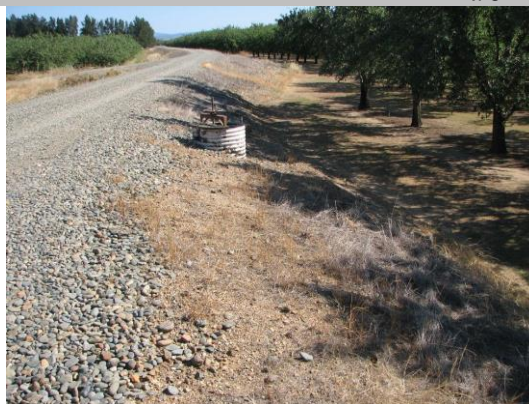
Photo 2 of 2 : UCIP_SP_2016_47623_66704.jpg

FS_ID:47623
DS_ID:16345
EP_NO: N/A
Repair Type: Non-Urgent
Crossing Status: Found
UCIP Comments: 4/28/2016 Pvc pipe is still present through the crossing. Slide gate cannot shut fully.7/14/2015 4-inch pipe still present and blocking the screw gate.5/21/2014 Same as last inspection.12/2/2013 Same as last inspection.7/15/2013 Same as last inspection.4/17/2012 Crossing has 4-inch pipe inside blocking positive closure/notify landowner to remove prior to flood season. LS crossing is blocked about 50% by sediment build up. Burrow activity present on LS near crossing.
FIELD_STRUCT_DESC: 24-inch corrugated metal irrigation pipe through the levee, 7.6 feet below the crown. Slide gate in corrugated metal pipe (CMP) riser on the waterside (WS) slope. Concrete headwall on the landside (LS). 36-inch concrete standpipe in the channel with 2 piles to deflect debris (USACE-1960). This entry matches the Drainage or Irrigation Structure referenced in O&M manual (HLM 1.69).

WS view looking upstream.

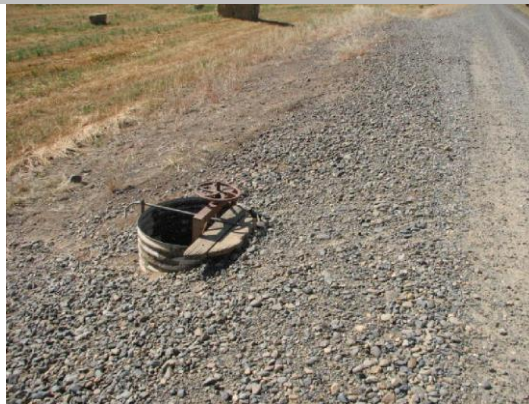
Photo 2 of 2 : UCIP_SP_2016_47624_66709.jpg

FS_ID:47624
DS_ID:16346
EP_NO: N/A
Repair Type: Non-Urgent
Crossing Status: Found
UCIP Comments: 4/28/2016 Appears to be an abandoned crossing. LS headwall and pipe inlet are still completely buried. 7/14/2015 Still cannot find an inlet or outlet. 5/21/2014 Same as last inspection. 12/2/2013 Same as last inspection. 7/15/2013 Same as last inspection. 4/17/2012 Non functional crossing due to LS headwall buried. This crossing was listed in the USACE Periodic Inspection report as Corp's inspect ID#USACE_CESPK_M13D_2011_p_0119 for no inlet or outlet visible.
FIELD_STRUCT_DESC: *ABANDONED* 24-inch corrugated metal irrigation pipe through the levee 7.8 feet below the crown. Slide gate in corrugated metal pipe riser on the waterside (WS) slope. Pipe continues across channel. Concrete "U" headwall on the landside (LS). (USACE-1960). This entry matches the Drainage or Irrigation Structure referenced in O&M manual (HLM 2.35).

Corrugated riser located on WS slope.

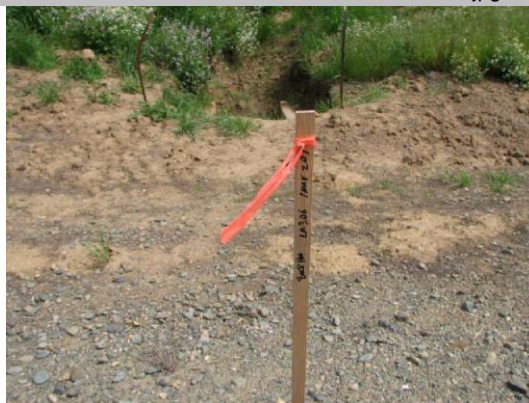
Photo 2 of 2 : UCIP_SP_2016_47640_66716.jpg

FS_ID:47640
DS_ID:17372
EP_NO: N/A
Repair Type: Non-Urgent
Crossing Status: Found
UCIP Comments: 4/28/2016 Pipe on LS is about 50% full of sediment. There is now a concrete pipe that discharges into the LS inlet of this crossing. Not sure where the concrete pipe comes from. 7/14/2015 Crossing appears in good condition. No noticeable issues to report. 5/21/2014 Same as last inspection. 12/2/2013 Pipe section was dug up and repaired. Crossing is now in good condition. 7/15/2013 Pipe appears to have a possible hole in top of pipe about 10ft. in from LS headwall. 4/17/2012 LS headwall blocked by sediment (50 % of opening is covered). LS floor is higher than LS pipe invert. WS headwall has been recently cleared of vegetation and sediment. This crossing was listed in the USACE Periodic Inspection report as Corp's inspect ID#USACE_CESPK_M13D_2011_p_0157 for WS and LS inlet/outlet blocked by sediment.

WS levee slope.

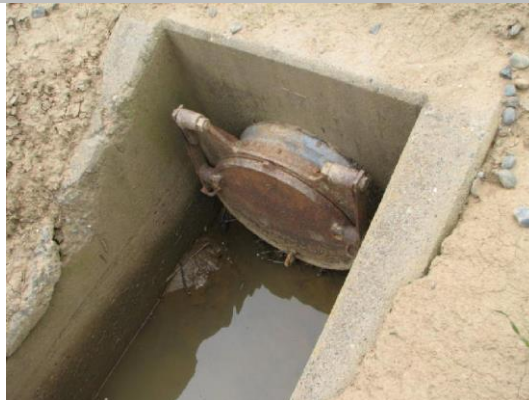
Photo 2 of 2 : UCIP_SP_2016_48019_66724.jpg

FS_ID:48019
DS_ID:16349
EP_NO: N/A
Repair Type: Non-Urgent
Crossing Status: Found
UCIP Comments: 4/28/2016 Sediment build up on both gates blocking them from operating properly.7/14/2015 Crossing appears in good condition. No noticeable issues to report.5/21/2014 Same as last inspection.12/2/2013 Same as last inspection.7/15/2013 Stem on LS screw gate has been replaced and is now full functional.4/17/2012 LS slide gate stem is bent and prevents gate from fully closing. Both WS and LS have been cleared of debris and sediment. This crossing was listed in the USACE Periodic Inspection report as Corp's inspect ID#USACE_CESPK_M13D_2011_p_0162 for inoperable gates on WS & LS due to sediment and grass blocking inlet and outlet.
FIELD_STRUCT_DESC: 24-inch corrugated metal drainpipe through the levee, 8.9 feet below the crown. Flap gate on waterside (WS) end. Concrete "U" headwalls on both ends (USACE-1960). This entry matches the Drainage or Irrigation Structure referenced in O&M manual (HLM 3.29).

Flap gate on WS.

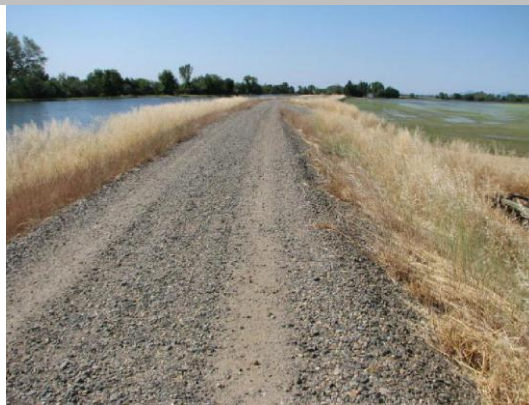
Photo 1 of 2 : UCIP_SP_2016_47639_66743.jpg

Comment Code					
Inspector Comment					
FS_ID:47639 DS_ID:16365 EP_NO: N/A Repair Type: Non-Urgent Crossing Status: Found UCIP Comments: 4/28/2016 Abandoned crossing. Ls screw is still bent and mostly buried.7/14/2015 LS screw gate is still damaged and buried. Crossing is non-functional.5/21/2014 Same as last inspection.12/2/2013 Same as last inspection.7/15/2013 Slopes have been cleared of vegetation and are in good condition. LS screw gate is still bent and silted over.4/18/2012 LS slide gate covered with silt. Slide gate is bent. Crossing appears not be in use. Limited inspection on WS and LS slope due to dense vegetation. Need photos of cleared slopes. FIELD_STRUCT_DESC: *ABANDONED* 24-inch corrugated metal drainage pipe through the levee, 7.9 feet below the crown. Flap gate on the waterside (WS) end. Screw gate on the landside (LS) end. Concrete "U" headwalls on both ends (USACE-1960). This entry matches the Drainage or Irrigation Structure referenced in O&M manual (HLM 3.82). FS Date: 5/4/2016 8:34:00 AM

Overview of levee crown at crossing looking downstream.

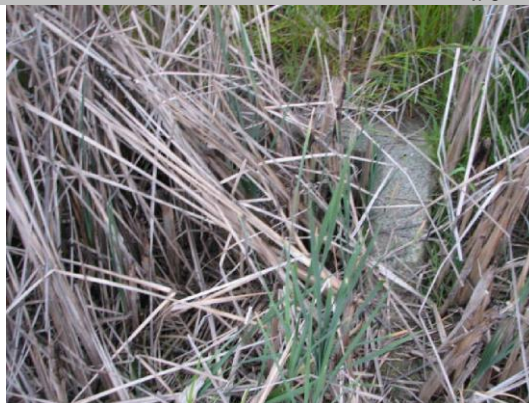
Photo 2 of 2 : UCIP_SP_2016_47639_66741.jpg

Comment Code						
Inspector Comment						
FS_ID:47639 DS_ID:16365 EP_NO: N/A Repair Type: Non-Urgent Crossing Status: Found UCIP Comments: 4/28/2016 Abandoned crossing. Ls screw is still bent and mostly buried.7/14/2015 LS screw gate is still damaged and buried. Crossing is non-functional.5/21/2014 Same as last inspection.12/2/2013 Same as last inspection.7/15/2013 Slopes have been cleared of vegetation and are in good condition. LS screw gate is still bent and silted over.4/18/2012 LS slide gate covered with silt. Slide gate is bent. Crossing appears not be in use. Limited inspection on WS and LS slope due to dense vegetation. Need photos of cleared slopes. FIELD_STRUCT_DESC: *ABANDONED* 24-inch corrugated metal drainage pipe through the levee, 7.9 feet below the crown. Flap gate on the waterside (WS) end. Screw gate on the landside (LS) end. Concrete "U" headwalls on both ends (USACE-1960). This entry matches the Drainage or Irrigation Structure referenced in O&M manual (HLM 3.82). FS Date: 5/4/2016 8:34:00 AM

WS flap gate blocked by debris.

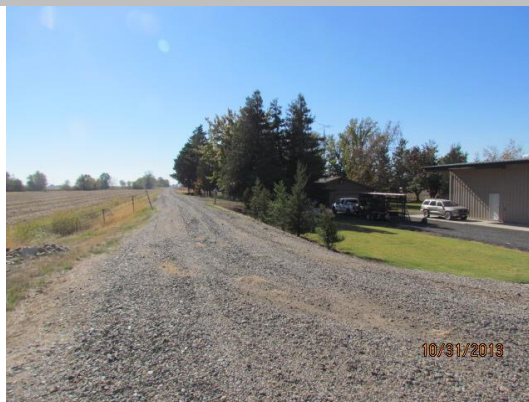
Photo 1 of 1 : SP_2016_MA0013_300_18_20160316_00008.jpg

LM Start	4.06	Rating **	M	Issue No.	18
LM End	4.13	Issue Type +	En	Location *	LS
Category	Earthen Levee			GPS Latitude/Longitude	
				Start	End
Item	Vegetation			39.541660 °	39.540651 °
				-121.707408 °	-121.707404 °
DWR ID	DWR_MA0013_01_s_2013_18				
Comment Code					
V6 : Landscaping					
Inspector Comment

View of the redwood trees along the landside slope.

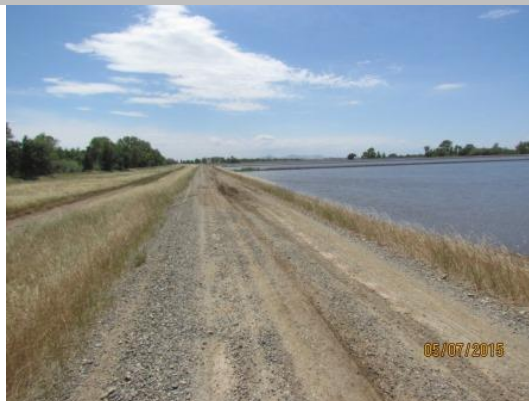
Photo 1 of 1 : SP_2016_MA0013_300_47_20160316_00012.jpg

LM Start	4.45	Rating **	M	Issue No.	47
LM End	5.35	Issue Type +	Ma	Location *	CR
Category	Earthen Levee			GPS Latitude/Longitude	
				Start	End
Item	Crown Surface / Depressions / Rutting			39.536017 °	39.523020 °
				-121.707705 °	-121.707577 °
DWR ID	DWR_MA0013_01_s _ 2015_47				
Comment Code					
C2 : Repair depressions or ruts in the crown or slope.					
Inspector Comment					
Repair the ruts in the crown roadway.

View of the ruts in the crown roadway.

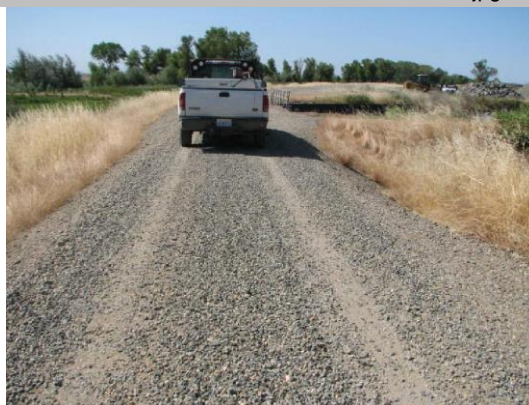
Photo 1 of 2 : UCIP_SP_2016_48051_66764.jpg

Comment Code					
Inspector Comment					
FS_ID:48051 DS_ID:16357 EP_NO: N/A Repair Type: Non-Urgent Crossing Status: Found UCIP Comments: 4/28/2016 WS flap gate blocked from opening by sediment.7/13/2015 WS flap gate is blocked from opening by sediment. Needs to be dug out.5/21/2014 Same as last inspection.12/2/2013 Same as last inspection.7/15/2013 Slopes have been cleared of vegetation and are in good condition.4/18/2012 Limited inspection on WS and LS slopes due to dense vegetation. Need photos of cleared slopes. FIELD_STRUCT_DESC: 24-inch corrugated metal drainage pipe through the levee, 8.6 feet below the crown. Flap gate on the waterside (WS) end. Concrete "U" headwalls an both ends (USACE-1960). This entry matches the Drainage or Irrigation Structure referenced in O&M manual (HLM 5.48). FS Date: 5/4/2016 8:51:00 AM

Overview of levee crown at crossing looking downstream.

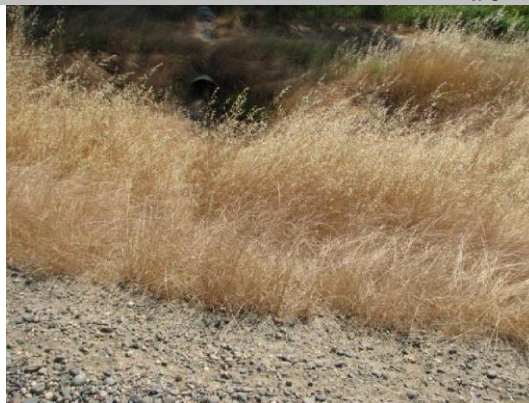
Photo 2 of 2 : UCIP_SP_2016_48051_66765.jpg

Comment Code						
Inspector Comment						
FS_ID:48051 DS_ID:16357 EP_NO: N/A Repair Type: Non-Urgent Crossing Status: Found UCIP Comments: 4/28/2016 WS flap gate blocked from opening by sediment.7/13/2015 WS flap gate is blocked from opening by sediment. Needs to be dug out.5/21/2014 Same as last inspection.12/2/2013 Same as last inspection.7/15/2013 Slopes have been cleared of vegetation and are in good condition.4/18/2012 Limited inspection on WS and LS slopes due to dense vegetation. Need photos of cleared slopes. FIELD_STRUCT_DESC: 24-inch corrugated metal drainage pipe through the levee, 8.6 feet below the crown. Flap gate on the waterside (WS) end. Concrete "U" headwalls an both ends (USACE-1960). This entry matches the Drainage or Irrigation Structure referenced in O&M manual (HLM 5.48). FS Date: 5/4/2016 8:51:00 AM

View of WS slope and channel.

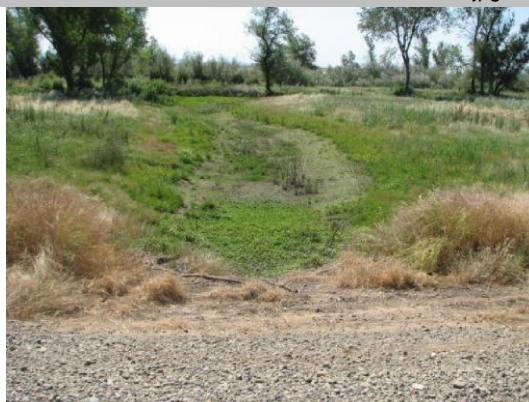
Photo 2 of 2 : UCIP_SP_2016_47642_66794.jpg

FS_ID:47642
DS_ID:16359
EP_NO: N/A
Repair Type: Non-Urgent
Crossing Status: Found
UCIP Comments: 4/28/2016 WS gate and headwall are buried. Only the top of the headwall was visible. LS appeared ok.7/13/2015 Both the LS screw gate and WS flapgate are completely buried.5/21/2014 Same as last inspection.12/2/2013 Same as last inspection.7/15/2013 Slopes have been cleared of vegetation and are in good condition. WS headwall and flapgate are fully covered in debris and not visible. Need to clear.4/18/2012 High sedimentation build up at WS and LS headwall. Limited inspection due to dense vegetation on WS and LS slope. Need photo of cleared WS and LS slopes. This crossing was listed in the USACE Periodic Inspection report as Corp's inspect ID# USACE_CESPK_M13D_2011_p_0210 for WS gate submerged.
FIELD_STRUCT_DESC: 24-inch corrugated metal drainage pipe through the levee, 9.2 feet below the crown. Flap gate on the waterside (WS) end. Concrete "U" headwalls on both ends (USACE-1960). This entry matches the Drainage or Irrigation Structure referenced in O&M manual (HLM 5.73).

View of WS slope and toe.

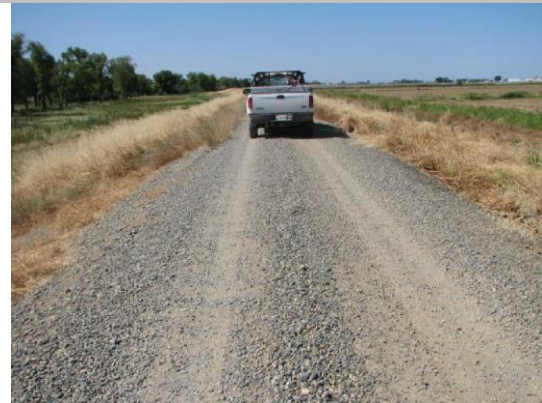
Photo 1 of 2 : UCIP_SP_2016_47644_66808.jpg

Comment Code					
Inspector Comment					
FS_ID:47644 DS_ID:16361 EP_NO: N/A Repair Type: Non-Urgent Crossing Status: Found UCIP Comments: 4/28/2016 LS screwgate is still completely buried. 7/13/2015 LS screw gate is completely buried.5/21/2014 Same as last inspection.7/15/2013 WS slope has been cleared of vegetation and is in good condition. LS screw gate is still buried.12/2/2013 Same as last inspection.4/18/2012 LS slide gate is buried. Pipe is not visible on LS toe. Limited inspection on WS slope due to dense vegetation. FIELD_STRUCT_DESC: 24-inch corrugated metal drainage pipe through the levee, 7.4 feet below the crown. Flap gate on the waterside (WS) end. Slide gate on the landside (LS) end. Concrete "U" headwalls on both ends (USACE-1960). This entry matches the Drainage or Irrigation Structure referenced in O&M manual (HLM 6.34). FS Date: 5/4/2016 9:01:00 AM

Overview of levee crown at crossing looking downstream.

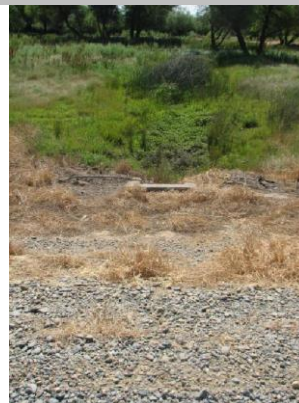
Photo 2 of 2 : UCIP_SP_2016_47644_66806.jpg

Comment Code						
Inspector Comment						
FS_ID:47644 DS_ID:16361 EP_NO: N/A Repair Type: Non-Urgent Crossing Status: Found UCIP Comments: 4/28/2016 LS screwgate is still completely buried. 7/13/2015 LS screw gate is completely buried.5/21/2014 Same as last inspection.7/15/2013 WS slope has been cleared of vegetation and is in good condition. LS screw gate is still buried.12/2/2013 Same as last inspection.4/18/2012 LS slide gate is buried. Pipe is not visible on LS toe. Limited inspection on WS slope due to dense vegetation. FIELD_STRUCT_DESC: 24-inch corrugated metal drainage pipe through the levee, 7.4 feet below the crown. Flap gate on the waterside (WS) end. Slide gate on the landside (LS) end. Concrete "U" headwalls on both ends (USACE-1960). This entry matches the Drainage or Irrigation Structure referenced in O&M manual (HLM 6.34). FS Date: 5/4/2016 9:01:00 AM

View of WS slope and toe.

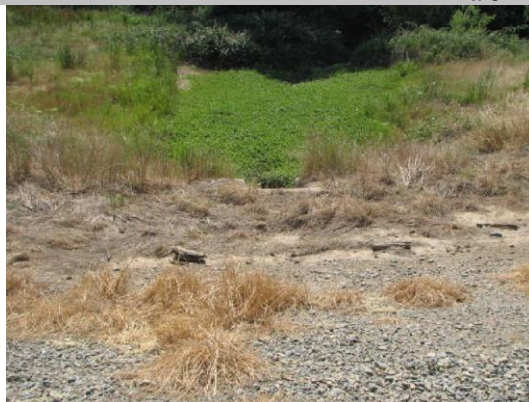
Photo 2 of 2 : UCIP_SP_2016_48134_66813.jpg

Comment Code					
Inspector Comment					
FS_ID:48134 DS_ID:16362 EP_NO: 5200B Repair Type: Urgent Crossing Status: Found UCIP Comments: 4/28/2016 Hole still present behind the LS flashboards. Rest of the crossing appeared in good condition.7/13/2015 Hole still present behind the LS flashboards.5/21/2014 Same as last inspection.12/2/2013 Same as last inspection.7/15/2013 WS slope has been cleared of vegetation and is in good condition. Hole is still present behind flash boards on LS.4/18/2012 Hole behind flashboards against slide gate on LS slope (Health and Safety Issue). Limited inspection on WS slope due to dense vegetation. Need photo of cleared slope on WS. FIELD_STRUCT_DESC: 1 of 10: 24-inch corrugated metal drainage pipe through the levee, 7.8 feet below the crown. Flap gate on the waterside (WS) end. Slide gate on the landside (LS) end. Concrete headwall on both ends (Permit No. 5200B-1965, Richvale Irrigation District) (Additional Related Permit(s): Permit No. 5200 and 5200A) [Additional Reference(s): DWR Levee Log, 1992. USACE Sacramento O&M Manual 519, June 1962 (HLM 6.56)] FS Date: 5/4/2016 9:02:00 AM

View of WS slope and toe.

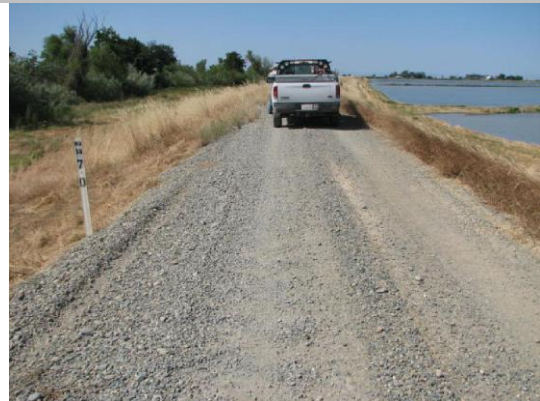
Photo 1 of 2 : UCIP_SP_2016_47689_66833.jpg

Comment Code					
Inspector Comment					
FS_ID:47689 DS_ID:16329 EP_NO: N/A Repair Type: Non-Urgent Crossing Status: Found UCIP Comments: 4/28/2016 LS slide gate is still bent. Everything else with the crossing appeared ok.7/13/2015 LS screw gate needs to be replaced. Everything else with crossing seems to be in good condition.5/21/2014 Same as last inspection.12/2/2013 Same as last inspection.7/15/2013 Slopes have been cleared of vegetation and are in good condition. There were no apparent signs of settling. LS screw gate is still damaged.4/18/2012 LMA's inspection sheet of 2011 indicates settlement and visible corrosion. Damage/severe corrosion on screw gate where it bolts to headwall. No visible signs of settlement due to high vegetation cover. Limited inspection on WS and LS slopes due to dense vegetation. Need photos of cleared slopes for this crossing. FIELD_STRUCT_DESC: 24-inch corrugated metal drainage pipe through the levee, 9.8 feet below the crown. Flap gate on the waterside (WS) end. Slide gate on the landside (LS) end. Concrete headwall on both ends (USACE-1960). This entry matches the Drainage or Irrigation Structure referenced in O&M manual (HLM 7.10). FS Date: 5/4/2016 9:11:00 AM

Overview of levee crown at crossing looking D/S.

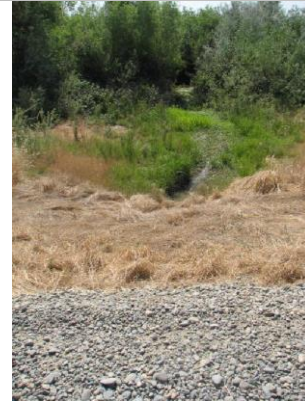
Photo 2 of 2 : UCIP_SP_2016_47689_66832.jpg

Comment Code						
Inspector Comment						
FS_ID:47689 DS_ID:16329 EP_NO: N/A Repair Type: Non-Urgent Crossing Status: Found UCIP Comments: 4/28/2016 LS slide gate is still bent. Everything else with the crossing appeared ok.7/13/2015 LS screw gate needs to be replaced. Everything else with crossing seems to be in good condition.5/21/2014 Same as last inspection.12/2/2013 Same as last inspection.7/15/2013 Slopes have been cleared of vegetation and are in good condition. There were no apparent signs of settling. LS screw gate is still damaged.4/18/2012 LMA's inspection sheet of 2011 indicates settlement and visible corrosion. Damage/severe corrosion on screw gate where it bolts to headwall. No visible signs of settlement due to high vegetation cover. Limited inspection on WS and LS slopes due to dense vegetation. Need photos of cleared slopes for this crossing. FIELD_STRUCT_DESC: 24-inch corrugated metal drainage pipe through the levee, 9.8 feet below the crown. Flap gate on the waterside (WS) end. Slide gate on the landside (LS) end. Concrete headwall on both ends (USACE-1960). This entry matches the Drainage or Irrigation Structure referenced in O&M manual (HLM 7.10). FS Date: 5/4/2016 9:11:00 AM

View of WS slope and toe.

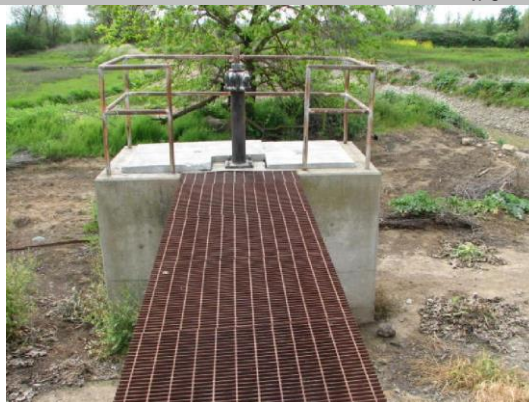
Photo 2 of 2 : UCIP_SP_2016_47659_66884.jpg

Comment Code					
Inspector Comment					
FS_ID:47659 DS_ID:16323 EP_NO: N/A Repair Type: Urgent Crossing Status: Found UCIP Comments: 4/28/2016 Erosion still present at the LS headwall.7/13/2015 Erosion still present behind the LS headwall. It looks to be getting worse and is starting to affect the levee slope.5/21/2014 Same as last inspection.12/3/2013 Same as last inspection.7/15/2013 Same as last inspection.4/18/2012 Concrete headwall is cracked, erosion behind headwall is also present. LS headwall needs to be repaired/replaced. Remove wooden debris from levee shoulder. FIELD_STRUCT_DESC: [Richvale Irrigation Canal Siphon] 5 by 7 foot concrete conduit through the levee, 18.4 feet below the crown. Distribution box and walkway are located on waterside (WS). Concrete headwall on the landside (LS). 28-foot reinforced concrete protective slab on top of the conduit in the center of the levee (USACE-1960). This entry matches the Drainage or Irrigation Structure referenced in O&M manual (HLM 8.95). FS Date: 5/4/2016 9:24:00 AM

Catwalk & gate located on WS. No daylight point on WS.

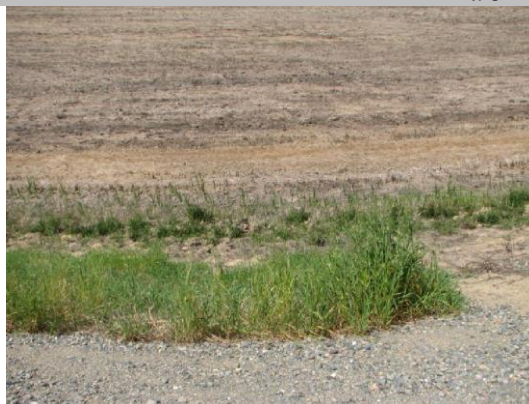
Photo 2 of 2 : UCIP_SP_2016_48050_66973.jpg

View of LS slope and toe. Unable to find welded plate on LS.

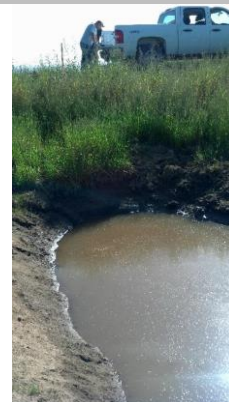
Photo 2 of 2 : UCIP_SP_2016_47735_67095.jpg

Flap gate submerged in water on WS of levee

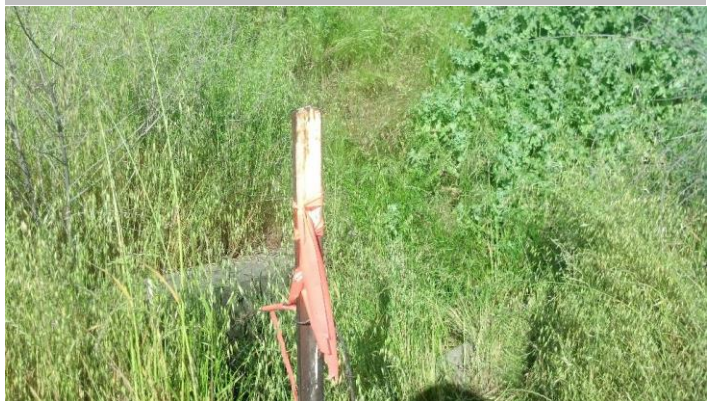
Photo 2 of 2 : UCIP_SP_2016_48066_67343.jpg

Dense vegetation covering the majority of the WS. WS headwall difficult to see through dense vegetation.

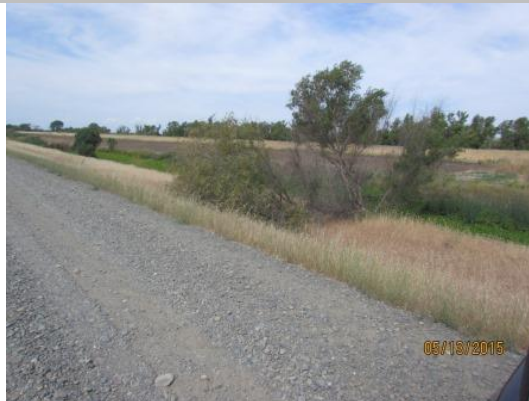
Photo 1 of 1 : SP_2016_MA0013_301_61_20160316_00016.jpg

View of the tree along the waterside toe and slope.

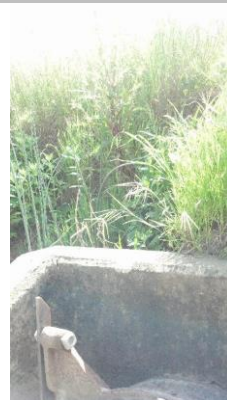
Photo 2 of 2 : UCIP_SP_2016_47758_67400.jpg

Erosion behind WS headwall at the upstream edge of headwall.

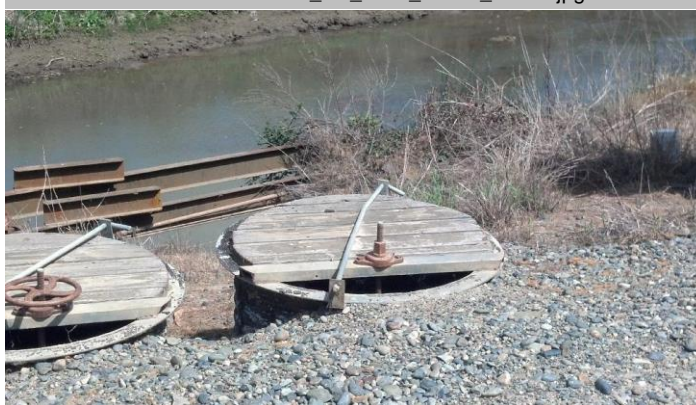
Photo 2 of 2 : UCIP_SP_2016_48035_67407.jpg

Corrugated metal pipe riser for pipe 1 of 3. Slide gate is missing handle.

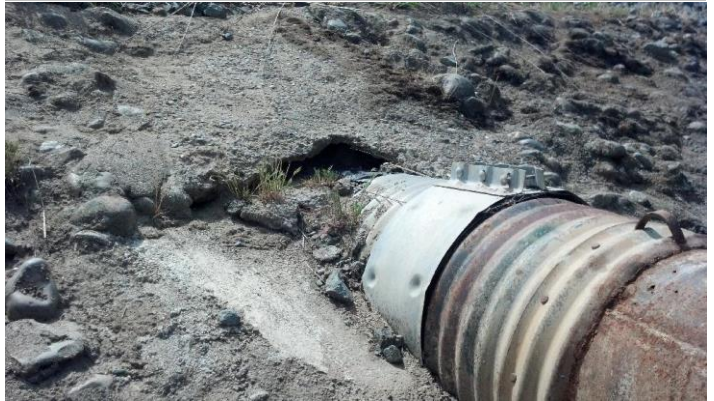
Photo 2 of 2 : UCIP_SP_2016_48493_67451.jpg

View of WS daylight. Hole present at pipe daylight.

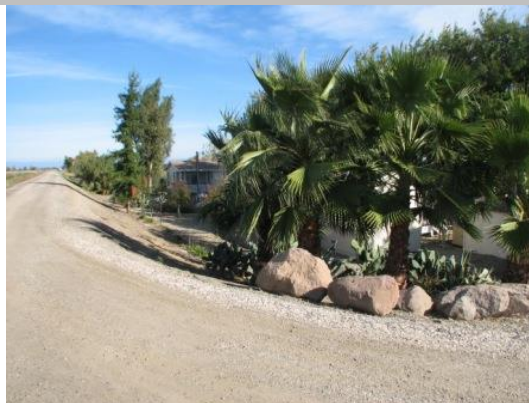
Photo 1 of 1 : SP_2016_MA0013_301_4_20160316_00001.jpg

View of landscaping along the toe.
