**Flood Control Project Maintenance  
Levee Inspections**  
**LMA District Cover Sheet**  
**Spring 2017 Levee Inspection Results**

**Sutter Maintenance Yard Maintenance Area 0013**

**Spring 2017 Levee Inspection Results**

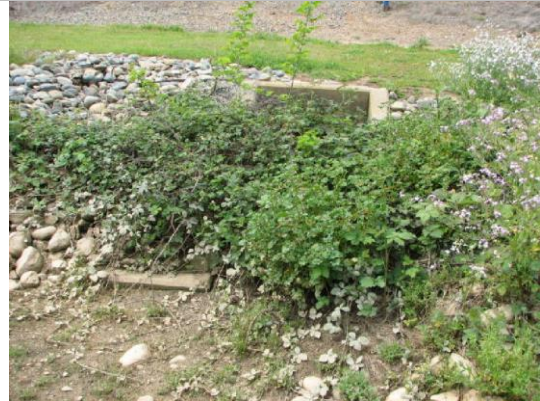
Photo 3 of 3 : UCIP\_SP\_2017\_50976\_66698.jpg

FS\_ID:50976  
DS\_ID:16831  
EP\_NO: N/A  
Repair Type: Urgent  
Crossing Status: Found  
UCIP Comments: 11/16/2016 WS structures still removed. (DWR Sutter Yard- AFreitag)10/17/2016 Landowner removed WS concrete headwall and pipe section through floodway to make room for orchard. The area disturbed appears to be from WS toe to where the mature trees are located within floodway, approximately 45 feet from WS toe. Crossing is classified as Urgent with potential levee integrity issues due to the disturbance of the WS without prior approval from the CVFPB. (DWR UCIP - omagana)  
4/28/2016 Landowner appears to have removed the WS headwall and pipe to make room for planting more orchard trees. LS pipe end was full of water as it has no where to drain to anymore. Changing to urgent listing but it currently does not affect the levee integrity. (see photos 8, 9, & 10) (DWR Sutter Yard - afreitag)7/14/2015 Crossing appears in good condition. No noticeable issues to report. (DWR Sutter Yard - afreitag)5/21/2014 Same as last inspection. (DWR Sutter Yard - afreitag)12/2/2013 Pipe section was dug up and repaired. Crossing is now in good condition. (DWR Sutter Yard - afreitag) 4/17/2012 Pipe collapse on WS 10 feet from toe, needs repair. From WS, sediment is visible inside pipe. (DWR UCIP - omagana)

WS headwall, rock protection, and outlet blocked by shrub.

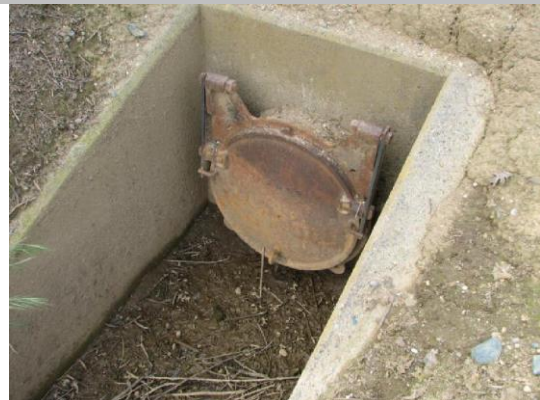
Photo 2 of 3 : UCIP\_SP\_2017\_50979\_66714.jpg

Flap gate at WS.

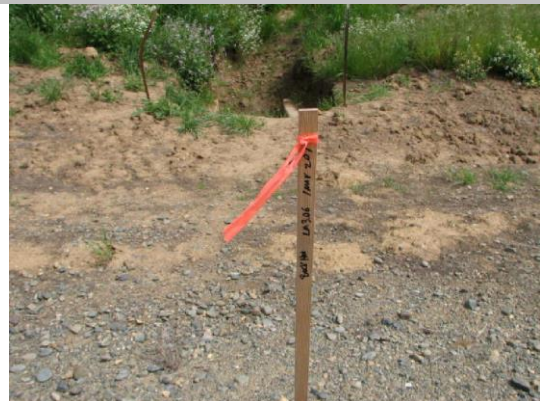
Photo 2 of 3 : UCIP\_SP\_2017\_50980\_66716.jpg

WS levee slope.

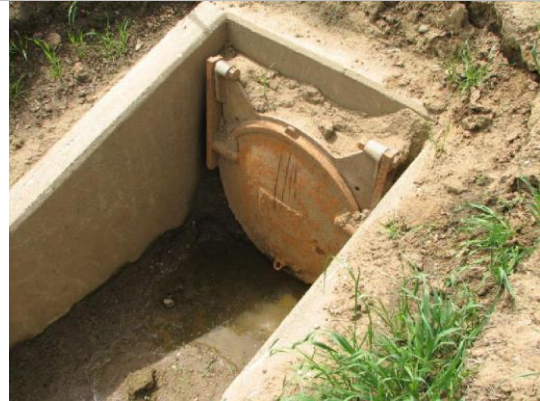
Photo 3 of 3 : UCIP\_SP\_2017\_50980\_66720.jpg

Comment Code						
Inspector Comment						
FS_ID:50980						
DS_ID:17372						
EP_NO: N/A						
Repair Type: Non-Urgent						
Crossing Status: Found						
UCIP Comments: 11/16/2016 Pipe about 50% full of sediment. (DWR Sutter Yard- A Freitag)4/28/2016 Pipe on LS is about 50% full of sediment. There is now a concrete pipe that discharges into the LS inlet of this crossing. Not sure where the concrete pipe comes from.7/14/2015 Crossing appears in good condition. No noticeable issues to report.5/21/2014 Same as last inspection.12/2/2013 Pipe section was dug up and repaired. Crossing is now in good condition.7/15/2013 Pipe appears to have a possible hole in top of pipe about 10ft. in from LS headwall.4/17/2012 LS headwall blocked by sediment (50 % of opening is covered). LS floor is higher than LS pipe invert. WS headwall has been recently cleared of vegetation and sediment. This crossing was listed in the USACE Periodic Inspection report as Corp's inspect ID#USACE_CESPK_M13D_2011_p_0157 for WS and LS inlet/outlet blocked by sediment.

Flap gate on waterside.

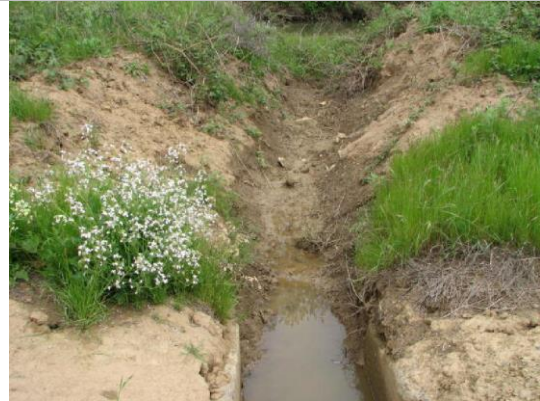
Photo 3 of 3 : UCIP\_SP\_2017\_50982\_66726.jpg

Recent sediment removal on WS.

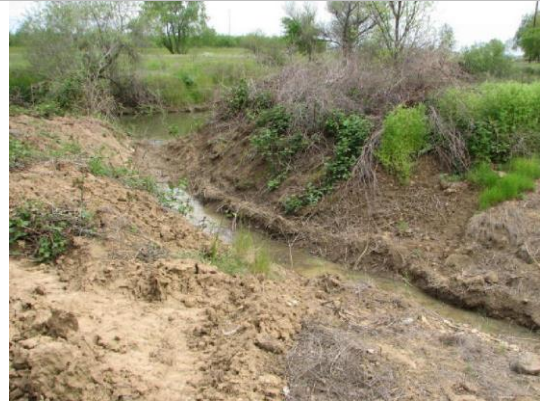
Photo 3 of 3 : UCIP\_SP\_2017\_50983\_66732.jpg

Sedimentation cleared on WS.

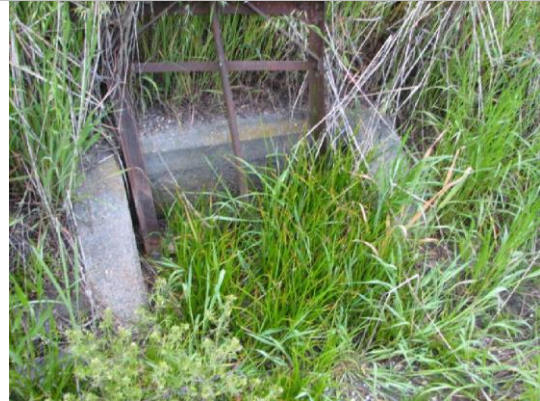
Photo 3 of 3 : UCIP\_SP\_2017\_50985\_66742.jpg

LS slide gate covered with silt. Slide gate is bent.

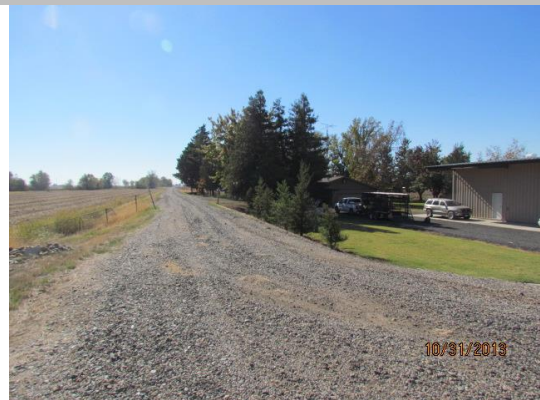
Photo 1 of 1 : SP\_2017\_MA0013\_300\_18\_20170315\_00006.jpg

LM Start	4.06	Rating **	M	Issue No.	18
LM End	4.13	Issue Type +	En	Location *	LS
Category	Earthen Levee			GPS Latitude/Longitude	
				Start	End
Item	Vegetation			39.541660 °	39.540651 °
				-121.707408 °	-121.707404 °
DWR ID	DWR_MA0013_01_s_2013_18				
Comment Code					
V6 : Landscaping					
Inspector Comment

View of the redwood trees along the landside slope.

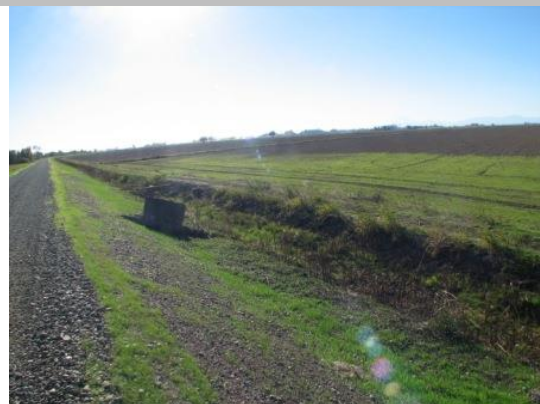
Photo 1 of 1 : SP\_2017\_MA0013\_300\_2\_20170315\_00001.jpg

LM Start	6.53	Rating **	M	Issue No.	2
LM End	6.53	Issue Type +	En	Location *	LS
Category	Earthen Levee			GPS Latitude/Longitude	
				Start	End
Item	Encroachments			39.507337 °	39.507337 °
				-121.715693 °	-121.715693 °
DWR ID	DWR_MA0013_01_s_2012_2				
Comment Code					
MA : Material					
Inspector Comment

View of a concrete block along the toe.

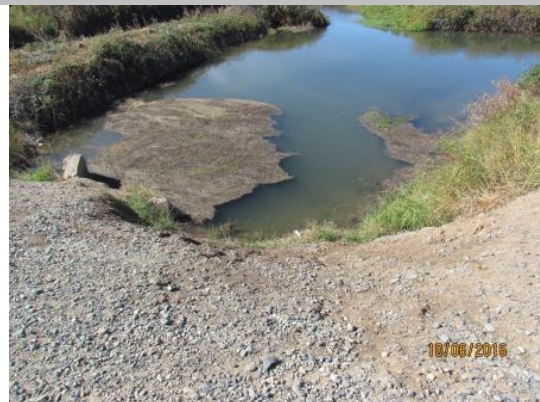
Photo 1 of 1 : SP\_2017\_MA0013\_300\_49\_20170315\_00009.jpg

LM Start	8.81	Rating **	M	Issue No.	49
LM End	8.81	Issue Type +	Ma	Location *	LS
Category	Earthen Levee			GPS Latitude/Longitude	
				Start	End
Item	Erosion / Bank Caving			39.478648 °	39.478648 °
				-121.736477 °	-121.736477 °
DWR ID	DWR_MA0013_01_f_2016_49				
Comment Code					
E2 : Schedule repair of erosion site prior to the next inspection.					
Inspector Comment

View of the erosion site along the landside toe.

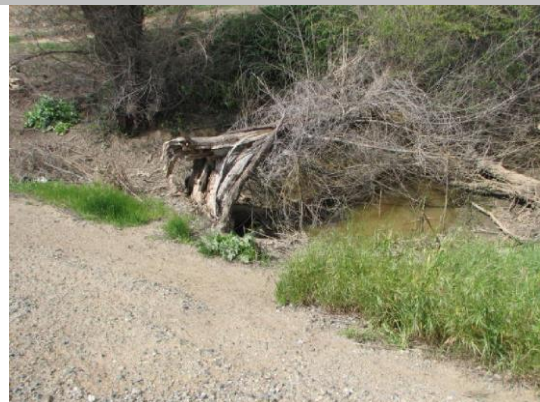
Photo 3 of 3 : UCIP\_SP\_2017\_51056\_66969.jpg

Tree fallen at LS headwall.

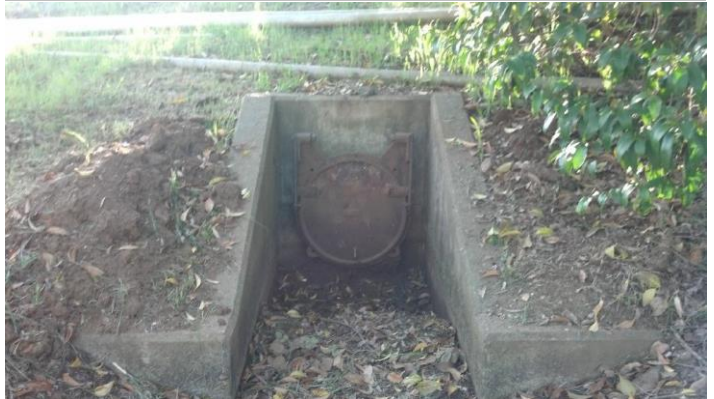
Photo 2 of 3 : UCIP\_SP\_2017\_51068\_45642.jpg

Headwall and flap gate on WS. Soil and pipes stockpiled next to headwall.

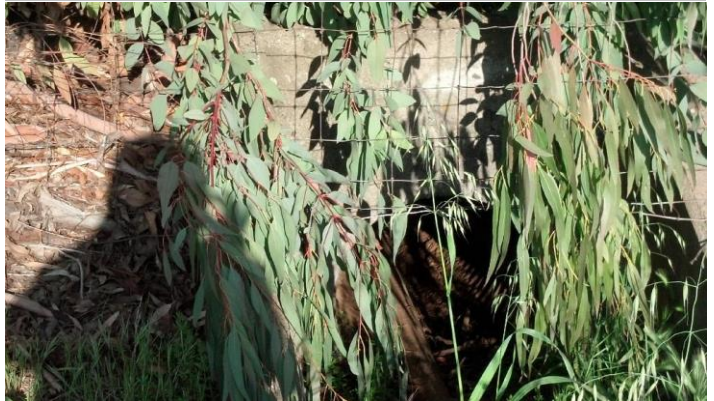
Photo 3 of 3 : UCIP\_SP\_2017\_51068\_45643.jpg

LS headwall blocked by overgrown branches.

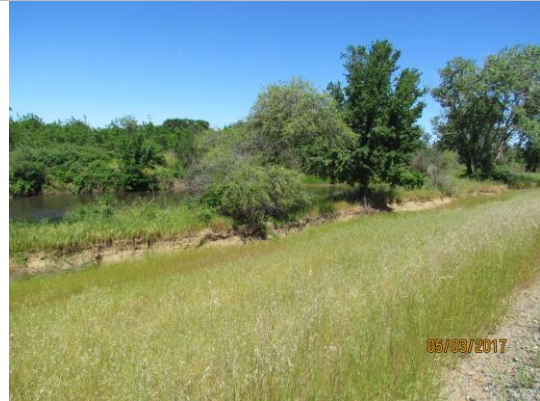
Photo 1 of 1 : SP\_2017\_MA0013\_301\_83\_20170508\_00139.jpg

View of erosion along the waterside toe.

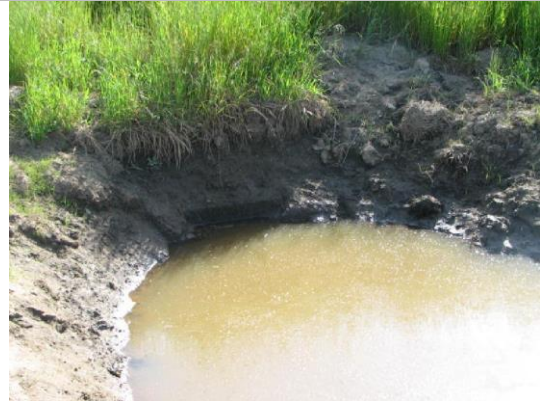
Photo 3 of 3 : UCIP\_SP\_2017\_51079\_67096.jpg

View of flap gate submerged on WS toe.

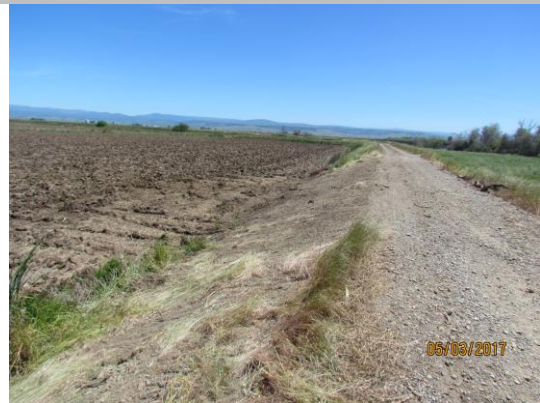
Photo 1 of 1 : SP\_2017\_MA0013\_301\_86\_20170508\_00140.jpg

View of the erosion along the landside slope.

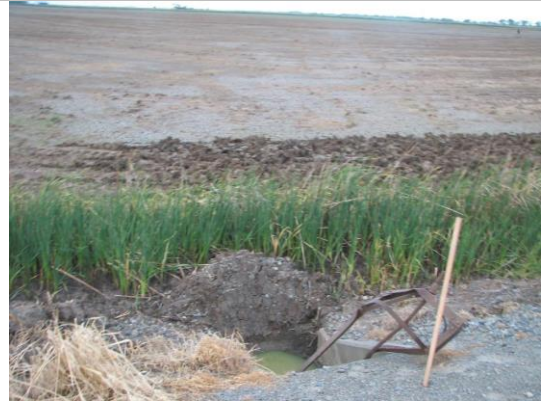
Photo 3 of 3 : UCIP\_SP\_2017\_51087\_67141.jpg

Overview of LS floor is higher in elevation than pipe invert causing build up sediment.

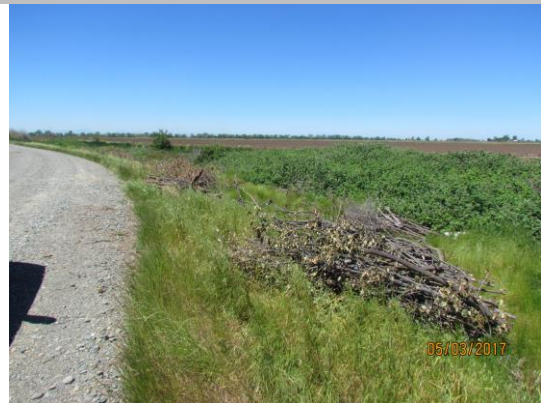
Photo 1 of 1 : SP\_2017\_MA0013\_301\_48\_20170508\_00144.jpg

View of the prunings along the landside slope.

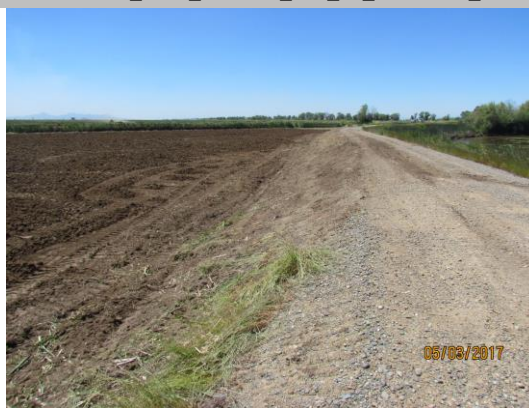
Photo 1 of 1 : SP\_2017\_MA0013\_301\_90\_20170508\_00147.jpg

View of the erosion along the landside slope.

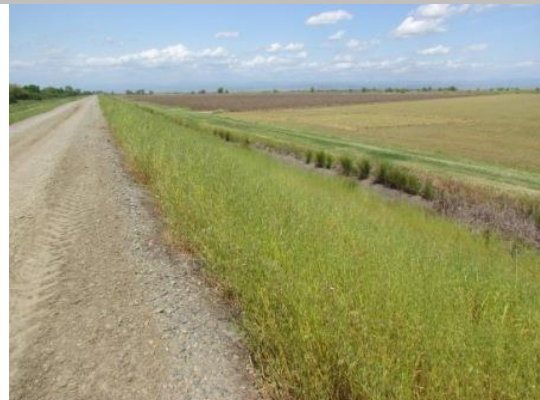
Photo 1 of 1 : SP\_2017\_MA0013\_301\_13\_20170315\_00005.jpg

View of the agricultural ditch along the toe.

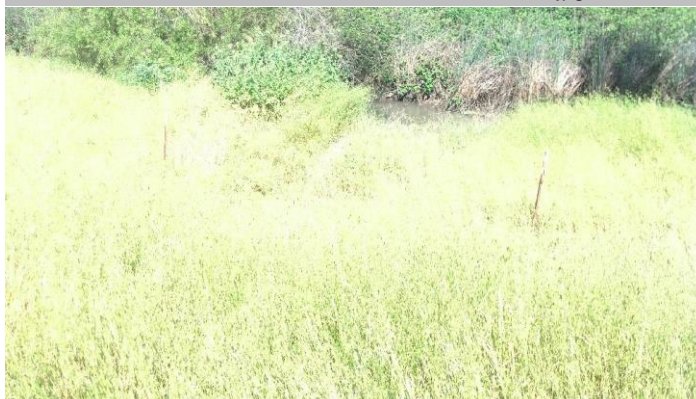
Photo 2 of 3 : UCIP\_SP\_2017\_51133\_67351.jpg

View of WS slope. Limited inspection due to the dense vegetation.

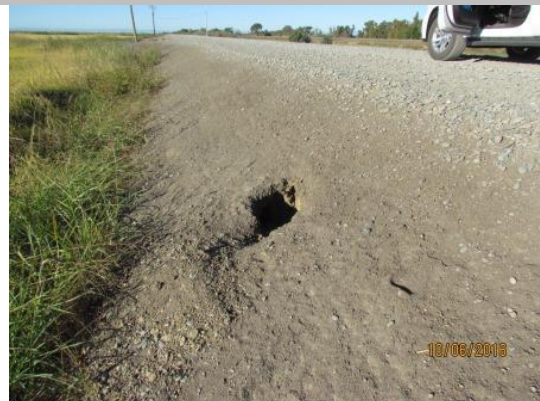
Photo 1 of 1 : SP\_2017\_MA0013\_301\_64\_20170315\_00020.jpg

View of the rodent holes along the landside slope.

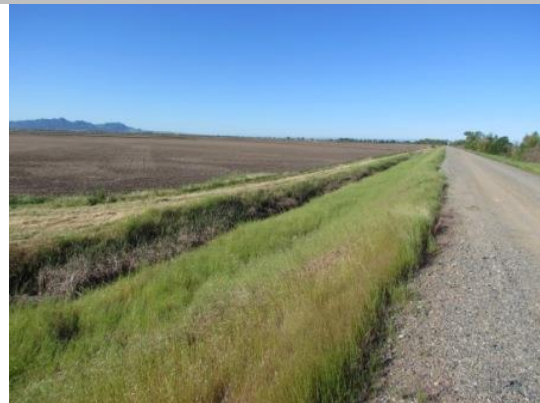
Photo 1 of 1 : SP\_2017\_MA0013\_301\_21\_20170315\_00009.jpg

View of the agricultural ditch along the toe.

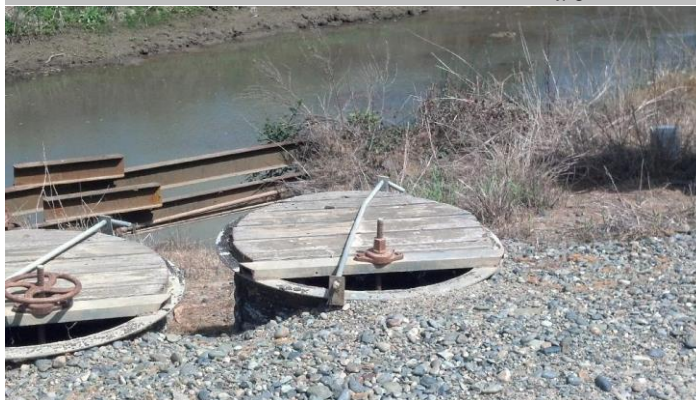
Photo 2 of 3 : UCIP\_SP\_2017\_51146\_67407.jpg

Corrugated metal pipe riser for pipe 1 of 3. Slide gate is missing handle.

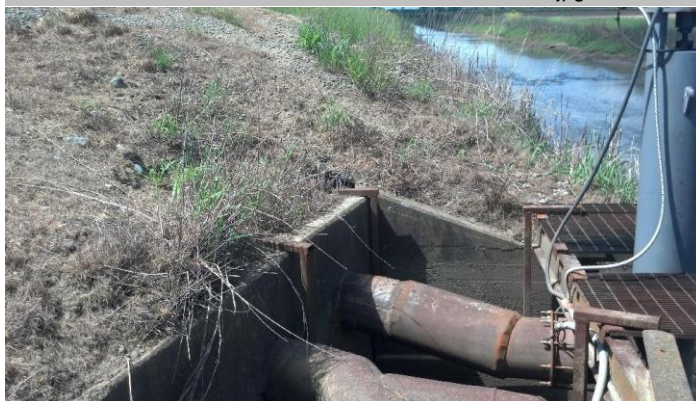
Photo 3 of 3 : UCIP\_SP\_2017\_51146\_67409.jpg

Sink hole observed behind WS headwall at the downstream edge of headwall. (Sink hole picture 1 of 2)

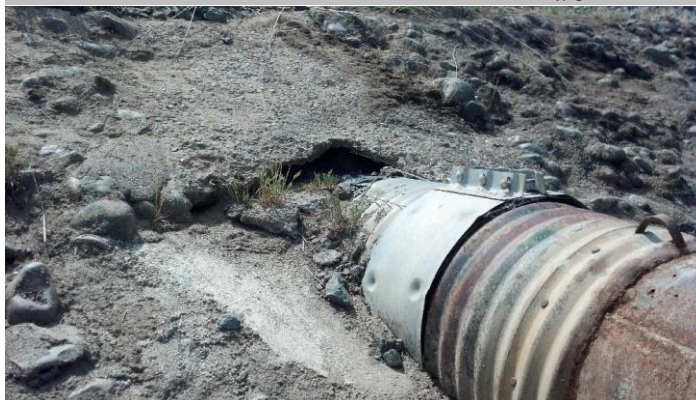
Photo 2 of 3 : UCIP\_SP\_2017\_51147\_67451.jpg

View of WS daylight. Hole present at pipe daylight.

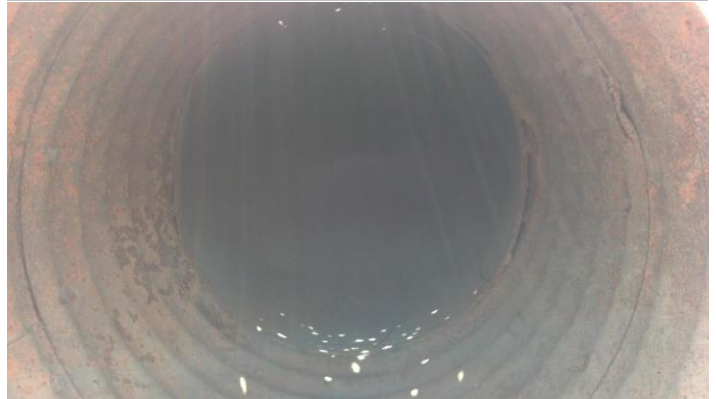
Photo 3 of 3 : UCIP\_SP\_2017\_51147\_67450.jpg

WS-view of internal pipe with severe corrosion-holes present along pipe wall.
