**Flood Control Project Maintenance
Levee Inspections**
LMA District Cover Sheet
Spring 2018 Levee Inspection Results

Sutter Maintenance Yard Maintenance Area 0013

Spring 2018 Levee Inspection Results

Waterway			Bank	Unit Miles
Unit No. 01 Cherokee Canal			Right	18.19
	Spring (March - May)	Summer (June - August)	(September - November) Fall	Winter (December - February)
Unit Maintenance Rating (Fall Only)				
Date of Inspection	4/17/2018 - 4/17/2018			
DWR Inspector	Bob Duffey			
Accompanied By	Shawn Freitag Sutter Maintenance Yard

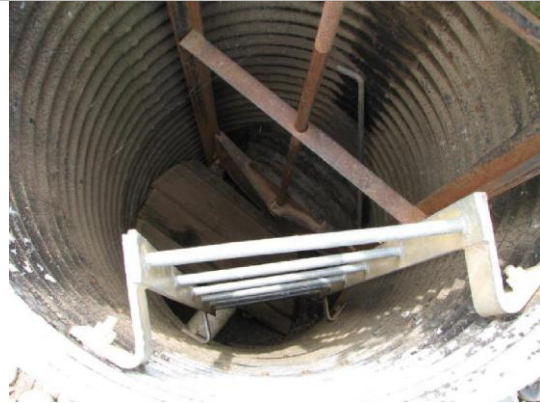
Photo 3 of 3 : UCIP_SP_2018_52183_66702.jpg

Comment Code						
Inspector Comment						
FS_ID:52183 DS_ID:16345 EP_NO: N/A Repair Type: Non-Urgent Crossing Status: Found UCIP Comments: 6/14/2017 PVC pipe still present blocking screw gate. LS inlet of the 24" cmp pipe is about 75% blocked by sediment. (DWR Sutter Yard- A Freitag)11/16/2016 PVC pipe still present blocking the screw gate. (DWR Sutter Yard- A Freitag)4/28/2016 Pvc pipe is still present through the crossing. Slide gate cannot shut fully.7/14/2015 4-inch pipe still present and blocking the screw gate.5/21/2014 Same as last inspection.12/2/2013 Same as last inspection.7/15/2013 Same as last inspection.4/17/2012 Crossing has 4-inch pipe inside blocking positive closure/notify landowner to remove prior to flood season. LS crossing is blocked about 50% by sediment build up. Burrow activity present on LS near crossing. FIELD_STRUCT_DESC: 24-inch corrugated metal irrigation pipe through the levee, 7.6 feet below the crown. Slide gate in corrugated metal pipe (CMP) riser on the waterside (WS) slope. Concrete headwall on the landside (LS). 36-inch concrete standpipe in the channel with 2 piles to deflect debris. [Additional Reference(s): DWR Levee Log, 1993. USACE Sacramento O&M Manual 519, June 1962 (HLM 1.69)] FS Date: 6/16/2017 12:21:04 PM

Positive closure device on WS slope, panel lid fell in.

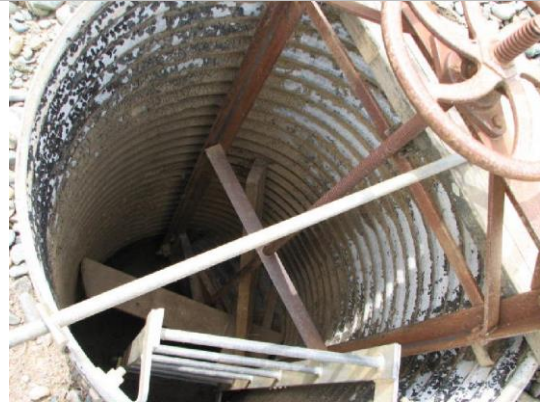
Photo 3 of 3 : UCIP_SP_2018_52184_66707.jpg

Comment Code						
Inspector Comment						
FS_ID:52184 DS_ID:16346 EP_NO: N/A Repair Type: Non-Urgent Crossing Status: Found UCIP Comments: 6/14/2017 Still no LS inlet visible- trace with locator/GPR to try and locate. Wooden debris down inside of WS standpipe. Pipe has been selected to be internally cleaned and inspected as part of the DMP project. (DWR Sutter Yard-AFreitag)11/16/2016 Appears abandoned. Unable to find anything on LS. (DWR Sutter Yard- AFreitag)4/28/2016 Appears to be an abandoned crossing. LS headwall and pipe inlet are still completely buried.7/14/2015 Still cannot find an inlet or outelt.5/21/2014 Same as last inspection.12/2/2013 Same as last inspection.7/15/2013 Same as last inspection.4/17/2012 Non functional crossing due to LS headwall buried. This crossing was listed in the USACE Periodic Inspection report as Corp's inspect ID#USACE_CESPK_M13D_2011_p_0119 for no inlet or outlet visible. FIELD_STRUCT_DESC: *ABANDONED* 24-inch corrugated metal irrigation pipe through the levee 7.8 feet below the crown. Slide gate in corrugated metal pipe riser on the waterside (WS) slope. Pipe continues across channel. Concrete "U" headwall on the landside (LS). [Additional Reference(s): DWR Levee Log, 1993. USACE Sacramento O&M Manual 519, June 1962 (HLM 2.35)] FS Date: 6/16/2017 12:24:07 PM

Corrugated metal riser on WS slope. Lid panel blocking gate.

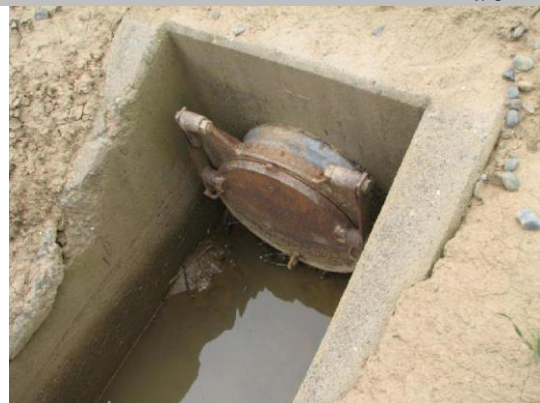
Photo 2 of 3 : UCIP_SP_2018_52188_66724.jpg

FS_ID:52188
DS_ID:16349
EP_NO: N/A
Repair Type: Non-Urgent
Crossing Status: Found
UCIP Comments: 6/14/2017 Both pipe ends and gates are mostly buried- need to be dug out. Pipe has been selected to be internally cleaned and inspected as part of the DMP project. (DWR Sutter Yard- A/Freitag)11/16/2016 Both gates closed but partially buried and unable to open. (DWR Sutter Yard- A/Freitag)4/28/2016 Sediment build up on both gates blocking them from operating properly.7/14/2015 Crossing appears in good condition. No noticeable issues to report.5/21/2014 Same as last inspection.12/2/2013 Same as last inspection.7/15/2013 Stem on LS screw gate has been replaced and is now full functional.4/17/2012 LS slide gate stem is bent and prevents gate from fully closing. Both WS and LS have been cleared of debris and sediment. This crossing was listed in the USACE Periodic Inspection report as Corp's inspect ID#USACE_CESPK_M13D_2011_p_0162 for inoperable gates on WS & LS due to sediment and grass blocking inlet and outlet. FIELD_STRUCT_DESC: 24-inch corrugated metal drainage pipe through the levee, 8.9 feet below the crown. Concrete "U" headwalls on both the waterside (WS) and landside (LS) ends. Flap gate visible on the waterside (WS) end. [Additional Reference(s): DWR Levee Log, 1993. USACE Sacramento O&M Manual 519, June 1962 (HLM 3.29)]

Flap gate on WS.

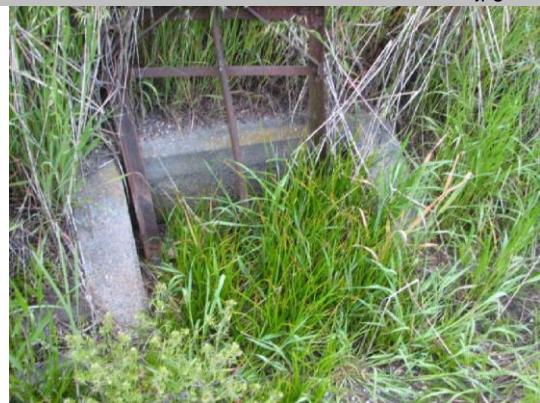
Photo 3 of 3 : UCIP_SP_2018_52191_66742.jpg

LS slide gate covered with silt. Slide gate is bent.

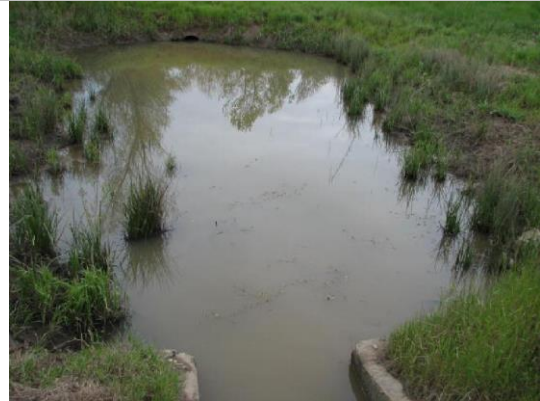
Photo 3 of 3 : UCIP_SP_2018_52195_66763.jpg

WS view of outlet cleared of vegetation.

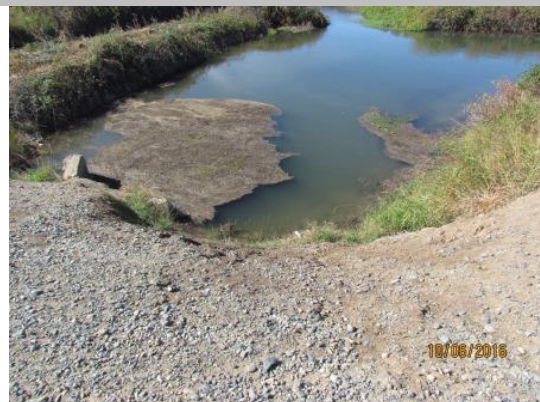
Photo 1 of 1 : SP_2018_MA0013_300_49_20180305_00007.jpg

View of the erosion site along the landside toe.

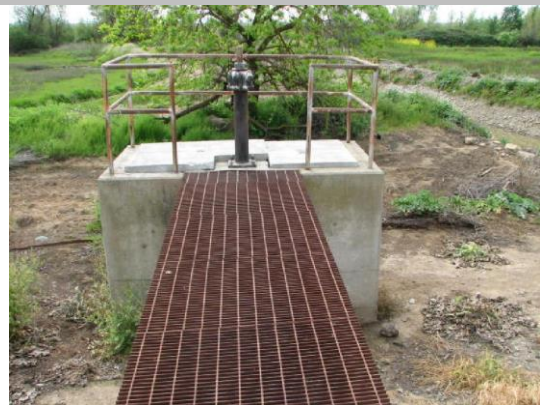
Photo 2 of 3 : UCIP_SP_2018_52220_66884.jpg

Catwalk & gate located on WS. No daylight point on WS.

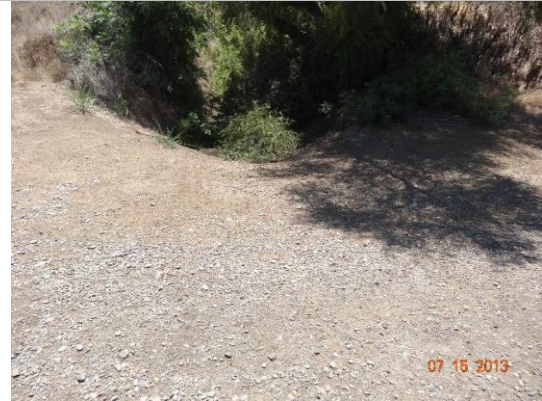
Photo 3 of 3 : UCIP_SP_2018_52242_66982.jpg

WS slope cleared of vegetation

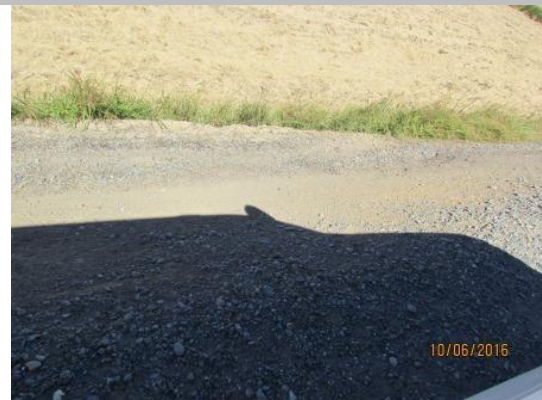
Photo 1 of 1 : SP_2018_MA0013_300_57_20180305_00010.jpg

View of slope instability along the landside slope.

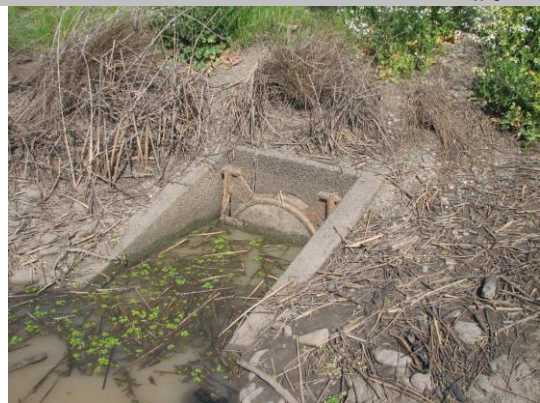
Photo 2 of 3 : UCIP_SP_2018_52124_67116.jpg

Unable to determine condition of flap gate on WS due to high water.

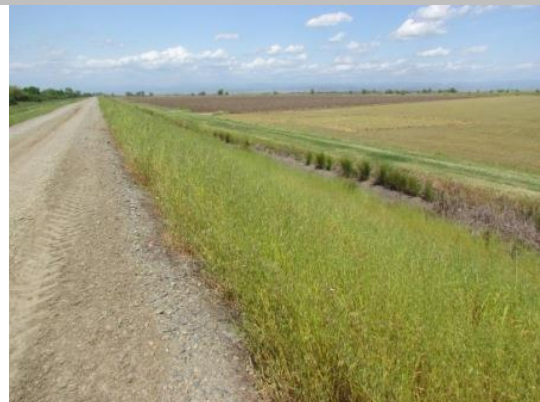
Photo 1 of 1 : SP_2018_MA0013_301_13_20180305_00005.jpg

View of the agricultural ditch along the toe.

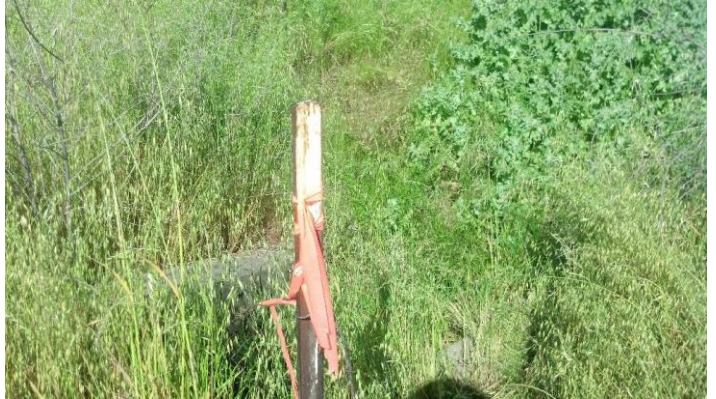
Photo 2 of 3 : UCIP_SP_2018_52156_67343.jpg

Dense vegetation covering the majority of the WS. WS headwall difficult to see through dense vegetation.

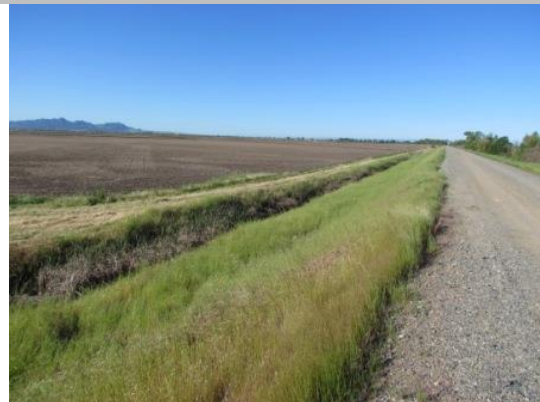
Photo 1 of 1 : SP_2018_MA0013_301_21_20180305_00009.jpg

View of the agricultural ditch along the toe.

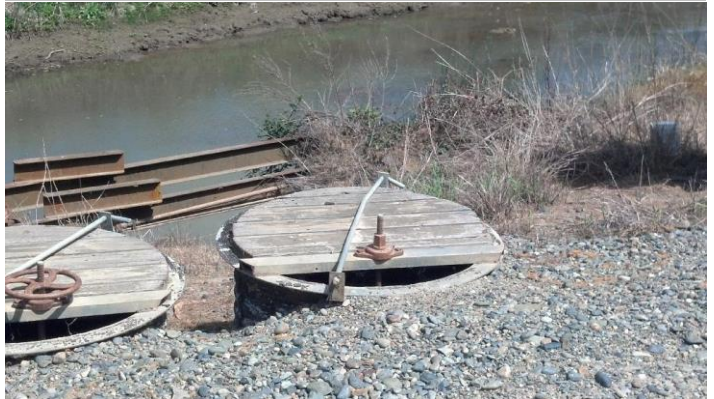
Photo 2 of 3 : UCIP_SP_2018_52165_67407.jpg

Corrugated metal pipe riser for pipe 1 of 3. Slide gate is missing handle.

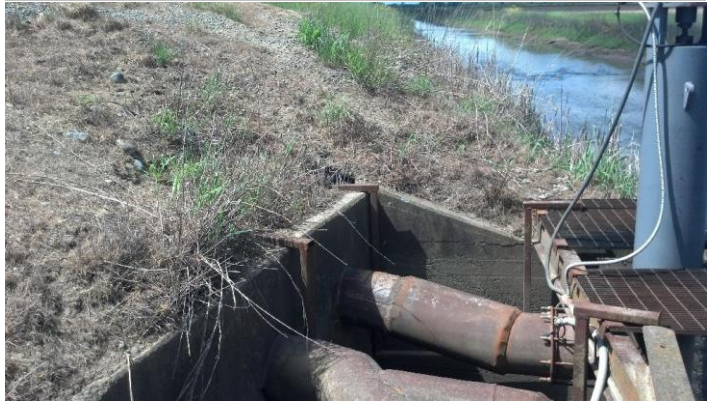
Photo 3 of 3 : UCIP_SP_2018_52165_67409.jpg

Sink hole observed behind WS headwall at the downstream edge of headwall. (Sink hole picture 1 of 2)

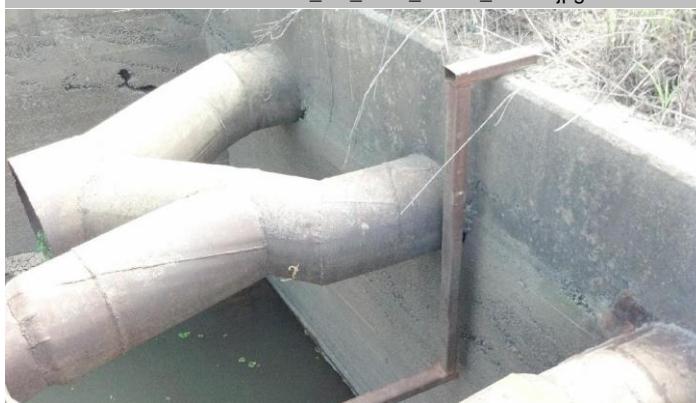
Photo 3 of 3 : UCIP_SP_2018_52166_67415.jpg

View of pipe 2. Pipe 2 diverts flow to pipe 1.
