**Flood Control Project Maintenance
Levee Inspections**
LMA District Cover Sheet
Spring 2019 Levee Inspection Results

Sutter Maintenance Yard Maintenance Area 0013

Spring 2019 Levee Inspection Results

Waterway			Bank	Unit Miles
Unit No. 01 Cherokee Canal			Right	18.19
	Spring (March - May)	Summer (June - August)	(September - November) Fall	Winter (December - February)
Unit Maintenance Rating (Fall Only)				
Date of Inspection	5/15/2019 - 5/15/2019			
DWR Inspector	Makar Sokol			
Accompanied By	Shawn Freitag Sutter Maintenance Yard

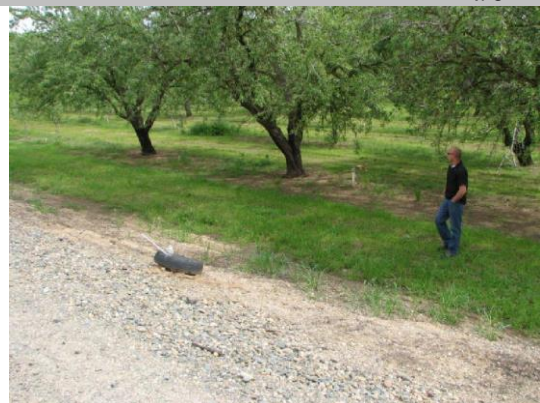
Photo 2 of 3 : UCIP_SP_2019_53313_66683.jpg

Air Vent located on WS.

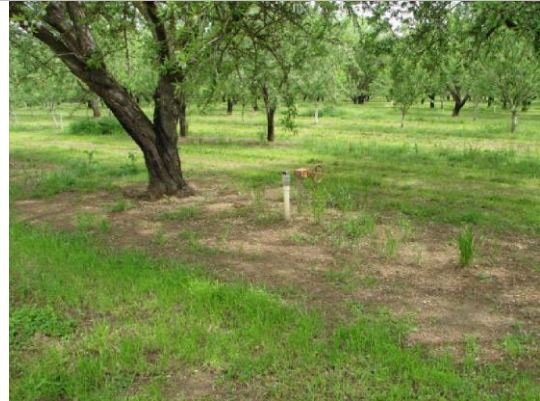
Photo 3 of 3 : UCIP_SP_2019_53313_66681.jpg

Air vent and gate located in channel. Unable to determine if part of crossing.

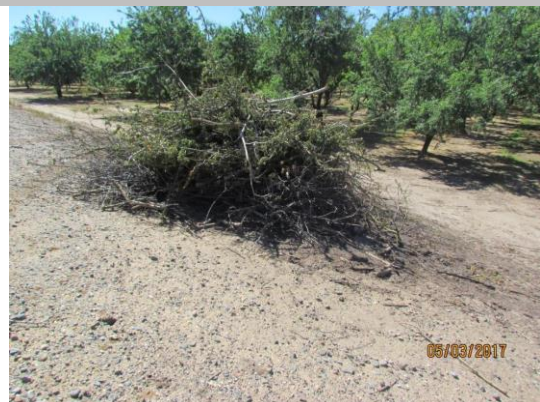
Photo 1 of 1 : SP_2019_MA0013_300_89_20190327_00011.jpg

LM Start	0.44	Rating **	M	Issue No.	89
LM End	0.44	Issue Type +	En	Location *	LS
Category	Earthen Levee			GPS Latitude/Longitude	
				Start	End
Item	Encroachments			39.591300 °	39.591300 °
				-121.702194 °	-121.702194 °
DWR ID	DWR_MA0013_01_s_2017_89				
Comment Code					
PR : Prunings					
Inspector Comment					
Remove the prunings from the landside slope.

View of prunings along the landside slope.

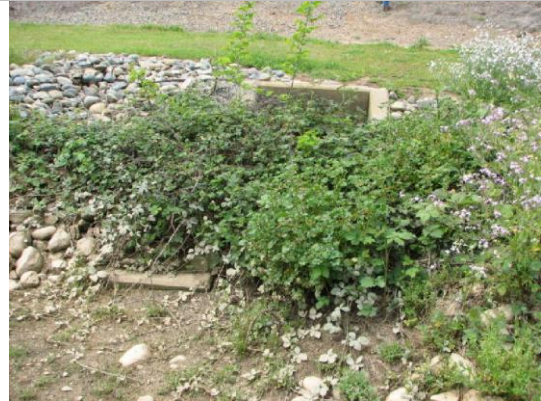
Photo 3 of 3 : UCIP_SP_2019_52938_66698.jpg

WS headwall, rock protection, and outlet blocked by shrub.

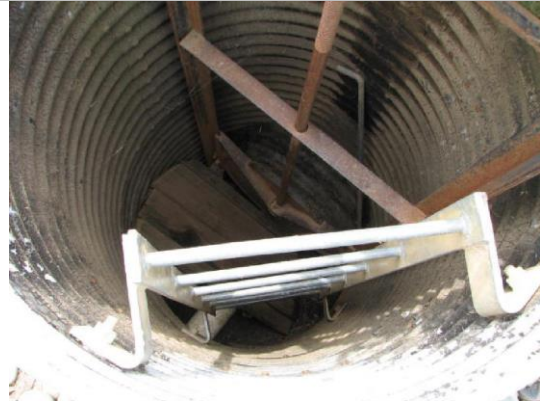
Photo 3 of 3 : UCIP_SP_2019_52183_66702.jpg

Positive closure device on WS slope, panel lid fell in.

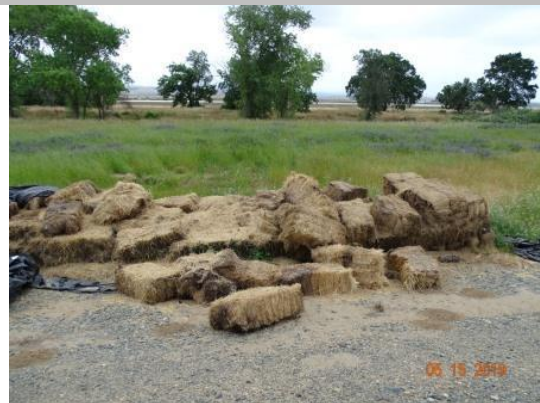
Photo 1 of 1 : SP_2019_MA0013_300_6_20190520_00143.jpg

LM Start	2.37	Rating **	M	Issue No.	6
LM End	2.37	Issue Type +	En	Location *	WS
Category	Earthen Levee			GPS Latitude/Longitude	
				Start	End
Item	Encroachments			39.565577 °	39.565577 °
				-121.703721 °	-121.703721 °
DWR ID	DWR_MA0013_01_s_2019_6				
Comment Code					
MA : Material					
Inspector Comment					
Remove the bales of straw from the waterside toe.

View of the straw bales at the waterside toe. Spring 2019.

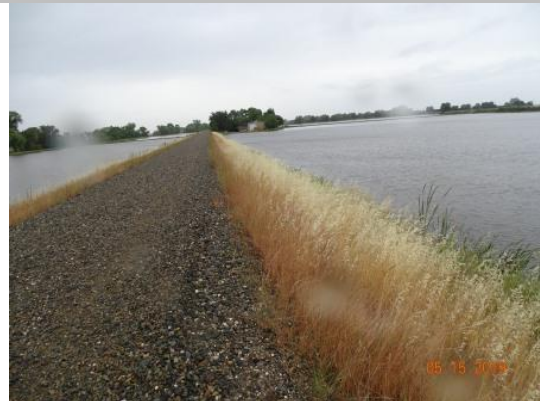
Photo 1 of 1 : SP_2019_MA0013_300_75_20190520_00145.jpg

LM Start	3.79	Rating **	U	Issue No.	75	
LM End	15.81	Issue Type +	Ma	Location *	LS	
Category	Earthen Levee			GPS Latitude/Longitude		
				Start		End
Item	Vegetation			39.545590 °		39.398277 °
				-121.707382 °		-121.811794 °
DWR ID	DWR_MA0013_01_s_2019_75					
Comment Code						
V1 : Control annual grass and weeds on the levee slopes and easements.						
Inspector Comment

View of the vegetation on the landside slope. Spring 2019.

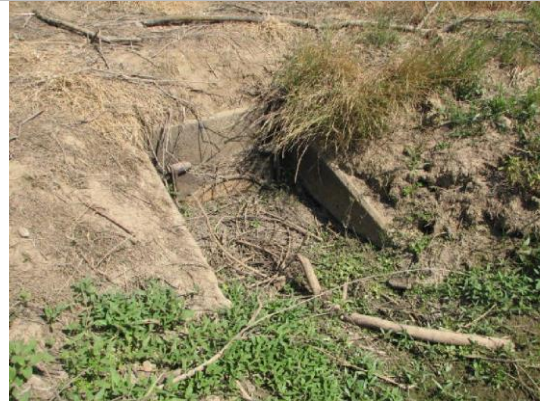
Photo 3 of 3 : UCIP_SP_2019_52201_66791.jpg

View of WS flap gate buried.

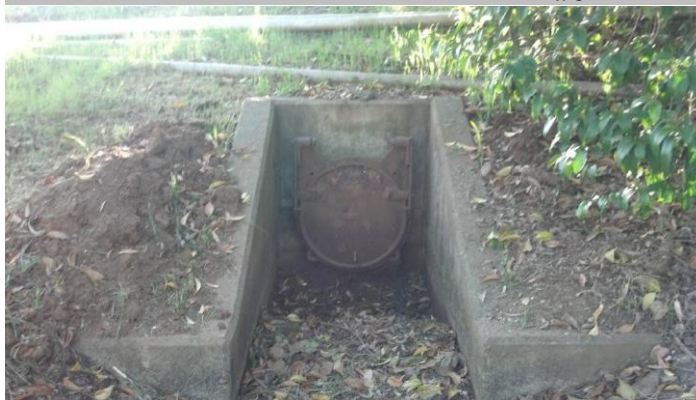
Photo 2 of 3 : UCIP_SP_2019_52111_45642.jpg

Headwall and flap gate on WS. Soil and pipes stockpiled next to headwall.

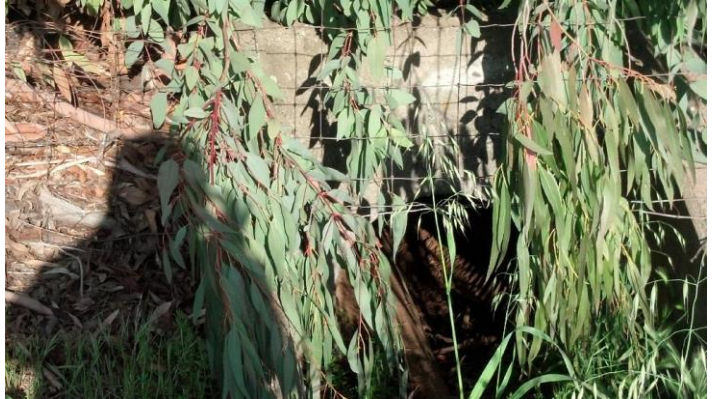
Photo 3 of 3 : UCIP_SP_2019_52111_45643.jpg

LS headwall blocked by overgrown branches.

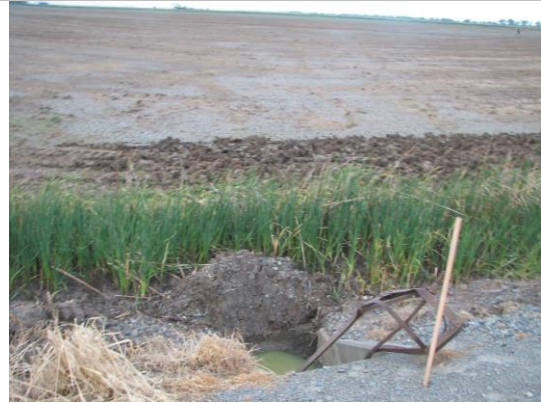
Photo 3 of 3 : UCIP_SP_2019_52129_67141.jpg

Overview of LS floor is higher in elevation than pipe invert causing build up sediment.

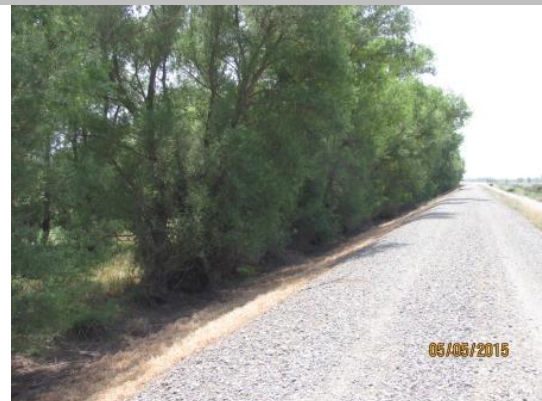
Photo 1 of 1 : SP_2019_MA0013_301_6_20190327_00002.jpg

View of the overgrown trees along the landside slope.

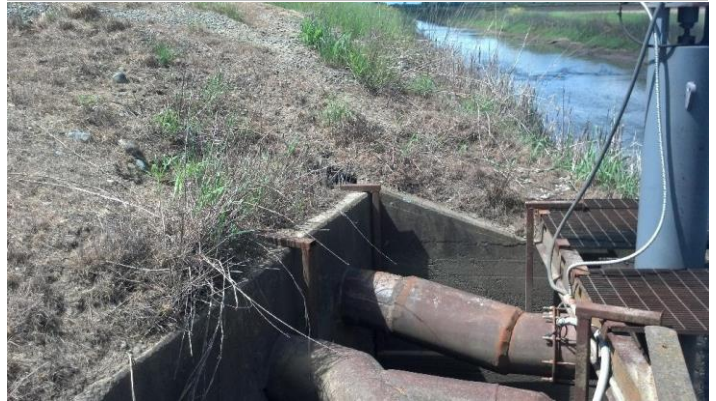
Photo 3 of 3 : UCIP_SP_2019_53320_67409.jpg

Sink hole observed behind WS headwall at the downstream edge of headwall. (Sink hole picture 1 of 2)

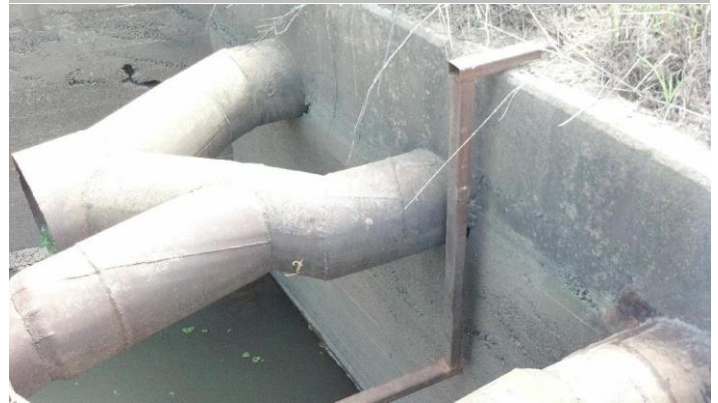
Photo 3 of 3 : UCIP_SP_2019_53321_67415.jpg

View of pipe 2. Pipe 2 diverts flow to pipe 1.

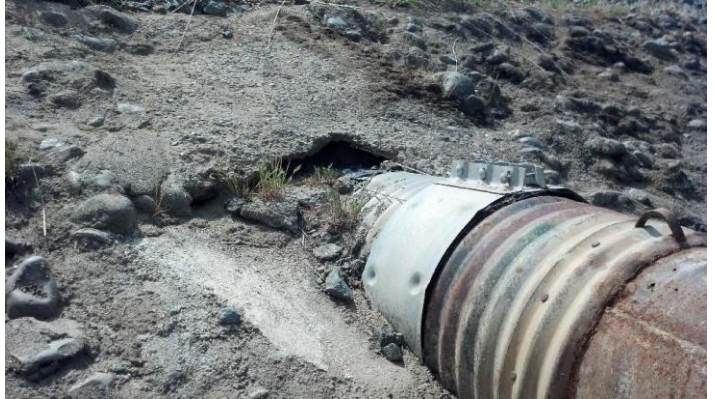
Photo 2 of 3 : UCIP_SP_2019_52168_67451.jpg

View of WS daylight. Hole present at pipe daylight.
