**Flood Control Project Maintenance
Levee Inspections**
LMA District Cover Sheet
Spring 2020 Levee Inspection Results

Sutter Maintenance Yard Maintenance Area 0013

Spring 2020 Levee Inspection Results

Waterway			Bank	Unit Miles
Unit No. 01 Cherokee Canal			Right	18.19
	Spring (March - May)	Summer (June - August)	(September - November) Fall	Winter (December - February)
Unit Maintenance Rating (Fall Only)				
Date of Inspection	4/9/2020 - 4/9/2020			
DWR Inspector	Makar Sokol			
Accompanied By	Bob Duffey Sutter Maintenance Yard

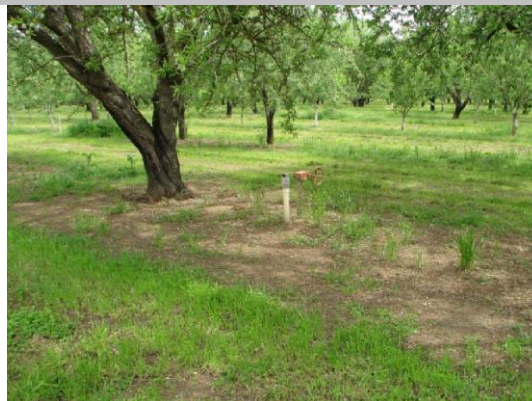
Photo 3 of 3 : UCIP_SP_2020_54936_66681.jpg

Air vent and gate located in channel. Unable to determine if part of crossing.

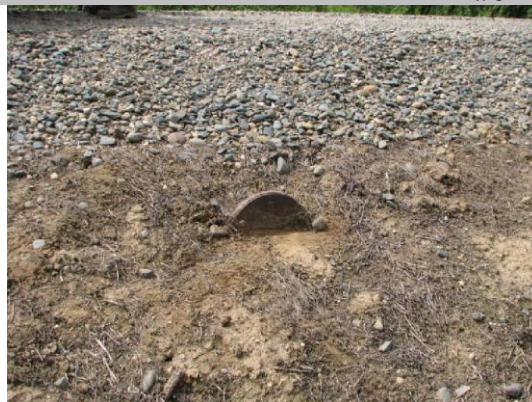
Photo 2 of 3 : UCIP_SP_2020_54937_66684.jpg

WS-Bolted plate

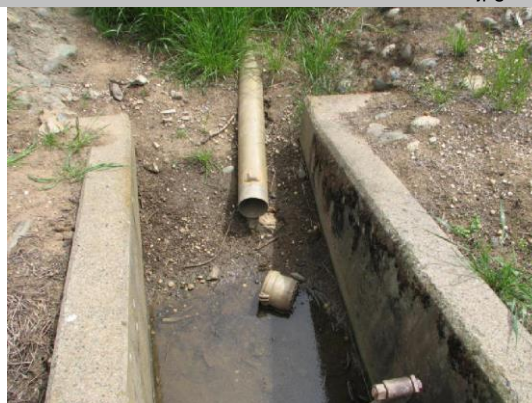
Photo 3 of 3 : UCIP_SP_2020_54938_66687.jpg

View of WS with pipe in channel.

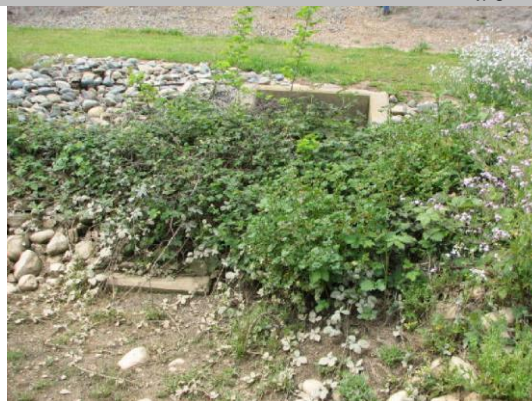
Photo 3 of 3 : UCIP_SP_2020_54939_66698.jpg

WS headwall, rock protection, and outlet blocked by shrub.

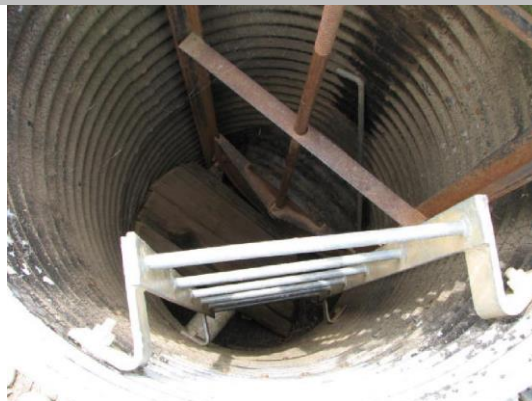
Photo 3 of 3 : UCIP_SP_2020_56082_66702.jpg

Positive closure device on WS slope, panel lid fell in.

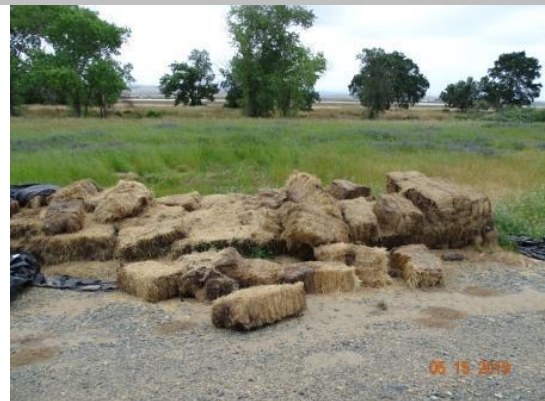
Photo 1 of 1 : SP_2020_MA0013_300_6_20200226_00003.jpg

View of the straw bales at the waterside toe. Spring 2019.

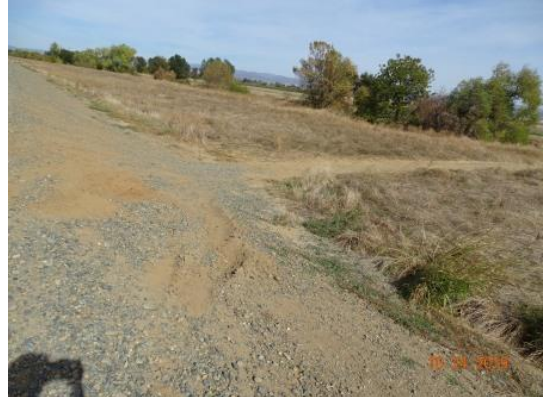
Photo 1 of 1 : SP_2020_MA0013_300_73_20200226_00011.jpg

LM Start	2.50	Rating **	M	Issue No.	73
LM End	2.50	Issue Type +	Ma	Location *	WS
Category	Earthen Levee			GPS Latitude/Longitude	
				Start	End
Item	Slope Stability			39.563676 °	39.563676 °
				-121.703775 °	-121.703775 °
DWR ID	DWR_MA0013_01_f _ 2019_73				
Comment Code					
S3 : Repair the levee slope damaged by vehicle traffic and prevent access where possible.					
Inspector Comment

View of depressions in the waterside slope due to vehicle traffic. Fall 2019.

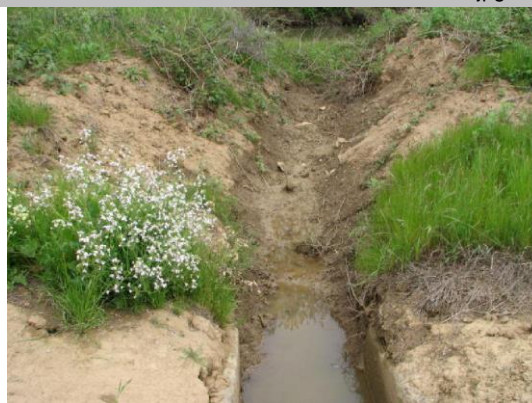
Photo 3 of 3 : UCIP_SP_2020_54944_66726.jpg

Recent sediment removal on WS.

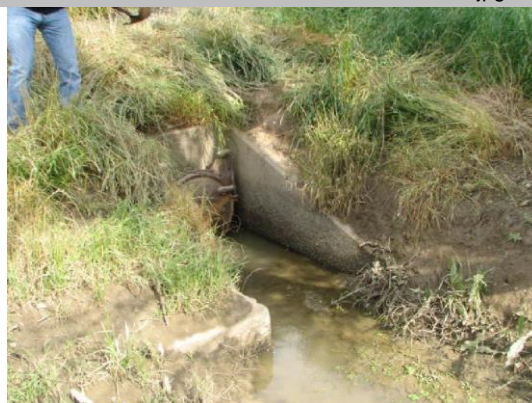
Photo 3 of 3 : UCIP_SP_2020_54969_66849.jpg

View of WS flap gate. Dense vegetation on WS slope.

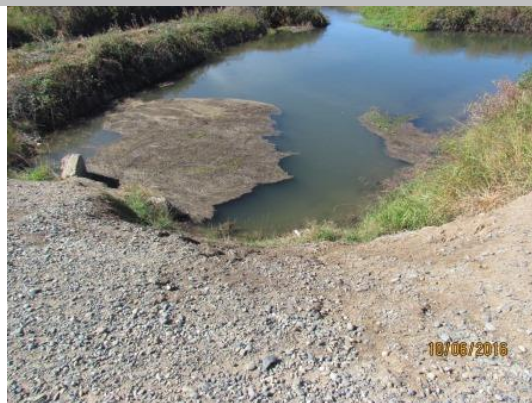
Photo 1 of 1 : SP_2020_MA0013_300_49_20200226_00007.jpg

View of the erosion site along the landside toe.

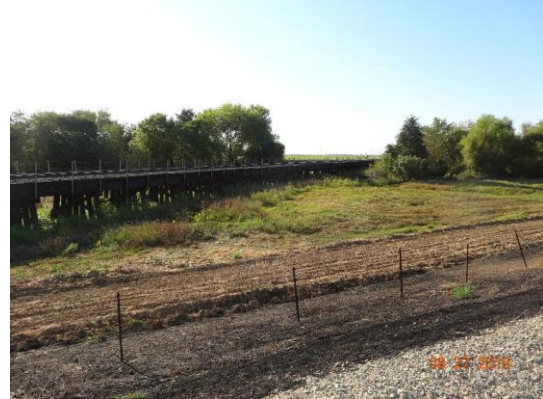
Photo 3 of 3 : UCIP_SP_2020_54981_80468.jpg

WS view: overview of WS, no marker found.

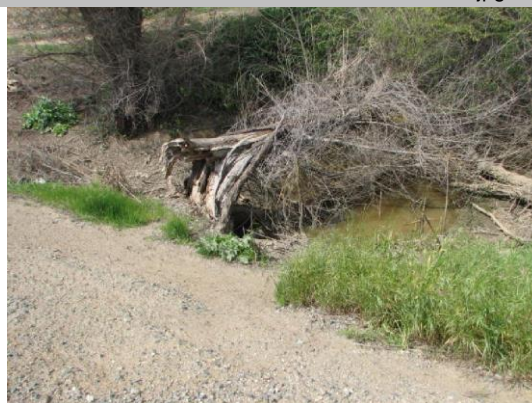
Photo 3 of 3 : UCIP_SP_2020_54997_66969.jpg

Tree fallen at LS headwall.

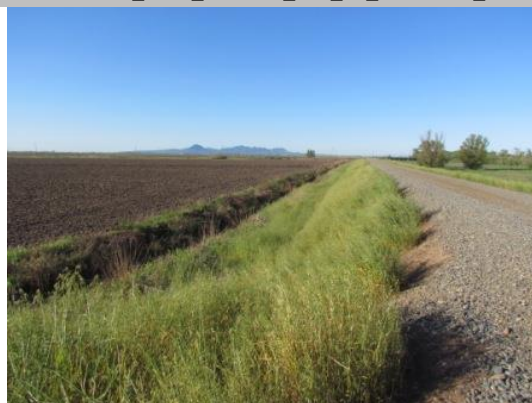
Photo 1 of 1 : SP_2020_MA0013_301_19_20200226_00004.jpg

View of the agricultural ditch along the toe.

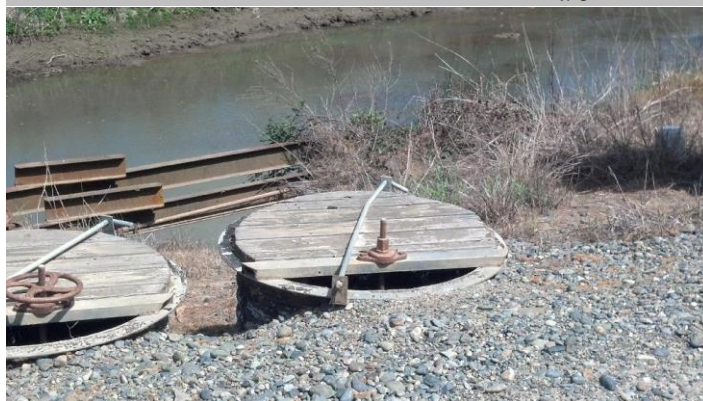
Photo 2 of 3 : UCIP_SP_2020_56078_67407.jpg

Corrugated metal pipe riser for pipe 1 of 3. Slide gate is missing handle.

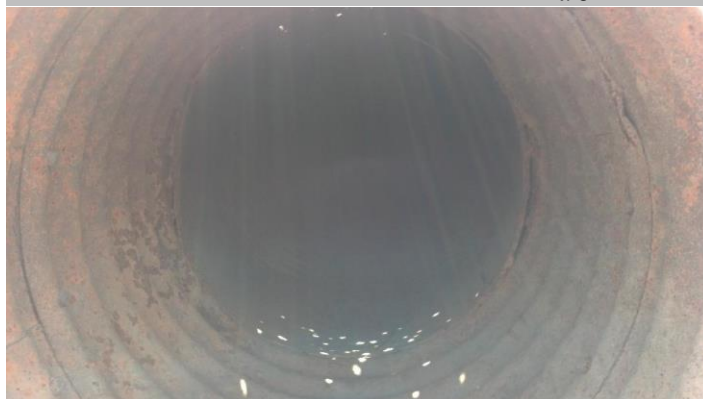
Photo 3 of 3 : UCIP_SP_2020_55413_67450.jpg

WS-view of internal pipe with severe corrosion-holes present along pipe wall.
