**Flood Control Project Maintenance
Levee Inspections
LMA District Cover Sheet**

Sutter Maintenance Yard Maintenance Area 0013

Waterway			Bank	Unit Miles
Unit No. 01 Cherokee Canal			Right	18.19
	Spring (March - May)	Summer (June - August)	(September - November) Fall	Winter (December - February)
Unit Maintenance Rating (Fall Only)				
Date of Inspection	3/24/2021 - 3/24/2021			
DWR Inspector	Makar Sokol			
Accompanied By	Bob Duffey Sutter Maintenance Yard

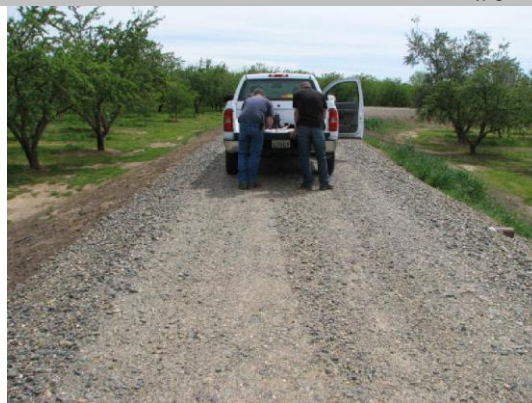
Photo 1 of 3 : UCIP_SP_2021_57515_66686.jpg

Comment Code						
Inspector Comment						
FS_ID:57515 DS_ID:16342 EP_NO: 12129 Repair Type: Non-Urgent Crossing Status: Found UCIP Comments: 08/06/2019 Need to contact owner to address proper abandonment per Title 23. Owner will need to coordinate with CVFPB. (O. Magana - DWR UCIP, A. Freitag - DWR Sutter Yard)06/14/2017 Abandoned- needs to be done properly. (A. Freitag - DWR Sutter Yard)11/16/2016 Abandoned. WS end still has plate bolted on. (A. Freitag - DWR Sutter Yard)04/28/2016 Crossing still has plate bolted on it at the WS end and LS end was mostly buried. (A. Freitag - DWR Sutter Yard)07/14/2015 WS pipe end still had plate bolted on it. (A. Freitag - DWR Sutter Yard)05/21/2014 Same as last inspection. (A. Freitag - DWR Sutter Yard)12/02/2013 Same as last inspection. (A. Freitag - DWR Sutter Yard)07/10/2013 Same as last inspection. (A. Freitag - DWR Sutter Yard)04/12/2012 WS pipe daylight has bolted plate. (O. Magana - DWR UCIP) FIELD_STRUCT_DESC: 6-inch steel irrigation pipe through the levee, 2.4 feet below the crown. Steel plate bolted on the waterside (WS) end. (5-inch water pipe authorized under Permit No. 12129, 12129A, 1977 - John & Jerie Malina) [Additional Reference(s): DWR Levee Log, 1993 (HLM 0.52)] FS Date: 8/6/2019 8:35:00 AM

View of levee crown at crossing looking downstream at right bank of Cherokee Canal.

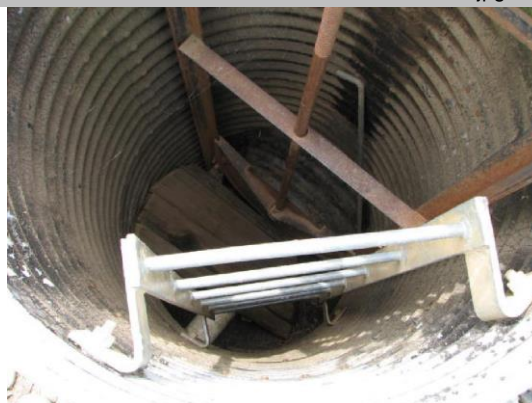
Photo 3 of 3 : UCIP_SP_2021_58463_66702.jpg

FS_ID:58463
DS_ID:16345
EP_NO: N/A
Repair Type: Non-Urgent
Crossing Status: Found
UCIP Comments: 08/06/2019 Record remains Non-Urgent, pipe has been abandoned. Crossing needs to be abandoned properly per Title 23. No owner has been identified for this crossing. Recommend adding cover to riser as a safety measure. (O. Magana - DWR UCIP, A. Freitag - DWR Sutter Yard)06/14/2017 PVC pipe still present blocking screw gate. LS inlet of the 24" cmp pipe is about 75% blocked by sediment. (A. Freitag - DWR Sutter Yard)11/16/2016 PVC pipe still present blocking the screw gate. (A. Freitag - DWR Sutter Yard)04/28/2016 Pvc pipe is still present through the crossing. Slide gate cannot shut fully. (A. Freitag - DWR Sutter Yard)07/14/2015 4-inch pipe still present and blocking the screw gate. (A. Freitag - DWR Sutter Yard)05/21/2014 Same as last inspection. (A. Freitag - DWR Sutter Yard)12/02/2013 Same as last inspection. (A. Freitag - DWR Sutter Yard)07/15/2013 Same as last inspection. (A. Freitag - DWR Sutter Yard)04/17/2012 Crossing has 4-inch pipe inside blocking positive closure/notify landowner to remove prior to flood season. LS crossing is blocked about 50% by sediment build up. Burrow activity present on LS near crossing. (O. Magana - DWR UCIP)

Positive closure device on WS slope, panel lid fell in.

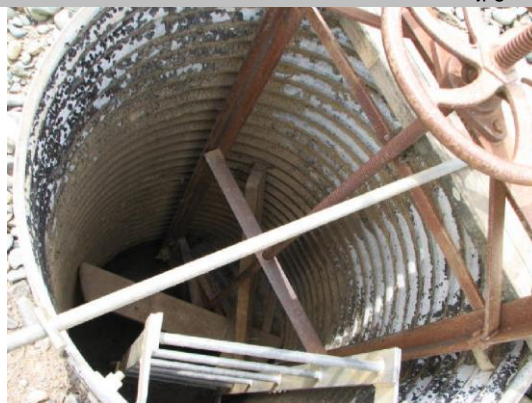
Photo 3 of 3 : UCIP_SP_2021_58464_66707.jpg

FS_ID:58464
DS_ID:16346
EP_NO: N/A
Repair Type: Non-Urgent
Crossing Status: Found
UCIP Comments: 08/06/2019 Record remains Non-Urgent, pipe has been abandoned. Crossing needs to be abandoned properly per Title 23. No owner has been identified for this irrigation pipe. Recommend adding cover to riser as a safety measure. (O. Magana - DWR UCIP, A. Freitag - DWR Sutter Yard)06/14/2017 Still no LS inlet visible- trace with locator/GPR to try and locate. Wooden debris down inside of WS standpipe. Pipe has been selected to be internally cleaned and inspected as part of the DMP project. (A. Freitag - DWR Sutter Yard)11/16/2016 Appears abandoned. Unable to find anything on LS. (A. Freitag - DWR Sutter Yard)04/28/2016 Appears to be an abandoned crossing. LS headwall and pipe inlet are still completely buried. (A. Freitag - DWR Sutter Yard)07/14/2015 Still cannot find an inlet or outlet. (A. Freitag - DWR Sutter Yard)05/21/2014 Same as last inspection. (A. Freitag - DWR Sutter Yard)12/02/2013 Same as last inspection. (A. Freitag - DWR Sutter Yard)07/15/2013 Same as last inspection. (A. Freitag - DWR Sutter Yard)04/17/2012 Non functional crossing due to LS headwall buried. This crossing was listed in the USACE Periodic Inspection report as Corp's inspect ID#USACE_CESPK_M13D_2011_p_0119 for no inlet or outlet visible. (O. Magana - DWR UCIP)

Corrugated metal riser on WS slope. Lid panel blocking gate.

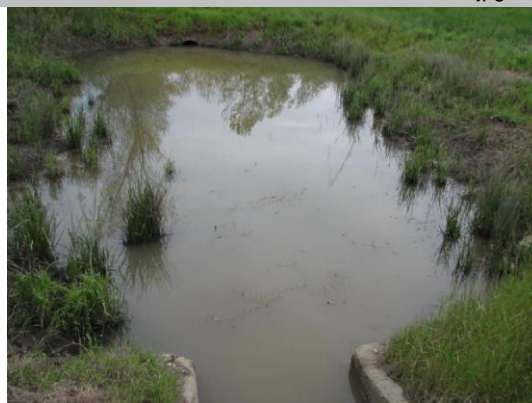
Photo 3 of 3 : UCIP_SP_2021_58473_66763.jpg

WS view of outlet cleared of vegetation.

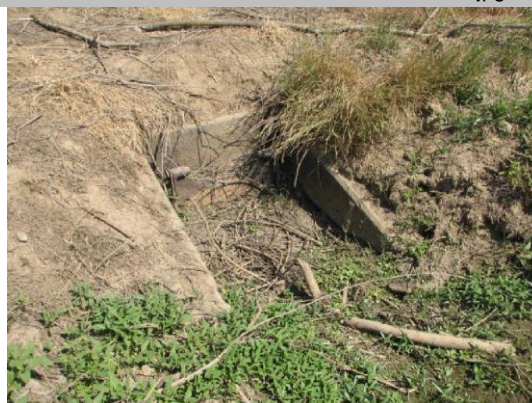
Photo 3 of 3 : UCIP_SP_2021_58478_66791.jpg

View of WS flap gate buried.

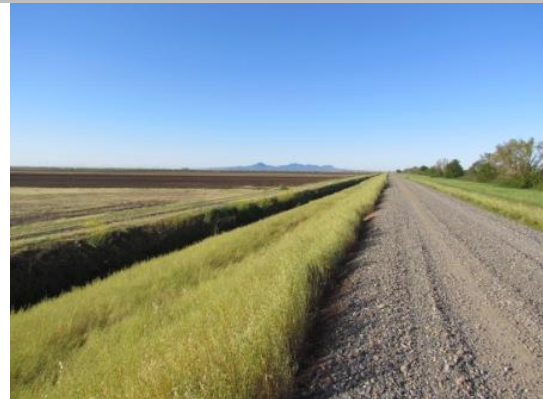
Photo 1 of 1 : SP_2021_MA0013_301_18_20210224_00003.jpg

View of the agricultural ditch along the toe.

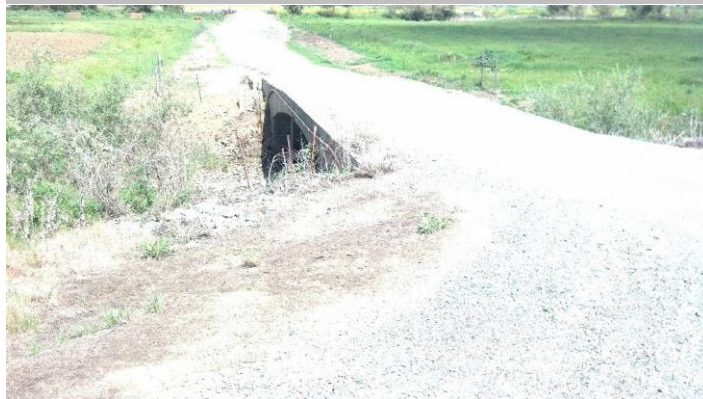
Photo 3 of 3 : UCIP_SP_2021_57681_67395.jpg

View of WS where cable line is attached to culvert crossing.

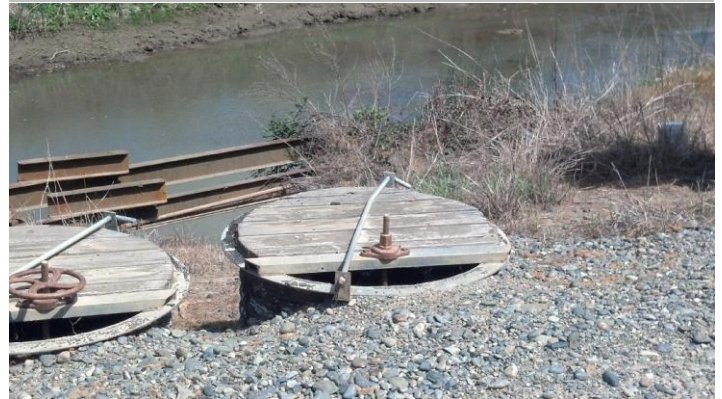
Photo 2 of 3 : UCIP_SP_2021_58559_67407.jpg

Corrugated metal pipe riser for pipe 1 of 3. Slide gate is missing handle.

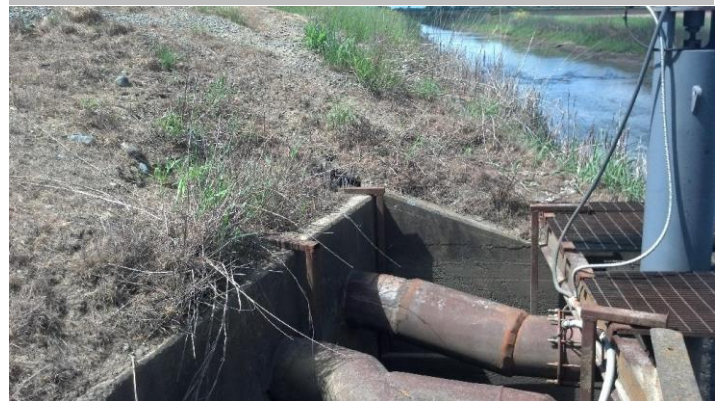
Photo 3 of 3 : UCIP_SP_2021_58559_67409.jpg

Sink hole observed behind WS headwall at the downstream edge of headwall. (Sink hole picture 1 of 2)

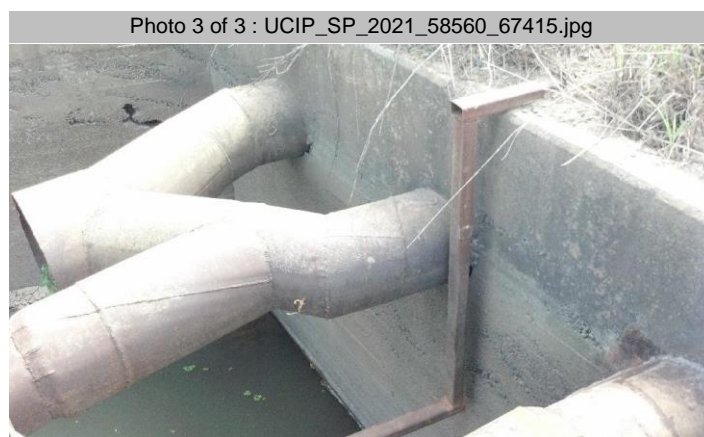
View of pipe 2. Pipe 2 diverts flow to pipe 1.

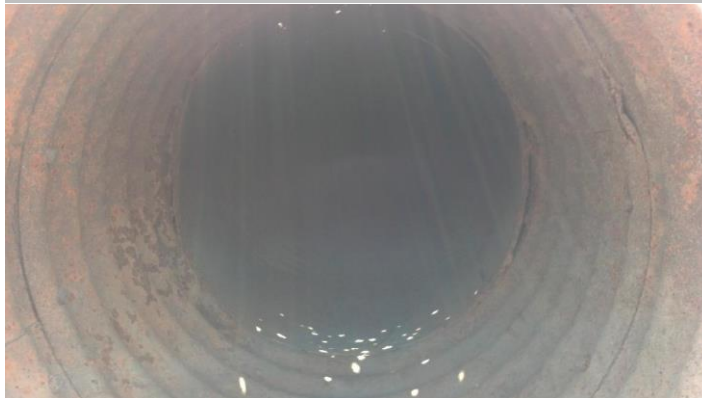
Photo 3 of 3 : UCIP_SP_2021_58562_67450.jpg

WS-view of internal pipe with severe corrosion-holes present along pipe wall.

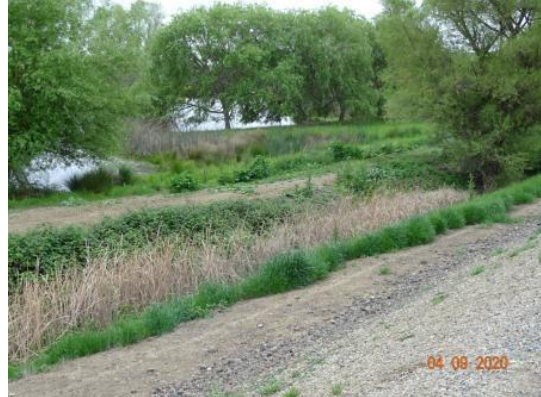
Photo 1 of 1 : SP_2021_MA0013_301_59_20210224_00009.jpg

View of the ditch along the landside toe. Spring 2020.

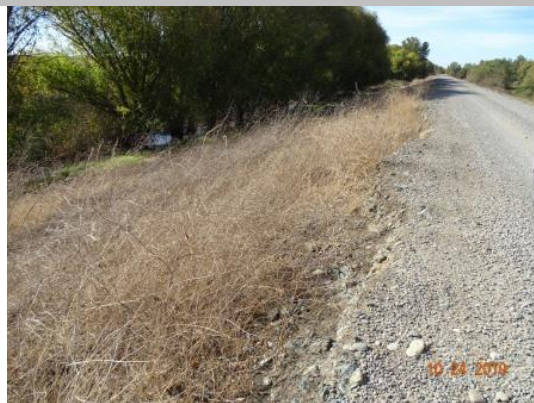
Photo 1 of 1 : SP_2021_MA0013_301_58_20210224_00008.jpg

View of erosion on the landside slope. Fall 2019.

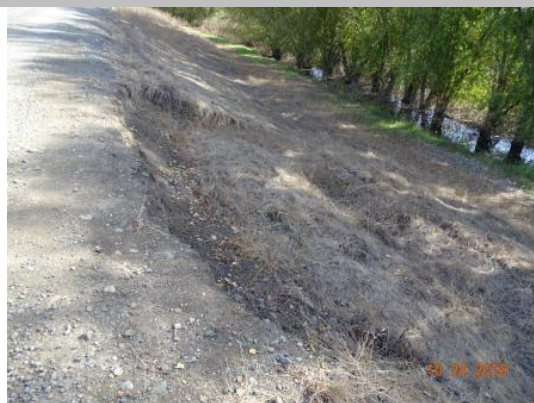
Photo 1 of 1 : SP_2021_MA0013_301_60_20210224_00010.jpg

View of sloughing on the landside slope. Fall 2019.
