**Flood Control Project Maintenance
Levee Inspections
LMA District Cover Sheet**

**Flood Control Project Maintenance
Levee Inspections
Unit Cover Sheet**

Waterway			Bank	Unit Miles
Unit No. 01 Cherokee Canal			Right	18.19
	Spring (March - May)	Summer (June - August)	(September - November) Fall	Winter (December - February)
Unit Maintenance Rating (Fall Only)				
Date of Inspection	3/23/2022 - 3/23/2022			
DWR Inspector	Makar Sokol			
Accompanied By

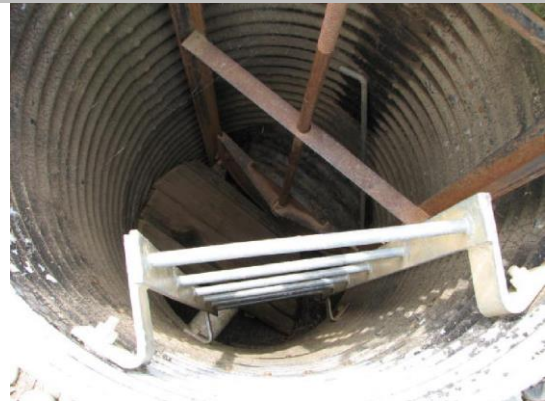
Photo 3 of 3 : UCIP_SP_2022_58463_66702.jpg

Positive closure device on WS slope, panel lid fell in.

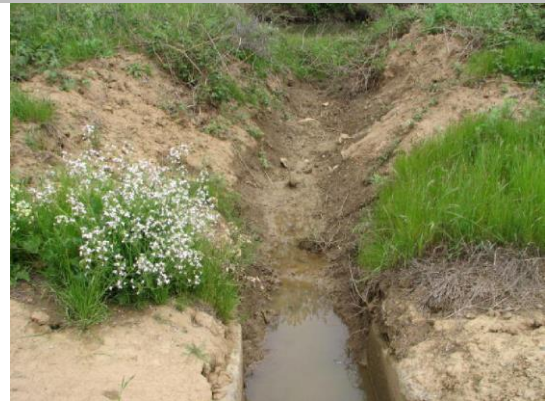
Photo 3 of 3 : UCIP_SP_2022_58577_66726.jpg

Recent sediment removal on WS.

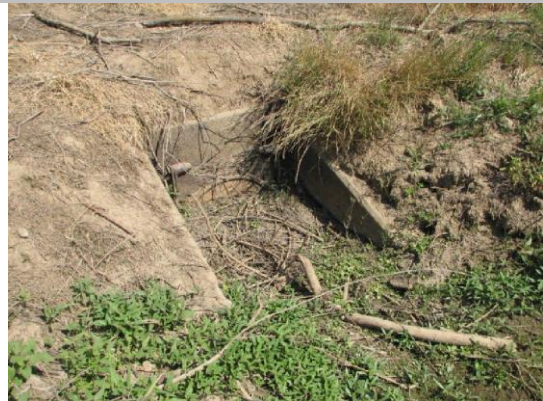
Photo 3 of 3 : UCIP_SP_2022_58478_66791.jpg

View of WS flap gate buried.

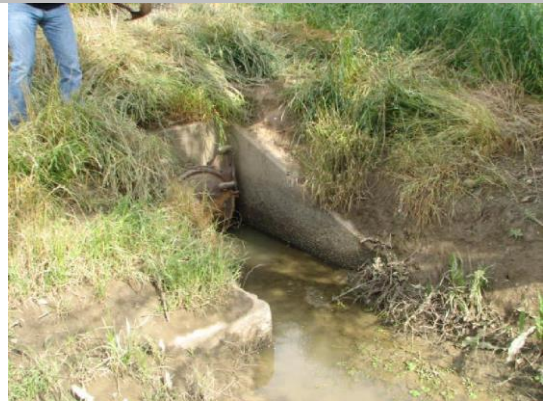
Photo 3 of 3 : UCIP_SP_2022_58485_66849.jpg

View of WS flap gate. Dense vegetation on WS slope.

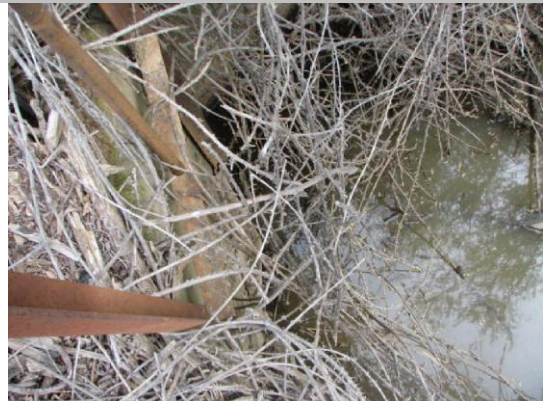
Photo 3 of 3 : UCIP_SP_2022_58493_66900.jpg

View of slide gate on WS. Debris blocking gate.

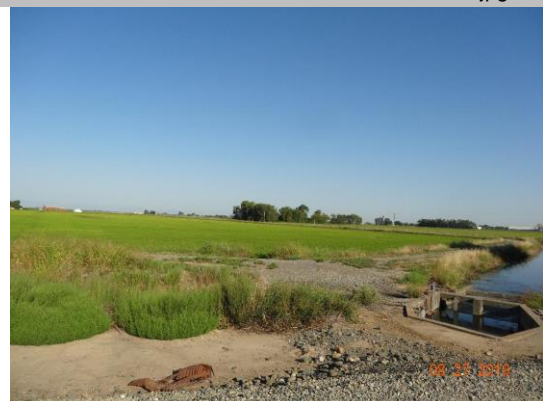
Photo 2 of 3 : UCIP_SP_2022_58516_80467.jpg

LS view: overview of LS, no marker found.

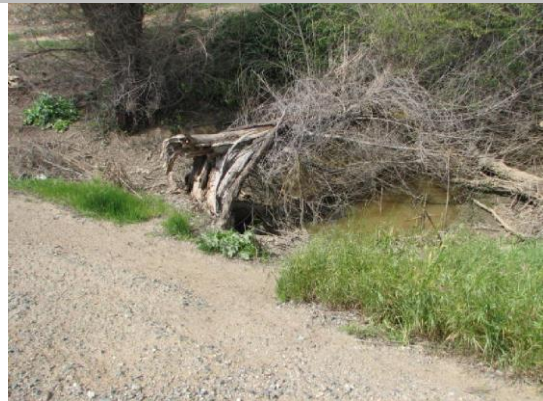
Photo 3 of 3 : UCIP_SP_2022_58515_66969.jpg

Tree fallen at LS headwall.

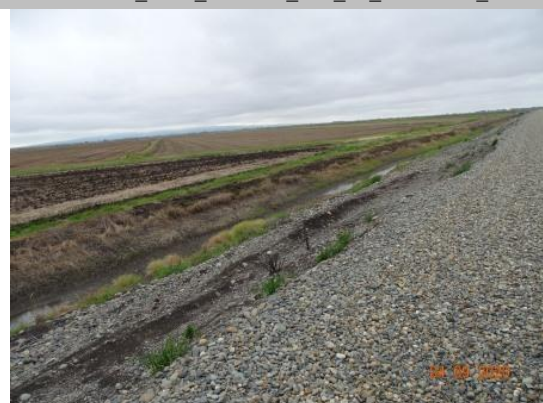
Photo 1 of 1 : SP_2022_MA0013_301_69_20220307_00013.jpg

View of slope instability along the landside slope. Spring 2020.

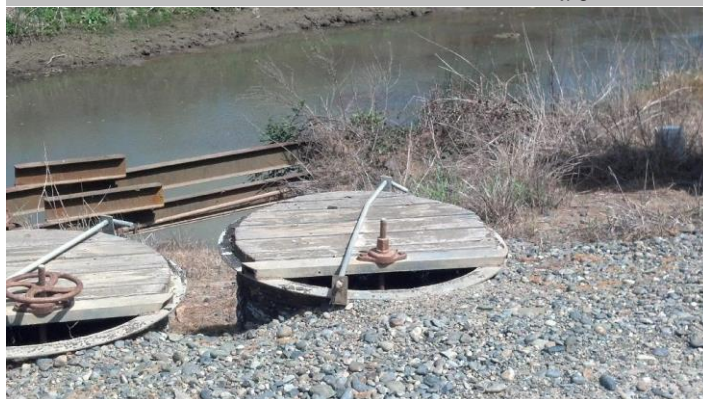
Photo 2 of 3 : UCIP_SP_2022_58559_67407.jpg

Corrugated metal pipe riser for pipe 1 of 3. Slide gate is missing handle.

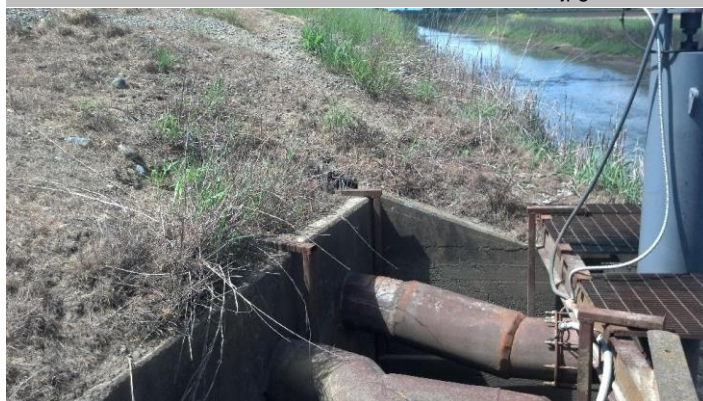
Photo 3 of 3 : UCIP_SP_2022_58559_67409.jpg

Sink hole observed behind WS headwall at the downstream edge of headwall. (Sink hole picture 1 of 2)

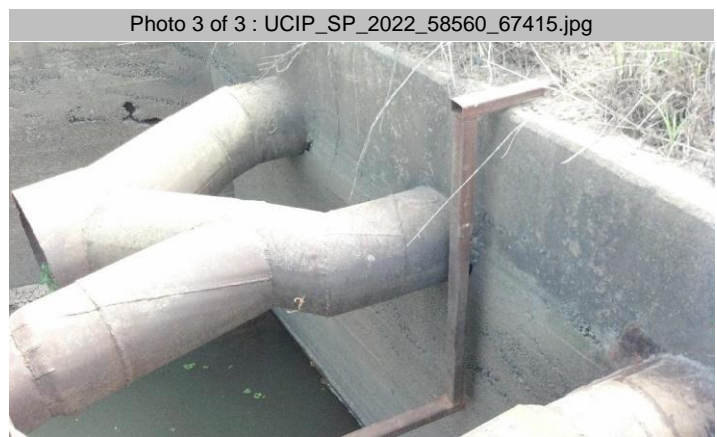
View of pipe 2. Pipe 2 diverts flow to pipe 1.

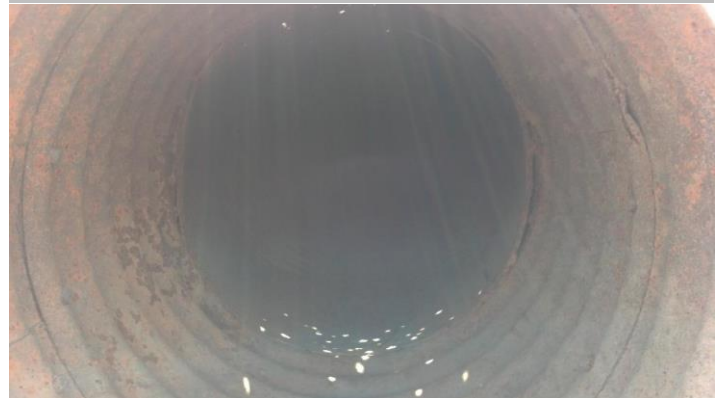
Photo 3 of 3 : UCIP_SP_2022_58562_67450.jpg

WS-view of internal pipe with severe corrosion-holes present along pipe wall.
