**Flood Control Project Maintenance
Levee Inspections
LMA District Cover Sheet**

**Flood Control Project Maintenance
Levee Inspections
Unit Cover Sheet**

Waterway			Bank	Unit Miles
Unit No. 01 Cherokee Canal			Right	18.19
	Spring (March - May)	Summer (June - August)	(September - November) Fall	Winter (December - February)
Unit Maintenance Rating (Fall Only)				
Date of Inspection	4/26/2023 - 4/26/2023			
DWR Inspector	Makar Sokol			
Accompanied By	Shawn Freitag DWR Sutter Yard

Levee Inspection Report By Mile - Spring 2023

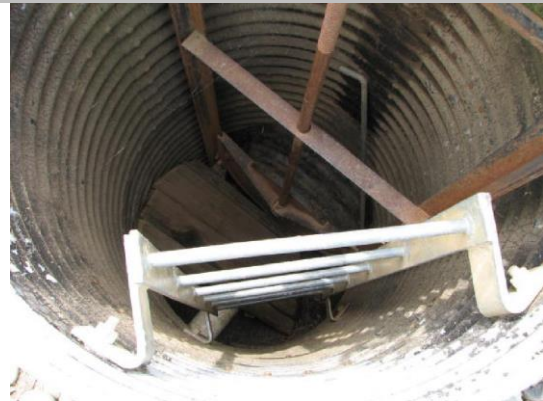
Photo 3 of 3 : UCIP_SP_2023_58463_66702.jpg

Positive closure device on WS slope, panel lid fell in.

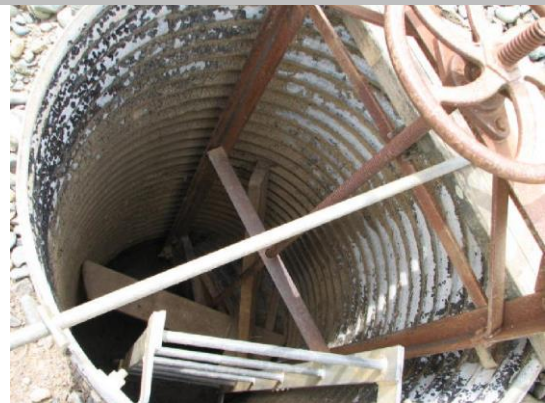
Photo 3 of 3 : UCIP_SP_2023_58464_66707.jpg

Corrugated metal riser on WS slope. Lid panel blocking gate.

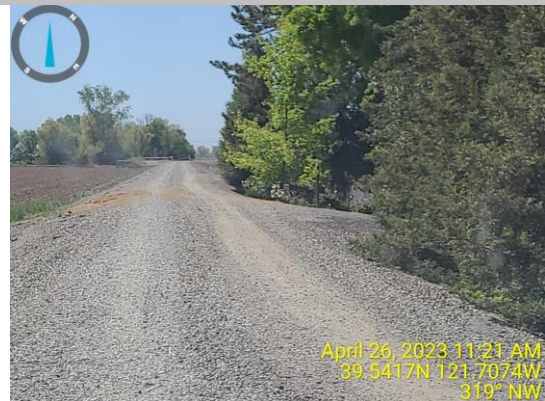
Photo 1 of 1 : SP_2023_MA0013_300_18_20230427_00129.jpg

View of the trees along the landside slope. Spring 2023.

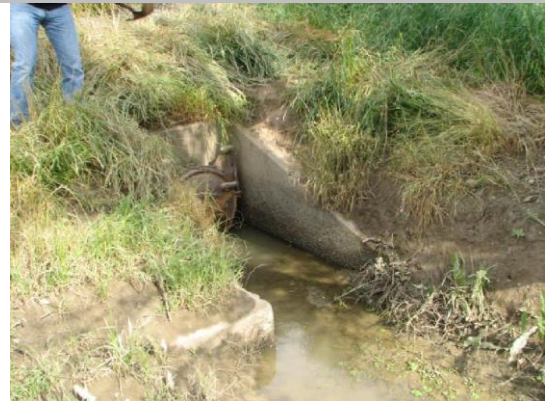
Photo 3 of 3 : UCIP_SP_2023_58485_66849.jpg

View of WS flap gate. Dense vegetation on WS slope.

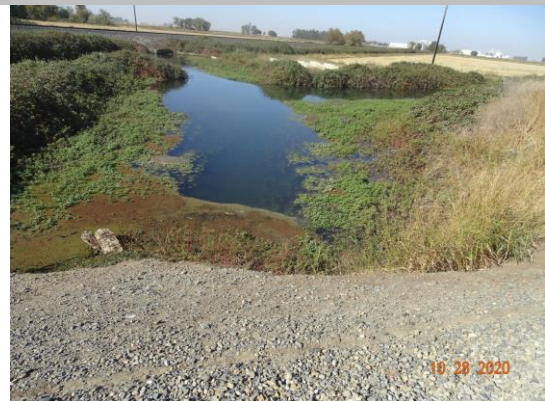
Photo 1 of 1 : SP_2023_MA0013_300_49_20230417_00006.jpg

View of the erosion site along the landside toe. Fall 2020.

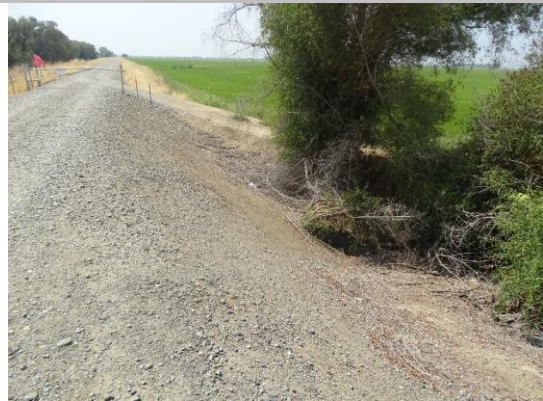
Photo 3 of 3 : UCIP_SP_2023_58515_77944.jpg

LS view: vegetation and debris still present; levee looks in good condition.

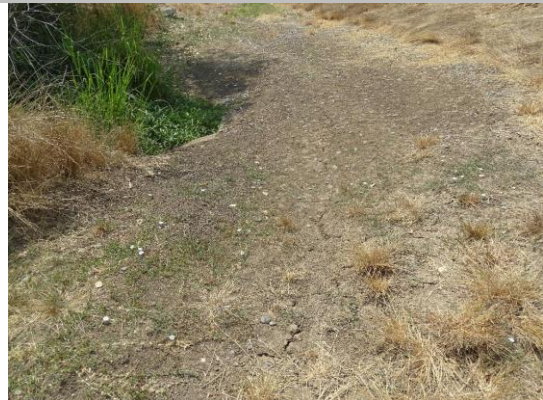
Photo 3 of 3 : UCIP_SP_2023_58505_77948.jpg

WS view: long crack above the headwall could be of concern.

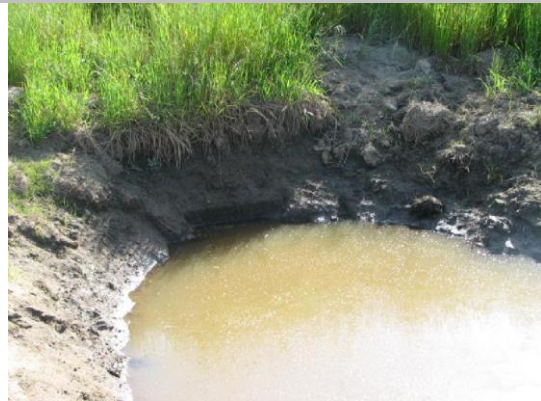
Photo 3 of 3 : UCIP_SP_2023_58527_67096.jpg

View of flap gate submerged on WS toe.

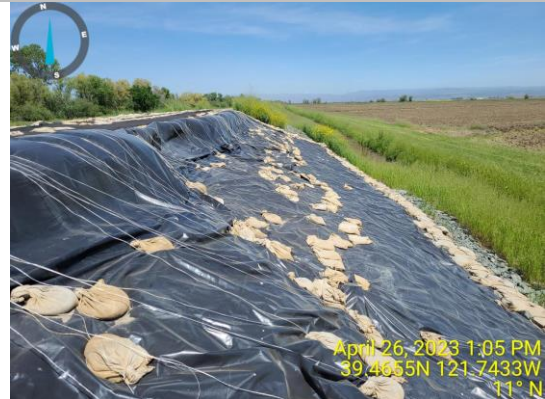
Photo 1 of 1 : SP_2023_MA0013_301_50_20230427_00127.jpg

View of the slope stability/sloughing issue along the landside slope. LMA put a raincoat to protect from further saturation. Spring 2023.

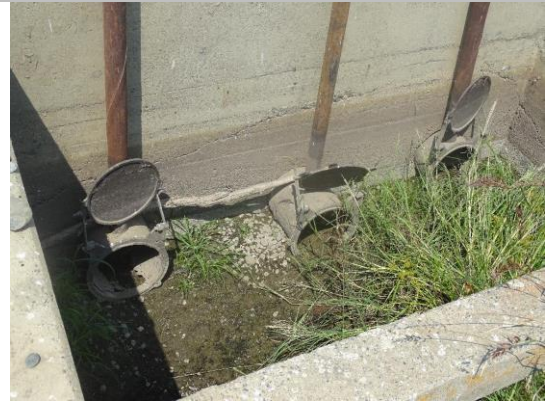
Photo 2 of 3 : UCIP_SP_2023_58559_77952.jpg

LS view: corroded outlet pipes.

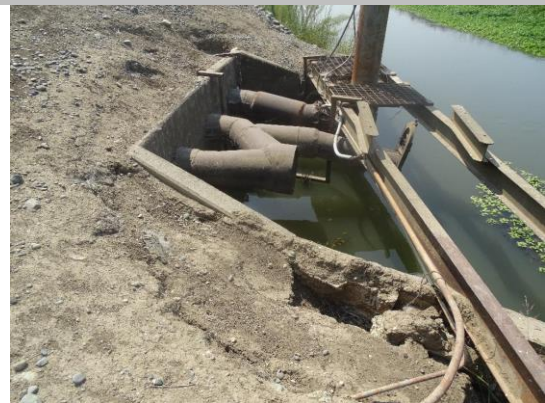
Photo 3 of 3 : UCIP_SP_2023_58559_77954.jpg

WS view: massive erosion around headwall.

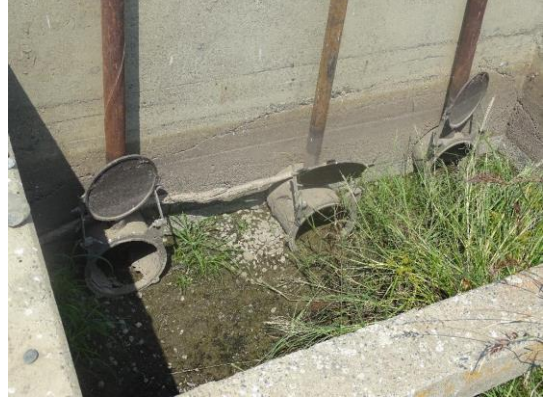
Photo 2 of 3 : UCIP_SP_2023_58560_77956.jpg

LS view: corroded outlet pipes.

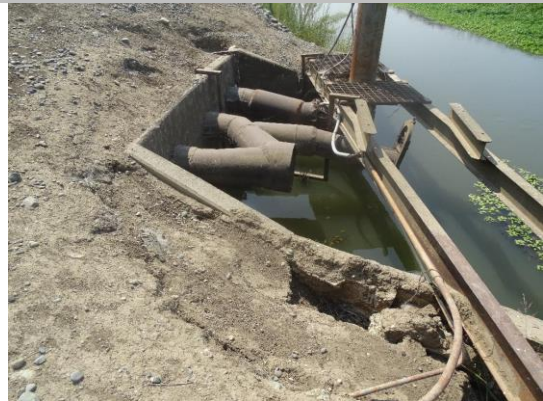
Photo 3 of 3 : UCIP_SP_2023_58561_77960.jpg

WS view: massive erosion around headwall.

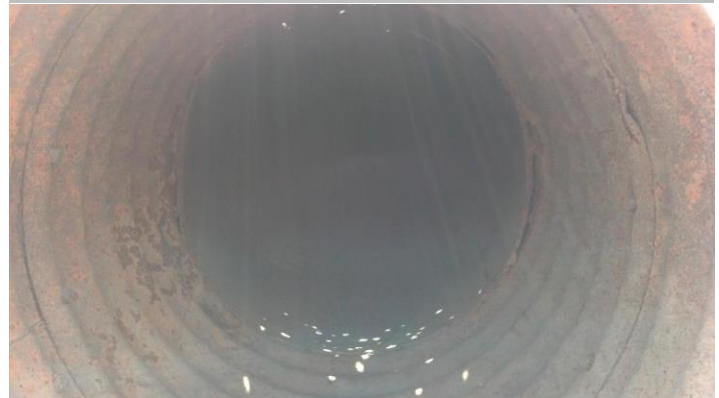
Photo 3 of 3 : UCIP_SP_2023_58562_67450.jpg

WS-view of internal pipe with severe corrosion-holes present along pipe wall.
