Flood Control Project Maintenance  
Levee Inspections  
LMA District Cover Sheet

Sutter Maintenance Yard Maintenance Area 0013

**Flood Control Project Maintenance  
Levee Inspections  
Unit Cover Sheet**

Waterway			Bank	Unit Miles
Unit No. 01 Cherokee Canal			Right	18.19
	Spring (March - May)	Summer (June - August)	(September - November) Fall	Winter (December - February)
Unit Maintenance Rating (Fall Only)				
Date of Inspection	4/17/2024 - 4/17/2024			
DWR Inspector	Makar Sokol			
Accompanied By	Shawn Freitag DWR Sutter Yard

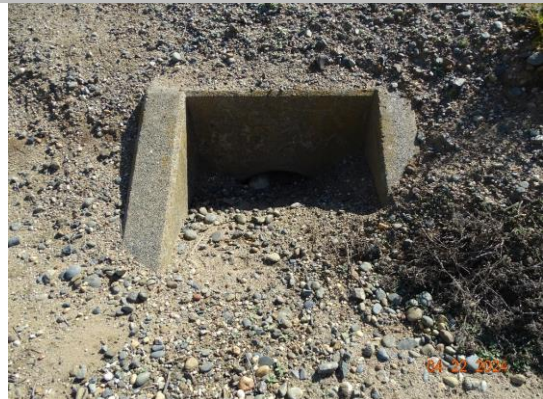
Photo 3 of 3 : UCIP\_SP\_2024\_83161\_121371.jpg

Comment Code						
Inspector Comment						
DS_ID:16345 FS_ID:83161 EP_NO: N/A Repair Type: Non-Urgent EVAL Issue: 4b, Safety Issue Crossing Status: Found UCIP Comments: 04/22/2024 Record remains Non-Urgent. No cover was present on CMP riser causing a safety hazard; recommend adding a cover. Wooden riser cover debris present within CMP riser located on the WS slope. Pipe outlet on LS is approximately 90% blocked by sediment; crossing appears to no longer be in use. Recommend owner to contact CVFPB to abandon or remove pipe from levee. No permit has been identified authorizing pipe. (M. Thao - DWR UCIP) 08/06/2019 Record remains Non-Urgent, pipe has been abandoned. Crossing needs to be abandoned properly per Title 23. No owner has been identified for this crossing. Recommend adding cover to riser as a safety measure. (O. Magana - DWR UCIP, A. Freitag - DWR Sutter Yard) 06/14/2017 PVC pipe still present blocking screw gate. LS inlet of the 24" cmp pipe is about 75% blocked by sediment. (A. Freitag - DWR Sutter Yard) 11/16/2016 PVC pipe still present blocking the screw gate. (A. Freitag - DWR Sutter Yard) 04/28/2016 Pvc pipe is still present through the crossing. Slide gate cannot shut fully. (A. Freitag - DWR Sutter Yard) 07/14/2015 4-inch pipe still present and blocking the screw gate. (A. Freitag - DWR Sutter Yard) 05/21/2014 Same as last inspection. (A. Freitag - DWR Sutter Yard) 12/02/2013 Same as last inspection. (A. Freitag - DWR Sutter Yard) 07/15/2013 Same as last inspection. (A. Freitag - DWR Sutter Yard) 04/17/2012 Crossing has 4-inch pipe inside blocking positive closure/notify landowner to remove prior to flood season. LS crossing is blocked about 50% by sediment build up. Burrow activity present on LS near crossing. (O. Magana - DWR UCIP) FIELD_STRUCT_DESC: 24-inch corrugated metal irrigation pipe through the levee, 7.6 feet below the crown. Slide gate in corrugated metal pipe (CMP) riser on the waterside (WS) slope. Concrete headwall on the landside (LS). 36-inch concrete standpipe in the channel with 2 piles to deflect debris (39.576614, -121.7009). [Additional Reference(s): DWR Levee Log, 1993 (HLM 1.68). USACE Sacramento O&M Manual, Unit 519, June 1962, Revised 3 Feb 2011, (HLM 1.69), listed as 24-inch pipe, no as-built referenced found] FS Date: 4/22/2024 11:20:06 AM

LS view: Close-up view of concrete headwall at toe covered with sediment; pipe outlet approximately 90% blocked.

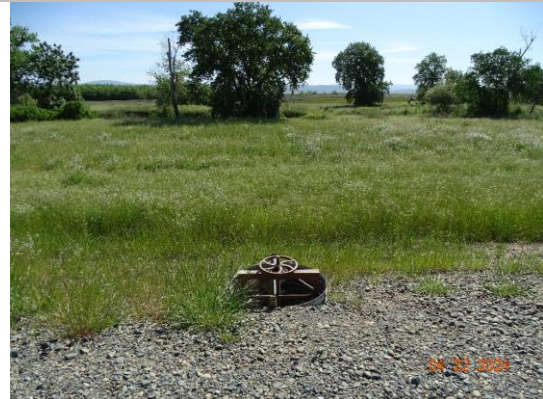
Photo 1 of 1 : UCIP\_SP\_2024\_83158\_121363.jpg

DS\_ID:16346  
FS\_ID:83158  
EP\_NO: N/A  
Repair Type: Non-Urgent  
EVAL Issue: 4b, Safety Issue  
Crossing Status: Found  
UCIP Comments: 04/22/2024 Record remains Non-Urgent. No cover was present on CMP riser causing a safety hazard; recommend adding a cover. Unsure why previous inspection describes crossing as being abandoned; crossing appears to still be operable. No permit has been identified authorizing pipe. DMP internal video inspection has found none or minor pipe defects. (M. Thao - DWR UCIP)  
08/06/2019 Record remains Non-Urgent, pipe has been abandoned. Crossing needs to be abandoned properly per Title 23. No owner has been identified for this irrigation pipe. Recommend adding cover to riser as a safety measure. DMP internal video inspection has not found pipe integrity issues. LOF of crossing is less or equal to 4. Recommend next video inspection in 5 years. (O. Magana - DWR UCIP, A. Freitag - DWR Sutter Yard)

WS view: CMP riser with no cover located on slope.

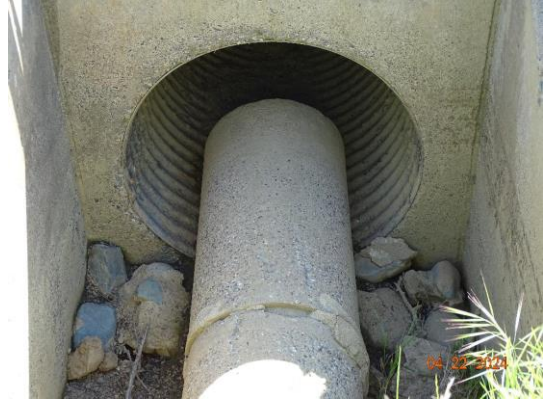
Photo 2 of 2 : UCIP\_SP\_2024\_83133\_121335.jpg

DS\_ID:17372  
FS\_ID:83133  
EP\_NO: N/A  
Repair Type: Non-Urgent  
EVAL Issue: 10, Unauthorized Modification or Non-Compliant Permit  
Crossing Status: Found  
UCIP Comments: 04/22/2024 Record remains Non-Urgent. 18-inch concrete pipe inserted partially into 36-inch CMP pipe at LS. Unable to find a permit for modification. DMP internal video inspection has found none or minor pipe defects. (M. Thao - DWR UCIP)  
08/06/2019 Record remains Non-Urgent, no permit identified authorizing pipe. Pipe has been internally cleaned and cleared of any obstructions on the WS and LS. DMP internal inspection pending. (O. Magana - DWR UCIP, A. Freitag - DWR Sutter Yard)  
06/14/2017 WS flap gate is completely buried by sediment - needs to be dug out. Pipe is about 50% full of sediment inside. Pipe has been selected to be internally cleaned and inspected as part of the DMP project. (A. Freitag - DWR Sutter Yard)

LS view: Close-up view of 18-inch concrete pipe inserted partially into 36-inch CMP pipe at the toe.

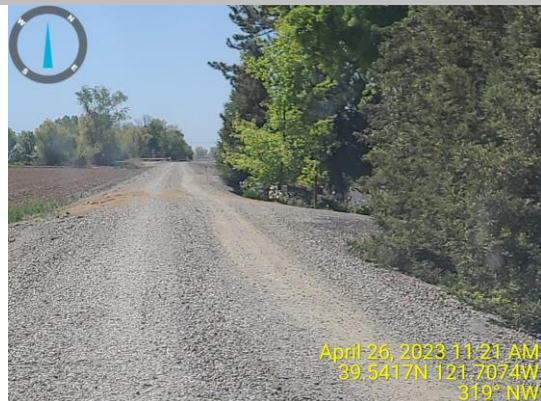
Photo 1 of 1 : SP\_2024\_MA0013\_300\_18\_20240212\_00005.jpg

View of the trees along the landside slope. Spring 2023.

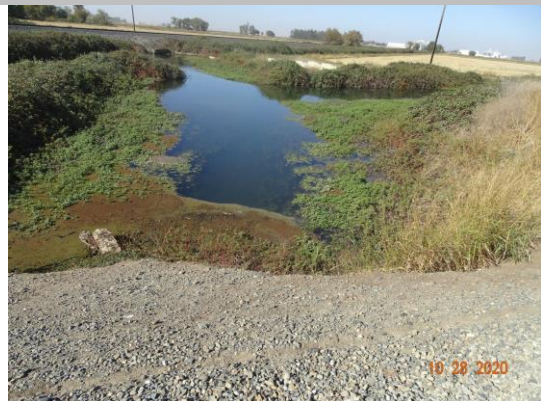
Photo 1 of 1 : SP\_2024\_MA0013\_300\_49\_20240212\_00006.jpg

View of the erosion site along the landside toe. Fall 2020.

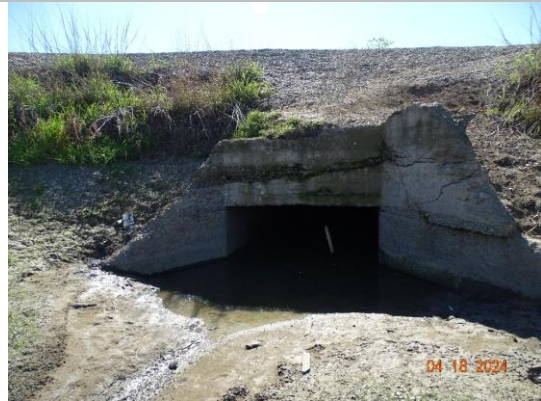
Photo 3 of 3 : UCIP\_SP\_2024\_83060\_121036.jpg

LS view: Damaged concrete headwall with erosion behind it.

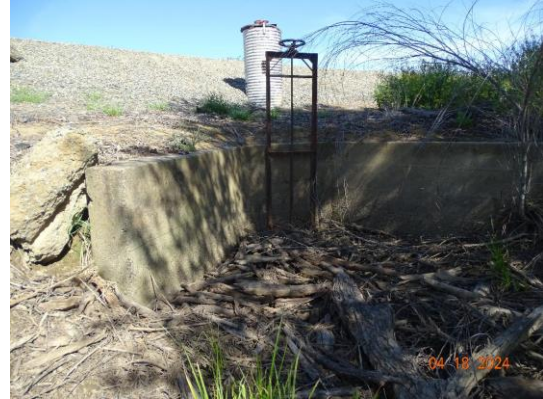
Photo 1 of 1 : UCIP\_SP\_2024\_83057\_121020.jpg

WS view: Debris drift wood buildup at slide gate located at the toe.

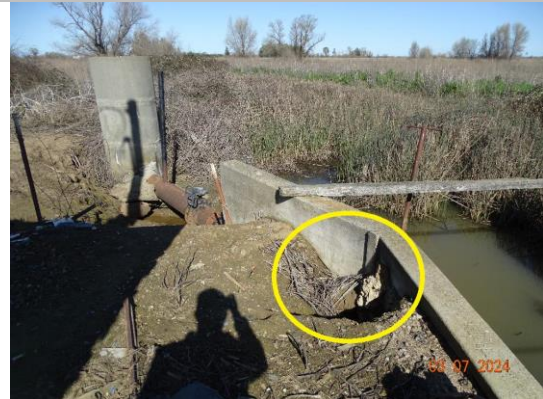
Photo 3 of 3 : UCIP\_SP\_2024\_82523\_119631.jpg

LS view: Minor erosion on downstream wingwall; looking away from levee.

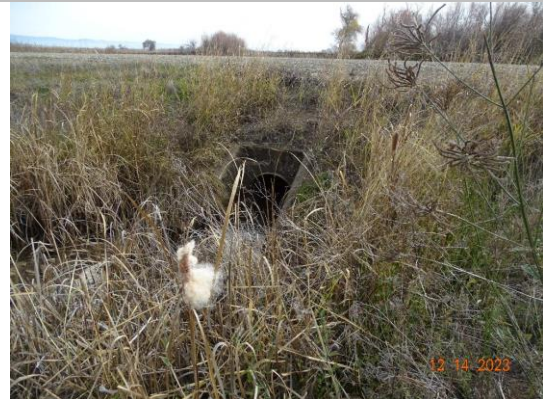
Photo 1 of 2 : UCIP\_SP\_2024\_82179\_119038.jpg

LS view: Concrete headwall with missing slide gate at toe.

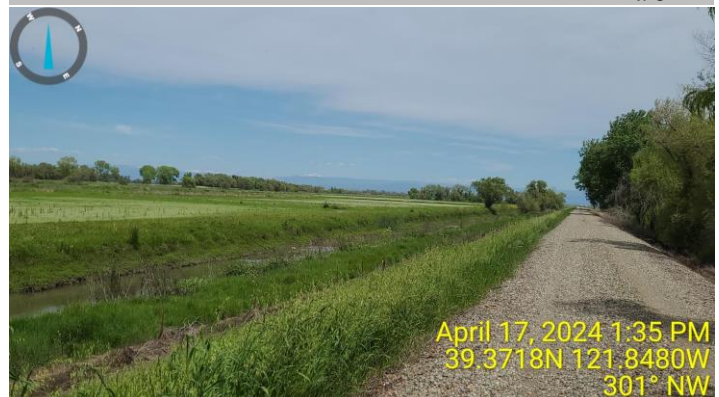
Photo 1 of 1 : SP\_2024\_MA0013\_301\_45\_20240422\_00119.jpg

View of the vegetation along the waterside slope. Spring 2024.

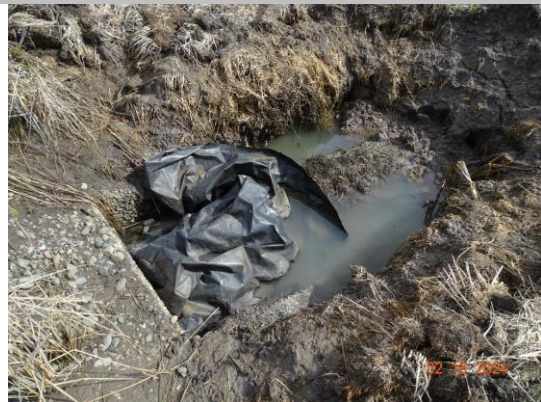
Photo 3 of 3 : UCIP\_SP\_2024\_82329\_119270.jpg

LS view: Close-up view of dammed up concrete headwall and pipe inlet; visqueen is present at pipe inlet.

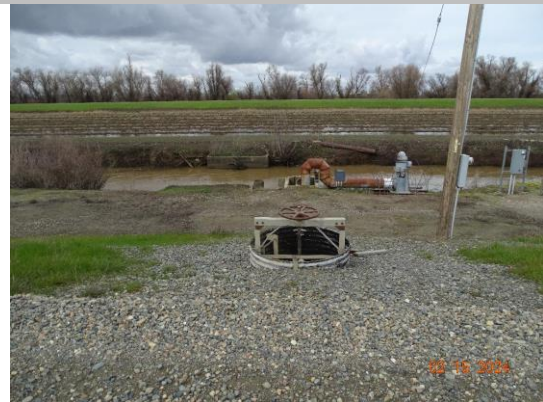
Photo 2 of 2 : UCIP\_SP\_2024\_82332\_119281.jpg

WS view: General overview looking from crown; CMP riser on slope missing cover.

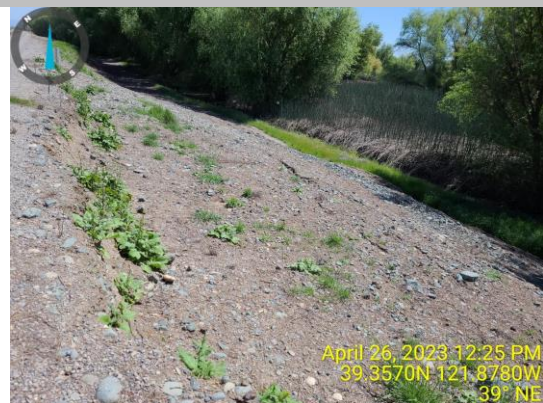
Photo 1 of 1 : SP\_2024\_MA0013\_301\_58\_20240212\_00009.jpg

View of the sloughing along the landside slope. Spring 2023.
