**Flood Control Project Maintenance  
Levee Inspections**

**Fall 2013 Levee Maintenance Deficiency Summary Report**

**Sutter Maintenance Yard Maintenance Area 0016**

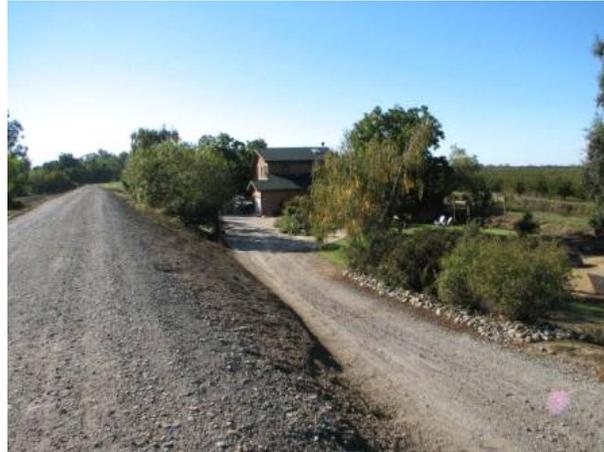
Levee Mile Report Line	4
Start Levee Mile	0.06
End Levee Mile	0.10
Location	Land Side
Category	Earthen Levee
Item	Vegetation

Levee mile 0.10. This photo shows the landscaping on the landside slope and toe.

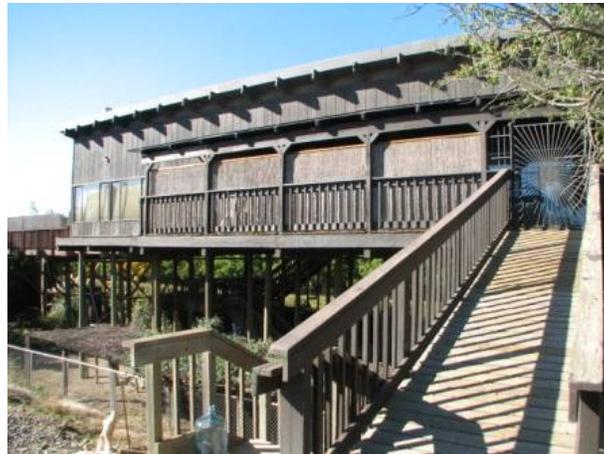
Levee Mile Report Line	5
Start Levee Mile	0.18
End Levee Mile	0.18
Location	Land Side
Category	Earthen Levee
Item	Encroachments

Levee mile 0.18. This photo shows the building on the landside shoulder and toe.

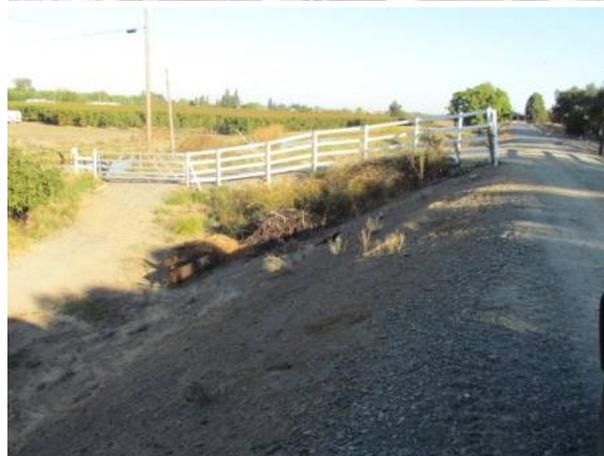
Levee Mile Report Line	7
Start Levee Mile	0.25
End Levee Mile	0.25
Location	Land Side
Category	Earthen Levee
Item	Encroachments

This photo was taken from the levee crown facing west looking down at a pile of prunings on the landward slope. Fall 2013.

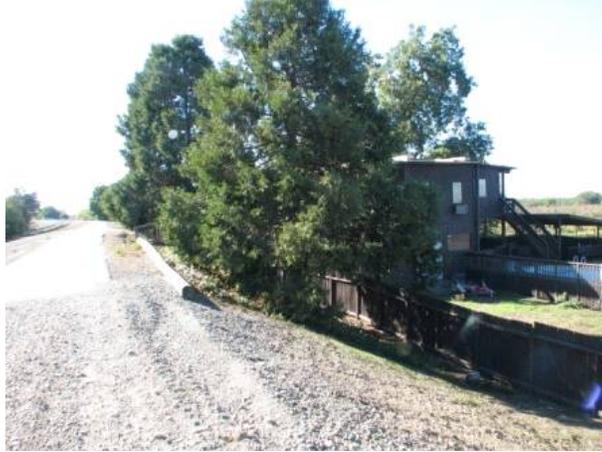
Levee Mile Report Line	8
Start Levee Mile	0.45
End Levee Mile	0.49
Location	Land Side
Category	Earthen Levee
Item	Encroachments

Levee mile 0.49. This photo shows the building and landscaping on the landside slope and toe.

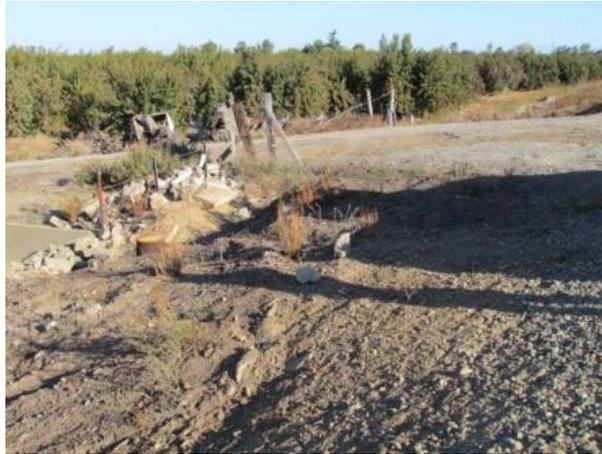
Levee Mile Report Line	9
Start Levee Mile	1.14
End Levee Mile	1.14
Location	Land Side
Category	Earthen Levee
Item	Encroachments

This photo was taken from the levee crown facing west looking down the landward slope at a power pole that was cut off approx. 1' above ground level. Fall 2013

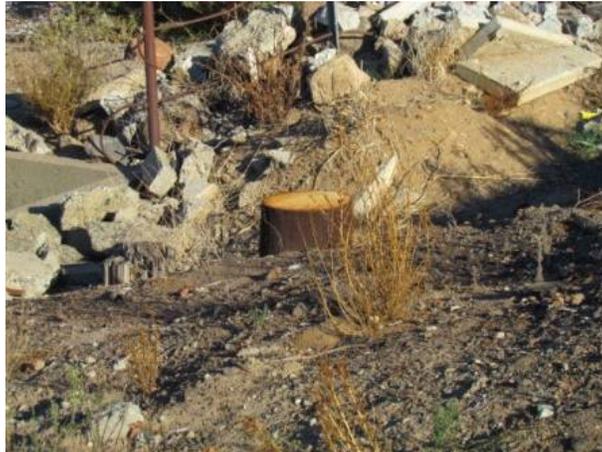
Levee Mile Report Line	9
Start Levee Mile	1.14
End Levee Mile	1.14
Location	Land Side
Category	Earthen Levee
Item	Encroachments

Close up of said power pole. Fall 2013

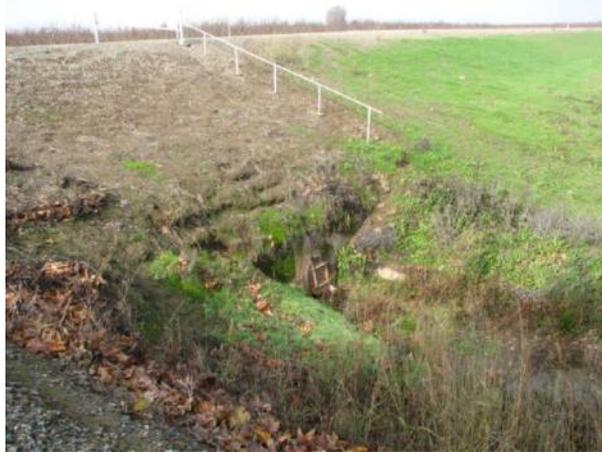
Levee Mile Report Line	11
Start Levee Mile	1.44
End Levee Mile	1.44
Location	Land Side
Category	Supplemental
Item	DWR UCIP Field Study

11	1.44	1.44	Supplemental	DWR UCIP Field Study	LS	M En	Inspector Comments: FS_ID:13227 EP_NO: N/A Repair Type: Non-Urgent Crossing Status: Found UCIP Comments: Inlet heavily vegetated may need to be cleared out.5/14/2013 SBFCA project recommends replacing in accordance with title 23.5/14/2013 Same as last inspection. FIELD_STRUCT_DESC: 36 inch steel drain pipe approximately 16-feet below the crown. Headwall and Model No. 100 flapgate of WS toe. Headwall and 24-inch concrete standpipe drop-inlet located approximately 1000-feet west of levee crown just on west side of canal. O&M Sac 148 Revision: February 2011 FS Date: 5/14/2013 12:30:52 PM	39.276170 ° -121.632598 ° 39.276170 ° -121.632598 °	6 Y
----	------	------	--------------	----------------------	----	---------	---	--	--------

WS headwall and flapgate at WS toe.

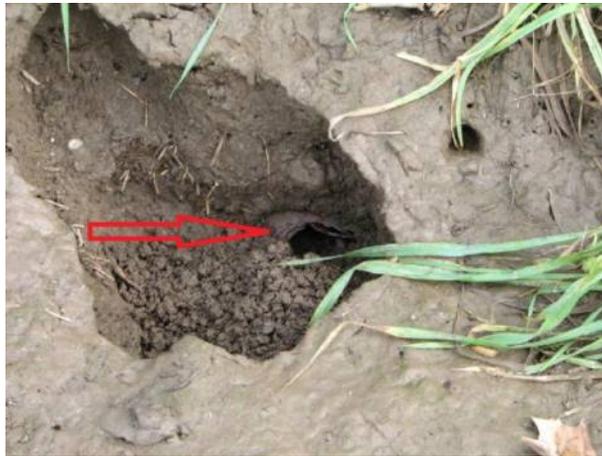
Levee Mile Report Line	13
Start Levee Mile	1.70
End Levee Mile	1.70
Location	Land Side
Category	Supplemental
Item	DWR UCIP Field Study

13	1.70	1.70	Supplemental	DWR UCIP Field Study	LS	M En	Inspector Comments: FS_ID:13229 EP_NO: N/A Repair Type: Non-Urgent Crossing Status: Found UCIP Comments: Pipe is partially buried at LS toe and shows heavy corrosion. Unable to locate headwalls on either side of levee. Pipe should be cleared of soil and inspected (suspect heavy corrosion throughout pipe).5/14/2013 SBFCA project recommends replacing in accordance with title 23.5/14/2013 Same as last inspection. FIELD_STRUCT_DESC: 12-inch CM Storm drain pipe through the levee 14.5 feet below the crown. Slide gate on the waterward end. (O&M entry-As built available 50-4-2193A). FS Date: 5/14/2013 12:33:49 PM	39.279812 ° -121.632987 ° 39.279812 ° -121.632987 °	9 Y
----	------	------	--------------	----------------------	----	---------	--	--	--------

Pipe at LS inlet showing heavy silt and corrosion of pipe.

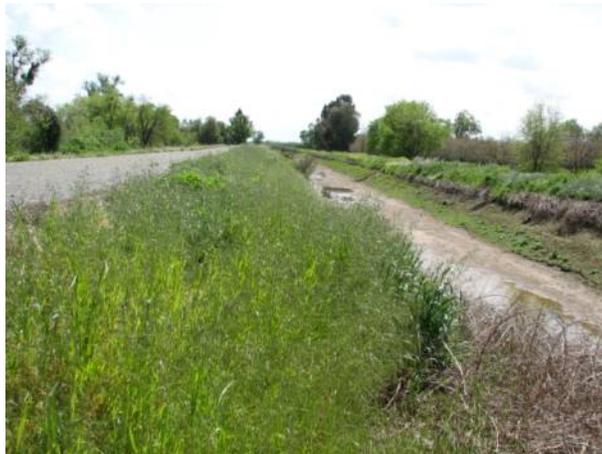
Levee Mile Report Line	16
Start Levee Mile	2.85
End Levee Mile	3.08
Location	Land Side
Category	Earthen Levee
Item	Encroachments

Land side ditch levee mile 3.08.

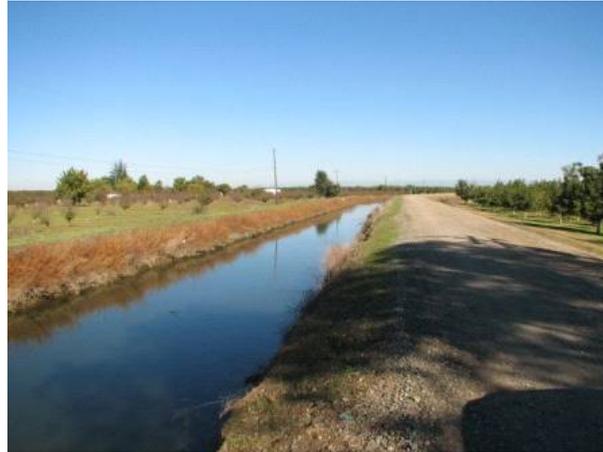
Levee Mile Report Line	16
Start Levee Mile	2.85
End Levee Mile	3.08
Location	Land Side
Category	Earthen Levee
Item	Encroachments
Agricultural ditch land side slope and toe.	
mhoffman_f_20130917_034.jpg

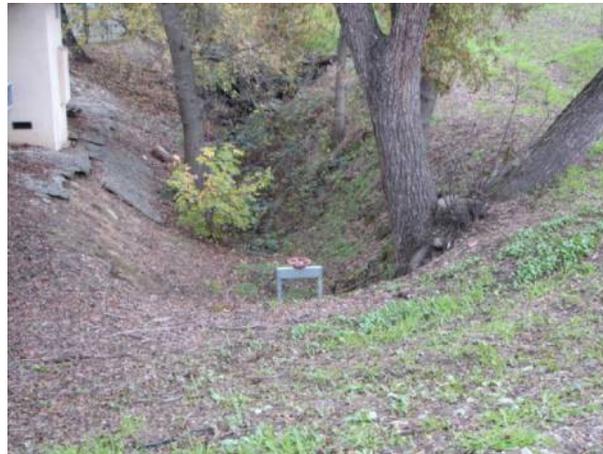
Levee Mile Report Line	18
Start Levee Mile	2.86
End Levee Mile	2.86
Location	Land Side
Category	Supplemental
Item	DWR UCIP Field Study
Slide gate at swale on WS toe.	
UCIP_7177.jpg

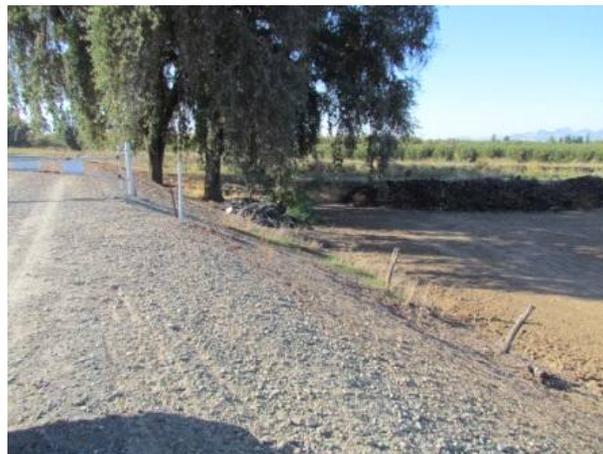
Levee Mile Report Line	20
Start Levee Mile	3.11
End Levee Mile	3.11
Location	Land Side
Category	Earthen Levee
Item	Encroachments
This photo was taken from the levee crown facing south looking down the landward slope at a pile of irrigation pipe. Fall 2013.	
mhoffman_f_20131028_673.JPG

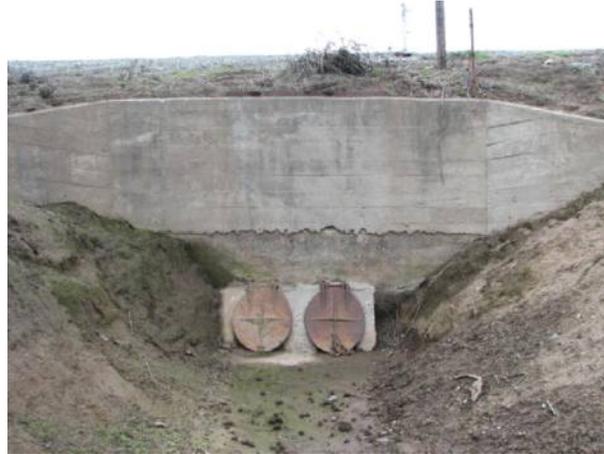
Levee Mile Report Line	22
Start Levee Mile	3.39
End Levee Mile	3.39
Location	Land Side
Category	Supplemental
Item	DWR UCIP Field Study

LMR No.	Levee Mile		Category	Item	Location	Rating	Action/Comment	GPS Latitude/Longitude		Issue No. Photo
	Start	End						Start	End	
22	3.39	3.39	Supplemental	DWR UCIP Field Study	LS	U En	Inspector Comments: FS_ID:8454 EP_NO: N/A Repair Type: Urgent Crossing Status: Found UCIP Comments: Concrete headwall on LS toe is cracked through middle and pipe is burried in soil. pipe appears corroded FIELD_STRUCT_DESC: 1 of 2: 24-inch CMP drain pipe 16.6-feet below the crown. Concrete headwalls on both ends. Flap gate on the waterward end. FS Date: 12/11/2012	39.301218 °	-121.638332 °	13 Y
DWR ID: DWR_MA0016_01_f_2013_13										
23	3.39	3.39	Supplemental	DWR UCIP Field Study	LS	M En	Inspector Comments: FS_ID:8458 EP_NO: N/A Repair Type: Non-Urgent Crossing Status: Indicator Found UCIP Comments: Pipe burried on LS toe and should be inspected along with adjacent 24-inch once uncovered. FIELD_STRUCT_DESC: 2 of 2: 24-inch CMP drain pipe through the levee 16.6-feet below the crown. Headwalls at both ends and a Flap gate on the WS toe. FS Date: 12/11/2012	39.301218 °	-121.638332 °	16

Headwall on WS toe with flap gates.

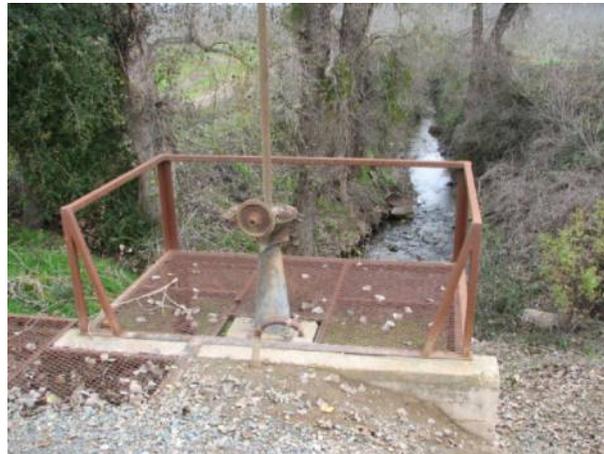
Levee Mile Report Line	26
Start Levee Mile	4.08
End Levee Mile	4.08
Location	Land Side
Category	Supplemental
Item	DWR UCIP Field Study

LMIR No.	Levee Mile		Category	Item	* Location	+ Rating	Action/Comment	GPS Latitude/Longitude		Issue No. Photo
	Start	End						Start	End	
26	4.08	4.08	Supplemental	DWR UCIP Field Study	LS	M	Inspector Comments: FS_ID:8457 EP_NO: N/A Repair Type: Non-Urgent Crossing Status: Found UCIP Comments: Lock missing from concrete well access door-this should be resplaced. Some debris blocking preventing flapgate from completely closing. FIELD_STRUCT_DESC: 4-foot by 6-foot concrete culvert through the levee, 20.5 feet below the crown. Slide gate in concrete well on waterward slope. Siphon breaker/air vent on WS shoulder at concrete well. FS Date: 12/11/2012	39.311127 °	-121.637606 °	19 Y

Slide gate, concrete well, siphon breaker/air vent and open channel on WS of levee.
