**Flood Control Project Maintenance
Levee Inspections**

**Fall 2015 Levee Maintenance Deficiency Summary Report
Overall LMA & Unit Ratings, including USACE Erosion Survey**

Sacramento River Basin

Sutter Maintenance Yard Maintenance Area 0016

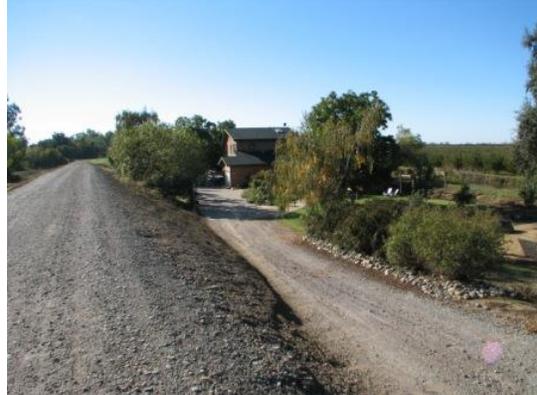
Photo 1 of 1 : FA_2015_MA0016_302_2_20151109_00001.jpg

LM Start	0.06	Rating **	M	Issue No.	2
LM End	0.10	Issue Type +	En	Location *	LS
Category	Earthen Levee		GPS Latitude/Longitude		
			Start	End	
Item	Vegetation		39.256618 °	39.257228 °	
			-121.636442 °	-121.636462 °	
DWR ID	DWR_MA0016_01_s_2012_2				
Action/Comments					
Landscaping

This photo shows the landscaping on the landside slope and toe.

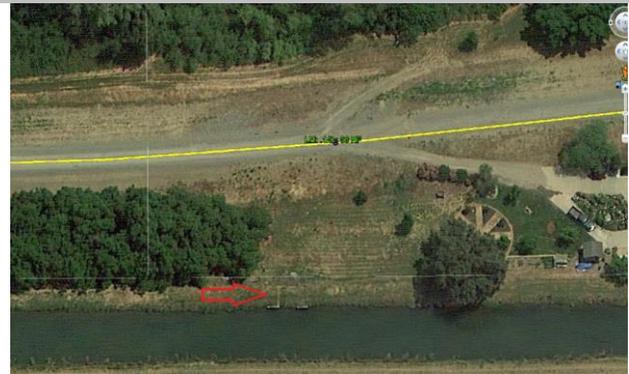
Photo 1 of 1 : UCIP_FA_2015_6028.jpg

LM Start	0.11	Rating **	M	Issue No.	26
LM End	0.11	Issue Type +	En	Location *	LS
Category	Supplemental		GPS Latitude/Longitude		
			Start	End	
Item	DWR UCIP Field Study		39.257308 °	39.257308 °	
			-121.636582 °	-121.636582 °	
DWR ID					
Action/Comments					
Inspector Comments: FS_ID:45934 DS_ID:17180 EP_NO: 4556 FS_HLM: 0.11 Repair Type: Non-Urgent Crossing Status: Indicator Found UCIP Comments: 6/8/2015 Unable to locate.2/11/2015: Revised Location and added arial photo showing U-shaped concrete headwall on LS toe. Pipe should be completely removed from levee. Unable to locate any evidence of crossing 12/11/12.11/6/2013 Unable to locate.5/19/2014 SBFCFA project had levee access blocked. Could not get to pipe.12/29/2014 Access bocked due to SBFCFA project. FIELD_STRUCT_DESC: *ABANDONED* 36 inch CMP drainpipe through the levee 22-feet below the crown. Concrete U-shaped headwall on LS toe. Originally included in O+M manual at 473+30. Pipe was abandoned in place and a concrete plug was installed in WS slope after pipe failed in 1964 under permit No. 4556. FS Date: 06/16/2015

Arial photo showing location of Concrete headwall on LS toe.

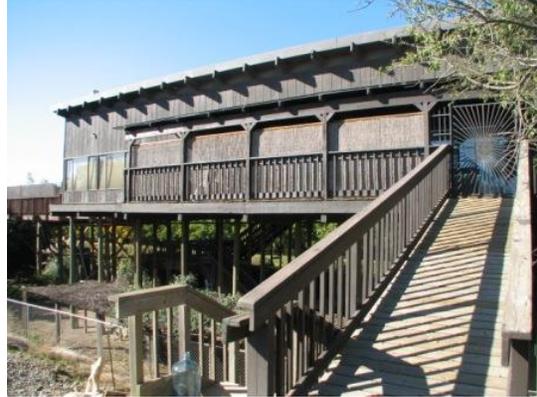
Photo 1 of 1 : FA_2015_MA0016_302_15_20151109_00005.jpg

LM Start	0.18	Rating **	M	Issue No.	15
LM End	0.18	Issue Type +	En	Location *	LS
Category	Earthen Levee		GPS Latitude/Longitude		
			Start	End	
Item	Encroachments		39.258437 °	39.258437 °	
			-121.636613 °	-121.636613 °	
DWR ID	DWR_MA0016_01_s_2012_15				
Action/Comments					
Building

Levee mile 0.18. This photo shows the building on the landside shoulder and toe.

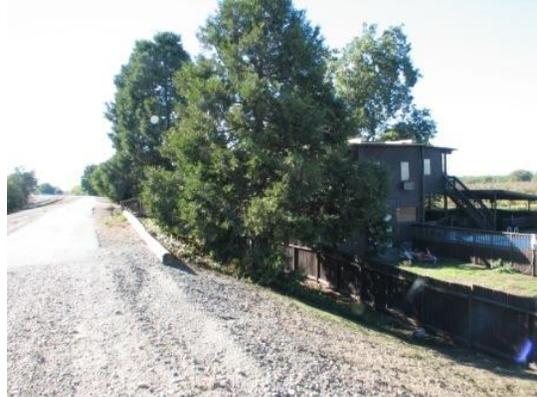
Photo 1 of 1 : FA_2015_MA0016_302_7_20151109_00002.jpg

LM Start	0.44	Rating **	U	Issue No.	7
LM End	0.49	Issue Type +	En	Location *	LS
Category	Earthen Levee		GPS Latitude/Longitude		
			Start	End	
Item	Encroachments		39.262213 °	39.262825 °	
			-121.636545 °	-121.636430 °	
DWR ID	DWR_MA0016_01_s_2012_7				
Action/Comments					
Building

Levee mile 0.49. This photo shows the building and landscaping on the landside slope and toe.

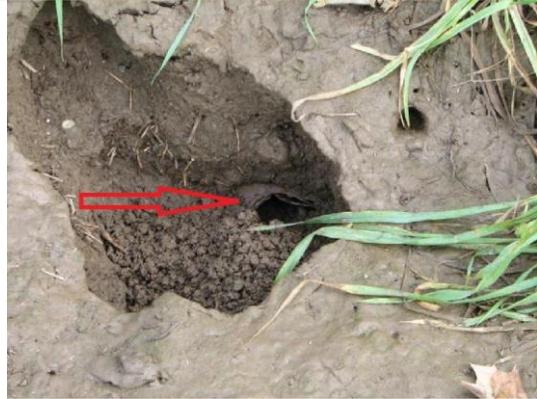
Photo 1 of 2 : UCIP_FA_2015_5416.jpg

Inspector Comments: FS_ID:45938
 DS_ID:17129
 EP_NO: N/A
 FS_HLM: 1.696
 Repair Type: Non-Urgent
 Crossing Status: Found
 UCIP Comments: 6/8/2015 SBFCA project recommended replacing this pipe but after completion of the project in this area i was unable locate any signs of this crossing.Pipe is partially buried at LS toe and shows heavy corrosion. Unable to locate headwalls on either side of levee. Pipe should be cleared of soil and inspected (suspect heavy corrosion throughout pipe).5/14/2013 SBFCA project recommends replacing in accordance with title 23.5/14/2013 Same as last inspection.11/6/2013 Same as last inspection.5/19/2014 SBFCA project had levee access blocked. Could not get to pipe.12/29/2014 Access bocked due to SBFCA project.
 FIELD_STRUCT_DESC: 12-inch CM Storm drain pipe through the levee 14.5 feet below the crown. Slide gate on the waterward end. (O&M entry-As builds available 50-4-2193A).

Pipe at LS inlet showing heavy silt and corrosion of pipe.

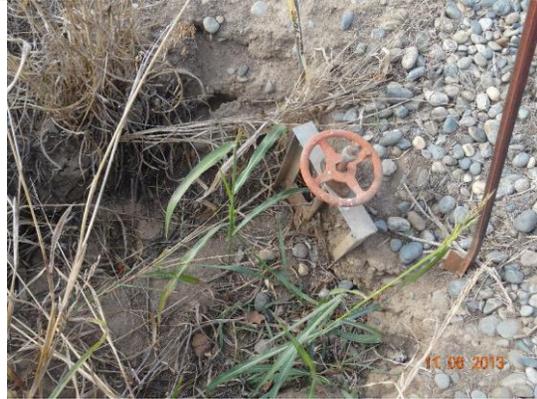
Photo 2 of 2 : UCIP_FA_2015_5417.jpg

LM Start	1.69	Rating **	M	Issue No.	27 (cont)
LM End	1.69	Issue Type +	En	Location *	WS
Category	Supplemental			GPS Latitude/Longitude	
				Start	End
Item	DWR UCIP Field Study			39.279812 °	39.279812 °
				-121.632987 °	-121.632987 °
DWR ID					
Action/Comments					
Inspector Comments: FS_ID:45938 DS_ID:17129 EP_NO: N/A FS_HLM: 1.696 Repair Type: Non-Urgent Crossing Status: Found UCIP Comments: 6/8/2015 SBFCA project recommended replacing this pipe but after completion of the project in this area i was unable locate any signs of this crossing. Pipe is partially buried at LS toe and shows heavy corrosion. Unable to locate headwalls on either side of levee. Pipe should be cleared of soil and inspected (suspect heavy corrosion throughout pipe). 5/14/2013 SBFCA project recommends replacing in accordance with title 23.5/14/2013 Same as last inspection. 11/6/2013 Same as last inspection. 5/19/2014 SBFCA project had levee access blocked. Could not get to pipe. 12/29/2014 Access bocked due to SBFCA project. FIELD_STRUCT_DESC: 12-inch CM Storm drain pipe through the levee 14.5 feet below the crown. Slide gate on the waterward end. (O&M entry-As built available 50-4-2193A). FS Date: 06/16/2015

screwgate and headwall found on LS

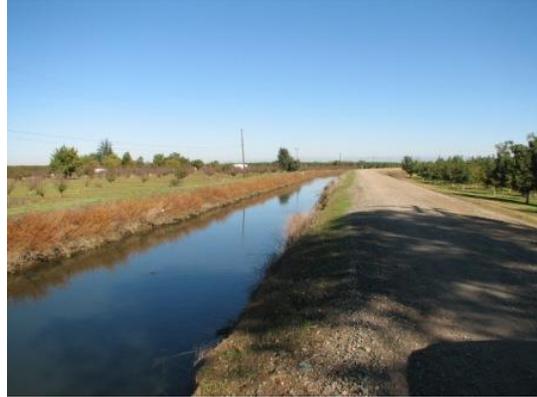
Photo 1 of 1 : FA_2015_MA0016_302_14_20151109_00003.jpg

LM Start	2.85	Rating **	M	Issue No.	14
LM End	3.08	Issue Type +	En	Location *	LS
Category	Earthen Levee		GPS Latitude/Longitude		
			Start	End	
Item	Encroachments		39.293675 °	39.296748 °	
			-121.636615 °	-121.638192 °	
DWR ID	DWR_MA0016_01_s_2012_14				
Action/Comments					
Ditch

Agricultural ditch land side slope and toe.

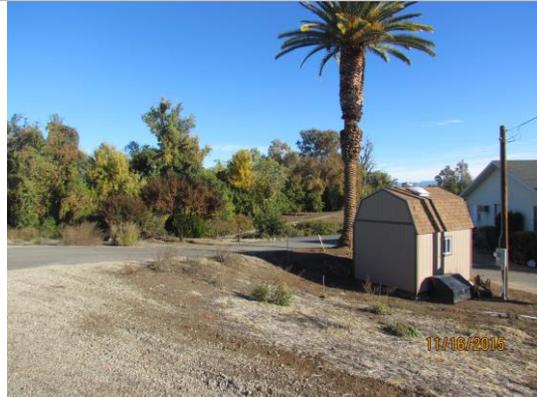
Photo 1 of 1 : FA_2015_MA0016_302_25_20151118_00006.jpg

LM Start	2.86	Rating **	M	Issue No.	25
LM End	2.86	Issue Type +	En	Location *	WS
Category	Earthen Levee		GPS Latitude/Longitude		
			Start	End	
Item	Vegetation		39.293865 °	39.293865 °	
			-121.636690 °	-121.636690 °	
DWR ID	DWR_MA0016_01_f_2013_25				
Action/Comments					
Landscaping Inspector Comments: Remove the landscape from the waterside slope.

View of the landscape along the waterside slope.

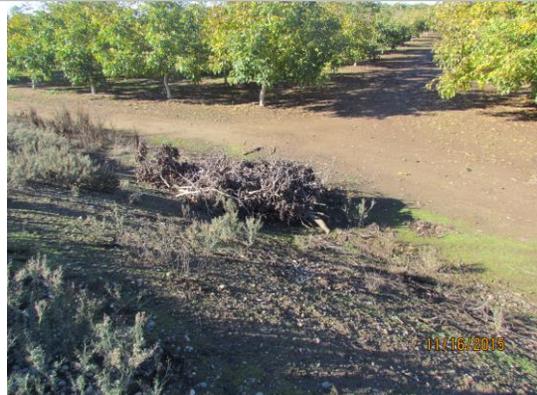
Photo 1 of 1 : FA_2015_MA0016_302_23_20151118_00007.jpg

LM Start	3.27	Rating **	M	Issue No.	23
LM End	3.27	Issue Type +	En	Location *	WS
Category	Earthen Levee		GPS Latitude/Longitude		
			Start	End	
Item	Encroachments		39.299516 °	39.299516 °	
			-121.638335 °	-121.638335 °	
DWR ID	DWR_MA0016_01_s_2015_23				
Action/Comments					
Prunings Inspector Comments: Remove the prunings from the landside toe.

View of the prunings along the landside toe.

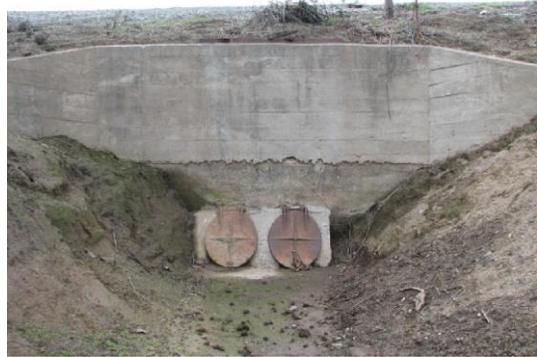
Photo 1 of 2 : UCIP_FA_2015_5418.jpg

LM Start	3.39	Rating **	M	Issue No.	28
LM End	3.39	Issue Type +	En	Location *	WS
Category	Supplemental			GPS Latitude/Longitude	
				Start	End
Item	DWR UCIP Field Study			39.301218 °	39.301218 °
				-121.638332 °	-121.638332 °
DWR ID					
Action/Comments					
Inspector Comments: FS_ID:45943 DS_ID:17183 EP_NO: N/A FS_HLM: 3.39 Repair Type: Non-Urgent Crossing Status: Indicator Found UCIP Comments: 6/8/2015 Concrete headwall is still cracked and inlet is buried. It was said to be replaced with the SBFCA project but the project skipped over in this area. Pipe buried on LS toe and should be inspected along with adjacent 24-inch once uncovered. 5/14/2013 SBFCA project recommends replacing in accordance with title 23.5/14/2013 Same as last inspection. 11/6/2013 Same as last inspection. 5/19/2014 Same as last inspection. 12/29/2014 Same as last inspection. FIELD_STRUCT_DESC: 2 of 2: 24-inch CMP drain pipe through the levee 16.6-feet below the crown. Headwalls at both ends and a Flap gate on the WS toe. FS Date: 06/16/2015

Headwall and flap gate on WS toe.

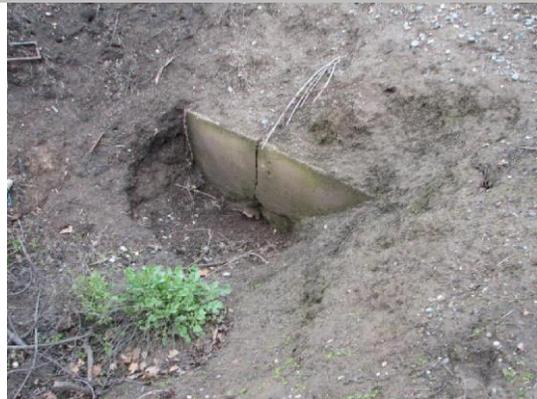
Photo 2 of 2 : UCIP_FA_2015_5419.jpg

Pipe should be located on either side of the one visible in this picture.
