**Flood Control Project Maintenance  
Levee Inspections  
LMA District Cover Sheet  
Spring 2013 Levee Inspection Results**

**Sutter Maintenance Yard Maintenance Area 0016**

**Levee Inspection Report By Mile - Spring 2013**

Waterway	Bank	Unit Miles	Inspection Start/End	Inspector
Unit No. 01 Feather River	Right	4.09	03/26/2013 03/26/2013	Rick Burnett

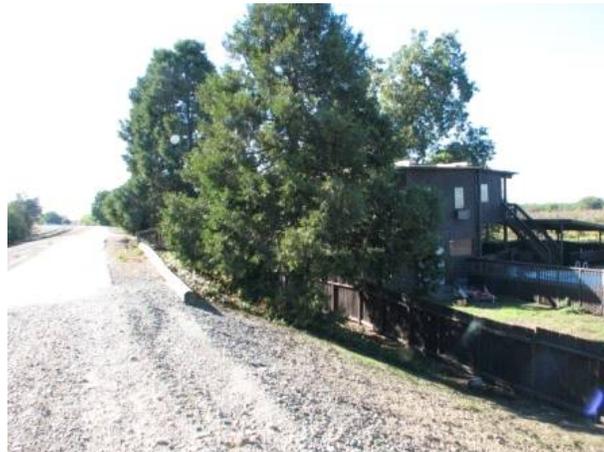
Levee Mile Report Line	6
Start Levee Mile	0.45
End Levee Mile	0.49
Location	Land Side
Category	
Item	Encroachments
Levee mile 0.49. This photo shows the building and landscaping on the landside slope and toe.	
jhirabay_s_20130314_024.jpg

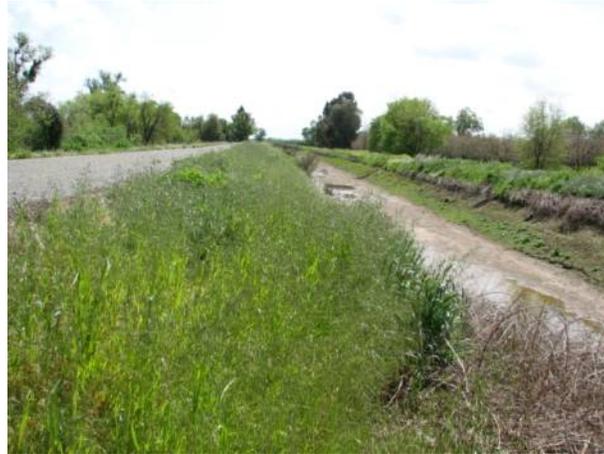
DWR ID: DWR_MA0016_01_s_2013_1										
8	2.85	3.08		Encroachments	LS	M En	DT : Ditch	39.293675 ° -121.636615 °	39.296748 ° -121.638192 °	14 Y
DWR ID: DWR_MA0016_01_s_2012_14

Levee Mile Report Line	8
Start Levee Mile	2.85
End Levee Mile	3.08
Location	Land Side
Category	
Item	Encroachments
Land side ditch levee mile 3.08.	
jhirabay_s_20130314_025.jpg

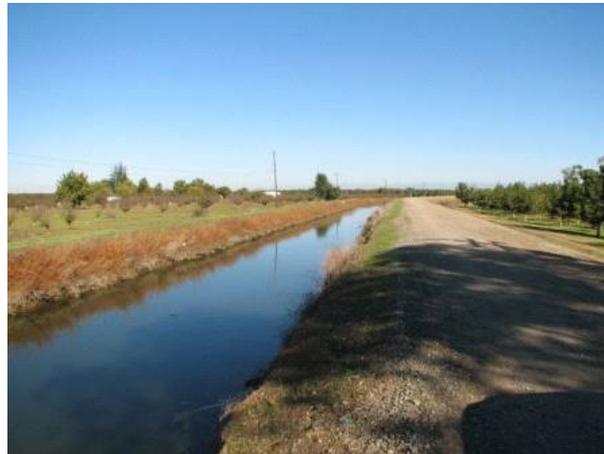
Levee Mile Report Line	8
Start Levee Mile	2.85
End Levee Mile	3.08
Location	Land Side
Category	
Item	Encroachments
AG ditch land side slope and toe.	
jhirabay_s_20130314_026.jpg
