**Flood Control Project Maintenance  
Levee Inspections**

**Maintenance Issue Types Only, Levee Inspection Report By Mile - Fall 2014**

**Sutter Maintenance Yard Maintenance Area 0016**

Waterway	Bank	Unit Miles	Inspection Start/End	Inspector
Unit No. 01 Feather River	Right	4.06	11/19/2014 11/19/2014	Matthew Hoffman

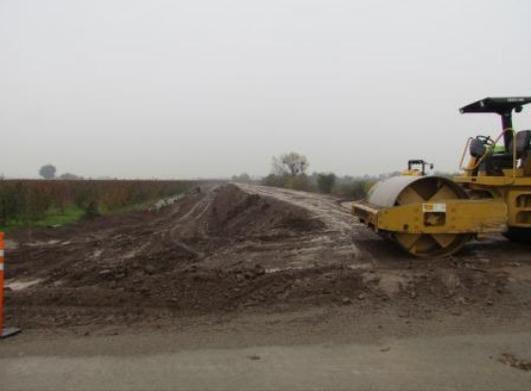
Photo 1 of 1 : FA\_2014\_MA0016\_302\_13\_20141124\_00008.jpg

LM Start	<b>0.00</b>	Rating **	A/W	Issue No.	<b>13</b>
LM End	<b>4.09</b>	Issue Type +	Ma	Location *	CR
Category	Earthen Levee		GPS Latitude/Longitude		
			Start	End	
Item	Encroachments		°	°	
			°	°	
DWR ID	DWR_MA0016_01_f_2014_13				
Action/Comments					
Material

This photo was taken from the crown facing north looking at the levee currently under construction and unable to inspect. Fall 2014.
