**Flood Control Project Maintenance
Levee Inspections**

Fall 2010 Levee Maintenance Deficiency Summary Report

Sutter Maintenance Yard Maintenance Area 0017

Waterway	Bank	Unit Miles
Unit No. 01 Lake County Sutter Maintenance Yard - Middle Creek	Left	3.90

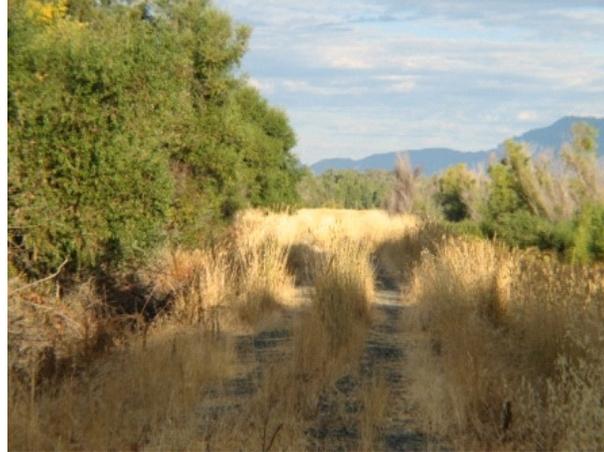
Levee Mile Report Line	1
Start Levee Mile	4.18
End Levee Mile	7.30
Location	Water Side
Category	Earthen Levee
Item	Trim / Thin Trees
View of the trees on the waterside slope of the Levee.	
rduffey_f_20101109_250.jpg

LMR No.	Levee Mile		Category	Item	* Location	** Rating	Action/Comment	GPS Latitude/Longitude		Issue No. Photo
	Start	End						Start	End	
1	4.18	7.30	Earthen Levee	Trim / Thin Trees	WS	U	Thin trees to allow visibility of the ground and room to flood fight.	39.142155 ° -122.902343 °	39.118735 ° -122.884892 °	2 Y
2	4.18	7.31	Earthen Levee	Vegetation	WS	U	Remove the wild growth other than native grasses from the levee slopes.	39.142155 ° -122.902343 °	39.118675 ° -122.884772 °	1 Y

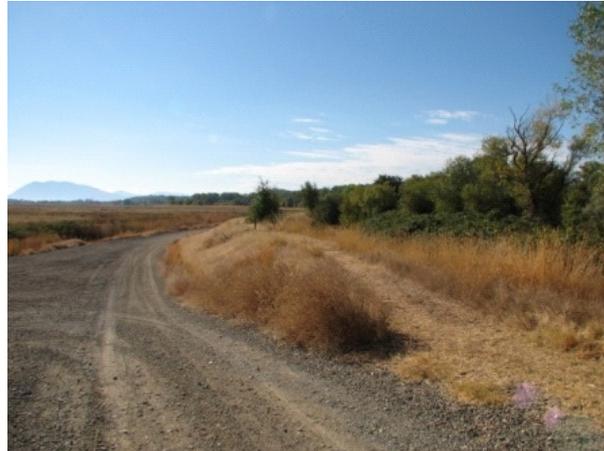
Levee Mile Report Line	2
Start Levee Mile	4.18
End Levee Mile	7.31
Location	Water Side
Category	Earthen Levee
Item	Vegetation
View of the six-foot crown levee & heavy vegetation on waterside slope.	
rduffey_f_20101109_248.jpg

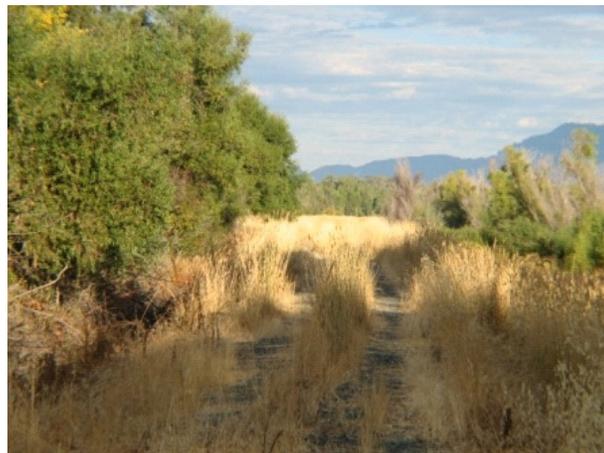
Levee Mile Report Line	2
Start Levee Mile	4.18
End Levee Mile	7.31
Location	Water Side
Category	Earthen Levee
Item	Vegetation
View of the vegetation on the both slopes of the levee.	
rduffey_f_20101109_249.jpg
