**Flood Control Project Maintenance
Levee Inspections
LMA District Cover Sheet
Spring 2011 Levee Inspection Results**

Spring 2011 Levee Inspection Results

Sutter Maintenance Yard Maintenance Area 0017

Waterway		Bank	Unit Miles
Unit No. 01 Lake County Sutter Maintenance Yard - Middle Creek		Left	3.90

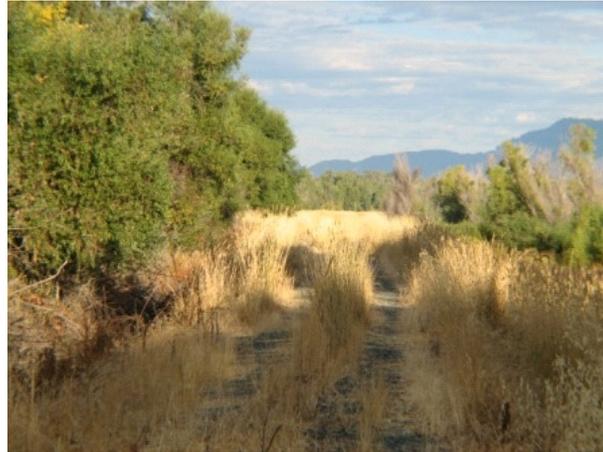
Levee Mile Report Line	1
Start Levee Mile	4.18
End Levee Mile	7.30
Location	Water Side
Category	Earthen Levee
Item	Trim / Thin Trees
View of the trees on the waterside slope of the Levee.	
rduffey_s_20110228_060.jpg

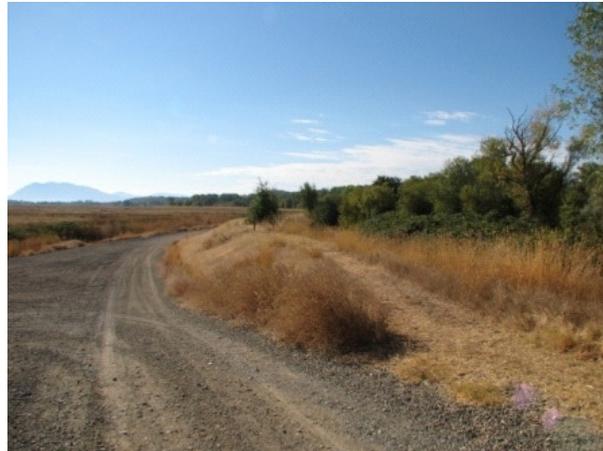
Levee Mile Report Line	2
Start Levee Mile	4.18
End Levee Mile	7.31
Location	Water Side
Category	Earthen Levee
Item	Vegetation
View of the six-foot crown levee & heavy vegetation on waterside slope.	
rduffey_s_20110228_058.jpg

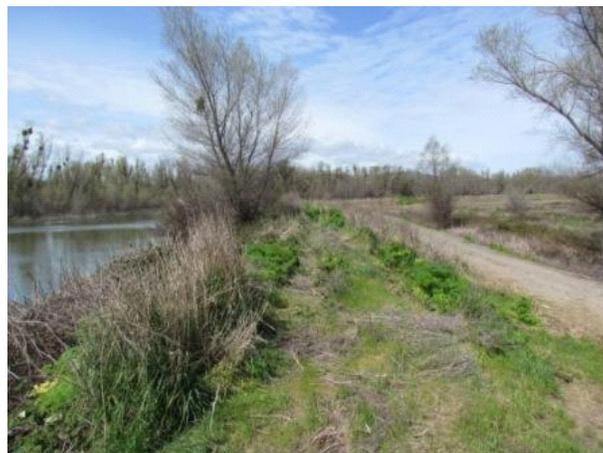
Levee Mile Report Line	3
Start Levee Mile	4.18
End Levee Mile	7.30
Location	Land Side
Category	Earthen Levee
Item	Vegetation
View of the vegetation on the both slopes & crown.	
rduffey_s_20110419_257.jpg
