**Flood Control Project Maintenance
Levee Inspections**
LMA District Cover Sheet
Spring 2014 Levee Inspection Results

Sutter Maintenance Yard Maintenance Area 0017

Waterway		Bank	Unit Miles
Unit No. 01 Lake County Sutter Maintenance Yard - Middle Creek		Left	3.90

Levee Inspection Report By Mile - Spring 2014

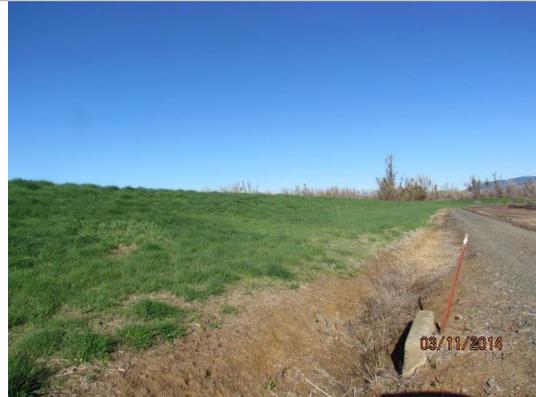
Photo 1 of 1 : rduffey_s_20140317_114.jpg

LM Start	3.42	Rating **	A	Issue No.	3
LM End	7.32	Issue Type +	Ma	Location *	LS
Category	Earthen Levee		GPS Latitude/Longitude		
			Start	End	
Item	Vegetation		39.149126 °	39.118708 °	
			-122.912345 °	-122.884834 °	
DWR ID	DWR_MA0017_01_s_2012_3				
Action/Comments					
Control annual grass and weeds on the levee slopes and easements.

View of the native grasses along the landside slope.

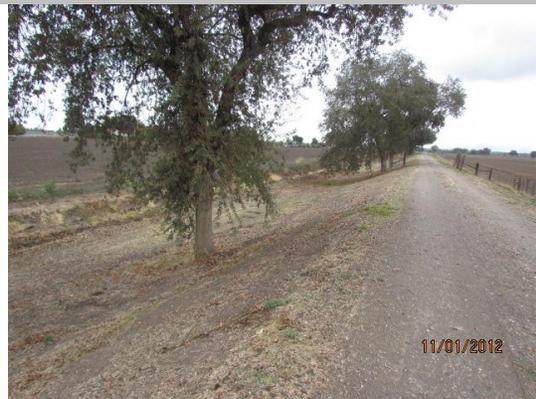
Photo 1 of 1 : rduffey_s_20140304_508.jpg

LM Start	4.18	Rating **	U	Issue No.	2
LM End	7.30	Issue Type +	Ma	Location *	WS
Category	Earthen Levee		GPS Latitude/Longitude		
			Start	End	
Item	Trim / Thin Trees		39.142155 °	39.118735 °	
			-122.902343 °	-122.884892 °	
DWR ID	DWR_MA0017_01_s_2012_2				
Action/Comments					
Thin trees to allow visibility of the ground and room to flood fight.

View of the trees on the waterside slope of the Levee.

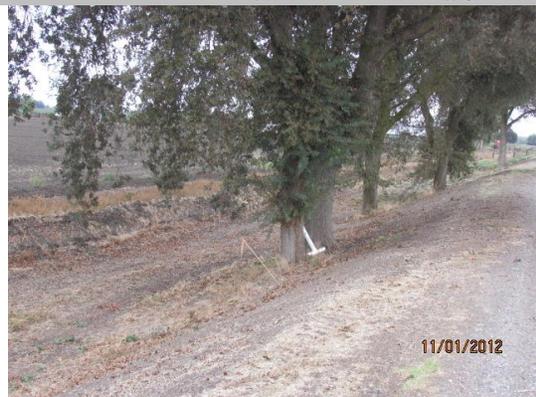
Photo 1 of 1 : rduffey_s_20140304_507.jpg

LM Start	4.18	Rating **	U	Issue No.	1
LM End	7.31	Issue Type +	Ma	Location *	WS
Category	Earthen Levee		GPS Latitude/Longitude		
			Start	End	
Item	Vegetation		39.142155 °	39.118675 °	
			-122.902343 °	-122.884772 °	
DWR ID	DWR_MA0017_01_s_2012_1				
Action/Comments					
Remove the wild growth other than native grasses from the levee slopes.

View of the six-foot crown levee & heavy vegetation on waterside slope.

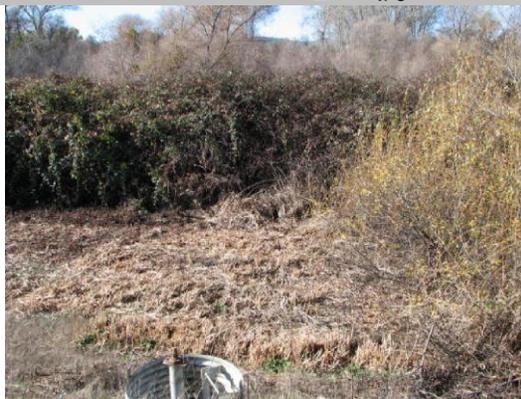
Photo 1 of 1 : UCIP_5042.jpg

LM Start	4.28	Rating **	M	Issue No.	4
LM End	4.28	Issue Type +	En	Location *	WS
Category	Supplemental		GPS Latitude/Longitude		
			Start	End	
Item	DWR UCIP Field Study		39.140422 °	39.140422 °	
			-122.902022 °	-122.902022 °	
DWR ID	DWR_MA0017_01_s_2014_4				
Action/Comments					
Inspector Comments: FS_ID:25867 EP_NO: N/A Repair Type: Crossing Status: UCIP Comments: No lid on riser-may or may not be an issue 6/2/2013 Same as last inspection 12/23/2013 Same as last inspection. FIELD_STRUCT_DESC: 24-inch CMP drainpipe through the levee, 19 feet below the crown. Slide gate in 36-inch CMP riser on the waterward slope (USCE 1909). FS Date: 12/31/2013 9:49:50 AM

Slide gate in CMP riser on WS slope.

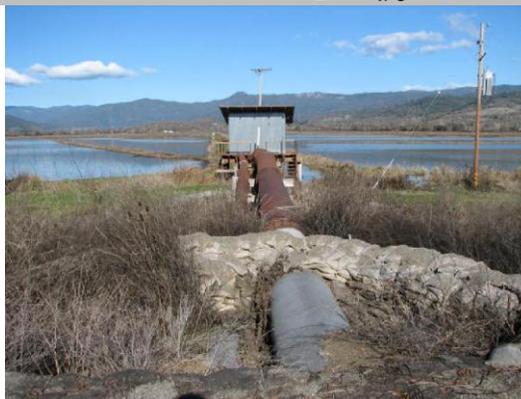
Photo 1 of 1 : UCIP_5044.jpg

LM Start	5.38	Rating **	M	Issue No.	11
LM End	5.38	Issue Type +	En	Location *	WS
Category	Supplemental			GPS Latitude/Longitude	
				Start	End
Item	DWR UCIP Field Study			39.127449 °	39.127449 °
				-122.893460 °	-122.893460 °
DWR ID	DWR_MA0017_01_s_2014_11				
Action/Comments					
Inspector Comments: FS_ID:25871 EP_NO: 11469 Repair Type: Crossing Status: UCIP Comments: flood fight materials-ring levees around both LS and WS slopes at pipe crossing. This may or may not be an issue 2/2/2013 Same as last inspection 12/23/2013 Same as last inspection. FIELD_STRUCT_DESC: 1 of 2: 16 inch steel drainpipe through the levee 5-feet below the crown. Drainage pumping plant on the landward side. Flap gate on the waterward end. (ABO No.11469-R.D.# 2070). This entry matches the Drainage/Irrigation Structure referenced in O&M manual (Levee Mile 5.43). Permit document and O&M referred As-built drawings are available. O&M manual Vol. 5, Revision Year 2010. FS Date: 12/31/2013 9:50:25 AM

Pumping plant, pipes, and ring levees on LS toe.

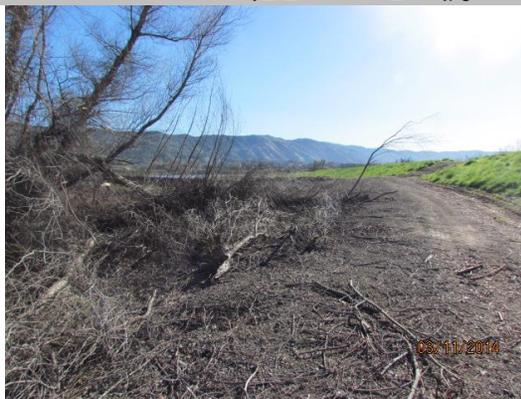
Photo 1 of 1 : rduffey_s_20140317_113.jpg

LM Start	5.39	Rating **	M	Issue No.	18
LM End	5.39	Issue Type +	En	Location *	LS
Category	Earthen Levee			GPS Latitude/Longitude	
				Start	End
Item	Encroachments			39.127544 °	39.127544 °
				-122.893763 °	-122.893763 °
DWR ID	DWR_MA0017_01_s_2014_18				
Action/Comments					
Tree or limb

View of the down tree along the landside toe.

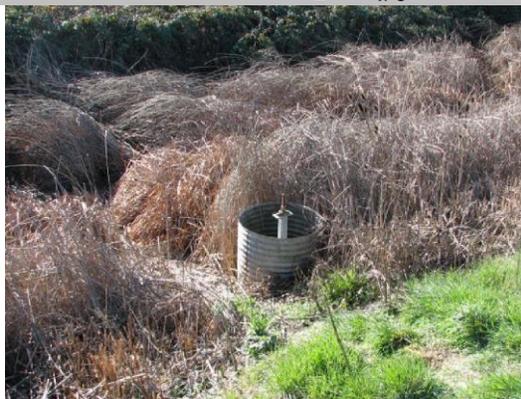
Photo 1 of 1 : UCIP_5050.jpg

LM Start	5.81	Rating **	M	Issue No.	12
LM End	5.81	Issue Type +	En	Location *	LS
Category	Supplemental			GPS Latitude/Longitude	
				Start	End
Item	DWR UCIP Field Study			39.127612 °	39.127612 °
				-122.885520 °	-122.885520 °
DWR ID	DWR_MA0017_01_s_2014_12				
Action/Comments					
Inspector Comments: FS_ID:25886 EP_NO: 11457 Repair Type: Crossing Status: UCIP Comments: No cover on CMP riser and no handle for actuating gate. This may or may not be an issue 6/2/2013 Handle to operate gate was in place but still no cover on riser 2/23/2013 Same as last inspection. FIELD_STRUCT_DESC: 24-inch drainpipe under patrol road and through the levee, 13.5 feet below the crown. Concrete "U" shaped headwall on the landward end. Slide gate in 36-inch CMP riser on the waterward slope. Riser unit is mounted on concrete base. (ABO No.11457-Crawford). O&M manual Vol. 5, Revision Year 2010 FS Date: 12/31/2013 9:52:44 AM

36-inch CMP riser and slide gate on WS slope.

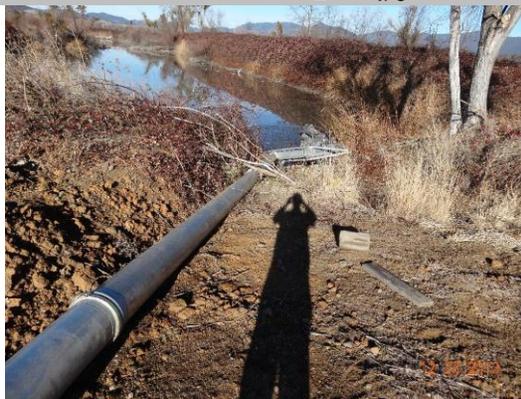
Photo 1 of 1 : UCIP_5268.jpg

LM Start	6.02	Rating **	M	Issue No.	13
LM End	6.02	Issue Type +	En	Location *	LS
Category	Supplemental			GPS Latitude/Longitude	
				Start	End
Item	DWR UCIP Field Study			39.126057 °	39.126057 °
				-122.883096 °	-122.883096 °
DWR ID	DWR_MA0017_01_s_2014_13				
Action/Comments					
Inspector Comments: FS_ID:26394 EP_NO: N/A Repair Type: Crossing Status: UCIP Comments: No permit for crossing 6/2/2013 Same as last inspection 12/23/2013 No signs of 12" pvc. Portable tow-pump was lowered down on waterside with 12" pipe ran over roadway. FIELD_STRUCT_DESC: 12-inch HDPE storm drain pipe through the crown of the levee 1.5-feet below the crown. FS Date: 1/6/2014 9:53:43 AM

Portable pump on WS and temporary piping over roadway

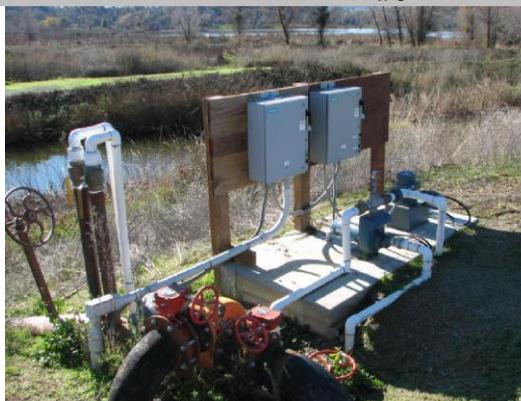
Photo 1 of 1 : UCIP_5051.jpg

LM Start	6.03	Rating **	M	Issue No.	15
LM End	6.03	Issue Type +	En	Location *	LS
Category	Supplemental			GPS Latitude/Longitude	
				Start	End
Item	DWR UCIP Field Study			39.126038 °	39.126038 °
				-122.883351 °	-122.883351 °
DWR ID	DWR_MA0017_01_s_2014_15				
Action/Comments					
Inspector Comments: FS_ID:25907 EP_NO: N/A Repair Type: Crossing Status: UCIP Comments: No permit for this crossing. It is unclear what these hydraulic lines are for, but it is probably the works for a hydraulic butterfly valve at the outlet 2/2013 Erosion on WS shoulder above pipes 2/23/2013 Same as last inspection. FIELD_STRUCT_DESC: 4-inch PVC conduit through the levee 2-feet below the crown with hydraulic lines running through it to pump on LS shoulder. FS Date: 12/31/2013 9:58:13 AM

Pump station on LS shoulder, see hydraulic pump at right.

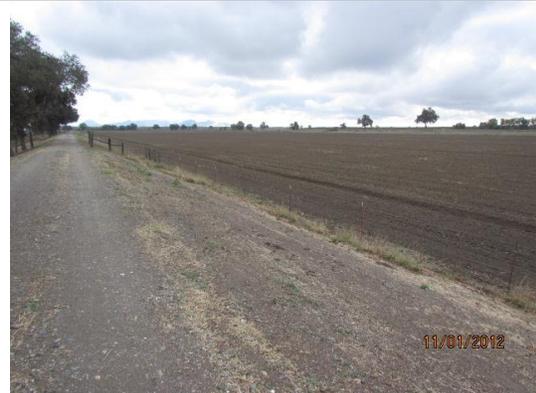
Photo 1 of 1 : rduffey_s_20140304_509.jpg

LM Start	6.08	Rating **	M	Issue No.	5
LM End	6.08	Issue Type +	En	Location *	CR
Category	Earthen Levee			GPS Latitude/Longitude	
				Start	End
Item	Encroachments			39.126003 °	39.126003 °
				-122.883353 °	-122.883353 °
DWR ID	DWR_MA0017_01_s_2013_5				
Action/Comments					
Pipe

View of the non-permitted pump and pipe through the levee.

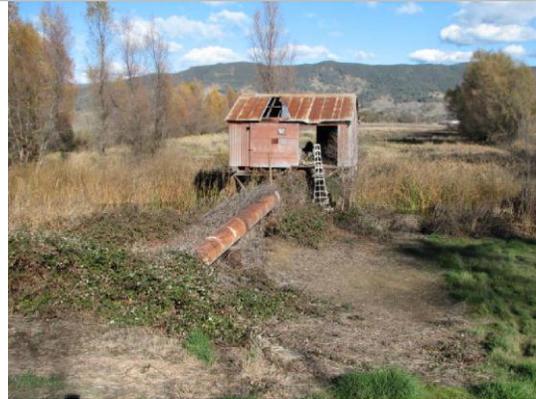
Photo 1 of 1 : UCIP_5062.jpg

LM Start	7.19	Rating **	M	Issue No.	17
LM End	7.19	Issue Type +	En	Location *	CR
Category	Supplemental			GPS Latitude/Longitude	
				Start	End
Item	DWR UCIP Field Study			39.120083 °	39.120083 °
				-122.886502 °	-122.886502 °
DWR ID	DWR_MA0017_01_s_2014_17				
Action/Comments					
Inspector Comments: FS_ID:25910 EP_NO: 11467 Repair Type: Crossing Status: UCIP Comments: Pipe should be properly abandoned 8/2/2013 Same as last inspection 12/23/2013 Same as last inspection. FIELD_STRUCT_DESC: 1 of 2: *Abandoned* 16-inch Steel drainpipe through the levee 8-feet below the crown. Drainage pumping plant on the landward side. Flap gate on the waterward end. Steel plate welded on end of pipe at LS toe. (ABO No.11467- Modglin). This entry matches the Drainage/Irrigation Structure referenced in O&M manual (Levee Mile 7.19). Permit document and O&M referred As-built drawings are available. O&M manual Vol. 5, Revision Year 2010 FS Date: 12/31/2013 10:00:00 AM

Pumping plant in shed on LS at drainage ditch.
