**Flood Control Project Maintenance
Levee Inspections**

Maintenance Issue Types Only, Levee Inspection Report By Mile - Fall 2014

Sutter Maintenance Yard Maintenance Area 0017

Waterway	Bank	Unit Miles	Inspection Start/End	Inspector
Unit No. 01 Lake County Sutter Maintenance Yard - Middle Creek	Left	3.87	10/24/2014 10/24/2014	Bob Duffey

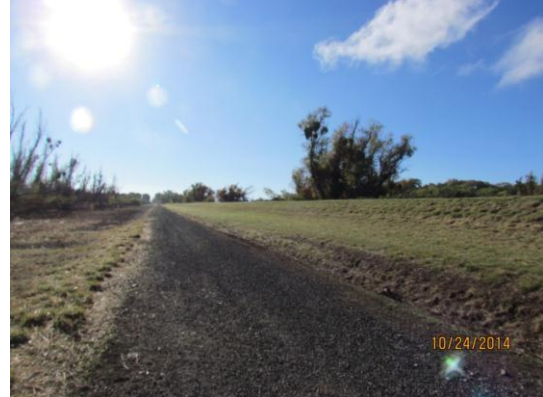
Photo 1 of 1 : FA_2014_MA0017_339_261_20141118_00067.jpg

LM Start	6.74	Rating **	A	Issue No.	261
LM End	6.74	Issue Type +	Ma	Location *	LS
Category	Earthen Levee			GPS Latitude/Longitude	
				Start	End
Item	Vegetation			39.124650 °	39.124650 °
				-122.891787 °	-122.891787 °
DWR ID	DWR_MA0017_01_f_2014_261				
Action/Comments					
Control annual grass and weeds on the levee slopes and easements.

View of the mowed vegetation on the landside slope.
