**Flood Control Project Maintenance
Levee Inspections**

Maintenance Issue Types Only, Levee Inspection Report By Mile - Fall 2015

Sutter Maintenance Yard Maintenance Area 0017

Waterway	Bank	Unit Miles	Inspection Start/End	Inspector
Unit No. 01 Lake County Sutter Maintenance Yard - Middle Creek	Left	3.87	10/14/2015 10/14/2015	Bob Duffey

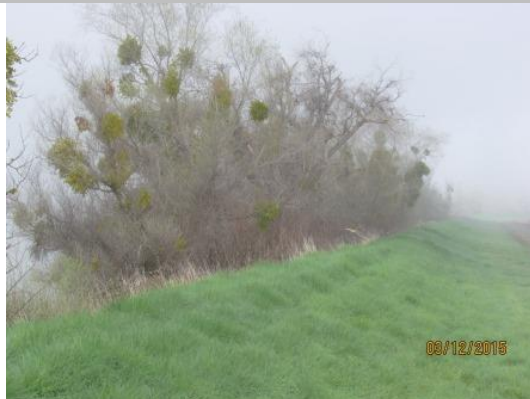
Photo 1 of 1 : FA_2015_MA0017_339_2_20150910_00002.jpg

LM Start	4.09	Rating **	U	Issue No.	2
LM End	7.23	Issue Type +	Ma	Location *	WS
Category	Earthen Levee			GPS Latitude/Longitude	
				Start	End
Item	Trim / Thin Trees			39.142155 °	39.118735 °
				-122.902343 °	-122.884892 °
DWR ID	DWR_MA0017_01_s_2012_2				
Action/Comments					
Thin trees to allow visibility of the ground and room to flood fight. Inspector Comments: Trees and limbs are completely obstructing the visibility.

View of the trees along the waterside slope and toe.

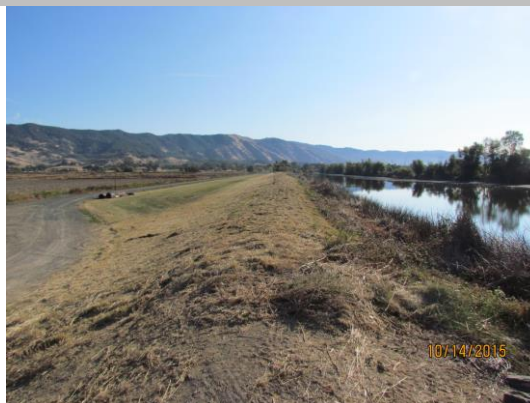
Photo 1 of 1 : FA_2015_MA0017_339_1_20151016_00007.jpg

LM Start	4.09	Rating **	A	Issue No.	1
LM End	7.11	Issue Type +	Ma	Location *	CR
Category	Earthen Levee			GPS Latitude/Longitude	
				Start	End
Item	Vegetation			39.120513 °	39.120513 °
				-122.887085 °	-122.887085 °
DWR ID	DWR_MA0017_01_s_2015_1				
Action/Comments					
Control annual grass and weeds on the levee slopes and easements. Inspector Comments: Sutter Yard mowed the levee crown.

View of the mowed levee crown.

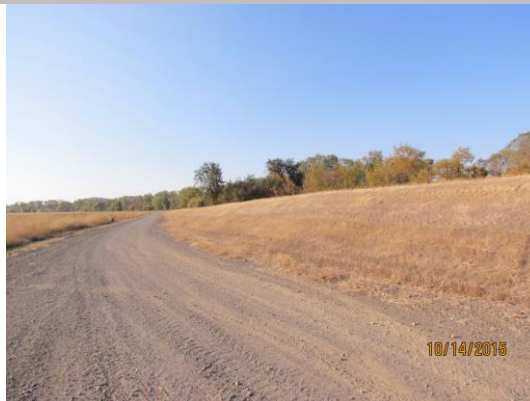
Photo 1 of 1 : FA_2015_MA0017_339_16_20151016_00005.jpg

LM Start	4.09	Rating **	A	Issue No.	16
LM End	7.28	Issue Type +	Ma	Location *	LS
Category	Earthen Levee			GPS Latitude/Longitude	
				Start	End
Item	Vegetation			39.141417 °	39.118730 °
				-122.901922 °	-122.884908 °
DWR ID	DWR_MA0017_01_f_2015_16				
Action/Comments					
Control annual grass and weeds on the levee slopes and easements. Inspector Comments: Sutter Yard mowed the landside slope.

View of no vegetation on the landside slope.
