**Flood Control Project Maintenance
Levee Inspections**

Maintenance Issue Types Only, Levee Inspection Report By Mile - Fall 2016

Sutter Maintenance Yard Maintenance Area 0017

Waterway	Bank	Unit Miles	Inspection Start/End	Inspector
Unit No. 01 Lake County Sutter Maintenance Yard - Middle Creek	Left	3.87	09/28/2016 09/28/2016	Tariq Chechi

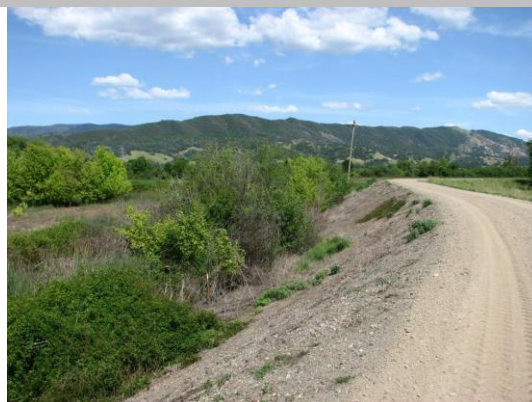
Photo 1 of 1 : FA_2016_MA0017_339_16_20160823_00008.jpg

LM Start	3.96	Rating **	M	Issue No.	16
LM End	4.03	Issue Type +	Ma	Location *	LS
Category	Earthen Levee			GPS Latitude/Longitude	
				Start	End
Item	Vegetation			39.143741 °	39.143585 °
				-122.904705 °	-122.903482 °
DWR ID	DWR_MA0017_01_s_2016_16				
Comment Code					
V2 : Remove the wild growth other than native grasses from the levee slopes.					
Inspector Comment					
Large bushes and brambles growing on wire fence on LS toe limiting visibility and access.

5/2/2016: Remove or trim dense vegetation growing on fence to allow visibility and access to L/S toe.

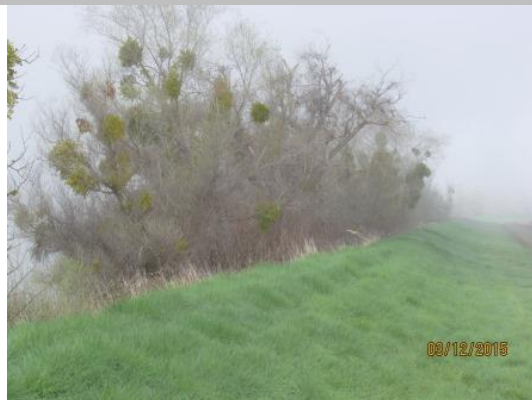
Photo 1 of 2 : FA_2016_MA0017_339_2_20160823_00001.jpg

LM Start	4.16	Rating **	U	Issue No.	2
LM End	7.10	Issue Type +	Ma	Location *	WS
Category	Earthen Levee			GPS Latitude/Longitude	
				Start	End
Item	Trim / Thin Trees			39.141894 °	39.120609 °
				-122.902201 °	-122.887166 °
DWR ID	DWR_MA0017_01_s_2012_2				
Comment Code					
T2 : Thin trees to allow visibility of the ground and room to flood fight.					
Inspector Comment					
Trees and limbs are completely obstructing visibility on crown and WS. Crown is too narrow to drive, and overgrown with weeds, brush and trees. Road follows LS toe.

View of the trees along the waterside slope and toe.

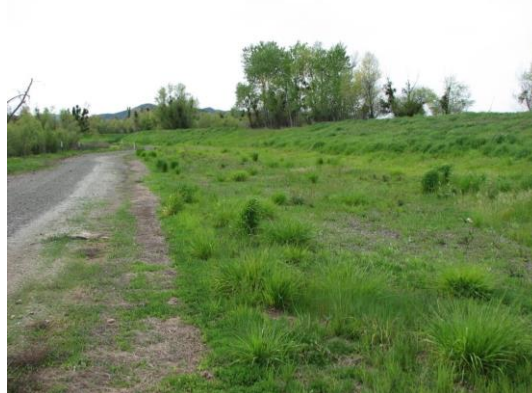
Photo 2 of 2 : FA_2016_MA0017_339_2_20160823_00002.jpg

LM Start	4.16	Rating **	U	Issue No.	2 (cont)	
LM End	7.10	Issue Type +	Ma	Location *	WS	
Category	Earthen Levee			GPS Latitude/Longitude		
				Start		End
Item	Trim / Thin Trees			39.141894 °		39.120609 °
				-122.902201 °		-122.887166 °
DWR ID	DWR_MA0017_01_s_2012_2					
Comment Code						
T2 : Thin trees to allow visibility of the ground and room to flood fight.						
Inspector Comment						
Trees and limbs are completely obstructing visibility on crown and WS. Crown is too narrow to drive, and overgrown with weeds, brush and trees. Road follows LS toe.

Photo taken at LM 6.41 looking west showing overgrown LS slope of levee at right and toe road at left. Note trees obstructing visibility and access at levee crown. Crown is +/- 5 feet wide, and impassible to vehicles due to vegetation, and in some places, to pedestrians.
4/19/2016
