**Flood Control Project Maintenance  
Levee Inspections**

**Maintenance Issue Types Only, Levee Inspection Report By Mile - Fall 2017**

**Sutter Maintenance Yard Maintenance Area 0017**

Waterway	Bank	Unit Miles	Inspection Start/End	Inspector
Unit No. 01 Lake County Sutter Maintenance Yard - Middle Creek	Left	3.87	10/25/2017 10/25/2017	Bob Duffey

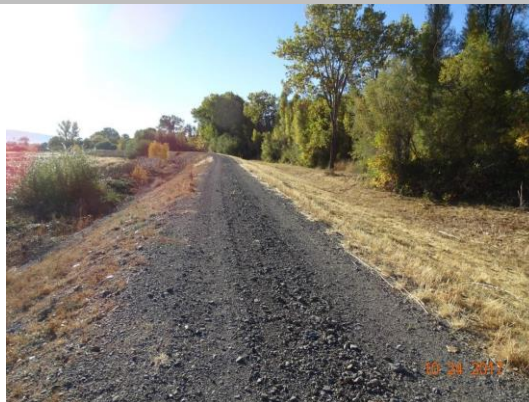
Photo 1 of 1 : FA\_2017\_MA0017\_339\_36\_20171030\_00072.jpg

LM Start	3.75	Rating **	A	Issue No.	36
LM End	3.75	Issue Type +	Ma	Location *	LS
Category	Earthen Levee			GPS Latitude/Longitude	
				Start	End
Item	Vegetation			39.145682 °	39.145682 °
				-122.907717 °	-122.907717 °
DWR ID	DWR_MA0017_01_f_2017_36				
Comment Code					
V1 : Control annual grass and weeds on the levee slopes and easements.					
Inspector Comment					
The vegetation was removed from both slopes.

View of no vegetation on both slopes.

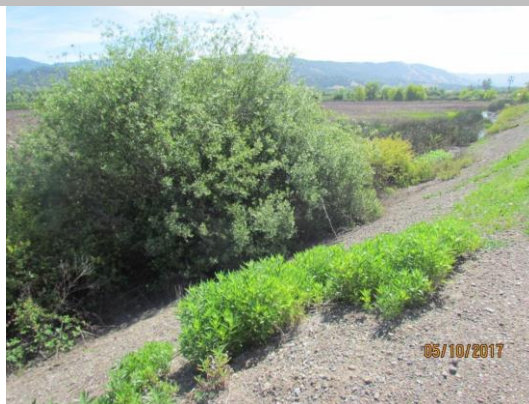
Photo 1 of 1 : FA\_2017\_MA0017\_339\_25\_20170911\_00006.jpg

View of the trees along the landside toe.

LM Start	3.84	Rating **	M	Issue No.	25
LM End	3.84	Issue Type +	Ma	Location *	LS
Category	Earthen Levee			GPS Latitude/Longitude	
				Start	End
Item	Trim / Thin Trees			39.144695 °	39.144695 °
				-122.906668 °	-122.906668 °
DWR ID	DWR_MA0017_01_s_2017_25				
Comment Code					
T2 : Thin trees to allow visibility of the ground and room to flood fight.					
Inspector Comment					
Trim the trees along the landside toe.

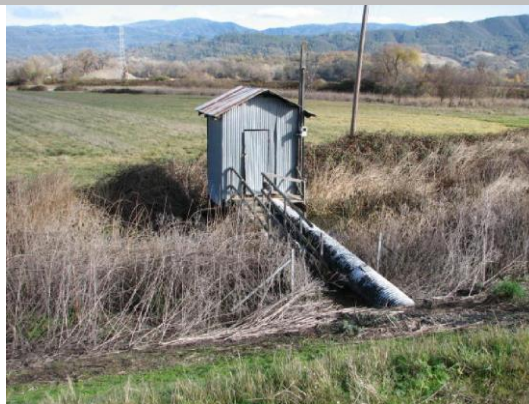
Photo 2 of 3 : UCIP\_FA\_2017\_50814\_46848.jpg

Pumphouse on piles at LS toe.

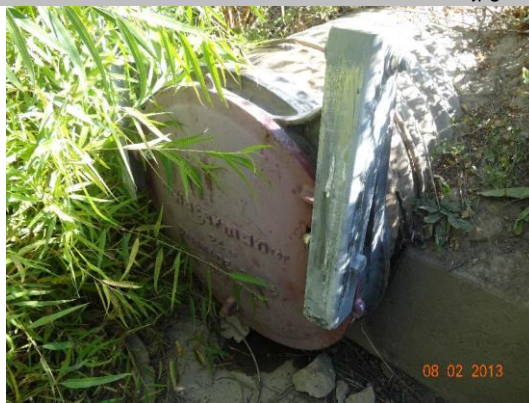
Photo 3 of 3 : UCIP\_FA\_2017\_50814\_46850.jpg

New flap gate on WS

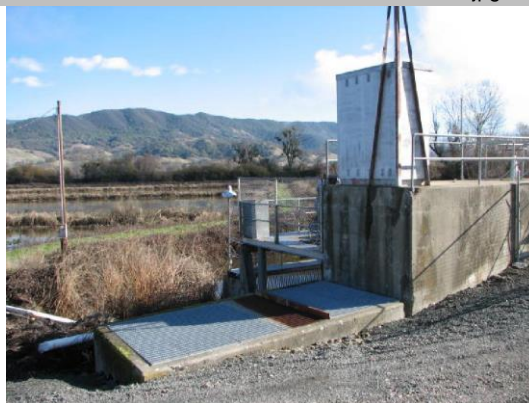
Photo 1 of 3 : UCIP\_FA\_2017\_50815\_46853.jpg

FS\_ID:50815  
DS\_ID:845  
EP\_NO: 11464  
Repair Type: No Action Needed  
Crossing Status: Found  
UCIP Comments: 10/27/2017 This structure is inspected annually under the Structure and Channel Summer Inspection (part of the Levee Inspection Program) conducted by the DWR Flood Project Integrity and Inspection Branch (FPIIB). (DWR UCIP - O. Magana)  
10/19/2016 Crossing appears to be in good condition. (DWR Sutter Yard- A Freitag) 6/14/2016 crossing appears to be in good condition. 4/23/2015 No issues with pipe. 7/3/2014 Same as last inspection. 12/23/2013 Same as last inspection. 8/2/2013 Same as last inspection.  
FIELD\_STRUCT\_DESC: [Bloody Island Pumping Plant] 1 of 2: 42-inch corrugated metal drainage pipe through the levee, 20.2 feet below the crown. Concrete headwall and discharge apron on the waterside (WS) shoulder. Three vertical pump units mounted on a reinforced concrete pump platform in drainage ditch at the landside (LS) toe. Flap gates in concrete discharge well on the LS. Combination flap and slide gate on a gravity pipe from drainage ditch into discharge well. (two 42-inch pipes [HLM 4.18] authorized under Automatic Board Order (ABO) issued as Permit No. 11464, 1975 - Lake County). [Additional Reference(s): DWR Levee Log, 2005. USACE Sacramento O&M Manual 506.2, August 1961, (HLM 4.18)].

Pumping Plant on LS shoulder.

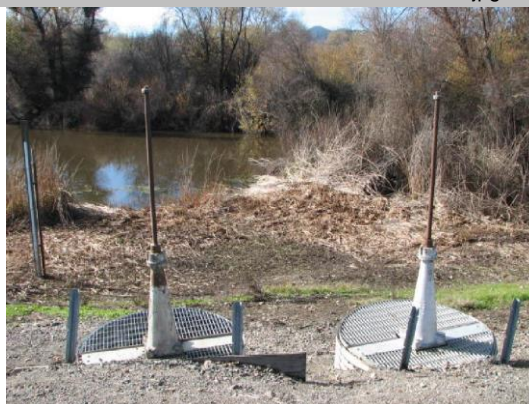
Photo 2 of 3 : UCIP\_FA\_2017\_50815\_46852.jpg

Slide gates in CMP risers on WS shoulder.

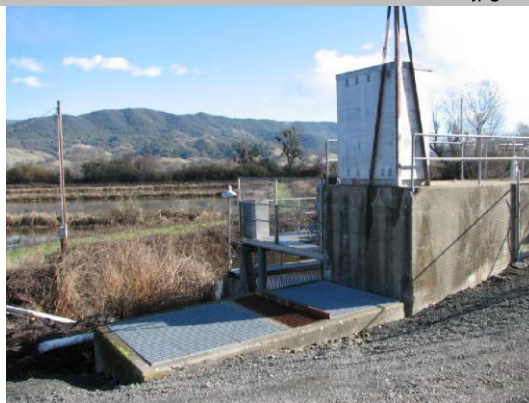
Photo 1 of 3 : UCIP\_FA\_2017\_50816\_46856.jpg

FS\_ID:50816  
DS\_ID:852  
EP\_NO: 11464  
Repair Type: No Action Needed  
Crossing Status: Found  
UCIP Comments: 10/27/2017 This structure is inspected annually under the Structure and Channel Summer Inspection (part of the Levee Inspection Program) conducted by the DWR Flood Project Integrity and Inspection Branch (FPIIB). (DWR UCIP - O. Magana)  
10/19/2016 Crossing appears to be in good condition. (DWR Sutter Yard- A Freitag) 6/14/2016 crossing appears to be in good condition. 4/23/2015 No issues with pipe. 7/3/2014 Same as last inspection. 12/23/2013 Same as last inspection. 8/2/2013 Same as last inspection.  
FIELD\_STRUCT\_DESC: [Bloody Island Pumping Plant] 2 of 2: 42-inch corrugated metal drainage pipe through the levee, 14.6 feet below the crown. Concrete headwall and discharge apron on the waterside (WS) shoulder. Three vertical pump units mounted on a reinforced concrete pump platform in drainage ditch at the landside (LS) toe. Flap gates in concrete discharge well on the LS. Combination flap and slide gate on a gravity pipe from drainage ditch into discharge well. (two 42-inch pipes [HLM 4.18] authorized under Automatic Board Order (ABO) issued as Permit No. 11464, 1975 - Lake County). [Additional Reference(s): DWR Levee Log, 2005. USACE Sacramento O&M Manual 506.2, August 1961, (HLM 4.18)].

Pumping plant on LS shoulder.

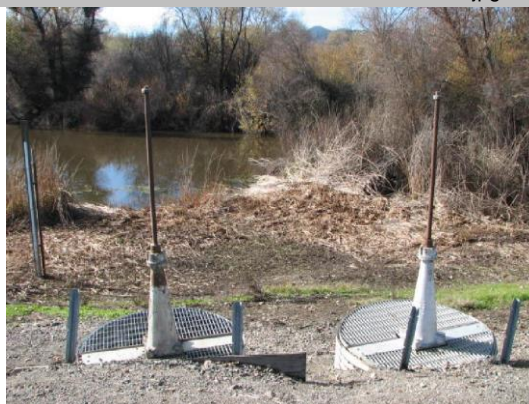
Photo 2 of 3 : UCIP\_FA\_2017\_50816\_46855.jpg

Slide gate in CMP riser on WS shoulder.

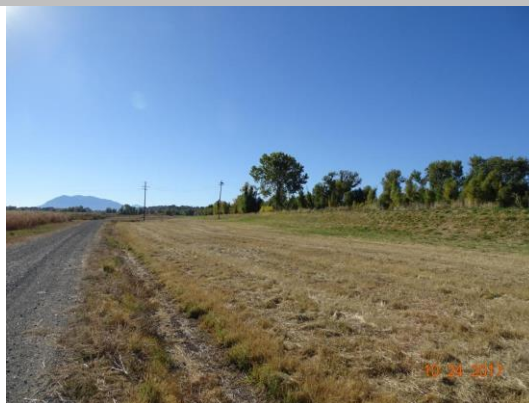
Photo 1 of 1 : FA\_2017\_MA0017\_339\_37\_20171030\_00073.jpg

LM Start	4.17	Rating **	A	Issue No.	37
LM End	5.97	Issue Type +	Ma	Location *	LS
Category	Earthen Levee			GPS Latitude/Longitude	
				Start	End
Item	Vegetation			39.141870 °	39.126123 °
				-122.902172 °	-122.882773 °
DWR ID	DWR_MA0017_01_f_2017_37				
Comment Code					
V1 : Control annual grass and weeds on the levee slopes and easements.					
Inspector Comment					
The vegetation was removed from the landside slope.

View of no vegetation on the landside slope.

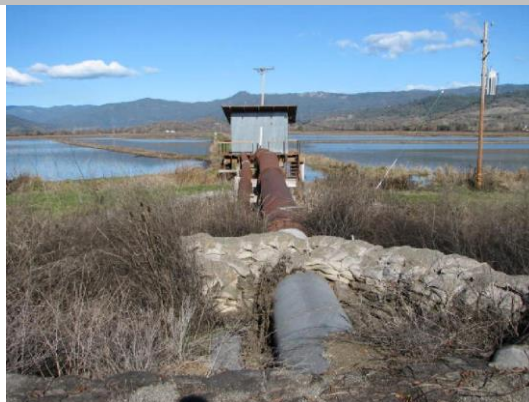
Photo 1 of 2 : UCIP\_FA\_2017\_50818\_46860.jpg

Comment Code					
Inspector Comment					
FS_ID:50818 DS_ID:847 EP_NO: 11469 Repair Type: Non-Urgent Crossing Status: Found UCIP Comments: 10/19/2016 Sack ring still in place. (DWR Sutter Yard- A Freitag)6/14/2016 Sack ring is still built up underneath the pipes.4/23/2015 Sack ring is still built up underneath the pipes.7/3/2014 Same as last inspection.12/23/2013 Same as last inspection.8/2/2013 Same as last inspection.12/13/2012 flood fight materials-ring levees around both LS and WS slopes at pipe crossing. This may or may not be an issue. FIELD_STRUCT_DESC: 1 of 2: 16-inch steel drainage pipe through the levee, 5 feet below the crown. Drainage pumping plant on the landside (LS). Flap gate on the waterside (WS) end. (one 16-inch and one 36-inch pipes [HLM 5.43] authorized under Automatic Board Order (ABO) issued as Permit No. 11469, 1975 - RD 2070). [Additional Reference(s): DWR Levee Log, 2005. USACE Sacramento O&M Manual 506.3, August 1961, (HLM 5.43)]. FS Date: 11/21/2016 12:11:57 PM

Pumping plant, pipes, and ring levees on LS toe.

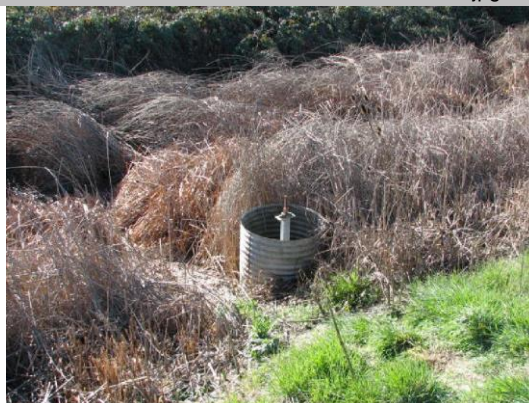
Photo 1 of 2 : UCIP\_FA\_2017\_50820\_46866.jpg

FS\_ID:50820  
DS\_ID:848  
EP\_NO: 11457  
Repair Type: Non-Urgent  
Crossing Status: Found  
UCIP Comments: 10/19/2016 No riser lid or slide gate wheel. (DWR Sutter Yard- AFreitag)6/14/2016 No riser lid and no wheel to operate screw gate.4/23/2015 No cover on riser and no wheel to operate gate.7/3/2014 Same as last inspection.12/23/2013 Same as last inspection.8/2/2013 Handle to operate gate was in place but still no cover on riser.12/13/2012 No cover on CMP riser and no handle for actuating gate. This may or may not be an issue.  
FIELD\_STRUCT\_DESC: 24-inch drainage pipe under patrol road and through the levee, 13.5 feet below the crown. Concrete "U" shaped headwall on the landside (LS) end. Slide gate in 36-inch corrugated metal pipe (CMP) riser on the waterside (WS) slope. Riser unit is mounted on concrete base. (24-inch pipe [HLM 5.87] authorized under Automatic Board Order (ABO) issued as Permit No. 11457, 1975 - Crawford). [Additional Reference(s): DWR Levee Log, 2005. USACE Sacramento O&M Manual 506.3, August 1961, (HLM 5.87)].

36-inch CMP riser and slide gate on WS slope.

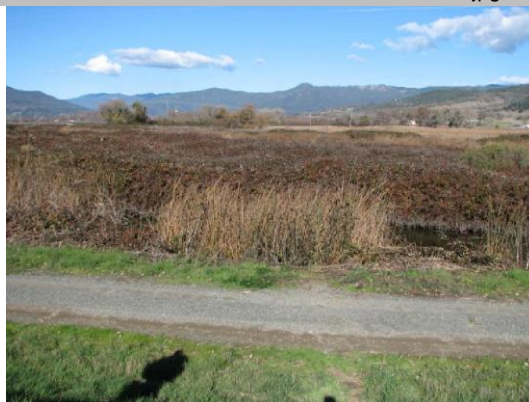
Photo 2 of 2 : UCIP\_FA\_2017\_50820\_46865.jpg

Approximate location of inlet on LS toe (not visible).

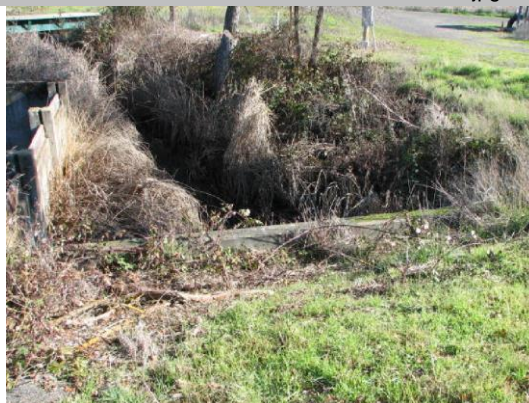
Photo 1 of 3 : UCIP\_FA\_2017\_50821\_46869.jpg

FS\_ID:50821  
DS\_ID:849  
EP\_NO: 11467  
Repair Type: No Action Needed  
Crossing Status: Found  
UCIP Comments: 10/27/2017 This structure is inspected annually under the Structure and Channel Summer Inspection (part of the Levee Inspection Program) conducted by the DWR Flood Project Integrity and Inspection Branch (FPIIB). (DWR UCIP - O. Magana)  
10/19/2016 Crossing appears to be in good condition. (DWR Sutter Yard- A Freitag) 6/14/2016 Flap gate propped open. Will make sure its closed before flood season. 4/23/2015 Flap gate propped open. Not an issue at this time. Will close it before high water season. 7/3/2014 Same as last inspection 12/23/2013 Same as last inspection. 8/2/2013 Same as last inspection.  
FIELD\_STRUCT\_DESC: [Highland Canal Diversion Weir and Drainage] 1 of 2: 54-inch corrugated metal drainage pipe through the levee 11.5 feet below the crown. Highland Canal Diversion Weir and Drainage Structure on the landside (LS). Concrete headwall on both landside (LS) and waterside (WS) toe with flap gate on the WS toe. (two 42-inch pipes [HLM 6.05] authorized under Automatic Board Order (ABO) issued as Permit No. 11467, 1975 - Modglin). [Additional Reference(s): DWR Levee Log, 2005. USACE Sacramento O&M Manual 506.3, August 1961, (HLM 6.05)].

Concrete weir/dam and channel on LS toe.

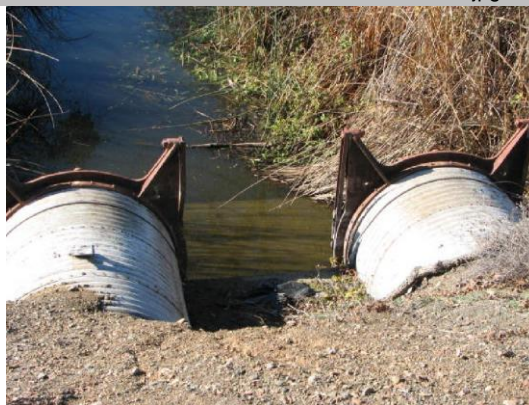
Photo 2 of 3 : UCIP\_FA\_2017\_50821\_46868.jpg

pipe and flap gate on WS toe.

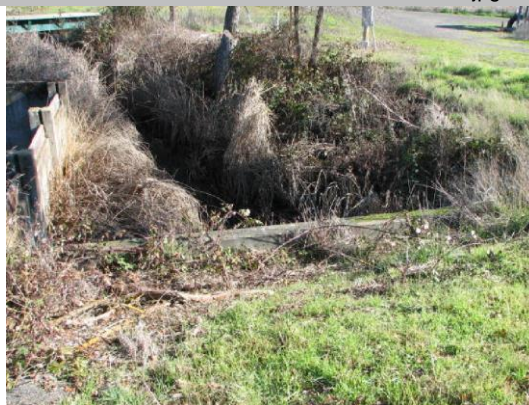
Photo 1 of 3 : UCIP\_FA\_2017\_50822\_46872.jpg

FS\_ID:50822  
DS\_ID:854  
EP\_NO: 11467  
Repair Type: No Action Needed  
Crossing Status: Found  
UCIP Comments: 10/27/2017 This structure is inspected annually under the Structure and Channel Summer Inspection (part of the Levee Inspection Program) conducted by the DWR Flood Project Integrity and Inspection Branch (FPIIB). (DWR UCIP - O. Magana)  
10/19/2016 Crossing appears to be in good condition. (DWR Sutter Yard- A Freitag) 6/14/2016 Flap gate propped open. Will make sure its closed before flood season. 4/23/2015 Flap gate propped open. Not an issue at this time. Will close it before high water season. 7/3/2014 Same as last inspection. 12/23/2013 Same as last inspection. 8/2/2013 Same as last inspection.  
FIELD\_STRUCT\_DESC: [Highland Canal Diversion Weir and Drainage] 2 of 2: 54-inch corrugated metal drainage pipe through the levee, 11.5 feet below the crown. Highland Canal Diversion Weir and Drainage Structure on the landside (LS). Concrete headwall on both landside (LS) and waterside (WS) toe with flap gate on the WS toe. (two 42-inch pipes [HLM 6.05] authorized under Automatic Board Order (ABO) issued as Permit No. 11467, 1975 - Modglin). [Additional Reference(s): DWR Levee Log, 2005. USACE Sacramento O&M Manual 506.3, August 1961, (HLM 6.05)].

Concrete dam/weir and channel on LS toe.

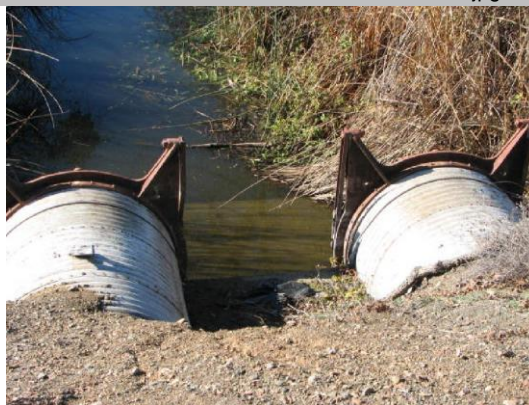
Photo 2 of 3 : UCIP\_FA\_2017\_50822\_46871.jpg

Pipe and flap gate on WS toe.

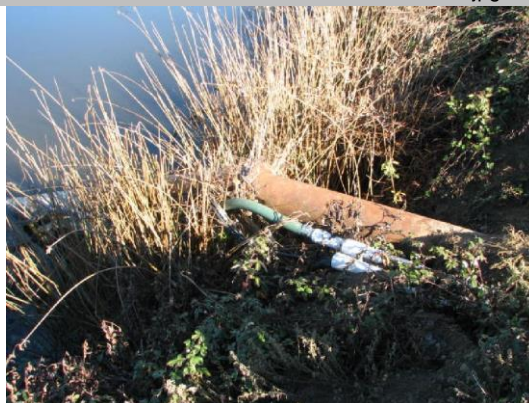
Photo 1 of 3 : UCIP\_FA\_2017\_50826\_46882.jpg

FS\_ID:50826  
DS\_ID:850  
EP\_NO: 11467  
Repair Type: Urgent  
Crossing Status: Found  
UCIP Comments: 10/19/2016 WS erosion still present. (DWR Sutter Yard - AFreitag)6/14/2016 WS erosion is still present. (DWR Sutter Yard - afreitag)4/23/2015 Same as last inspection. (DWR Sutter Yard - afreitag)7/3/2014 Same as last inspection. (DWR Sutter Yard - afreitag)12/23/2013 Same as last inspection. (DWR Sutter Yard - afreitag)8/2/2013 Same as last inspection. (DWR Sutter Yard - afreitag)12/13/2012 This pipe and appurtances do not match what was described in the permit (PN: 11467). Does not appear to be in compliance with board regulations. (DWR UCIP - wwylie)  
FIELD\_STRUCT\_DESC: 12-inch steel drainage pipe through the levee, 2 feet below the crown. Butterfly valve on the landside (LS) shoulder. Pump and electrical panel, along with multiple valves and appurtenances, on the LS shoulder. (12-inch pipe [HLM 6.11] authorized under Automatic Board Order (ABO) issued as Permit No. 11467, 1975 - B. F. Modglin). [Additional Reference(s): DWR Levee Log, 2005. USACE Sacramento O&M Manual 506.3, 1967, (HLM 6.11)].

12-inch pipe and appurtances on WS shoulder.

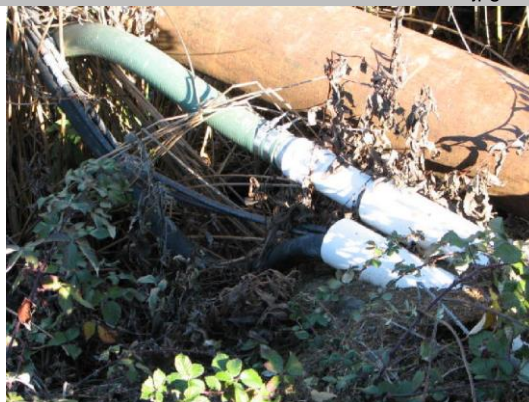
Photo 2 of 3 : UCIP\_FA\_2017\_50826\_46881.jpg

12-inch pipe and appurtances on WS shoulder.

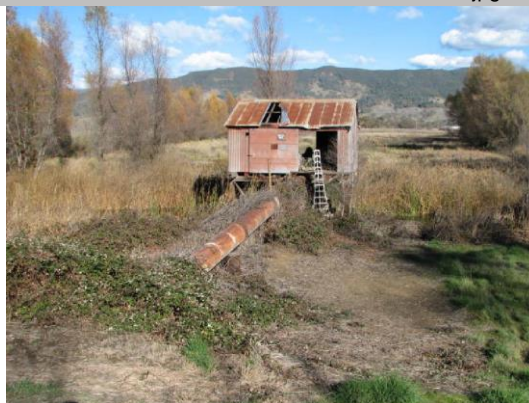
Photo 1 of 2 : UCIP\_FA\_2017\_50827\_46884.jpg

FS\_ID:50827  
DS\_ID:851  
EP\_NO: 11467  
Repair Type: Non-Urgent  
Crossing Status: Found  
UCIP Comments: 10/19/2016 Abandoned- should be done so properly. (DWR Sutter Yard- AFreitag)6/14/2016 Abandoned crossing.4/23/2015 Same as last inspection. Pipe still needs to be properly abandoned.7/3/2014 Same as last inspection.12/23/2013 Same as last inspection.8/2/2013 Same as last inspection.12/13/2012 Pipe should be properly abandoned.  
FIELD\_STRUCT\_DESC: \*ABANDONED\* 1 of 2: 16-inch steel drainage pipe through the levee, 8 feet below the crown. Drainage pumping plant on the landside (LS). Flap gate on the waterside (WS) end. Steel plate welded on end of pipe at LS toe. (one 16-inch and one 24-inch pipes [HLM 7.79] authorized under Automatic Board Order (ABO) issued as Permit No. 11467, 1975 - Modglin). [Additional Reference(s): DWR Levee Log, 2005. USACE Sacramento O&M Manual 506.3, August 1961, (HLM 7.19)].

Pumping plant in shed on LS at drainage ditch.

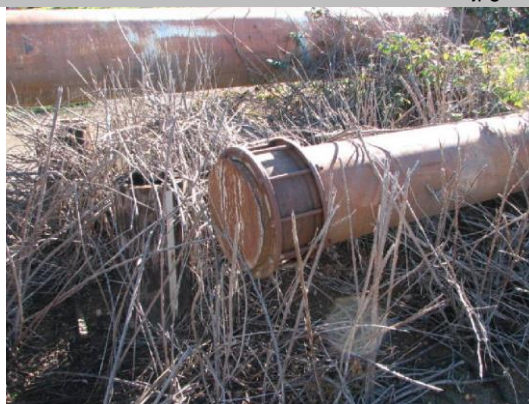
Photo 2 of 2 : UCIP\_FA\_2017\_50827\_46883.jpg

Steel plate welded over end of pipe at LS toe.

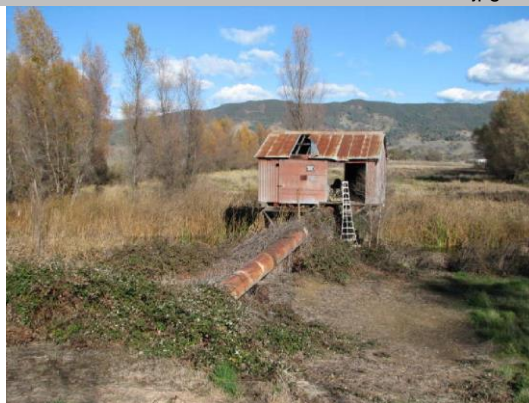
Photo 1 of 2 : UCIP\_FA\_2017\_50828\_46886.jpg

FS\_ID:50828  
DS\_ID:855  
EP\_NO: 11467  
Repair Type: No Action Needed  
Crossing Status: Found  
UCIP Comments: 10/19/2016 Crossing appears to be in good condition. (DWR Sutter Yard- A Freitag) 6/14/2016 Crossing appears to be in good condition. 4/23/2015 No issues seen with pipe. 7/3/2014 Same as last inspection. 8/2/2013 Same as last inspection. 12/23/2013 Same as last inspection.  
FIELD\_STRUCT\_DESC: 2 of 2: 24-inch steel drainage pipe through the levee, 8 feet below the crown.  
Drainage pumping plant on the landside (LS). Flap gate on the waterside (WS) end. (one 16-inch and one 24-inch pipes [HLM 7.79] authorized under Automatic Board Order (ABO) issued as Permit No. 11467, 1975 - Modglin). [Additional Reference(s): DWR Levee Log, 2005. USACE Sacramento O&M Manual 506.3, August 1961, (HLM 7.19)].  
FS Date: 11/21/2016 12:17:36 PM

24-inch steel pipe and pump house on LS.

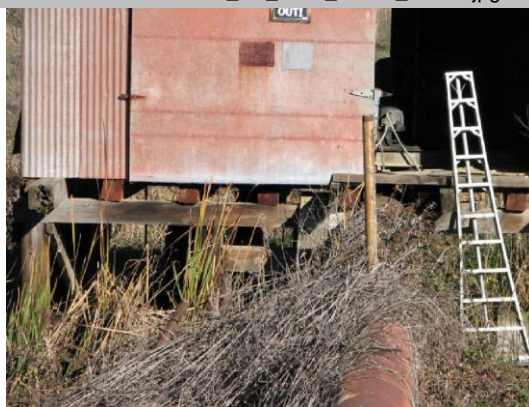
Photo 2 of 2 : UCIP\_FA\_2017\_50828\_46885.jpg

Air vent on pipe at LS pumphouse.
