**Flood Control Project Maintenance
Levee Inspections**

Maintenance Issue Types Only, Levee Inspection Report By Mile - Fall 2018

Sutter Maintenance Yard Maintenance Area 0017

Waterway	Bank	Unit Miles	Inspection Start/End	Inspector
Unit No. 01 Lake County Sutter Maintenance Yard - Middle Creek	Left	3.87	10/16/2018 10/16/2018	Luz Dial

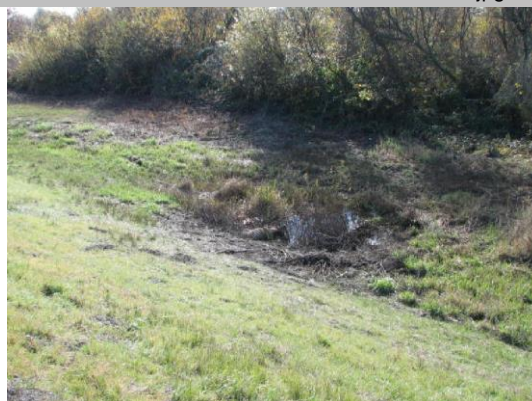
Photo 1 of 3 : UCIP_FA_2018_50814_46849.jpg

Comment Code					
Inspector Comment					
FS_ID:50814 DS_ID:844 EP_NO: 11463 Repair Type: No Action Needed Crossing Status: Found UCIP Comments: 10/19/2016 Crossing appears to be in good ondition. (DWR Sutter Yard- AFreitag)6/14/2016 crossing appears to be in good condition.4/23/2015 No issues with pipe.7/3/2014 Same as last inspection.12/23/2013 Same as last inspection.8/2/2013 New flap gate installed. No other issues with pipe. FIELD_STRUCT_DESC: 24-inch corrugated metal drainage pipe through the levee, 12.4 feet below the crown. Flap gate on the waterside (WS) end. Timber walkway on the landside (LS) slope to a timber walkway to pump house mounted on piles in drainage ditch. (24- inch pipe [HLM 3.99] authorized under Automatic Board Order (ABO) issued as Permit No. 11463, 1975 - Audrey Jones). [Additional Reference(s): DWR Levee Log, 2005. USACE Sacramento O&M Manual 506.2, August 1961, (HLM 3.99)]. FS Date: 11/21/2016 12:09:38 PM

24-inch CMP at outlet on WS toe.

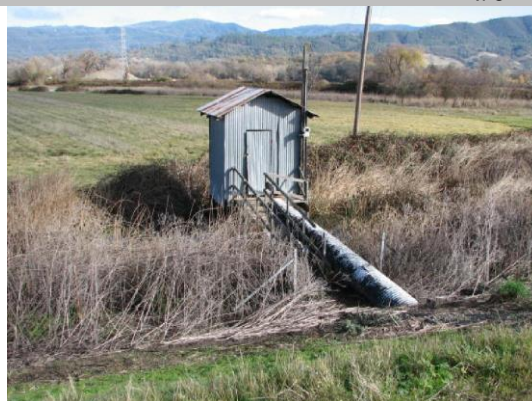
Photo 2 of 3 : UCIP_FA_2018_50814_46848.jpg

Pumphouse on piles at LS toe.

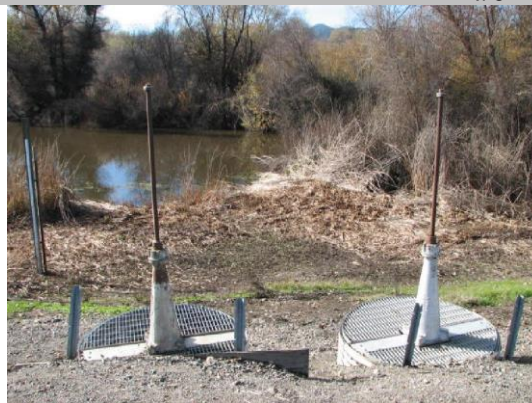
Photo 2 of 3 : UCIP_FA_2018_50815_46852.jpg

Slide gates in CMP risers on WS shoulder.

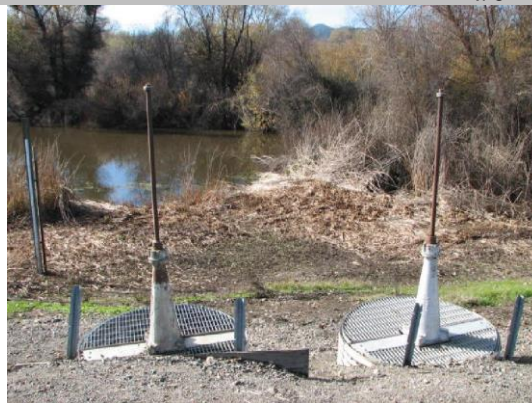
Photo 2 of 3 : UCIP_FA_2018_50816_46855.jpg

Slide gate in CMP riser on WS shoulder.

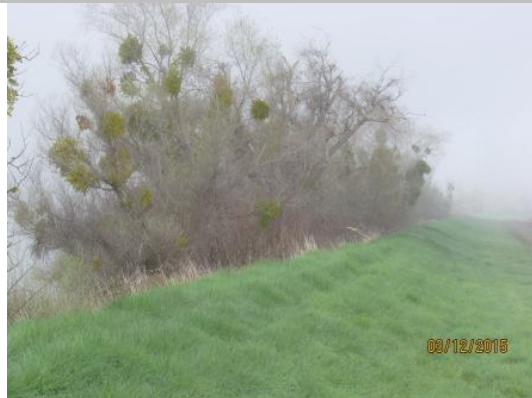
Photo 1 of 2 : FA_2018_MA0017_339_2_20180919_00001.jpg

LM Start	4.16	Rating **	U	Issue No.	2
LM End	7.10	Issue Type +	Ma	Location *	WS
Category	Earthen Levee			GPS Latitude/Longitude	
				Start	End
Item	Trim / Thin Trees			39.141894 °	39.120609 °
				-122.902201 °	-122.887166 °
DWR ID	DWR_MA0017_01_s_2012_2				
Comment Code					
T2 : Thin trees to allow visibility of the ground and room to flood fight.					
Inspector Comment					
Trees and limbs are completely obstructing visibility on crown and WS. Crown is too narrow to drive and overgrown with weeds, brush, and trees. Road follows LS toe.

View of the trees along the waterside slope and toe.

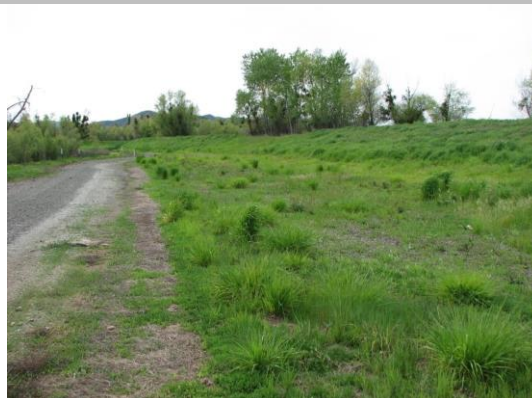
Photo 2 of 2 : FA_2018_MA0017_339_2_20180919_00002.jpg

Photo taken at LM 6.41 looking west showing overgrown LS slope of levee at right and toe road at left. Note trees obstructing visibility and access at levee crown. Crown is +/- 5 feet wide, and impassible to vehicles due to vegetation, and in some places, to pedestrians.
4/19/2016

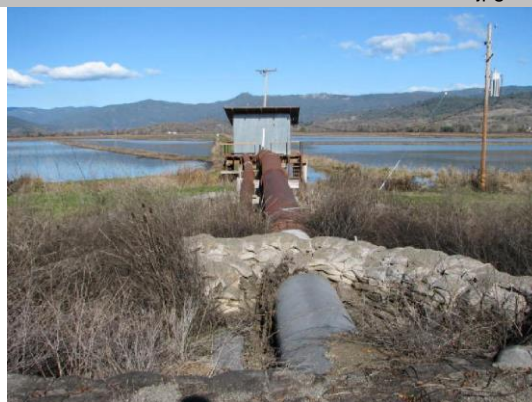
Photo 1 of 2 : UCIP_FA_2018_50818_46860.jpg

Comment Code					
Inspector Comment					
FS_ID:50818 DS_ID:847 EP_NO: 11469 Repair Type: Non-Urgent Crossing Status: Found UCIP Comments: 10/19/2016 Sack ring still in place. (DWR Sutter Yard- AFreitag)6/14/2016 Sack ring is still built up underneath the pipes.4/23/2015 Sack ring is still built up underneath the pipes.7/3/2014 Same as last inspection.12/23/2013 Same as last inspection.8/2/2013 Same as last inspection.12/13/2012 flood fight materials-ring levees around both LS and WS slopes at pipe crossing. This may or may not be an issue. FIELD_STRUCT_DESC: 1 of 2: 16-inch steel drainage pipe through the levee, 5 feet below the crown. Drainage pumping plant on the landside (LS). Flap gate on the waterside (WS) end. (one 16-inch and one 36-inch pipes [HLM 5.43] authorized under Automatic Board Order (ABO) issued as Permit No. 11469, 1975 - RD 2070). [Additional Reference(s): DWR Levee Log, 2005. USACE Sacramento O&M Manual 506.3, August 1961, (HLM 5.43)]. FS Date: 11/21/2016 12:11:57 PM

Pumping plant, pipes, and ring levees on LS toe.

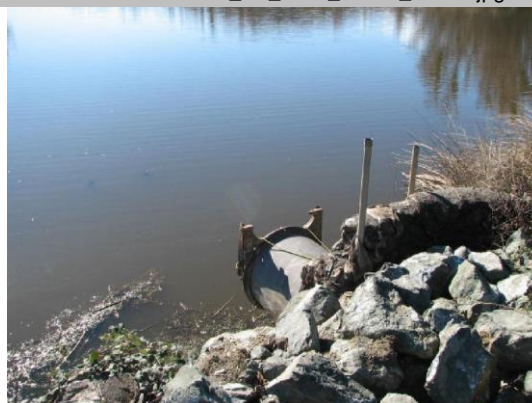
Photo 2 of 2 : UCIP_FA_2018_50819_46863.jpg

Pipe, flap gate, air vent, and sandbags on WS slope.

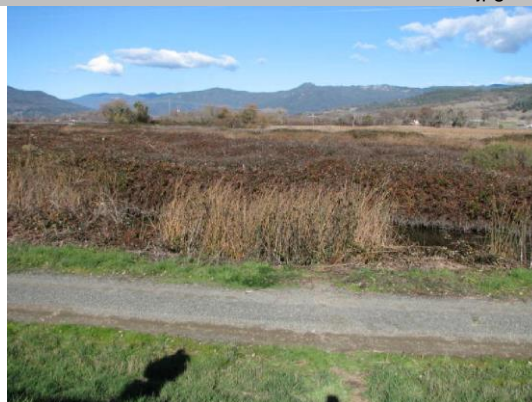
Photo 2 of 2 : UCIP_FA_2018_50820_46865.jpg

Approximate location of inlet on LS toe (not visible).

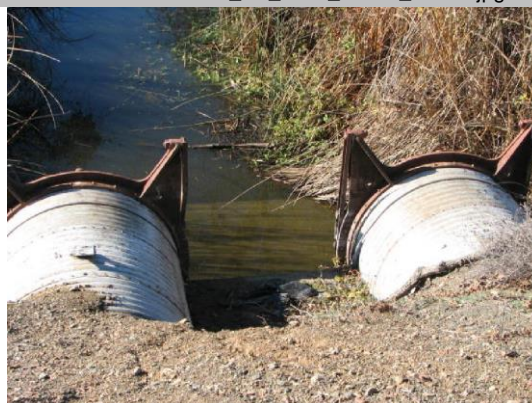
Photo 2 of 3 : UCIP_FA_2018_50821_46868.jpg

pipe and flap gate on WS toe.

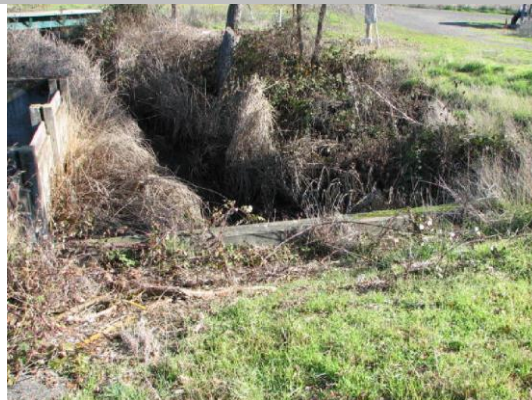
Photo 1 of 3 : UCIP_FA_2018_50822_46872.jpg

FS_ID:50822
DS_ID:854
EP_NO: 11467
Repair Type: No Action Needed
Crossing Status: Found
UCIP Comments: 10/27/2017 This structure is inspected annually under the Structure and Channel Summer Inspection (part of the Levee Inspection Program) conducted by the DWR Flood Project Integrity and Inspection Branch (FPIIB). (DWR UCIP - O. Magana)
10/19/2016 Crossing appears to be in good condition. (DWR Sutter Yard- A Freitag) 6/14/2016 Flap gate propped open. Will make sure its closed before flood season. 4/23/2015 Flap gate propped open. Not an issue at this time. Will close it before high water season. 7/3/2014 Same as last inspection. 12/23/2013 Same as last inspection. 8/2/2013 Same as last inspection.
FIELD_STRUCT_DESC: [Highland Canal Diversion Weir and Drainage] 2 of 2: 54-inch corrugated metal drainage pipe through the levee, 11.5 feet below the crown. Highland Canal Diversion Weir and Drainage Structure on the landside (LS). Concrete headwall on both landside (LS) and waterside (WS) toe with flap gate on the WS toe. (two 42-inch pipes [HLM 6.05] authorized under Automatic Board Order (ABO) issued as Permit No. 11467, 1975 - Modglin). [Additional Reference(s): DWR Levee Log, 2005. USACE Sacramento O&M Manual 506.3, August 1961, (HLM 6.05)].

Concrete dam/weir and channel on LS toe.

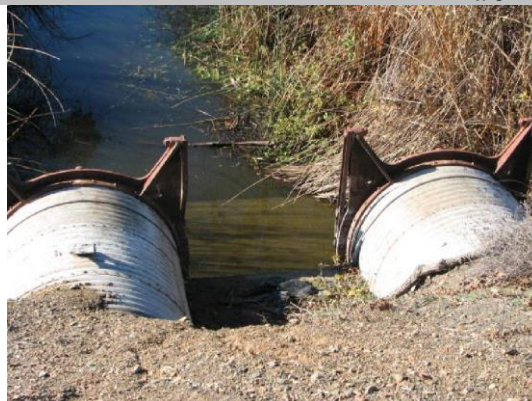
Photo 2 of 3 : UCIP_FA_2018_50822_46871.jpg

Pipe and flap gate on WS toe.

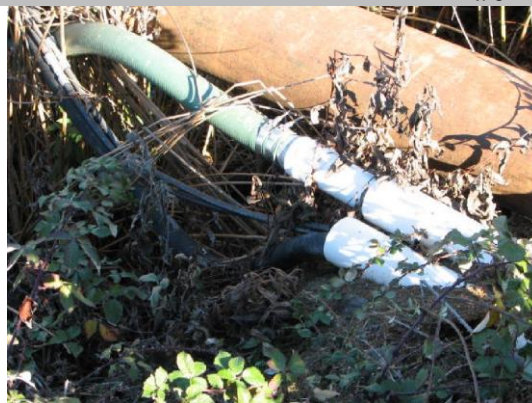
Photo 2 of 3 : UCIP_FA_2018_53323_46881.jpg

12-inch pipe and appurtenances on WS shoulder.

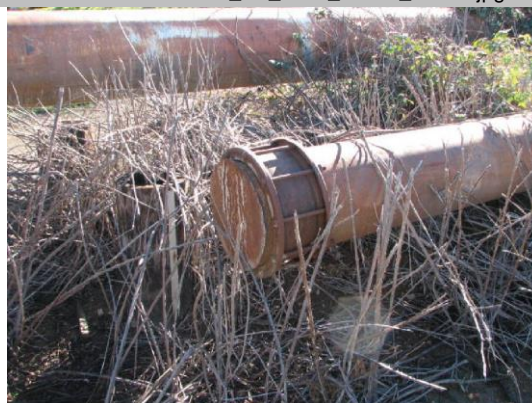
Photo 2 of 2 : UCIP_FA_2018_50827_46883.jpg

Steel plate welded over end of pipe at LS toe.

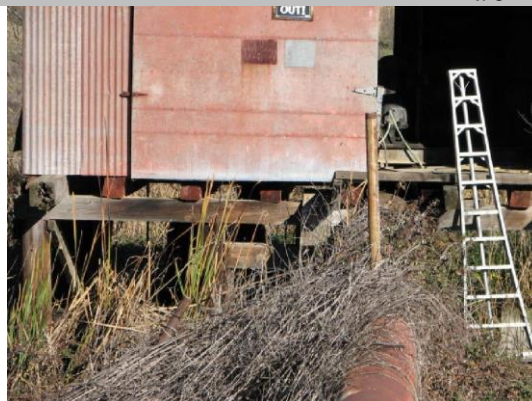
Photo 2 of 2 : UCIP_FA_2018_50828_46885.jpg

Air vent on pipe at LS pumphouse.
