**Flood Control Project Maintenance
Levee Inspections**

Maintenance Issue Types Only, Levee Inspection Report By Mile - Fall 2019

Sutter Maintenance Yard Maintenance Area 0017

Waterway	Bank	Unit Miles	Inspection Start/End	Inspector
Unit No. 01 Lake County Sutter Maintenance Yard - Middle Creek	Left	3.87	10/09/2019 10/09/2019	Luz Dial

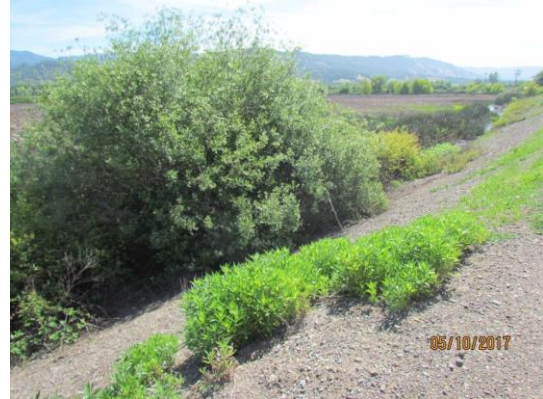
Photo 1 of 1 : FA_2019_MA0017_339_25_20190904_00007.jpg

LM Start	3.84	Rating **	M	Issue No.	25
LM End	3.84	Issue Type +	Ma	Location *	LS
Category	Earthen Levee			GPS Latitude/Longitude	
				Start	End
Item	Trim / Thin Trees			39.144695 °	39.144695 °
				-122.906668 °	-122.906668 °
DWR ID	DWR_MA0017_01_s_2017_25				
Comment Code					
T2 : Thin trees to allow visibility of the ground and room to flood fight.					
Inspector Comment					
Trim the trees along the landside toe.

View of the trees along the landside toe. Spring 2017

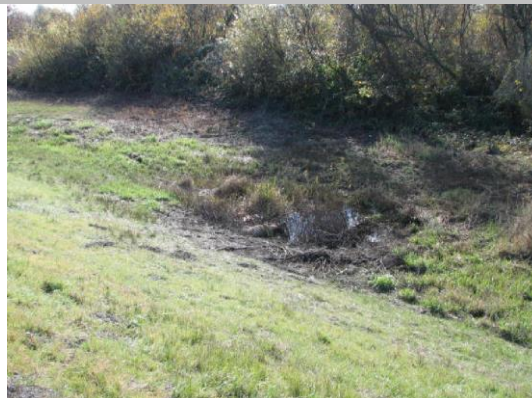
Photo 1 of 3 : UCIP_FA_2019_55641_46849.jpg

Comment Code					
Inspector Comment					
DS_ID:844 FS_ID:55641 EP_NO: 11463 Repair Type: Non-Urgent Crossing Status: Found UCIP Comments: 10/09/2019 The levee is maintained by DWR Sutter Yard. The State is currently working on purchasing adjacent land to eventually pursue the de-activation of this levee. Levee crown width through this section is about 12 feet. The UCIP inspection was completed with DWR Inspector, L. Dial, and DWR Sutter Yard Supervisor, B. Reniff. Crossing has been updated from No Action Needed to Non-Urgent; owner has changed [State owns structure]. (O. Magana - DWR UCIP)10/19/2016 Crossing appears to be in good condition. (DWR Sutter Yard- A Freitag)06/14/2016 crossing appears to be in good condition.04/23/2015 No issues with pipe.07/03/2014 Same as last inspection.12/23/2013 Same as last inspection.08/02/2013 New flap gate installed. No other issues with pipe. FIELD_STRUCT_DESC: 24-inch corrugated metal drainage pipe through the levee, 12.4 feet below the crown. Flap gate on the waterside (WS) end. Timber walkway on the landside (LS) slope to a timber walkway to pump house mounted on piles in drainage ditch. (24-inch pipe [HLM 3.99] authorized under Automatic Board Order (ABO) issued as Permit No. 11463, 1975 - Audrey Jones). [Additional Reference(s): DWR Levee Log, 2005. USACE Sacramento O&M Manual 506.2, August 1961, (HLM 3.99)]. FS Date: 10/9/2019 2:58:00 PM

24-inch CMP at outlet on WS toe.

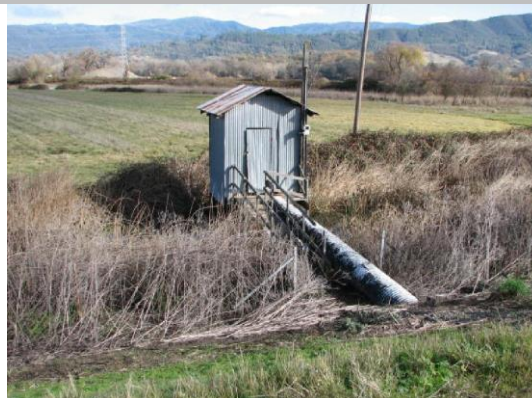
Photo 2 of 3 : UCIP_FA_2019_55641_46848.jpg

Pumphouse on piles at LS toe.

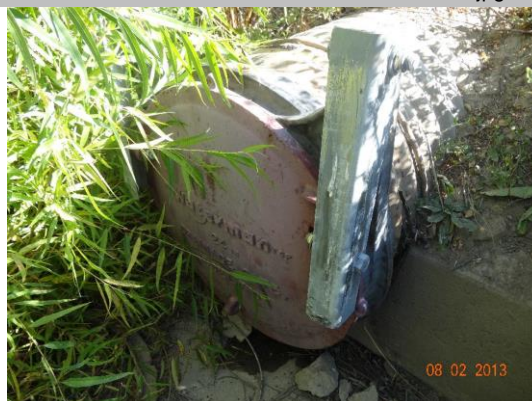
Photo 3 of 3 : UCIP_FA_2019_55641_46850.jpg

New flap gate on WS

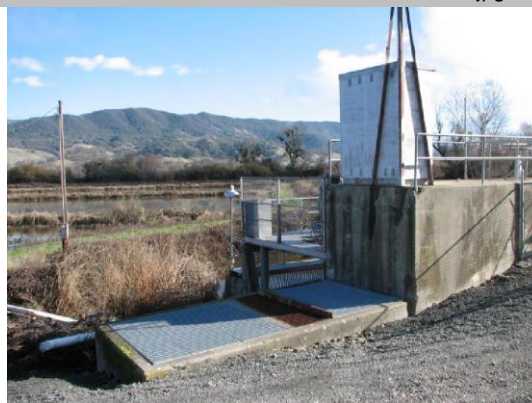
Photo 1 of 3 : UCIP_FA_2019_55642_46853.jpg

Pumping Plant on LS shoulder.

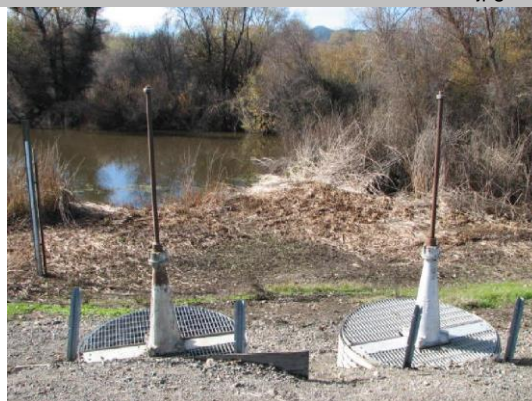
Photo 2 of 3 : UCIP_FA_2019_55642_46852.jpg

Slide gates in CMP risers on WS shoulder.

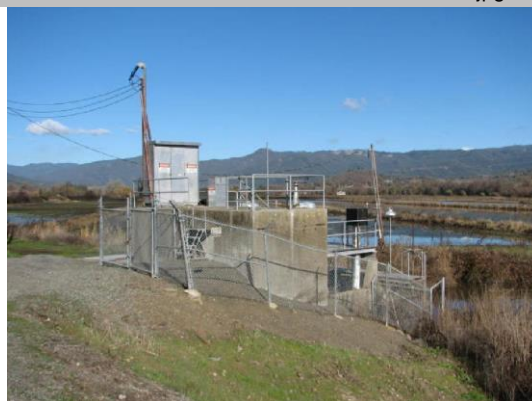
Photo 3 of 3 : UCIP_FA_2019_55642_46851.jpg

Pumping Plant on LS shoulder.

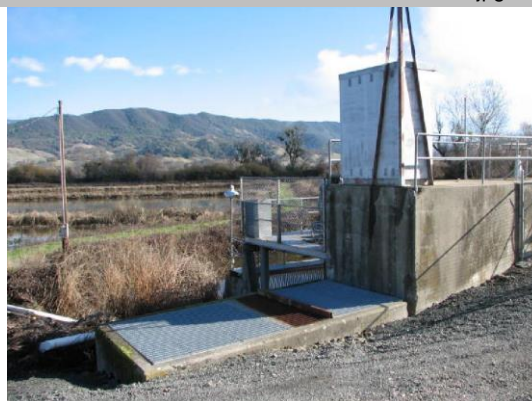
Photo 1 of 3 : UCIP_FA_2019_56066_46856.jpg

Pumping plant on LS shoulder.

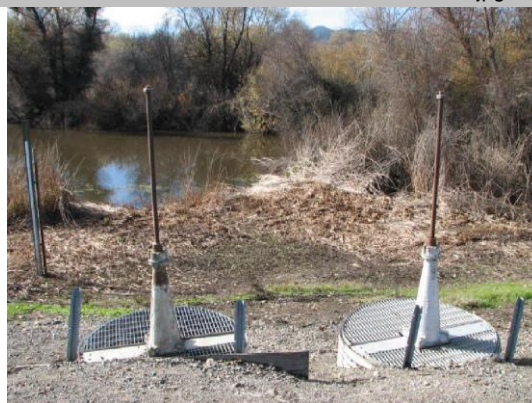
Photo 2 of 3 : UCIP_FA_2019_56066_46855.jpg

Slide gate in CMP riser on WS shoulder.

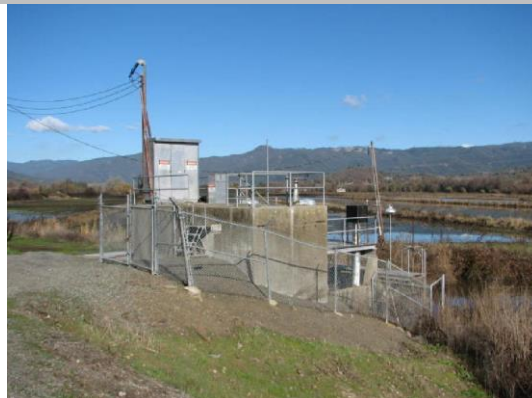
Photo 3 of 3 : UCIP_FA_2019_56066_46854.jpg

Pumping plant on LS shoulder.

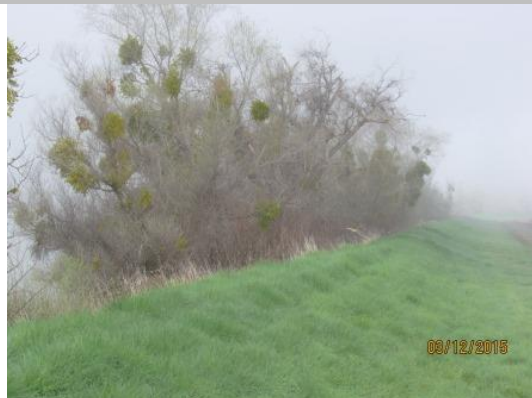
Photo 1 of 2 : FA_2019_MA0017_339_2_20190904_00001.jpg

View of the trees along the waterside slope and toe.

LM Start	4.16	Rating **	U	Issue No.	2 (cont)
LM End	7.10	Issue Type +	Ma	Location *	WS

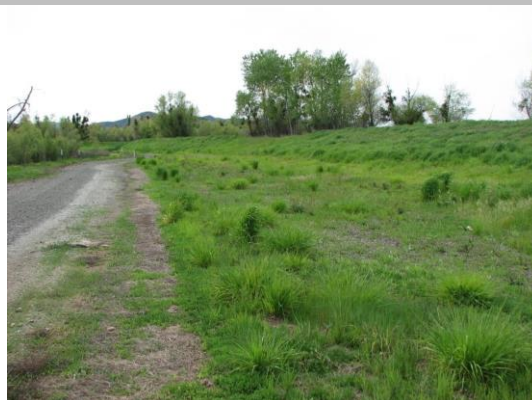
Photo 2 of 2 : FA_2019_MA0017_339_2_20190904_00002.jpg

Photo taken at LM 6.41 looking west showing overgrown LS slope of levee at right and toe road at left. Note trees obstructing visibility and access at levee crown. Crown is +/- 5 feet wide, and impassible to vehicles due to vegetation, and in some places, to pedestrians.
4/19/2016

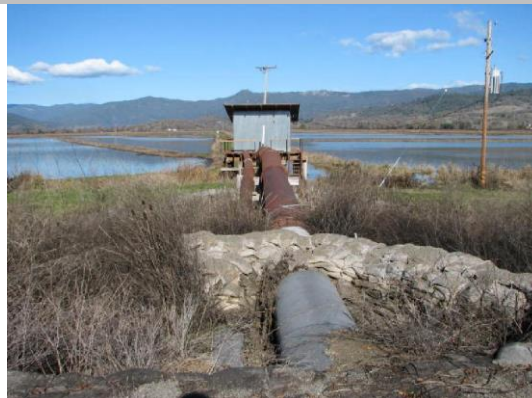
Photo 1 of 3 : UCIP_FA_2019_55648_46860.jpg

Pumping plant, pipes, and ring levees on LS toe.

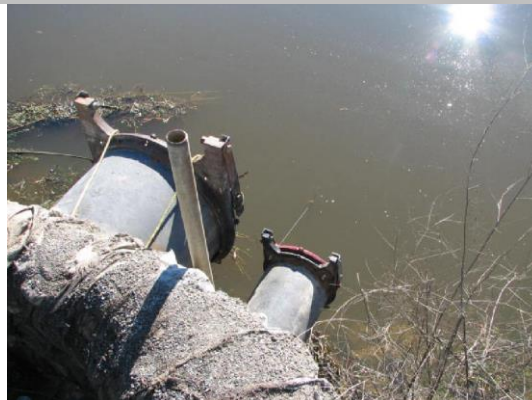
Photo 2 of 3 : UCIP_FA_2019_55648_46859.jpg

16-inch pipe, flap gate, air vent, and ring levee on WS slope.

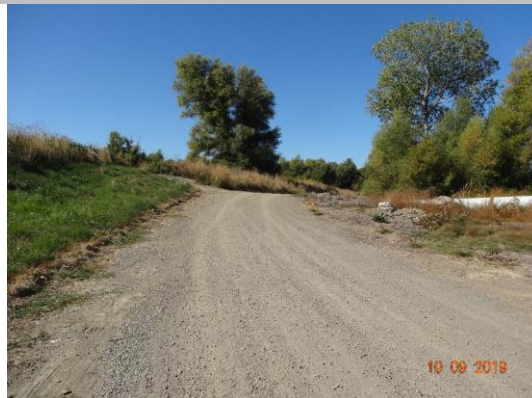
Photo 3 of 3 : UCIP_FA_2019_55648_82279.jpg

Overview of access road looking u/s towards pipe crossings.

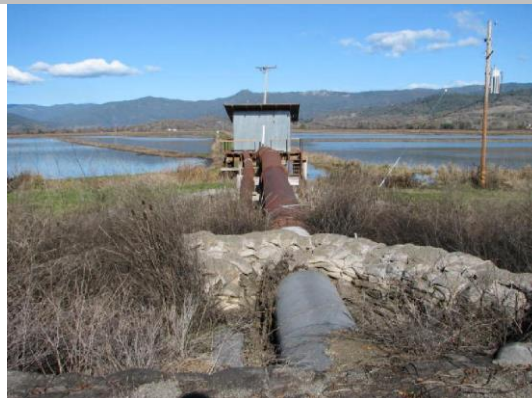
Photo 1 of 3 : UCIP_FA_2019_55649_46864.jpg

Pipes and pump house on LS toe with ring levees.

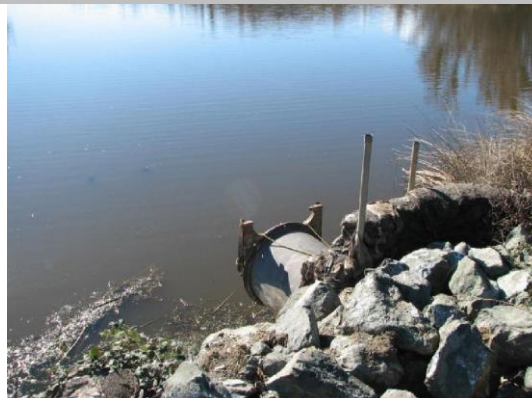
Photo 2 of 3 : UCIP_FA_2019_55649_46863.jpg

Pipe, flap gate, air vent, and sandbags on WS slope.

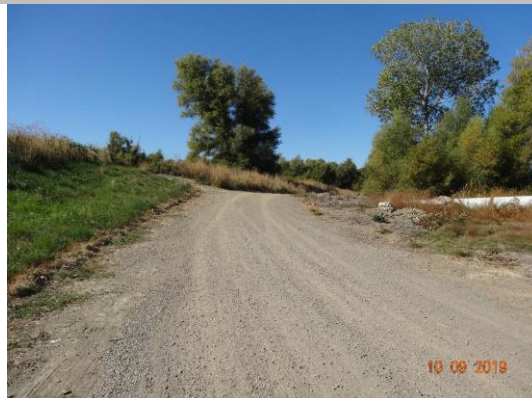
Photo 3 of 3 : UCIP_FA_2019_55649_82287.jpg

Overview of access road looking u/s towards pipe crossings.

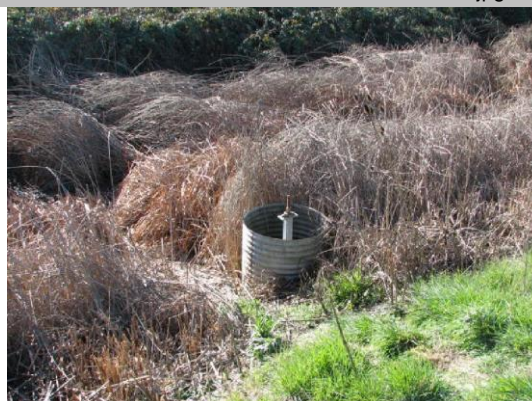
Photo 1 of 3 : UCIP_FA_2019_55650_46866.jpg

UCIP Comments: 10/09/2019 The levee is maintained by DWR Sutter Yard. The State is currently working on purchasing adjacent land to eventually pursue the de-activation of this levee. Levee crown width ranges from 3 to 4-feet. The UCIP inspection was completed with DWR Inspector, L. Dial, and DWR Sutter Yard Supervisor, B. Reniff. Crossing remains Non-Urgent; crossing has been abandoned, no riser lid or slide gate wheel are present. DWR DMP geophysical investigation found signals of potential metal pipe through this section of the levee. Owner will need coordinate with the CVFPB to remove or abandon crossing according to Title 23 requirements. (O. Magana - DWR UCIP)

36-inch CMP riser and slide gate on WS slope.

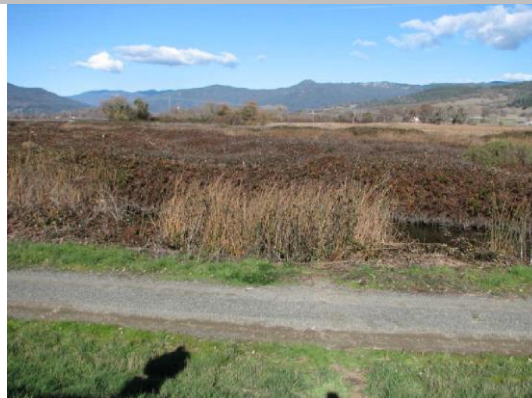
Photo 2 of 3 : UCIP_FA_2019_55650_46865.jpg

Approximate location of inlet on LS toe (not visible).

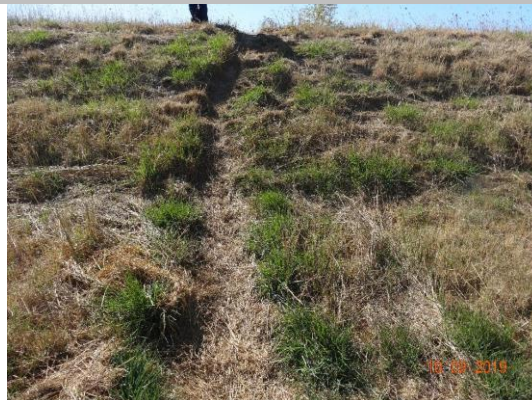
Photo 3 of 3 : UCIP_FA_2019_55650_82295.jpg

UCIP Comments: 10/09/2019 The levee is maintained by DWR Sutter Yard. The State is currently working on purchasing adjacent land to eventually pursue the de-activation of this levee. Levee crown width ranges from 3 to 4-feet. The UCIP inspection was completed with DWR Inspector, L. Dial, and DWR Sutter Yard Supervisor, B. Reniff. Crossing remains Non-Urgent; crossing has been abandoned, no riser lid or slide gate wheel are present. DWR DMP geophysical investigation found signals of potential metal pipe through this section of the levee. Owner will need coordinate with the CVFPB to remove or abandon crossing according to Title 23 requirements. (O. Magana - DWR UCIP)

LS view: overview of LS slope.

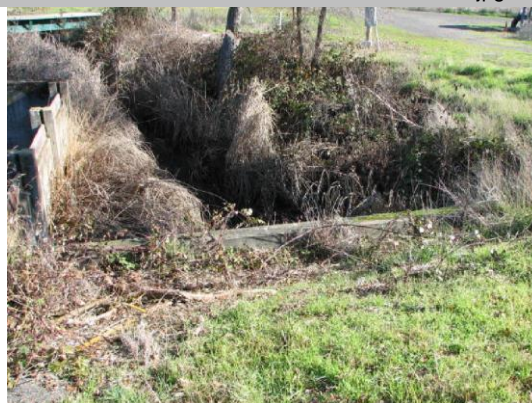
Photo 1 of 3 : UCIP_FA_2019_55651_46869.jpg

Concrete weir/dam and channel on LS toe.

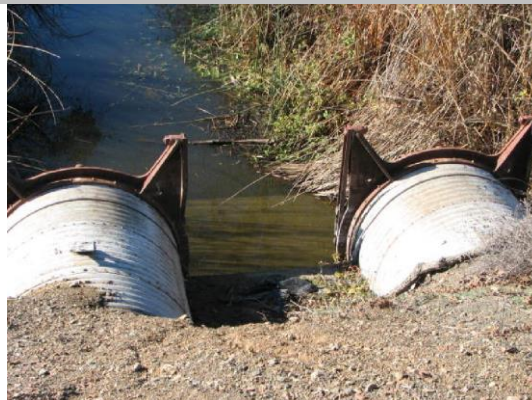
Photo 2 of 3 : UCIP_FA_2019_55651_46868.jpg

pipe and flap gate on WS toe.

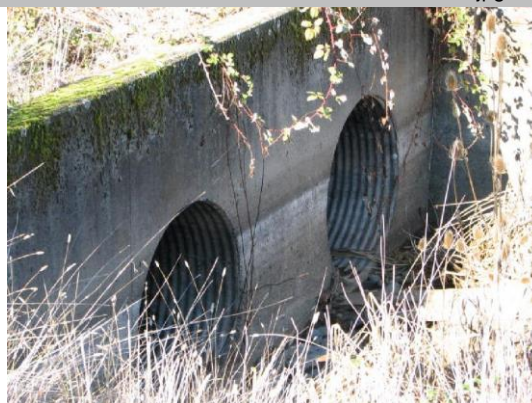
Photo 3 of 3 : UCIP_FA_2019_55651_46867.jpg

Concrete headwall at inlet on LS toe.

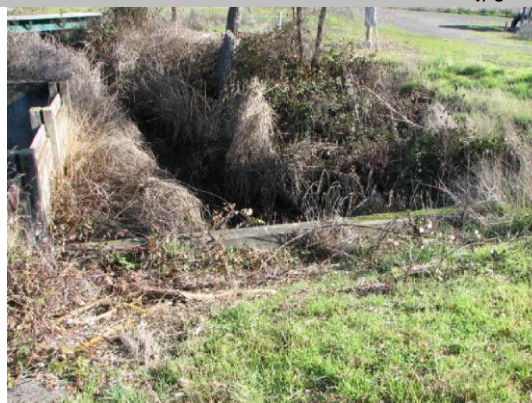
Photo 1 of 3 : UCIP_FA_2019_55773_46872.jpg

Concrete dam/weir and channel on LS toe.

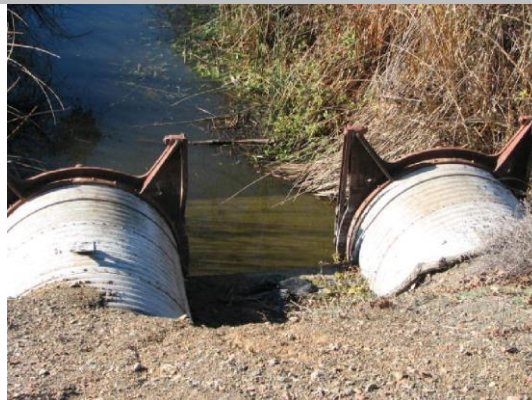
Photo 2 of 3 : UCIP_FA_2019_55773_46871.jpg

Pipe and flap gate on WS toe.

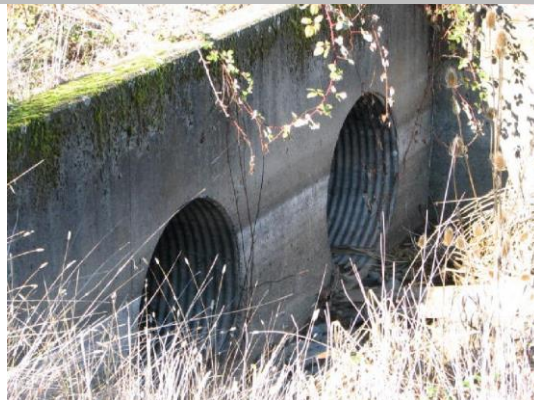
Photo 3 of 3 : UCIP_FA_2019_55773_46870.jpg

Concrete headwall on LS toe.

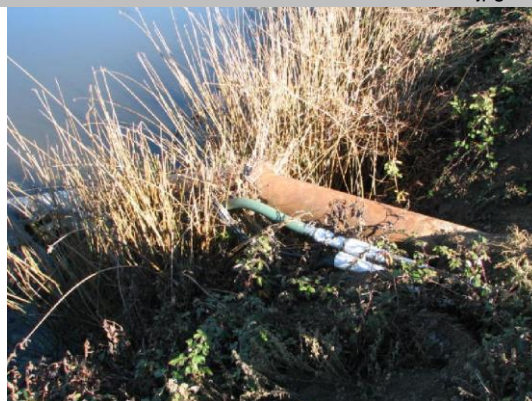
Photo 1 of 3 : UCIP_FA_2019_56065_46882.jpg

Comment Code					
Inspector Comment					
DS_ID:850 FS_ID:56065 EP_NO: 11467 Repair Type: Urgent Crossing Status: Found UCIP Comments: 10/09/2019 The levee is maintained by DWR Sutter Yard. The State is currently working on purchasing adjacent land to eventually pursue the de-activation of this levee. Levee crown width is more than 12 feet. The UCIP inspection was completed with DWR Inspector, L. Dial, and DWR Sutter Yard Supervisor, B. Reniff. Crossing remains Urgent; WS erosion is still present along WS slope. This crossing has been modified. It appears that this pipe is conveying water from WS to LS and LS to WS. Recommend auditing record to determine current owner. (O. Magana - DWR UCIP)09/06/2018 Same as last inspection; WS erosion is still present so the crossing remains Urgent (D. Sanoski - DWR UCIP).10/19/2016 WS erosion still present. (DWR Sutter Yard- AFreitag)06/14/2016 WS erosion is still present. (DWR Sutter Yard - afreitag)04/23/2015 Same as last inspection. (DWR Sutter Yard - afreitag)07/03/2014 Same as last inspection. (DWR Sutter Yard - afreitag)12/23/2013 Same as last inspection. (DWR Sutter Yard - afreitag)08/02/2013 Same as last inspection. (DWR Sutter Yard - afreitag)12/13/2012 The pipe and appurtenances do not match what was described in the permit (PN: 11467). Does not appear to be in compliance with board regulations. (DWR UCIP - wwylie) FIELD_STRUCT_DESC: 12-inch steel drainage pipe through the levee, 2 feet below the crown. Butterfly valve on the landside (LS) shoulder. Pump and electrical panel, along with multiple valves and appurtenances, on the LS shoulder. (12-inch pipe [HLM 6.11] authorized under Automatic Board Order (ABO) issued as Permit No. 11467, 1975 - B. F. Modglin). [Additional Reference(s): DWR Levee Log, 2005. USACE Sacramento O&M Manual 506.3, 1967, (HLM 6.11)]. FS Date: 10/9/2019 2:56:00 PM

12-inch pipe and appurtenances on WS shoulder.

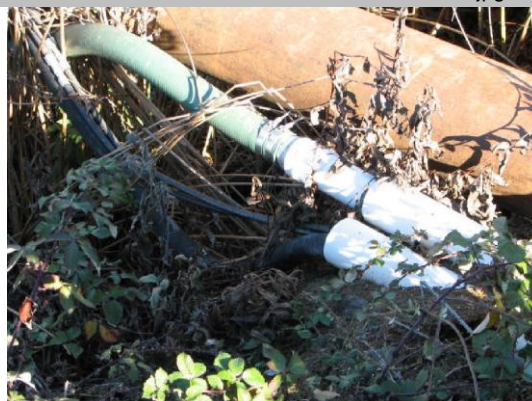
Photo 2 of 3 : UCIP_FA_2019_56065_46881.jpg

DS_ID:850
FS_ID:56065
EP_NO: 11467
Repair Type: Urgent
Crossing Status: Found
UCIP Comments: 10/09/2019 The levee is maintained by DWR Sutter Yard. The State is currently working on purchasing adjacent land to eventually pursue the de-activation of this levee. Levee crown width is more than 12 feet. The UCIP inspection was completed with DWR Inspector, L. Dial, and DWR Sutter Yard Supervisor, B. Reniff. Crossing remains Urgent; WS erosion is still present along WS slope. This crossing has been modified. It appears that this pipe is conveying water from WS to LS and LS to WS. Recommend auditing record to determine current owner. (O. Magana - DWR UCIP)09/06/2018 Same as last inspection; WS erosion is still present so the crossing remains Urgent (D. Sanoski - DWR UCIP).10/19/2016 WS erosion still present. (DWR Sutter Yard- AFreitag)06/14/2016 WS erosion is still present. (DWR Sutter Yard - afreitag)04/23/2015 Same as last inspection. (DWR Sutter Yard - afreitag)07/03/2014 Same as last inspection. (DWR Sutter Yard - afreitag)12/23/2013 Same as last inspection. (DWR Sutter Yard - afreitag)08/02/2013 Same as last inspection. (DWR Sutter Yard - afreitag)12/13/2012 The pipe and appurtenances do not match what was described in the permit (PN: 11467). Does not appear to be in compliance with board regulations. (DWR UCIP - wwylie)

12-inch pipe and appurtenances on WS shoulder.

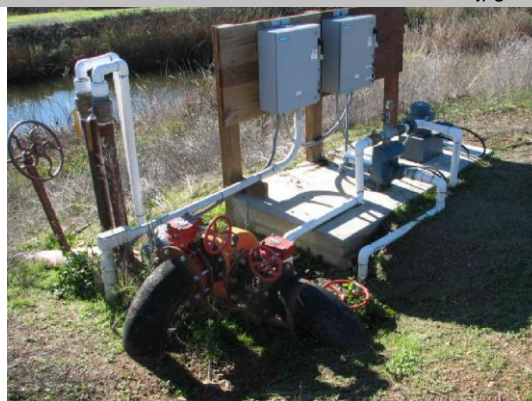
Photo 3 of 3 : UCIP_FA_2019_56065_46880.jpg

Pumping plant and appurtenances on LS shoulder.

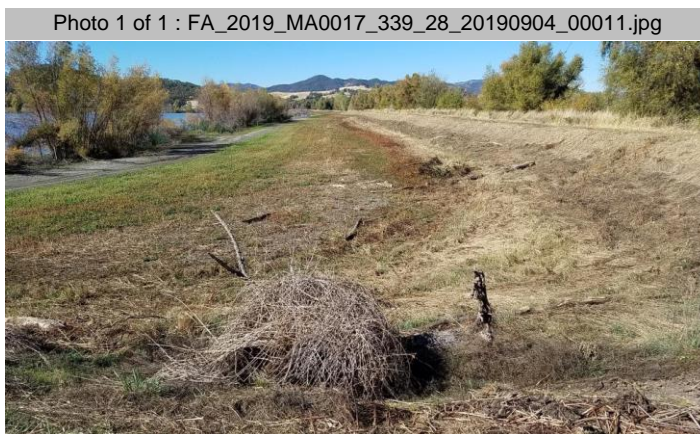
LM Start	6.12	Rating **	M	Issue No.	28
LM End	6.12	Issue Type +	Ma	Location *	LS
Category	Earthen Levee		GPS Latitude/Longitude		
			Start	End	
Item	Encroachments		39.126603°	39.126603°	
			-122.885331°	-122.885331°	
DWR ID	DWR_MA0017_01_f_2018_28				
Comment Code					
DE : Debris					
Inspector Comment					
Remove tree debris on the levee toe.

View of debris on the landside toe. Fall 2018

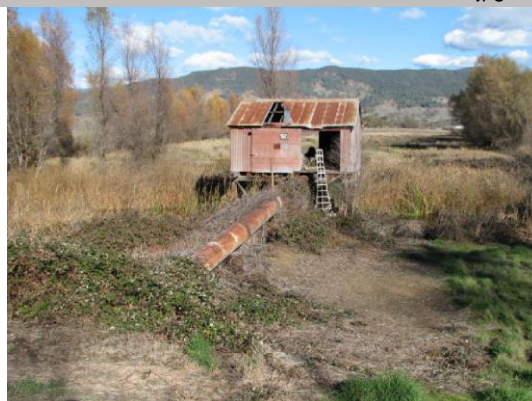
Photo 1 of 3 : UCIP_FA_2019_55658_46884.jpg

Pumping plant in shed on LS at drainage ditch.

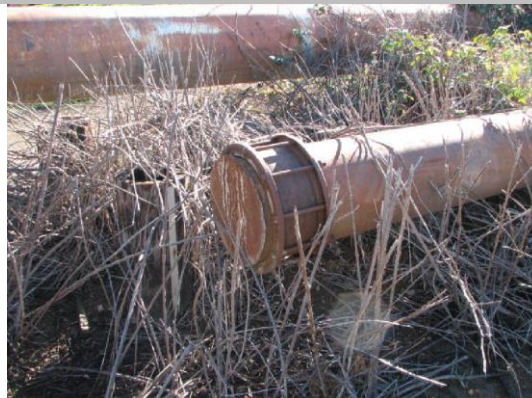
Photo 2 of 3 : UCIP_FA_2019_55658_46883.jpg

Steel plate welded over end of pipe at LS toe.

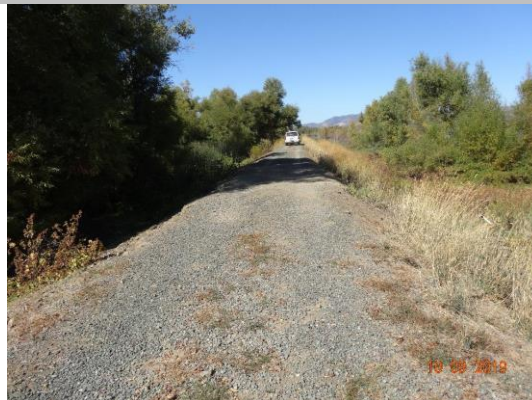
Photo 3 of 3 : UCIP_FA_2019_55658_82325.jpg

Overview of levee crown looking u/s towards pipe crossing.

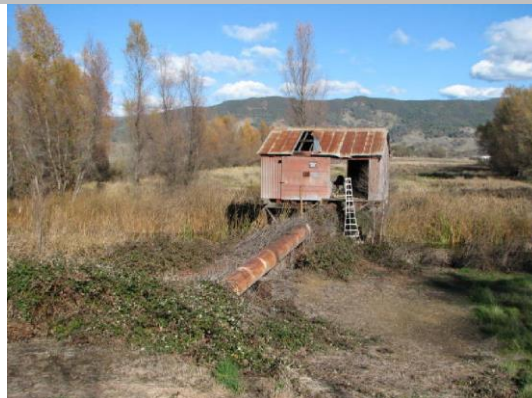
Photo 1 of 3 : UCIP_FA_2019_55660_46886.jpg

24-inch steel pipe and pump house on LS.

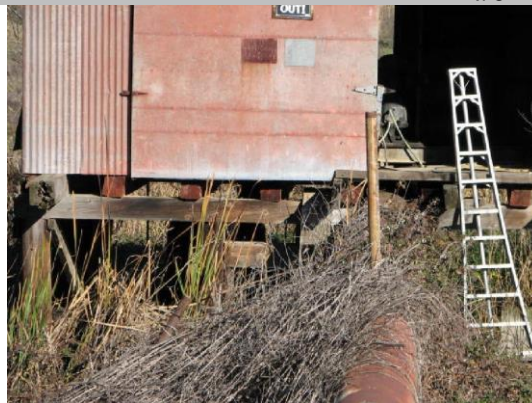
Photo 2 of 3 : UCIP_FA_2019_55660_46885.jpg

Air vent on pipe at LS pumphouse.

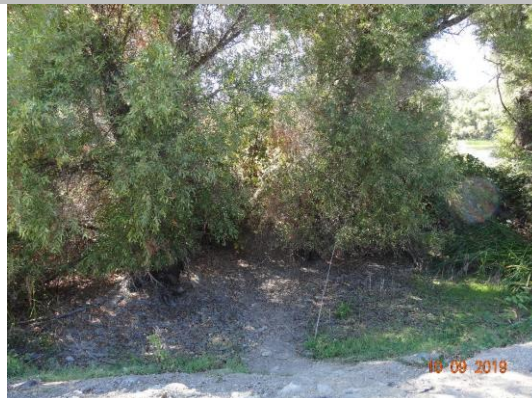
Photo 3 of 3 : UCIP_FA_2019_55660_82331.jpg

WS view: overview of WS.
