**Flood Control Project Maintenance
Levee Inspections**

Maintenance Issue Types Only, Levee Inspection Report By Mile - Fall 2020

Sutter Maintenance Yard Maintenance Area 0017

Waterway	Bank	Unit Miles	Inspection Start/End	Inspector
Unit No. 01 Lake County Sutter Maintenance Yard - Middle Creek	Left	3.87	10/07/2020 10/07/2020	Luz Dial

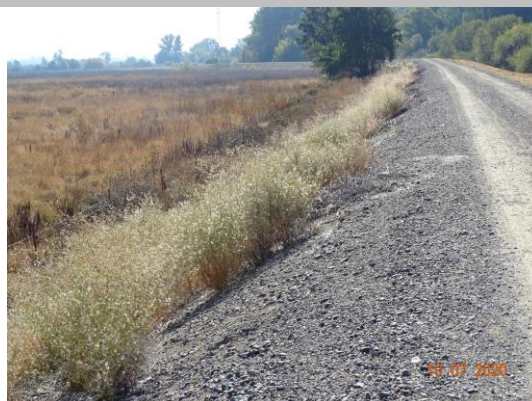
Photo 1 of 1 : FA_2020_MA0017_339_16_20201012_00051.jpg

LM Start	3.41	Rating **	M	Issue No.	16
LM End	4.04	Issue Type +	Ma	Location *	LS
Category	Earthen Levee			GPS Latitude/Longitude	
				Start	End
Item	Vegetation			39.148967 °	39.143520 °
				-122.912208 °	-122.903363 °
DWR ID	DWR_MA0017_01_s_2016_16				
Comment Code					
V2 : Remove the wild growth other than native grasses from the levee slopes.					
Inspector Comment					
Large bushes and brambles growing on wire fence on LS toe and slope limit visibility and access. Trim grass and weeds.

View of wild growth on the landside slope. Fall 2020

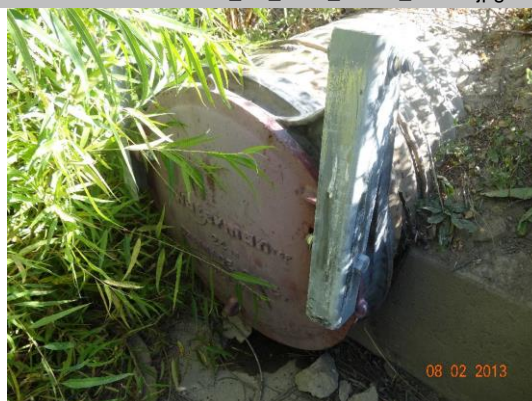
Photo 3 of 3 : UCIP_FA_2020_58627_46850.jpg

New flap gate on WS

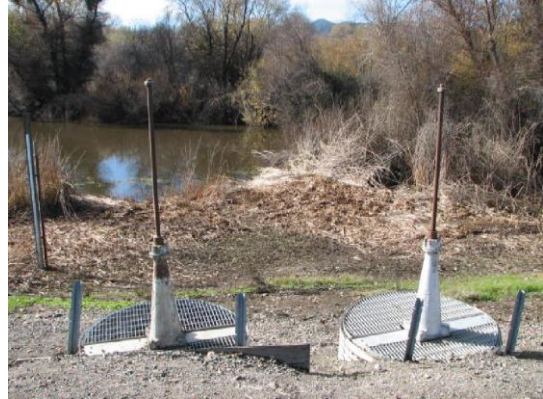
Photo 2 of 3 : UCIP_FA_2020_58626_46852.jpg

Slide gates in CMP risers on WS shoulder.

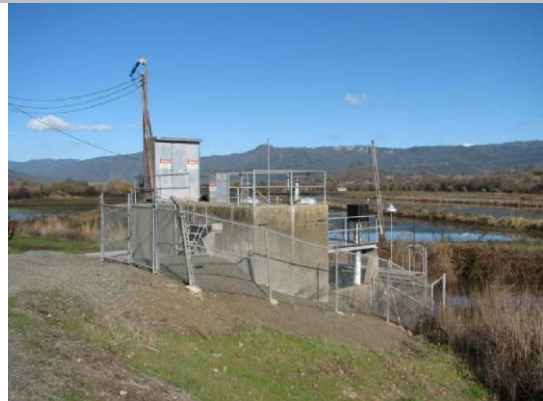
Photo 3 of 3 : UCIP_FA_2020_58626_46851.jpg

Pumping Plant on LS shoulder.

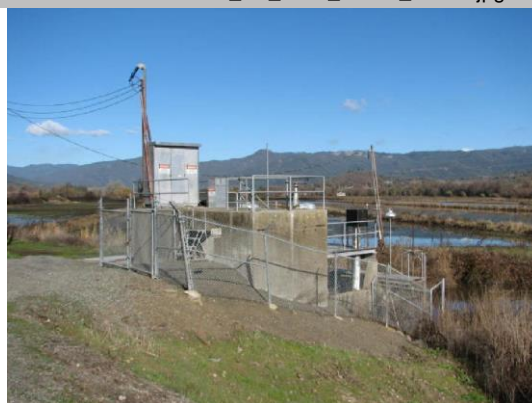
Photo 3 of 3 : UCIP_FA_2020_58625_46854.jpg

Pumping plant on LS shoulder.

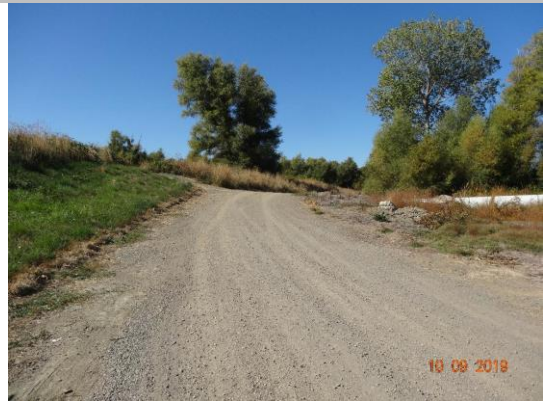
Photo 3 of 3 : UCIP_FA_2020_58629_82279.jpg

Overview of access road looking u/s towards pipe crossings.

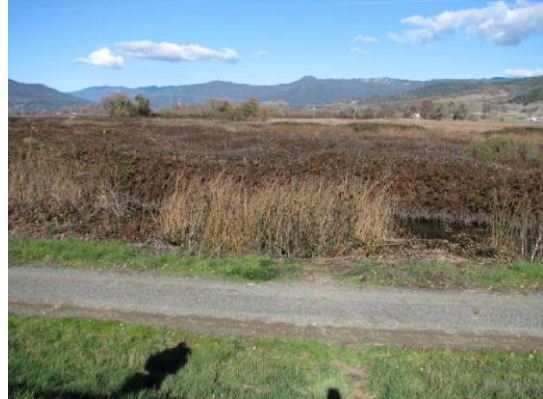
Photo 2 of 3 : UCIP_FA_2020_58631_46865.jpg

Approximate location of inlet on LS toe (not visible).

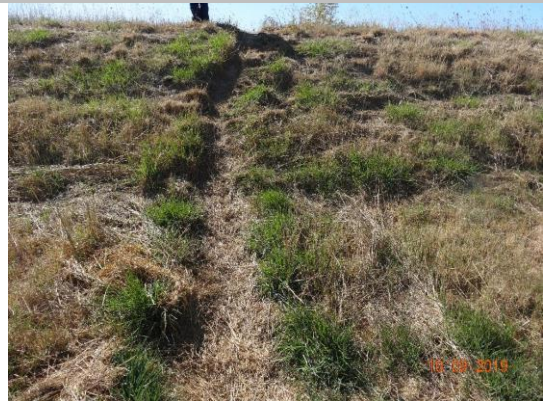
Photo 3 of 3 : UCIP_FA_2020_58631_82295.jpg

LS view: overview of LS slope.

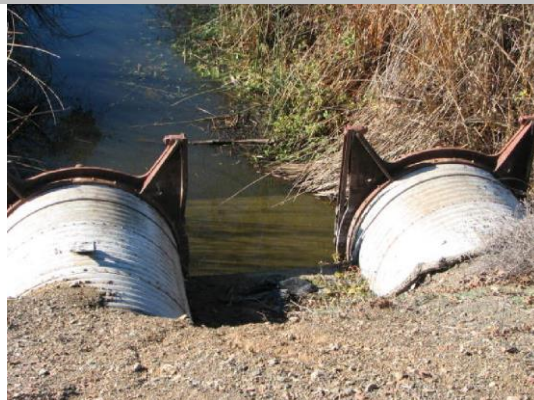
Photo 2 of 3 : UCIP_FA_2020_58608_46871.jpg

Pipe and flap gate on WS toe.

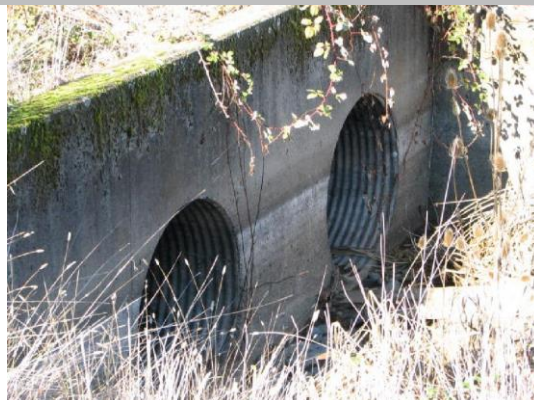
Photo 3 of 3 : UCIP_FA_2020_58608_46870.jpg

Concrete headwall on LS toe.

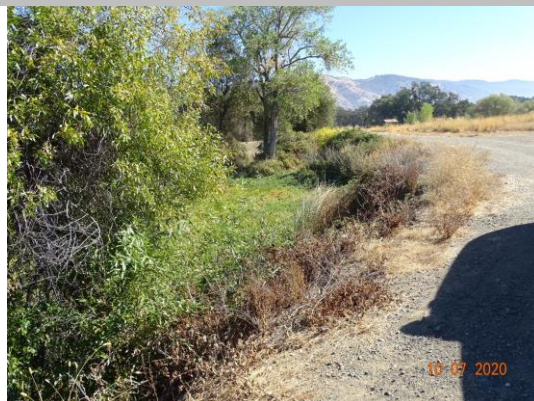
Photo 1 of 1 : FA_2020_MA0017_339_36_20201012_00052.jpg

LM Start	5.99	Rating **	M	Issue No.	36
LM End	6.06	Issue Type +	Ma	Location *	WS
Category	Earthen Levee			GPS Latitude/Longitude	
				Start	End
Item	Vegetation			39.126080 °	39.126210 °
				-122.883090 °	-122.884348 °
DWR ID	DWR_MA0017_01_s_2019_36				
Comment Code					
V2 : Remove the wild growth other than native grasses from the levee slopes.					
Inspector Comment

View of wild growth on the waterside slope. Fall 2020

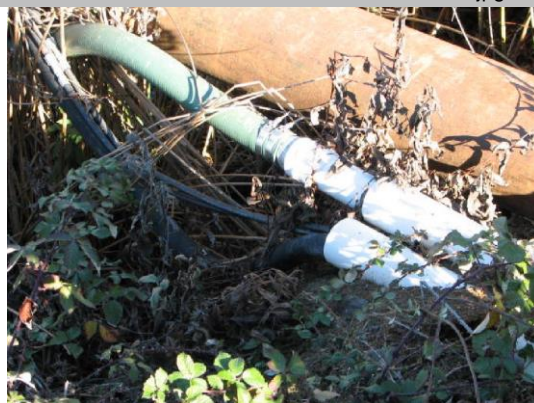
Photo 2 of 3 : UCIP_FA_2020_58637_46881.jpg

12-inch pipe and appurtenances on WS shoulder.

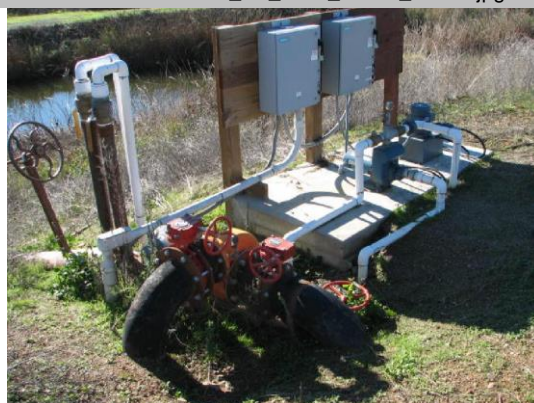
Photo 3 of 3 : UCIP_FA_2020_58637_46880.jpg

Pumping plant and appurtenances on LS shoulder.

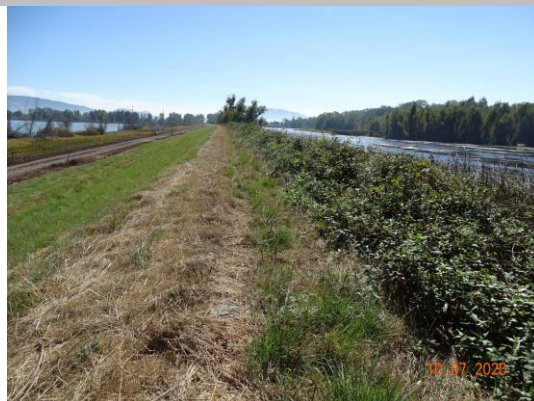
Photo 1 of 1 : FA_2020_MA0017_339_33_20201012_00055.jpg

LM Start	6.62	Rating **	M	Issue No.	33
LM End	7.28	Issue Type +	Ma	Location *	WS
Category	Earthen Levee			GPS Latitude/Longitude	
				Start	End
Item	Vegetation			39.125915 °	39.118732 °
				-122.892965 °	-122.884927 °
DWR ID	DWR_MA0017_01_f_2019_33				
Comment Code					
V2 : Remove the wild growth other than native grasses from the levee slopes.					
Inspector Comment					
Remove wild berry bushes on the waterside slope.

View of wild berry bushes on the waterside slope. Fall 2020

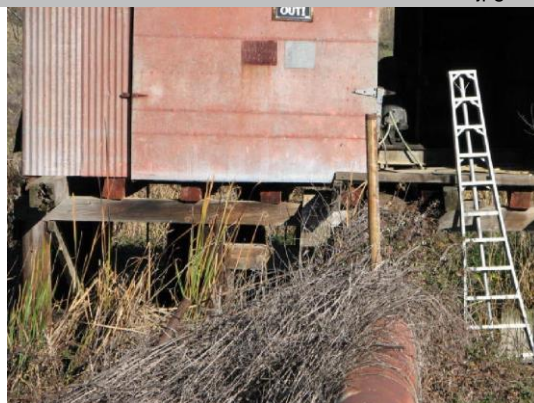
Photo 2 of 3 : UCIP_FA_2020_58639_46885.jpg

Air vent on pipe at LS pumphouse.

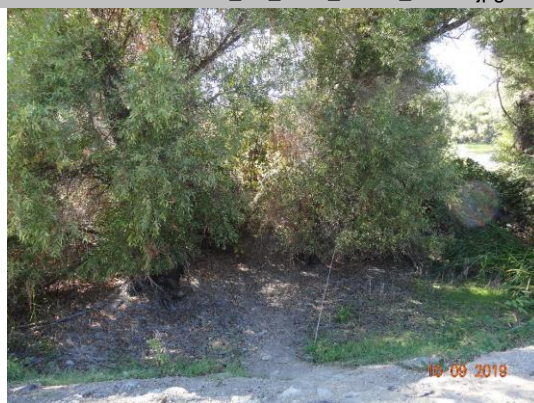
Photo 3 of 3 : UCIP_FA_2020_58639_82331.jpg

WS view: overview of WS.
