**Flood Control Project Maintenance
Levee Inspections**

Maintenance Issue Types Only, Levee Inspection Report By Mile - Fall 2021

Sutter Maintenance Yard Maintenance Area 0017

Waterway	Bank	Unit Miles	Inspection Start/End	Inspector
Unit No. 01 Lake County Sutter Maintenance Yard - Middle Creek	Left	3.87	10/28/2021 10/28/2021	Marvin Marshall

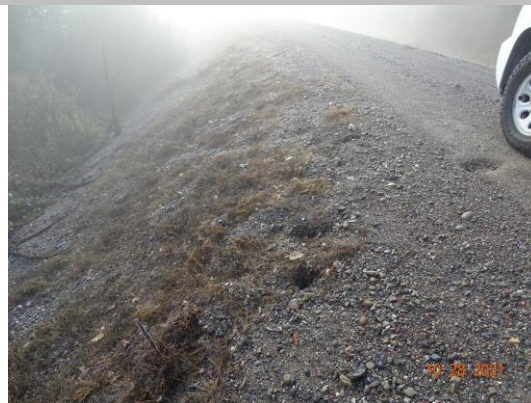
Photo 1 of 1 : FA_2021_MA0017_339_21_20211028_00049.jpg

LM Start	3.82	Rating **	M	Issue No.	21
LM End	3.82	Issue Type +	Ma	Location *	LS
Category	Earthen Levee			GPS Latitude/Longitude	
				Start	End
Item	Animal Control			39.144796 °	39.144796 °
				-122.906831 °	-122.906831 °
DWR ID	DWR_MA0017_01_f_2021_21				
Comment Code					
A3 : No rodents visible, but rodent burrows visible; need to backfill and compact or grout burrows.					
Inspector Comment					
Fill and compact burrows on the LS crown/slope.

Burrows on the LS slope and crown. Fall 2021

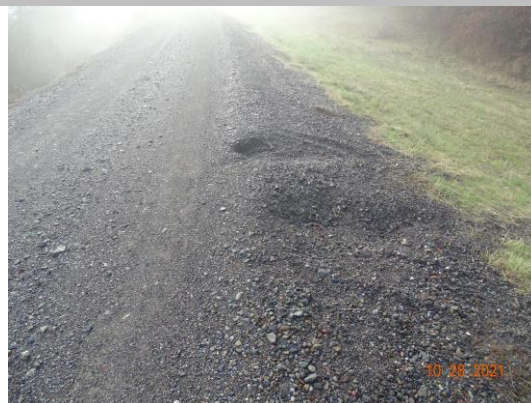
Photo 1 of 1 : FA_2021_MA0017_339_24_20211028_00050.jpg

LM Start	3.83	Rating **	M	Issue No.	24
LM End	3.83	Issue Type +	Ma	Location *	WS
Category	Earthen Levee			GPS Latitude/Longitude	
				Start	End
Item	Slope Stability			39.144748 °	39.144748 °
				-122.906759 °	-122.906759 °
DWR ID	DWR_MA0017_01_f_2021_24				
Comment Code					
S3 : Repair the levee slope damaged by vehicle traffic and prevent access where possible.					
Inspector Comment					
Repair rutting on WS crown/slope

Rutting on the WS crown/slope. Fall 2021

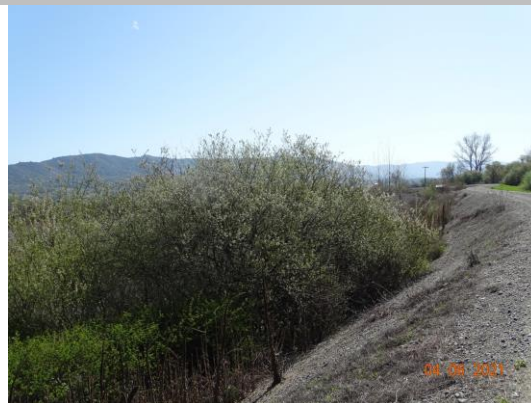
Photo 1 of 1 : FA_2021_MA0017_339_25_20210823_00004.jpg

LM Start	3.84	Rating **	M	Issue No.	25
LM End	3.84	Issue Type +	Ma	Location *	LS
Category	Earthen Levee			GPS Latitude/Longitude	
				Start	End
Item	Trim / Thin Trees			39.144695 °	39.144695 °
				-122.906668 °	-122.906668 °
DWR ID	DWR_MA0017_01_s_2017_25				
Comment Code					
T2 : Thin trees to allow visibility of the ground and room to flood fight.					
Inspector Comment					
Trim the trees along the landside toe.

View of the trees along the LS levee toe. Spring 2021.

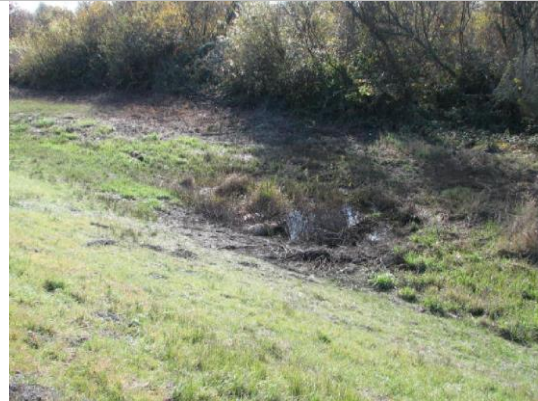
Photo 1 of 3 : UCIP_FA_2021_58627_46849.jpg

LM Start	3.95	Rating **	M	Issue No.	37	
LM End	3.95	Issue Type +	Ma	Location *		
Category	Supplemental			GPS Latitude/Longitude		
				Start	End	
Item	DWR UCIP LMA Responsibility			39.143792 °	39.143792 °	
				-122.904798 °	-122.904798 °	
DWR ID	844

Comment Code						
Inspector Comment						
DS_ID:844 FS_ID:58627 EP_NO: 11463 Repair Type: Non-Urgent EVAL Issue: Unauthorized Encroachment, installed decades prior Crossing Status: Found UCIP Comments: 10/09/2019 The levee is maintained by DWR Sutter Yard. The State is currently working on purchasing adjacent land to eventually pursue the de-activation of this levee. Levee crown width through this section is about 12 feet. The UCIP inspection was completed with DWR Inspector, L. Dial, and DWR Sutter Yard Supervisor, B. Reniff. Crossing has been updated from No Action Needed to Non-Urgent; owner has changed [State owns structure]. (O. Magana - DWR UCIP)10/19/2016 Crossing appears to be in good condition. (A. Freitag - DWR Sutter Yard)06/14/2016 crossing appears to be in good condition. (A. Freitag - DWR Sutter Yard)04/23/2015 No issues with pipe. (A. Freitag - DWR Sutter Yard)07/03/2014 Same as last inspection. (A. Freitag - DWR Sutter Yard)12/23/2013 Same as last inspection. (A. Freitag - DWR Sutter Yard)08/02/2013 New flap gate installed. No other issues with pipe. (A. Freitag - DWR Sutter Yard)12/13/2012 Flap gate broken in half and inoperable. (W. Wylie - DWR UCIP) FIELD_STRUCT_DESC: 24-inch corrugated metal drainage pipe through the levee, 12.4 feet below the crown. Flap gate on the waterside (WS) end. Timber walkway on the landside (LS) slope to a timber walkway to pump house mounted on piles in drainage ditch. (24-inch pipe [HLM 3.99] authorized under Automatic Board Order (ABO) issued as Permit No. 11463, 1975 - Audrey Jones). [Additional Reference(s): DWR Levee Log, 2005 (HLM 3.99). USACE Sacramento O&M Manual, Unit 506 Part 2 (SAC506.2), August 1961, Revised 25 May 2011, (HLM 3.99), listed as 24-inch CMP]. FS Date: 10/9/2019 2:58:00 PM

24-inch CMP at outlet on WS toe.

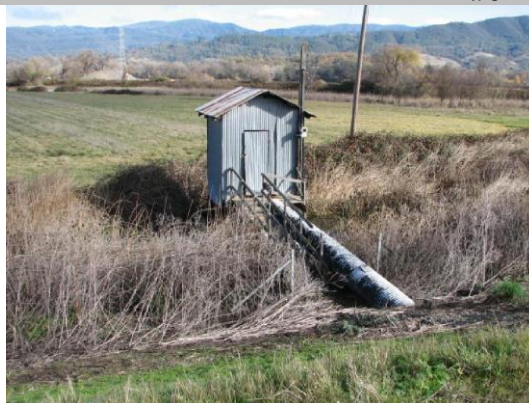
Photo 2 of 3 : UCIP_FA_2021_58627_46848.jpg

Pumphouse on piles at LS toe.

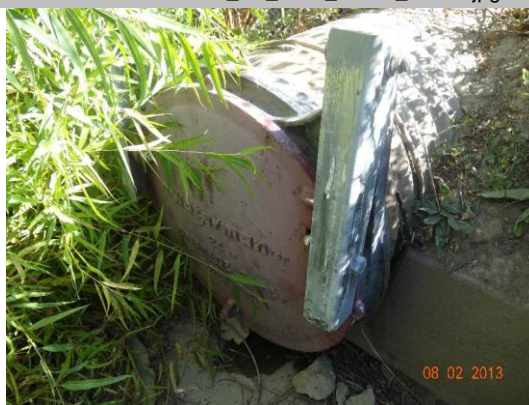
Photo 3 of 3 : UCIP_FA_2021_58627_46850.jpg

New flap gate on WS

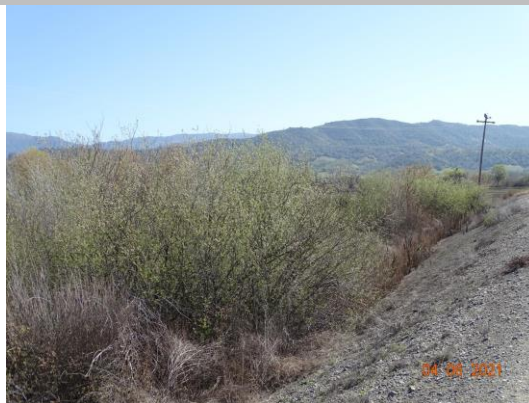
Photo 1 of 1 : FA_2021_MA0017_339_22_20210823_00002.jpg

LM Start	3.99	Rating **	M	Issue No.	22
LM End	3.99	Issue Type +	Ma	Location *	LS
Category	Earthen Levee			GPS Latitude/Longitude	
				Start	End
Item	Trim / Thin Trees			39.143634 °	39.143634 °
				-122.904215 °	-122.904215 °
DWR ID	DWR_MA0017_01_s_2021_22				
Comment Code					
T2 : Thin trees to allow visibility of the ground and room to flood fight.					
Inspector Comment

View of the trees along the LS levee toe. Spring 2021.

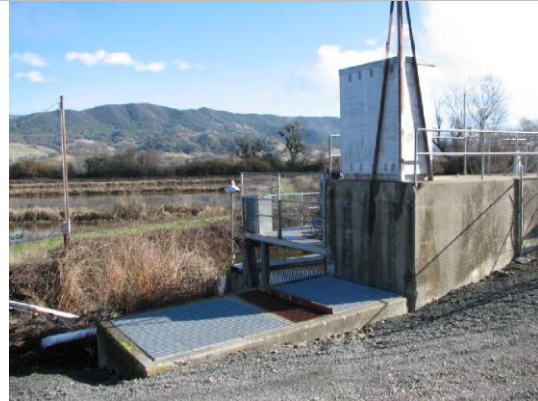
Photo 1 of 3 : UCIP_FA_2021_58626_46853.jpg

LM Start	4.13	Rating **	M	Issue No.	38	
LM End	4.13	Issue Type +	Ma	Location *		
Category	Supplemental			GPS Latitude/Longitude		
				Start	End	
Item	DWR UCIP LMA Responsibility			39.142287 °	39.142287 °	
				-122.902436 °	-122.902436 °	
DWR ID	845

Comment Code						
Inspector Comment						
DS_ID:845 FS_ID:58626 EP_NO: 11464 Repair Type: Non-Urgent EVAL Issue: Unauthorized Encroachment, installed decades prior Crossing Status: Found UCIP Comments: 10/09/2019 The levee is maintained by DWR Sutter Yard. The State is currently working on purchasing adjacent land to eventually pursue the de-activation of this levee. Levee crown width through this section is about 12 feet. The UCIP inspection was completed with DWR Inspector, L. Dial, and DWR Sutter Yard Supervisor, B. Reniff. Crossing has been updated from No Action Needed to Non-Urgent; owner has changed [State maintains structure]. (O. Magana - DWR UCIP)10/27/2017 This structure is inspected annually under the Structure and Channel Summer Inspection (part of the Levee Inspection Program) conducted by the DWR Flood Project Integrity and Inspection Branch (FPIIB). (O. Magana - DWR UCIP) 10/19/2016 Crossing appears to be in good condition. (A. Freitag - DWR Sutter Yard)06/14/2016 crossing appears to be in good condition. (A. Freitag - DWR Sutter Yard)04/23/2015 No issues with pipe. (A. Freitag - DWR Sutter Yard)07/03/2014 Same as last inspection. (A. Freitag - DWR Sutter Yard)12/23/2013 Same as last inspection. (A. Freitag - DWR Sutter Yard)08/02/2013 Same as last inspection. (A. Freitag - DWR Sutter Yard) FIELD_STRUCT_DESC: [Bloody Island Pumping Plant] 1 of 2: 42-inch corrugated metal drainage pipe through the levee, 20.2 feet below the crown. Concrete headwall and discharge apron on the waterside (WS) shoulder. Three vertical pump units mounted on a reinforced concrete pump platform in drainage ditch at the landside (LS) toe. Flap gates in concrete discharge well on the LS. Combination flap and slide gate on a gravity pipe from drainage ditch into discharge well. (two 42-inch pipes [HLM 4.18] authorized under Automatic Board Order (ABO) issued as Permit No. 11464, 1975 - Lake County). [Additional Reference(s): DWR Levee Log, 2005 (HLM 4.17). USACE Sacramento O&M Manual, Unit 506, Part 1 (SAC506.1) April 1961, and Part 2 (SAC506.2) August 1961, Revised 25 May 2011, (HLM 4.18), two 42-inch CMP -- referred to as Bloody Island Pumping Plant]. FS Date: 10/9/2019 2:59:00 PM

Pumping Plant on LS shoulder.

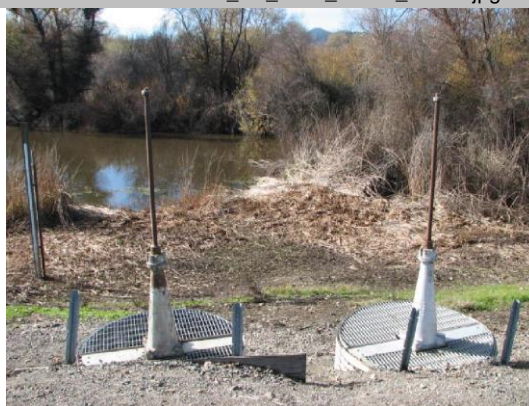
Photo 2 of 3 : UCIP_FA_2021_58626_46852.jpg

Slide gates in CMP risers on WS shoulder.

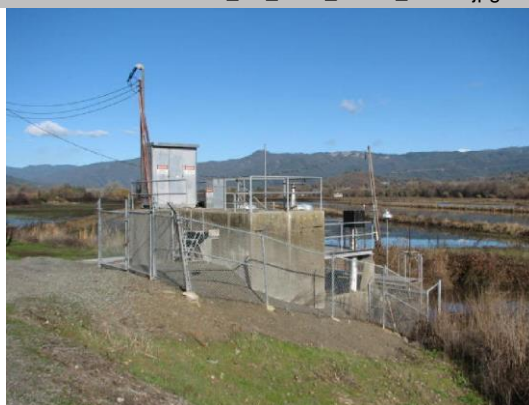
Photo 3 of 3 : UCIP_FA_2021_58626_46851.jpg

Pumping Plant on LS shoulder.

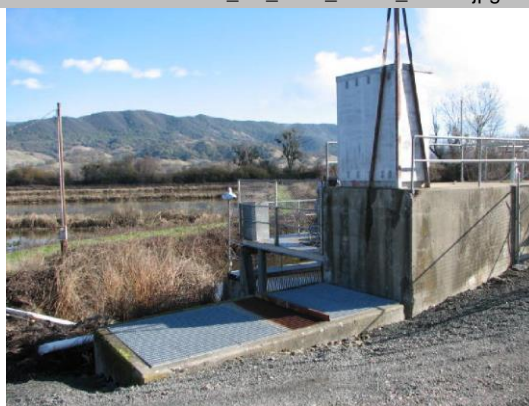
Photo 1 of 3 : UCIP_FA_2021_58625_46856.jpg

LM Start	4.14	Rating **	M	Issue No.	39
LM End	4.14	Issue Type +	Ma	Location *	
Category	Supplemental			GPS Latitude/Longitude	
				Start	End
Item	DWR UCIP LMA Responsibility			39.142262 °	39.142262 °
				-122.902423 °	-122.902423 °
DWR ID	852

Comment Code					
Inspector Comment					
DS_ID:852 FS_ID:58625 EP_NO: 11464 Repair Type: Non-Urgent EVAL Issue: Unauthorized Encroachment, installed decades prior Crossing Status: Found UCIP Comments: 10/09/2019 The levee is maintained by DWR Sutter Yard. The State is currently working on purchasing adjacent land to eventually pursue the de-activation of this levee. Levee crown width through this section is about 12 feet. The UCIP inspection was completed with DWR Inspector, L. Dial, and DWR Sutter Yard Supervisor, B. Reniff. Crossing has been updated from No Action Needed to Non-Urgent; owner has changed [State maintains structure]. (O. Magana - DWR UCIP)10/27/2017 This structure is inspected annually under the Structure and Channel Summer Inspection (part of the Levee Inspection Program) conducted by the DWR Flood Project Integrity and Inspection Branch (FPIIB). (O. Magana - DWR UCIP) 10/19/2016 Crossing appears to be in good condition. (A. Freitag - DWR Sutter Yard)06/14/2016 Crossing appears to be in good condition. (A. Freitag - DWR Sutter Yard)04/23/2015 No issues with pipe. (A. Freitag - DWR Sutter Yard)07/03/2014 Same as last inspection. (A. Freitag - DWR Sutter Yard)12/23/2013 Same as last inspection. (A. Freitag - DWR Sutter Yard)08/02/2013 Same as last inspection. (A. Freitag - DWR Sutter Yard) FIELD_STRUCT_DESC: [Bloody Island Pumping Plant] 2 of 2: 42-inch corrugated metal drainage pipe through the levee, 14.6 feet below the crown. Concrete headwall and discharge apron on the waterside (WS) shoulder. Three vertical pump units mounted on a reinforced concrete pump platform in drainage ditch at the landside (LS) toe. Flap gates in concrete discharge well on the LS. Combination flap and slide gate on a gravity pipe from drainage ditch into discharge well. (two 42-inch pipes [HLM 4.18] authorized under Automatic Board Order (ABO) issued as Permit No. 11464, 1975 - Lake County). [Additional Reference(s): DWR Levee Log, 2005 (HLM 4.17). USACE Sacramento O&M Manual, Unit 506, Part 1 (SAC506.1) April 1961, and Part 2 (SAC506.2) August 1961, Revised 25 May 2011, (HLM 4.18), two 42-inch CMP -- referred to as Bloody Island Pumping Plant]. FS Date: 10/9/2019 3:00:00 PM

Pumping plant on LS shoulder.

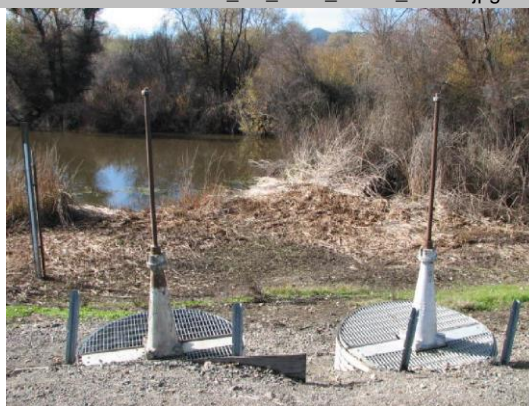
Photo 2 of 3 : UCIP_FA_2021_58625_46855.jpg

Slide gate in CMP riser on WS shoulder.

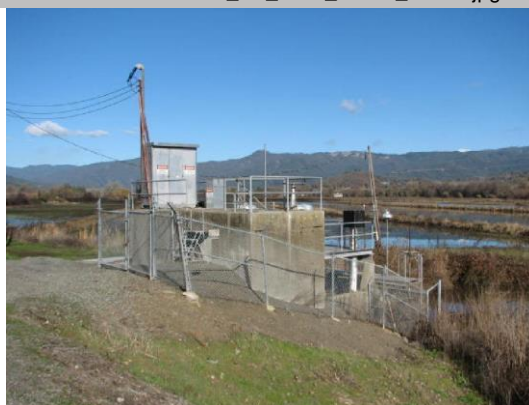
Photo 3 of 3 : UCIP_FA_2021_58625_46854.jpg

Pumping plant on LS shoulder.

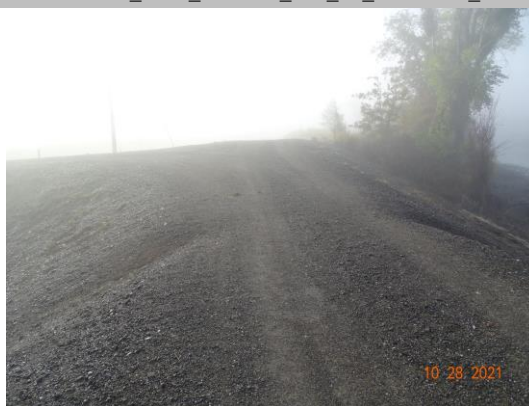
Photo 1 of 1 : FA_2021_MA0017_339_26_20211028_00051.jpg

LM Start	4.15	Rating **	M	Issue No.	26
LM End	4.15	Issue Type +	Ma	Location *	CR
Category	Earthen Levee			GPS Latitude/Longitude	
				Start	End
Item	Slope Stability			39.142068 °	39.142068 °
				-122.902285 °	-122.902285 °
DWR ID	DWR_MA0017_01_f_2021_26				
Comment Code					
S2 : Repair the levee slope damaged by foot traffic and prevent access where possible.					
Inspector Comment					
Repair footpath on both slopes.

Footpath crossing levee. Fall 2021

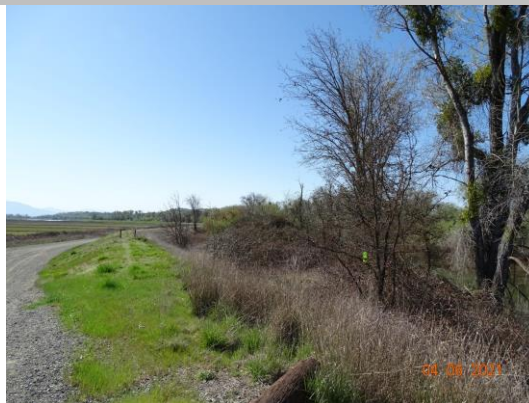
Photo 1 of 1 : FA_2021_MA0017_339_2_20210823_00001.jpg

View of the narrow, grassy levee crown and trees along the WS levee slope. Spring 2021.

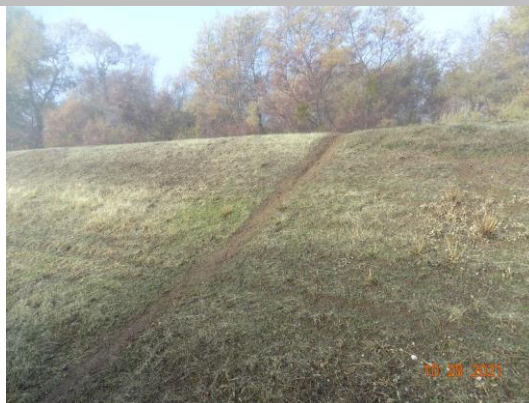
Photo 1 of 1 : FA_2021_MA0017_339_27_20211028_00052.jpg

LM Start	4.35	Rating **	A/W	Issue No.	27
LM End	4.35	Issue Type +	Ma	Location *	LS
Category	Earthen Levee			GPS Latitude/Longitude	
				Start	End
Item	Slope Stability			39.139235 °	39.139235 °
				-122.901924 °	-122.901924 °
DWR ID	DWR_MA0017_01_f_2021_27				
Comment Code					
S2 : Repair the levee slope damaged by foot traffic and prevent access where possible.					
Inspector Comment					
Monitor footpath for erosion.

Footpath on the LS slope. Fall 2021

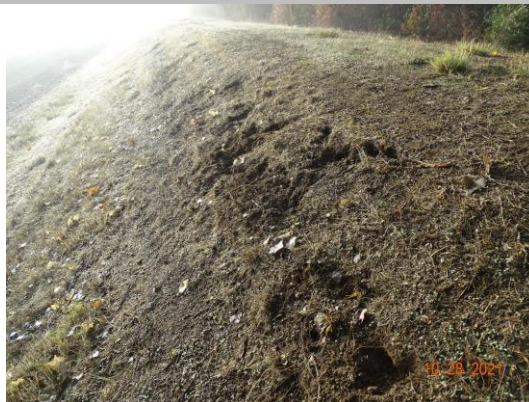
Photo 1 of 1 : FA_2021_MA0017_339_28_20211028_00053.jpg

LM Start	4.46	Rating **	M	Issue No.	28
LM End	4.47	Issue Type +	Ma	Location *	LS
Category	Earthen Levee			GPS Latitude/Longitude	
				Start	End
Item	Animal Control			39.137725 °	39.137567 °
				-122.901792 °	-122.901674 °
DWR ID	DWR_MA0017_01_f_2021_28				
Comment Code					
A3 : No rodents visible, but rodent burrows visible; need to backfill and compact or grout burrows.					
Inspector Comment					
Repair levee slope damaged by burrowing rodents.

Slope damage from burrowing rodents. Fall 2021

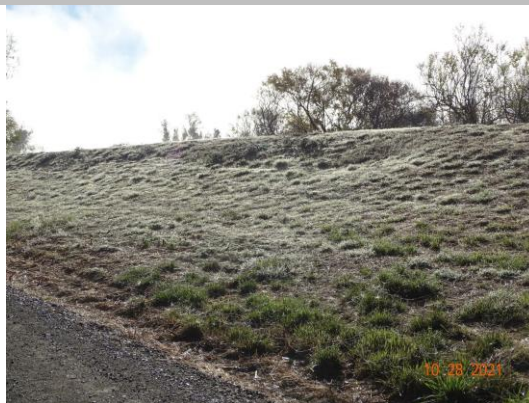
Photo 1 of 2 : FA_2021_MA0017_339_30_20211028_00054.jpg

LM Start	5.28	Rating **	M	Issue No.	30
LM End	5.28	Issue Type +	Ma	Location *	LS
Category	Earthen Levee			GPS Latitude/Longitude	
				Start	End
Item	Slope Stability			39.127645 °	39.127645 °
				-122.894563 °	-122.894563 °
DWR ID	DWR_MA0017_01_f_2021_30				
Comment Code					
S1 : Repair slope instability.					
Inspector Comment					
Depression in the LS slope with separation on crown. Approximately 50' long x 10' wide

Depression on LS slope. Fall 2021

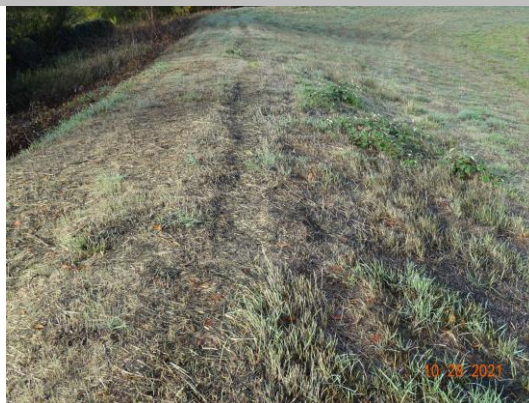
Photo 2 of 2 : FA_2021_MA0017_339_30_20211028_00055.jpg

Seperation on the crown. Fall 2021

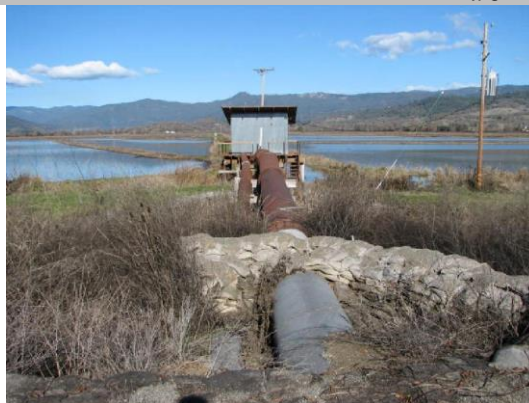
Photo 1 of 3 : UCIP_FA_2021_58629_46860.jpg

Comment Code						
Inspector Comment						
DS_ID:847 FS_ID:58629 EP_NO: 11469 Repair Type: Non-Urgent EVAL Issue: Maintenance Compliance Issue Crossing Status: Found UCIP Comments: 10/09/2019 The levee is maintained by DWR Sutter Yard. The State is currently working on purchasing adjacent land to eventually pursue the de-activation of this levee. Levee crown width ranges from 3 to 4-feet. The UCIP inspection was completed with DWR Inspector, L. Dial, and DWR Sutter Yard Supervisor, B. Reniff. Crossing remains Non-Urgent; sack ring built to control levee seepage has deteriorated and needs to be rebuilt or maintained. Pump station is maintained by RD2070. (O. Magana - DWR UCIP)10/19/2016 Sack ring still in place. (A. Freitag - DWR Sutter Yard)06/14/2016 Sack ring is still built up underneath the pipes. (A. Freitag - DWR Sutter Yard)04/23/2015 Sack ring is still built up underneath the pipes. (A. Freitag - DWR Sutter Yard)07/03/2014 Same as last inspection. (A. Freitag - DWR Sutter Yard)12/23/2013 Same as last inspection. (A. Freitag - DWR Sutter Yard)08/02/2013 Same as last inspection. (A. Freitag - DWR Sutter Yard)12/13/2012 Flood fight materials-ring levees around both LS and WS slopes at pipe crossing. This may or may not be an issue. (W. Wylie - DWR UCIP) FIELD_STRUCT_DESC: 1 of 2: 16-inch steel drainage pipe through the levee, 5 feet below the crown. Drainage pumping plant on the landside (LS). Flap gate on the waterside (WS) end. (one 16-inch and one 36-inch pipes [HLM 5.43] authorized under Automatic Board Order (ABO) issued as Permit No. 11469, 1975 - RD 2070). [Additional Reference(s): DWR Levee Log, 2005 (HLM 5.43). USACE Sacramento O&M Manual, Unit 506 Part 3 (506.3), 1967, (HLM 5.43), listed as 16-inch pipe]. FS Date: 10/9/2019 3:02:00 PM

Pumping plant, pipes, and ring levees on LS toe.

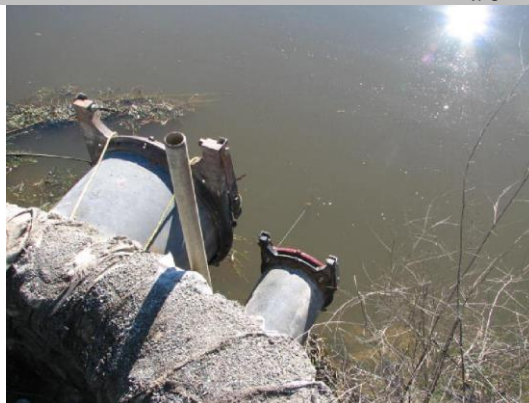
Photo 2 of 3 : UCIP_FA_2021_58629_46859.jpg

16-inch pipe, flap gate, air vent, and ring levee on WS slope.

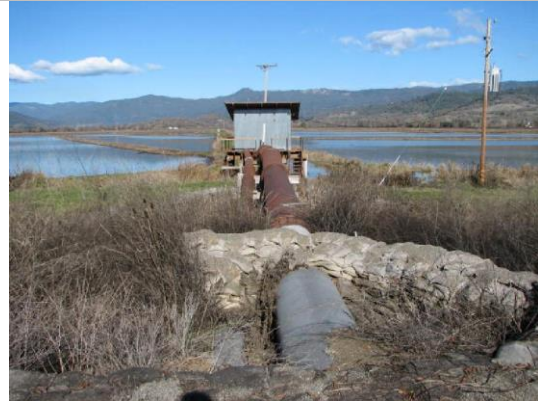
Photo 1 of 3 : UCIP_FA_2021_58630_46864.jpg

Comment Code						
Inspector Comment						
DS_ID:853 FS_ID:58630 EP_NO: 11469 Repair Type: Non-Urgent EVAL Issue: Maintenance Compliance Issue Crossing Status: Found UCIP Comments: 10/09/2019 The levee is maintained by DWR Sutter Yard. The State is currently working on purchasing adjacent land to eventually pursue the de-activation of this levee. Levee crown width ranges from 3 to 4-feet. The UCIP inspection was completed with DWR Inspector, L. Dial, and DWR Sutter Yard Supervisor, B. Reniff. Crossing remains Non-Urgent; sack ring built to control levee seepage has deteriorated and needs to be rebuilt or maintained. Pump station is maintained by RD2070. (O. Magana - DWR UCIP)10/19/2016 Sack ring still in place. (A. Freitag - DWR Sutter Yard)06/14/2016 Sack ring is still built up underneath the pipes. (A. Freitag - DWR Sutter Yard)04/23/2015 Sack ring still built up underneath the pipes. (A. Freitag - DWR Sutter Yard)07/03/2014 Same as last inspection. (A. Freitag - DWR Sutter Yard)12/23/2013 Same as last inspection. (A. Freitag - DWR Sutter Yard)08/02/2013 Same as last inspection. (A. Freitag - DWR Sutter Yard)12/13/2012 flood fight materials-ring levees around both LS and WS slopes at pipe crossing. This may or may not be an issue. (W. Wylie - DWR UCIP) FIELD_STRUCT_DESC: 2 of 2: 36-inch steel drainage pipe through the levee, 5 feet below the crown. Flap gate and air vent on the waterside (WS) slope. (one 36-inch and one 16-inch pipes [HLM 5.43] authorized under Automatic Board Order (ABO) issued as Permit No. 11469, 1975 - RD 2070). [Additional Reference(s): DWR Levee Log, 2005 (HLM 5.43). USACE Sacramento O&M Manual, Unit 506 Part 3 (506.3), 1967, (HLM 5.43), listed as 36-inch pipe]. FS Date: 10/9/2019 3:03:00 PM

Pipes and pump house on LS toe with ring levees.

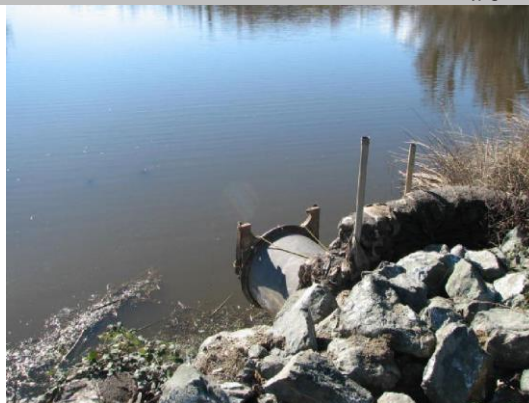
Photo 2 of 3 : UCIP_FA_2021_58630_46863.jpg

Pipe, flap gate, air vent, and sandbags on WS slope.

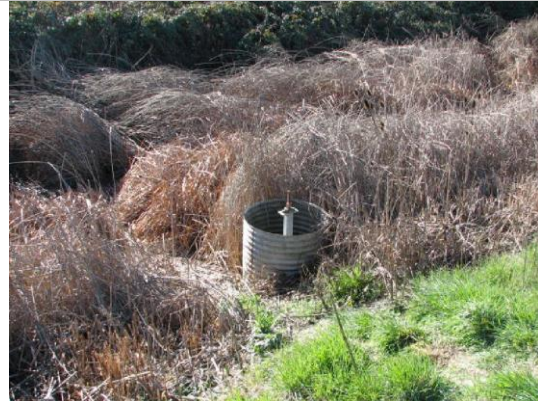
Photo 1 of 3 : UCIP_FA_2021_58631_46866.jpg

DS_ID:848
FS_ID:58631
EP_NO: 11457
Repair Type: Non-Urgent
EVAL Issue: Geophysical Evaluation (Confirmed)
Crossing Status: Found
UCIP Comments: 10/09/2019 The levee is maintained by DWR Sutter Yard. The State is currently working on purchasing adjacent land to eventually pursue the de-activation of this levee. Levee crown width ranges from 3 to 4-feet. The UCIP inspection was completed with DWR Inspector, L. Dial, and DWR Sutter Yard Supervisor, B. Reniff. Crossing remains Non-Urgent; crossing has been abandoned, no riser lid or slide gate wheel are present. DWR DMP geophysical investigation found signals of potential metal pipe through this section of the levee. Owner will need coordinate with the CVFPB to remove or abandon crossing according to Title 23 requirements. (O. Magana - DWR UCIP)

36-inch CMP riser and slide gate on WS slope.

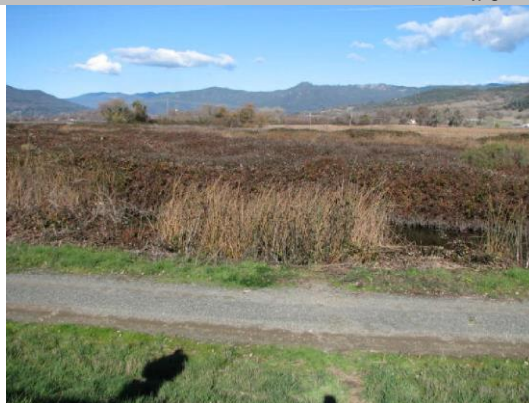
Photo 2 of 3 : UCIP_FA_2021_58631_46865.jpg

Approximate location of inlet on LS toe (not visible).

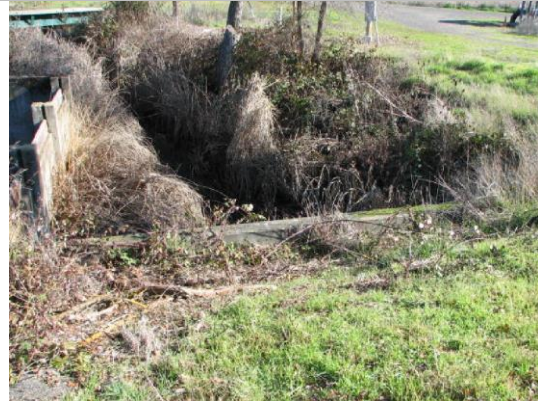
Photo 1 of 3 : UCIP_FA_2021_58632_46869.jpg

Comment Code					
Inspector Comment					
DS_ID:849 FS_ID:58632 EP_NO: 11467 Repair Type: Non-Urgent EVAL Issue: Unauthorized Encroachment, installed decades prior Crossing Status: Found UCIP Comments: 10/09/2019 The levee is maintained by DWR Sutter Yard. The State is currently working on purchasing adjacent land to eventually pursue the de-activation of this levee. Levee crown width is about 12 feet. The UCIP inspection was completed with DWR Inspector, L. Dial, and DWR Sutter Yard Supervisor, B. Reniff. Crossing has been updated from No Action Needed to Non-Urgent; need to audit record to confirm if ABO lists current owner for this structure. (O. Magana - DWR UCIP)10/27/2017 This structure is inspected annually under the Structure and Channel Summer Inspection (part of the Levee Inspection Program) conducted by the DWR Flood Project Integrity and Inspection Branch (FPIIB). (O. Magana - DWR UCIP) 10/19/2016 Crossing appears to be in good condition. (A. Freitag - DWR Sutter Yard)06/14/2016 Flap gate propped open. Will make sure its closed before flood season. (A. Freitag - DWR Sutter Yard)04/23/2015 Flap gate propped open. Not an issue at this time. Will close it before high water season. (A. Freitag - DWR Sutter Yard)07/03/2014 Same as last inspection. (A. Freitag - DWR Sutter Yard)12/23/2013 Same as last inspection. (A. Freitag - DWR Sutter Yard)08/02/2013 Same as last inspection. (A. Freitag - DWR Sutter Yard) FIELD_STRUCT_DESC: [Highland Canal Diversion Weir and Drainage] 1 of 2: 54-inch corrugated metal drainage pipe through the levee 11.5 feet below the crown. Highland Canal Diversion Weir and Drainage Structure on the landside (LS). Concrete headwall on both landside (LS) and waterside (WS) toe with flap gate on the WS toe. (two 54-inch pipes [HLM 6.05] authorized under Automatic Board Order (ABO) issued as Permit No. 11467, 1975 - Modglin). [Additional Reference(s): DWR Levee Log, 2005 (HLM 6.05). USACE Sacramento O&M Manual, Unit 506 Part 3 (506.3), 1967, (HLM 6.05), listed as two 54-inch pipes]. FS Date: 10/9/2019 3:05:00 PM

Concrete weir/dam and channel on LS toe.

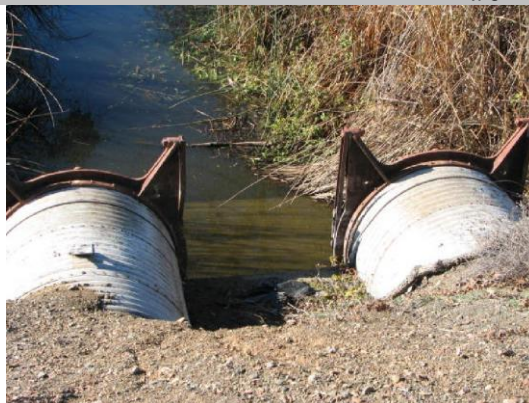
Photo 2 of 3 : UCIP_FA_2021_58632_46868.jpg

pipe and flap gate on WS toe.

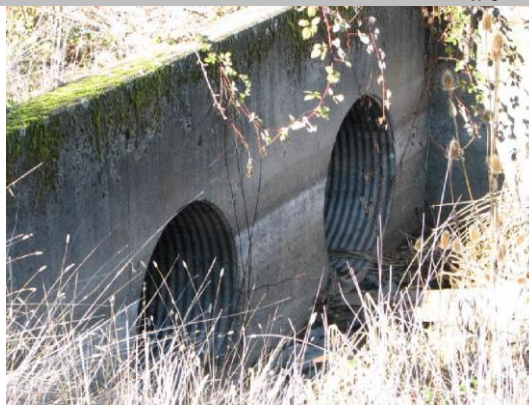
Photo 3 of 3 : UCIP_FA_2021_58632_46867.jpg

Concrete headwall at inlet on LS toe.

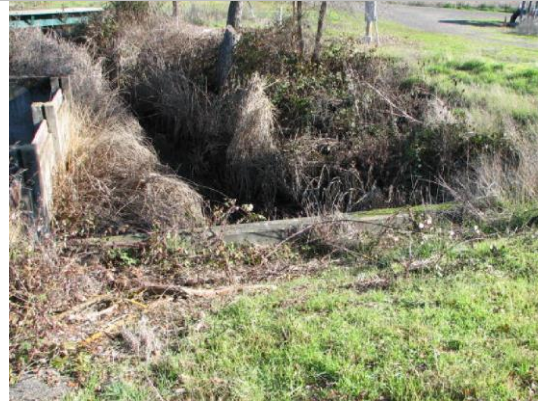
Photo 1 of 3 : UCIP_FA_2021_58608_46872.jpg

DS_ID:854
FS_ID:58608
EP_NO: 11467
Repair Type: Non-Urgent
EVAL Issue: Unauthorized Encroachment, installed decades prior
Crossing Status: Found
UCIP Comments: 10/09/2019 The levee is maintained by DWR Sutter Yard. The State is currently working on purchasing adjacent land to eventually pursue the de-activation of this levee. Levee crown width is about 12 feet. The UCIP inspection was completed with DWR Inspector, L. Dial, and DWR Sutter Yard Supervisor, B. Reniff. Crossing has been updated from No Action Needed to Non-Urgent; need to audit record to confirm if ABO lists current owner for this structure. (O. Magana - DWR UCIP)10/27/2017 This structure is inspected annually under the Structure and Channel Summer Inspection (part of the Levee Inspection Program) conducted by the DWR Flood Project Integrity and Inspection Branch (FPIIB). (O. Magana - DWR UCIP) 10/19/2016 Crossing appears to be in good condition. (A. Freitag - DWR Sutter Yard)06/14/2016 Flap gate propped open. Will make sure its closed before flood season. (A. Freitag - DWR Sutter Yard)04/23/2015 Flap gate propped open. Not an issue at this time. Will close it before high water season. (A. Freitag - DWR Sutter Yard)07/03/2014 Same as last inspection. (A. Freitag - DWR Sutter Yard)12/23/2013 Same as last inspection. (A. Freitag - DWR Sutter Yard)08/02/2013 Same as last inspection. (A. Freitag - DWR Sutter Yard)

Concrete dam/weir and channel on LS toe.

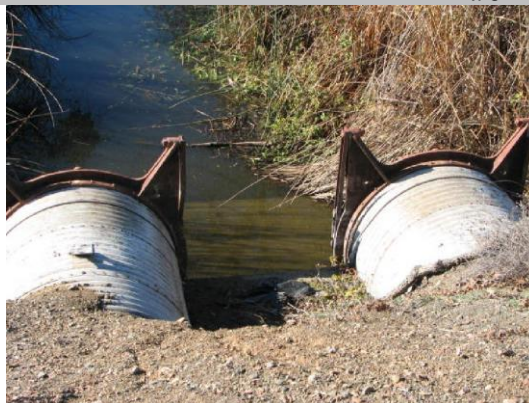
Photo 2 of 3 : UCIP_FA_2021_58608_46871.jpg

Pipe and flap gate on WS toe.

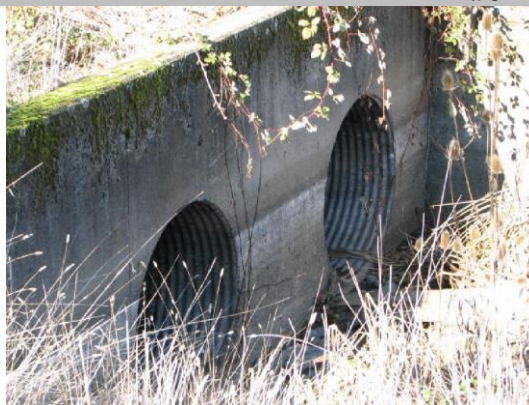
Photo 3 of 3 : UCIP_FA_2021_58608_46870.jpg

Concrete headwall on LS toe.

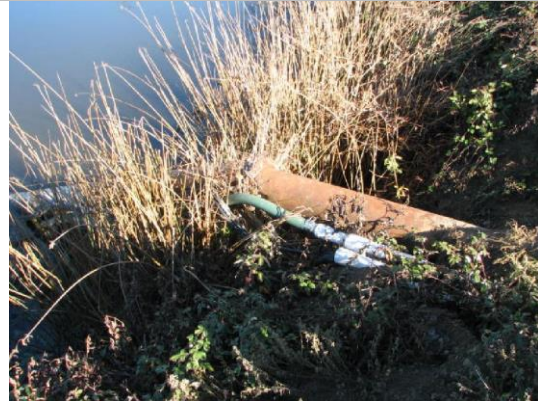
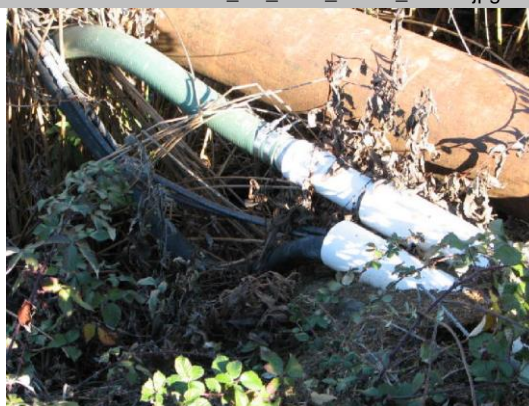
DS_ID:850
FS_ID:58637
EP_NO: 11467
Repair Type: Urgent
EVAL Issue:
Crossing Status: Found
UCIP Comments: 10/09/2019 The levee is maintained by DWR Sutter Yard. The State is currently working on purchasing adjacent land to eventually pursue the de-activation of this levee. Levee crown width is more than 12 feet. The UCIP inspection was completed with DWR Inspector, L. Dial, and DWR Sutter Yard Supervisor, B. Reniff. Crossing remains Urgent; WS erosion is still present along WS slope. This crossing has been modified. It appears that this pipe is conveying water from WS to LS and LS to WS. Recommend auditing record to determine current owner. (O. Magana - DWR UCIP)09/06/2018 Same as last inspection; WS erosion is still present so the crossing remains Urgent. (D. Sanoski - DWR UCIP).10/19/2016 WS erosion still present. (A. Freitag - DWR Sutter Yard)06/14/2016 WS erosion is still present. (A. Freitag - DWR Sutter Yard)04/23/2015 Same as last inspection. (A. Freitag - DWR Sutter Yard)07/03/2014 Same as last inspection. (A. Freitag - DWR Sutter Yard)12/23/2013 Same as last inspection. (A. Freitag - DWR Sutter Yard)08/02/2013 Same as last inspection. (A. Freitag - DWR Sutter Yard)12/13/2012 The pipe and appurtenances do not match what was described in the permit (PN: 11467). Does not appear to be in compliance with board regulations. (W. Wylie - DWR UCIP)

12-inch pipe and appurtenances on WS shoulder.

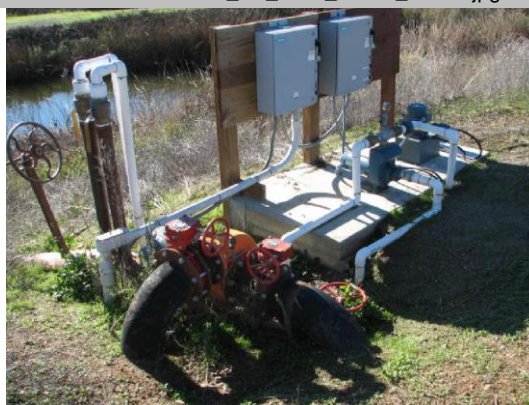
Photo 3 of 3 : UCIP_FA_2021_58637_46880.jpg

Pumping plant and appurtenances on LS shoulder.

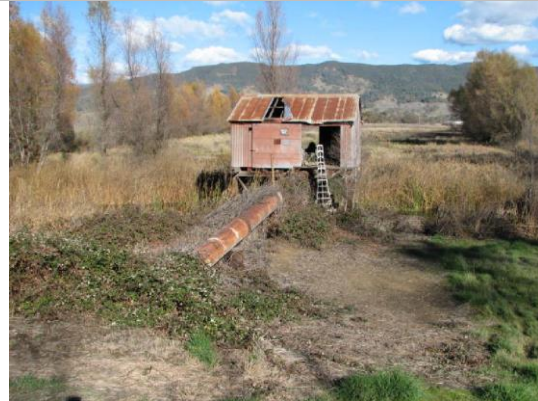
Photo 1 of 3 : UCIP_FA_2021_58638_46884.jpg

DS_ID:851
 FS_ID:58638
 EP_NO: 11467
 Repair Type: Non-Urgent
 EVAL Issue: Unauthorized Encroachment, installed decades prior
 Crossing Status: Found
 UCIP Comments: 10/09/2019 The levee is maintained by DWR Sutter Yard. The State is currently working on purchasing adjacent land to eventually pursue the de-activation of this levee. Levee crown width is about 12 feet. The UCIP inspection was completed with DWR Inspector, L. Dial, and DWR Sutter Yard Supervisor, B. Reniff. Crossing remains Non-Urgent; crossing has been abandoned. Owner will need coordinate with the CVFPB to remove or abandon crossing according to Title 23 requirements. (O. Magana - DWR UCIP)10/19/2016
 Abandoned- should be done so properly. (A. Freitag - DWR Sutter Yard)06/14/2016 Abandoned crossing. (A. Freitag - DWR Sutter Yard)04/23/2015 Same as last inspection. Pipe still needs to be properly abandoned. (A. Freitag - DWR Sutter Yard)07/03/2014 Same as last inspection. (A. Freitag - DWR Sutter Yard)12/23/2013 Same as last inspection. (A. Freitag - DWR Sutter Yard)08/02/2013 Same as last inspection. (A. Freitag - DWR Sutter Yard)12/13/2012 Pipe should be properly abandoned. (W. Wylie - DWR UCIP)

Pumping plant in shed on LS at drainage ditch.

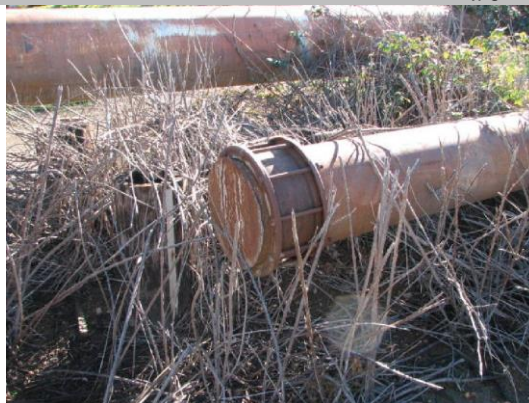
Photo 2 of 3 : UCIP_FA_2021_58638_46883.jpg

Steel plate welded over end of pipe at LS toe.

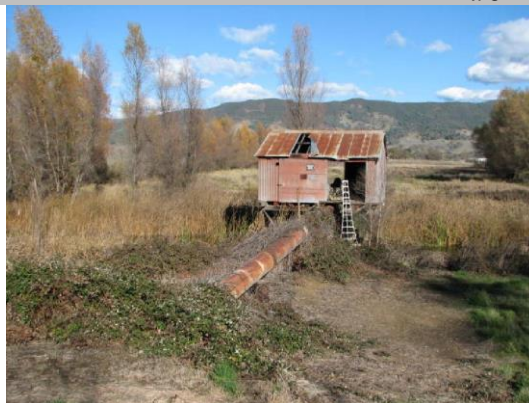
Photo 1 of 3 : UCIP_FA_2021_58639_46886.jpg

Comment Code						
Inspector Comment						
DS_ID:855 FS_ID:58639 EP_NO: 11467 Repair Type: Non-Urgent EVAL Issue: Unauthorized Encroachment, installed decades prior Crossing Status: Found UCIP Comments: 10/09/2019 The levee is maintained by DWR Sutter Yard. The State is currently working on purchasing adjacent land to eventually pursue the de-activation of this levee. Levee crown width is about 12 feet. The UCIP inspection was completed with DWR Inspector, L. Dial, and DWR Sutter Yard Supervisor, B. Reniff. Crossing remains Non-Urgent; crossing has been abandoned. Owner will need coordinate with the CVFPB to remove or abandon crossing according to Title 23 requirements. (O. Magana - DWR UCIP)10/19/2016 Crossing appears to be in good condition. (A. Freitag - DWR Sutter Yard)06/14/2016 Crossing appears to be in good condition. (A. Freitag - DWR Sutter Yard)04/23/2015 No issues seen with pipe. (A. Freitag - DWR Sutter Yard)07/03/2014 Same as last inspection. (A. Freitag - DWR Sutter Yard)08/02/2013 Same as last inspection. (A. Freitag - DWR Sutter Yard)12/23/2013 Same as last inspection. (A. Freitag - DWR Sutter Yard) FIELD_STRUCT_DESC: 2 of 2: 24-inch steel drainage pipe through the levee, 8 feet below the crown. Drainage pumping plant on the landside (LS). Flap gate on the waterside (WS) end. (one 16-inch and one 24-inch pipes [HLM 7.79] authorized under Automatic Board Order (ABO) issued as Permit No. 11467, 1975 - Modglin). [Additional Reference(s): DWR Levee Log, 2005 (HLM 7.19). USACE Sacramento O&M Manual, Unit 506 Part 3 (506.3), 1967, (HLM 7.19), listed as 24-inch pipe]. FS Date: 10/9/2019 3:12:00 PM

24-inch steel pipe and pump house on LS.

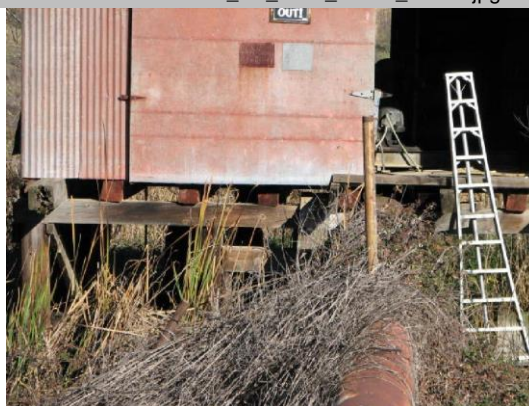
Photo 2 of 3 : UCIP_FA_2021_58639_46885.jpg

Air vent on pipe at LS pumphouse.
