**Flood Control Project Maintenance  
Levee Inspections**

**Maintenance Issue Types Only, Levee Inspection Report By Mile - Fall 2022**

**Sutter Maintenance Yard Maintenance Area 0017**

Waterway	Bank	Unit Miles	Inspection Start/End	Inspector
Unit No. 01 Lake County Sutter Maintenance Yard - Middle Creek	Left	3.87	10/13/2022 10/13/2022	Marvin Marshall

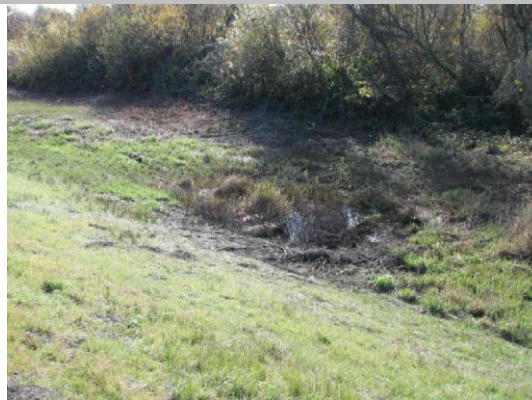
Photo 1 of 3 : UCIP\_FA\_2022\_58627\_46849.jpg

LM Start	3.95	Rating **	M	Issue No.	36	
LM End	3.95	Issue Type +	Ma	Location *		
Category	Supplemental			GPS Latitude/Longitude		
				Start	End	
Item	DWR UCIP LMA Responsibility			39.143792 °	39.143792 °	
				-122.904798 °	-122.904798 °	
DWR ID	844

Comment Code						
Inspector Comment						
DS_ID:844 FS_ID:58627 EP_NO: 11463 Repair Type: Non-Urgent EVAL Issue: Crossing Status: Found UCIP Comments: 10/09/2019 The levee is maintained by DWR Sutter Yard. The State is currently working on purchasing adjacent land to eventually pursue the de-activation of this levee. Levee crown width through this section is about 12 feet. The UCIP inspection was completed with DWR Inspector, L. Dial, and DWR Sutter Yard Supervisor, B. Reniff. Crossing has been updated from No Action Needed to Non-Urgent; owner has changed [State owns structure]. (O. Magana - DWR UCIP)10/19/2016 Crossing appears to be in good condition. (A. Freitag - DWR Sutter Yard)06/14/2016 crossing appears to be in good condition. (A. Freitag - DWR Sutter Yard)04/23/2015 No issues with pipe. (A. Freitag - DWR Sutter Yard)07/03/2014 Same as last inspection. (A. Freitag - DWR Sutter Yard)12/23/2013 Same as last inspection. (A. Freitag - DWR Sutter Yard)08/02/2013 New flap gate installed. No other issues with pipe. (A. Freitag - DWR Sutter Yard)12/13/2012 Flap gate broken in half and inoperable. (W. Wylie - DWR UCIP) FIELD_STRUCT_DESC: 24-inch corrugated metal drainage pipe through the levee, 12.4 feet below the crown. Flap gate on the waterside (WS) end. Timber walkway on the landside (LS) slope to a timber walkway to pump house mounted on piles in drainage ditch. (24-inch pipe [HLM 3.99] authorized under Automatic Board Order (ABO) issued as Permit No. 11463, 1975 - Audrey Jones). [Additional Reference(s): DWR Levee Log, 2005 (HLM 3.99). USACE Sacramento O&M Manual, Unit 506 Part 2 (SAC506.2), August 1961, Revised 25 May 2011, (HLM 3.99), listed as 24-inch CMP]. FS Date: 10/9/2019 2:58:00 PM

24-inch CMP at outlet on WS toe.

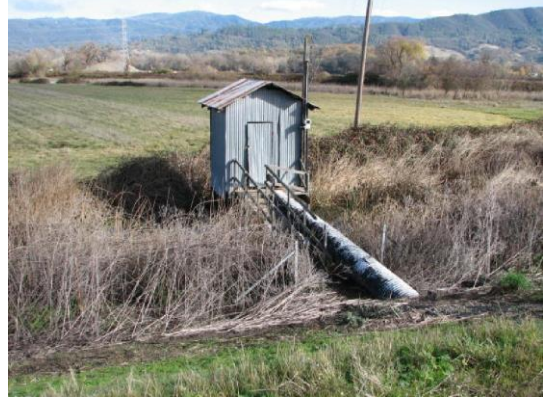
Photo 2 of 3 : UCIP\_FA\_2022\_58627\_46848.jpg

Pumphouse on piles at LS toe.

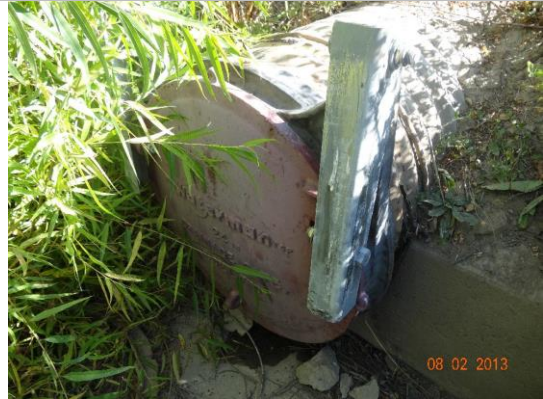
Photo 3 of 3 : UCIP\_FA\_2022\_58627\_46850.jpg

New flap gate on WS

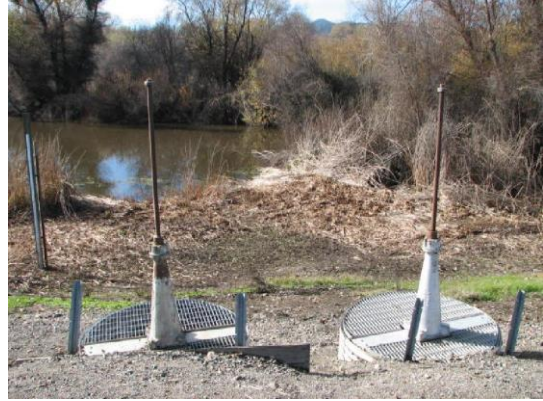
Photo 2 of 3 : UCIP\_FA\_2022\_58626\_46852.jpg

Slide gates in CMP risers on WS shoulder.

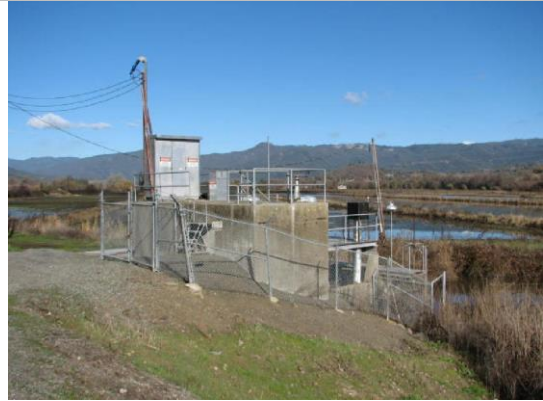
Photo 3 of 3 : UCIP\_FA\_2022\_58626\_46851.jpg

Pumping Plant on LS shoulder.

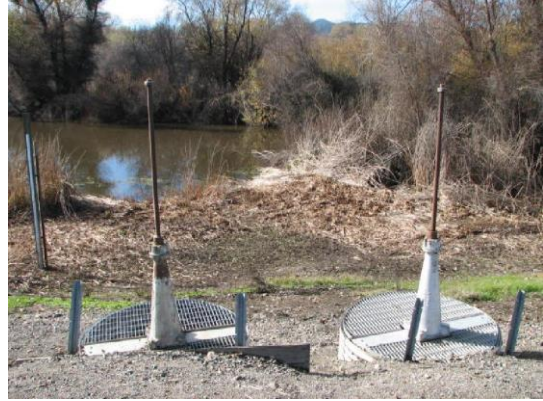
Photo 2 of 3 : UCIP\_FA\_2022\_58625\_46855.jpg

Slide gate in CMP riser on WS shoulder.

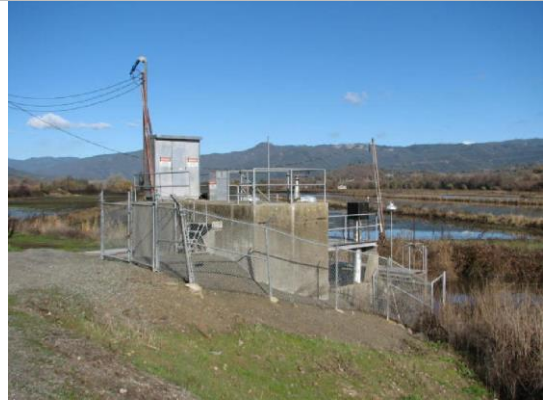
Photo 3 of 3 : UCIP\_FA\_2022\_58625\_46854.jpg

Pumping plant on LS shoulder.

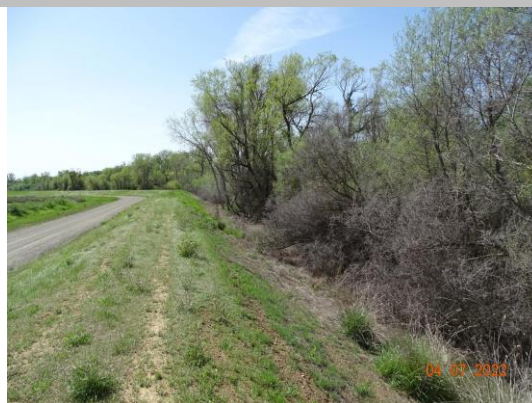
Photo 1 of 1 : FA\_2022\_MA0017\_339\_2\_20221012\_00001.jpg

LM Start	4.16	Rating **	M	Issue No.	2
LM End	7.10	Issue Type +	Ma	Location *	WS
Category	Earthen Levee			GPS Latitude/Longitude	
				Start	End
Item	Vegetation			39.141894 °	39.120609 °
				-122.902201 °	-122.887166 °
DWR ID	DWR_MA0017_01_s_2012_2				
Comment Code					
V1 : Control annual grass and weeds on the levee slopes and easements.					
Inspector Comment					
The crown is too narrow to drive and the access road follows the LS toe. Visual inspection of the WS and crown by periodically walking up to crown shows that maintenance is being performed on the crown and ~5' down the WS slope.

View of the narrow, grassy levee crown and trees along the WS levee slope. Spring 2022.

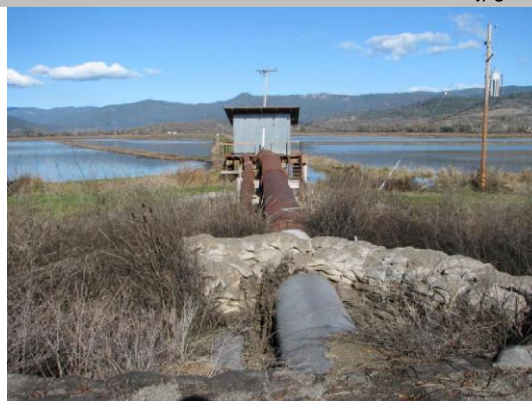
Photo 1 of 3 : UCIP\_FA\_2022\_58629\_46860.jpg

Comment Code						
Inspector Comment						
DS_ID:847 FS_ID:58629 EP_NO: 11469 Repair Type: Non-Urgent EVAL Issue: 11, Maintenance Compliance Issue Crossing Status: Found UCIP Comments: 10/09/2019 The levee is maintained by DWR Sutter Yard. The State is currently working on purchasing adjacent land to eventually pursue the de-activation of this levee. Levee crown width ranges from 3 to 4-feet. The UCIP inspection was completed with DWR Inspector, L. Dial, and DWR Sutter Yard Supervisor, B. Reniff. Crossing remains Non-Urgent; sack ring built to control levee seepage has deteriorated and needs to be rebuilt or maintained. Pump station is maintained by RD2070. (O. Magana - DWR UCIP)10/19/2016 Sack ring still in place. (A. Freitag - DWR Sutter Yard)06/14/2016 Sack ring is still built up underneath the pipes. (A. Freitag - DWR Sutter Yard)04/23/2015 Sack ring is still built up underneath the pipes. (A. Freitag - DWR Sutter Yard)07/03/2014 Same as last inspection. (A. Freitag - DWR Sutter Yard)12/23/2013 Same as last inspection. (A. Freitag - DWR Sutter Yard)08/02/2013 Same as last inspection. (A. Freitag - DWR Sutter Yard)12/13/2012 Flood fight materials-ring levees around both LS and WS slopes at pipe crossing. This may or may not be an issue. (W. Wylie - DWR UCIP) FIELD_STRUCT_DESC: 1 of 2: 16-inch steel drainage pipe through the levee, 5 feet below the crown. Drainage pumping plant on the landside (LS). Flap gate on the waterside (WS) end. (one 16-inch and one 36-inch pipes [HLM 5.43] authorized under Automatic Board Order (ABO) issued as Permit No. 11469, 1975 - RD 2070). [Additional Reference(s): DWR Levee Log, 2005 (HLM 5.43). USACE Sacramento O&M Manual, Unit 506 Part 3 (506.3), 1967, (HLM 5.43), listed as 16-inch pipe]. FS Date: 10/9/2019 3:02:00 PM

Pumping plant, pipes, and ring levees on LS toe.

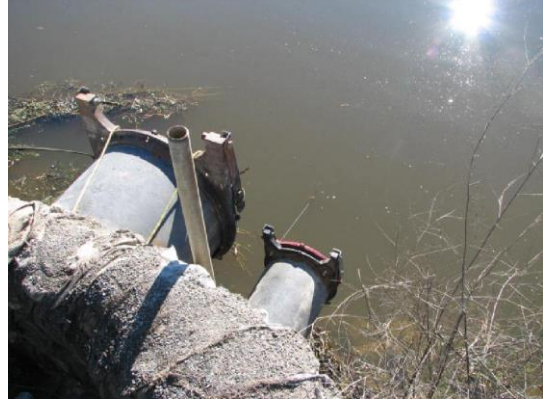
Photo 2 of 3 : UCIP\_FA\_2022\_58629\_46859.jpg

16-inch pipe, flap gate, air vent, and ring levee on WS slope.

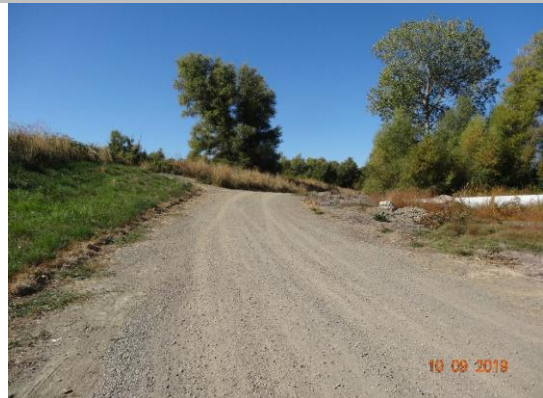
Photo 3 of 3 : UCIP\_FA\_2022\_58629\_82279.jpg

Overview of access road looking u/s towards pipe crossings.

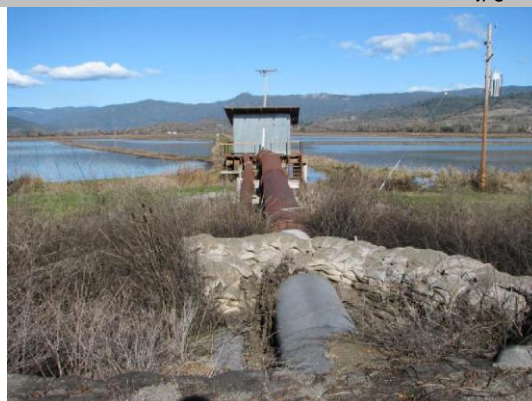
Photo 1 of 3 : UCIP\_FA\_2022\_58630\_46864.jpg

Comment Code					
Inspector Comment					
DS_ID:853 FS_ID:58630 EP_NO: 11469 Repair Type: Non-Urgent EVAL Issue: 11, Maintenance Compliance Issue Crossing Status: Found UCIP Comments: 10/09/2019 The levee is maintained by DWR Sutter Yard. The State is currently working on purchasing adjacent land to eventually pursue the de-activation of this levee. Levee crown width ranges from 3 to 4-feet. The UCIP inspection was completed with DWR Inspector, L. Dial, and DWR Sutter Yard Supervisor, B. Reniff. Crossing remains Non-Urgent; sack ring built to control levee seepage has deteriorated and needs to be rebuilt or maintained. Pump station is maintained by RD2070. (O. Magana - DWR UCIP)10/19/2016 Sack ring still in place. (A. Freitag - DWR Sutter Yard)06/14/2016 Sack ring is still built up underneath the pipes. (A. Freitag - DWR Sutter Yard)04/23/2015 Sack ring still built up underneath the pipes. (A. Freitag - DWR Sutter Yard)07/03/2014 Same as last inspection. (A. Freitag - DWR Sutter Yard)12/23/2013 Same as last inspection. (A. Freitag - DWR Sutter Yard)08/02/2013 Same as last inspection. (A. Freitag - DWR Sutter Yard)12/13/2012 flood fight materials-ring levees around both LS and WS slopes at pipe crossing. This may or may not be an issue. (W. Wylie - DWR UCIP) FIELD_STRUCT_DESC: 2 of 2: 36-inch steel drainage pipe through the levee, 5 feet below the crown. Flap gate and air vent on the waterside (WS) slope. (one 36-inch and one 16-inch pipes [HLM 5.43] authorized under Automatic Board Order (ABO) issued as Permit No. 11469, 1975 - RD 2070). [Additional Reference(s): DWR Levee Log, 2005 (HLM 5.43). USACE Sacramento O&M Manual, Unit 506 Part 3 (506.3), 1967, (HLM 5.43), listed as 36-inch pipe]. FS Date: 10/9/2019 3:03:00 PM

Pipes and pump house on LS toe with ring levees.

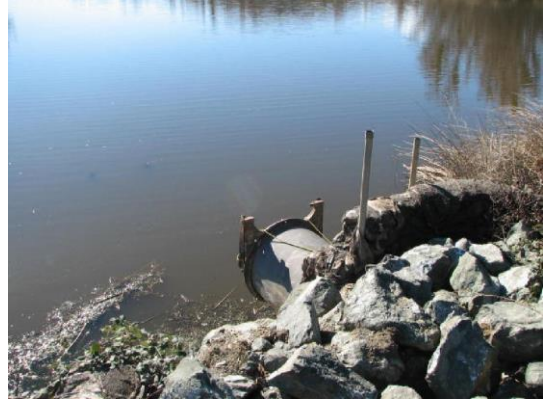
Photo 2 of 3 : UCIP\_FA\_2022\_58630\_46863.jpg

Pipe, flap gate, air vent, and sandbags on WS slope.

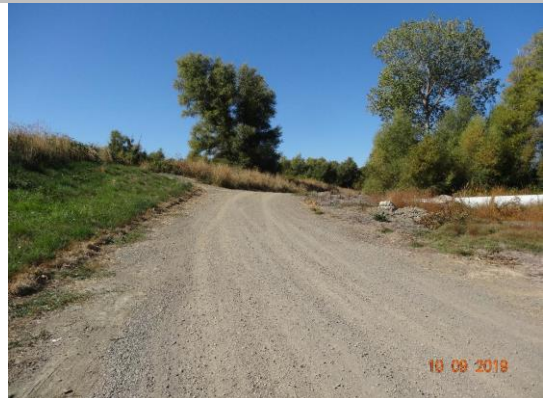
Photo 3 of 3 : UCIP\_FA\_2022\_58630\_82287.jpg

Overview of access road looking u/s towards pipe crossings.

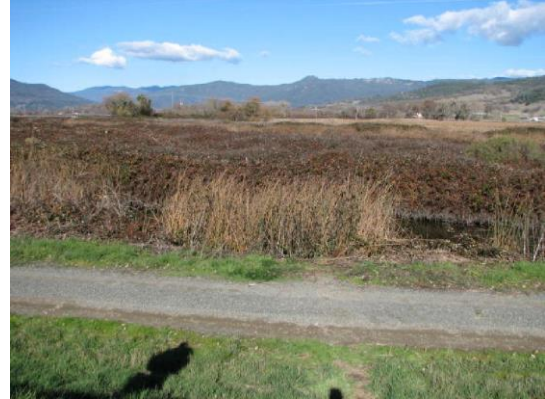
Photo 2 of 3 : UCIP\_FA\_2022\_58631\_46865.jpg

Approximate location of inlet on LS toe (not visible).

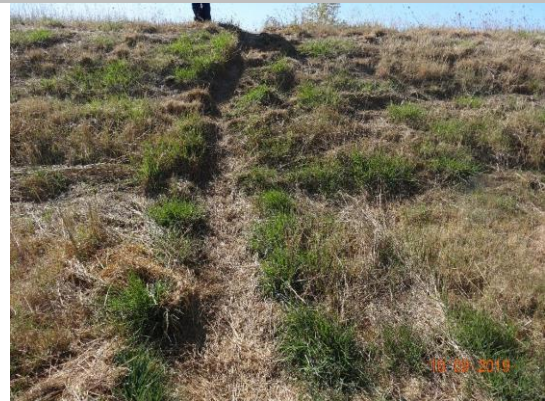
Photo 3 of 3 : UCIP\_FA\_2022\_58631\_82295.jpg

LS view: overview of LS slope.

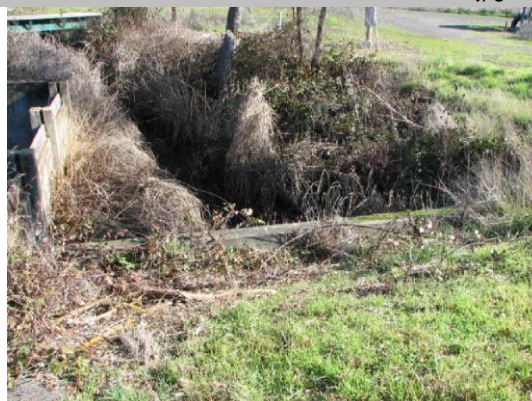
Photo 1 of 3 : UCIP\_FA\_2022\_58632\_46869.jpg

DS\_ID:849  
FS\_ID:58632  
EP\_NO: 11467  
Repair Type: Non-Urgent  
EVAL Issue:  
Crossing Status: Found  
UCIP Comments: 10/09/2019 The levee is maintained by DWR Sutter Yard. The State is currently working on purchasing adjacent land to eventually pursue the de-activation of this levee. Levee crown width is about 12 feet. The UCIP inspection was completed with DWR Inspector, L. Dial, and DWR Sutter Yard Supervisor, B. Reniff. Crossing has been updated from No Action Needed to Non-Urgent; need to audit record to confirm if ABO lists current owner for this structure. (O. Magana - DWR UCIP)10/27/2017 This structure is inspected annually under the Structure and Channel Summer Inspection (part of the Levee Inspection Program) conducted by the DWR Flood Project Integrity and Inspection Branch (FPIIB). (O. Magana - DWR UCIP) 10/19/2016 Crossing appears to be in good condition. (A. Freitag - DWR Sutter Yard)06/14/2016 Flap gate propped open. Will make sure its closed before flood season. (A. Freitag - DWR Sutter Yard)04/23/2015 Flap gate propped open. Not an issue at this time. Will close it before high water season. (A. Freitag - DWR Sutter Yard)07/03/2014 Same as last inspection. (A. Freitag - DWR Sutter Yard)12/23/2013 Same as last inspection. (A. Freitag - DWR Sutter Yard)08/02/2013 Same as last inspection. (A. Freitag - DWR Sutter Yard)

Concrete weir/dam and channel on LS toe.

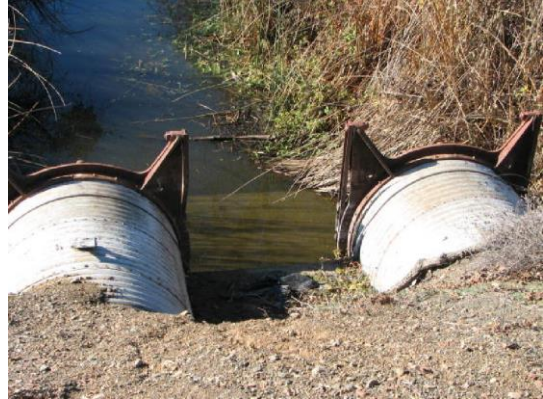
Photo 2 of 3 : UCIP\_FA\_2022\_58632\_46868.jpg

pipe and flap gate on WS toe.

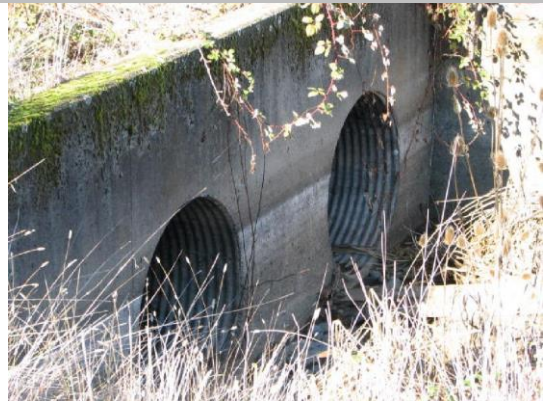
Photo 3 of 3 : UCIP\_FA\_2022\_58632\_46867.jpg

Concrete headwall at inlet on LS toe.

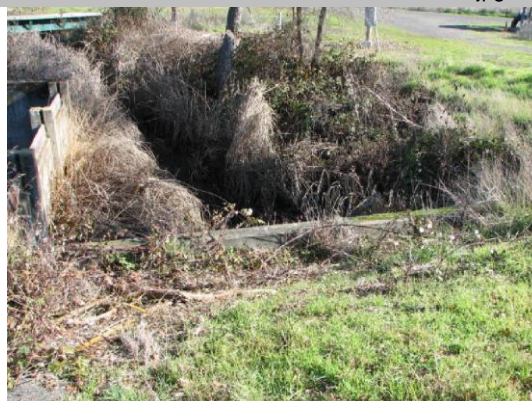
Photo 1 of 3 : UCIP\_FA\_2022\_58608\_46872.jpg

Comment Code					
Inspector Comment					
DS_ID:854 FS_ID:58608 EP_NO: 11467 Repair Type: Non-Urgent EVAL Issue: Crossing Status: Found UCIP Comments: 10/09/2019 The levee is maintained by DWR Sutter Yard. The State is currently working on purchasing adjacent land to eventually pursue the de-activation of this levee. Levee crown width is about 12 feet. The UCIP inspection was completed with DWR Inspector, L. Dial, and DWR Sutter Yard Supervisor, B. Reniff. Crossing has been updated from No Action Needed to Non-Urgent; need to audit record to confirm if ABO lists current owner for this structure. (O. Magana - DWR UCIP)10/27/2017 This structure is inspected annually under the Structure and Channel Summer Inspection (part of the Levee Inspection Program) conducted by the DWR Flood Project Integrity and Inspection Branch (FPIIB). (O. Magana - DWR UCIP) 10/19/2016 Crossing appears to be in good condition. (A. Freitag - DWR Sutter Yard)06/14/2016 Flap gate propped open. Will make sure its closed before flood season. (A. Freitag - DWR Sutter Yard)04/23/2015 Flap gate propped open. Not an issue at this time. Will close it before high water season. (A. Freitag - DWR Sutter Yard)07/03/2014 Same as last inspection. (A. Freitag - DWR Sutter Yard)12/23/2013 Same as last inspection. (A. Freitag - DWR Sutter Yard)08/02/2013 Same as last inspection. (A. Freitag - DWR Sutter Yard) FIELD_STRUCT_DESC: [Highland Canal Diversion Weir and Drainage] 2 of 2: 54-inch corrugated metal drainage pipe through the levee, 11.5 feet below the crown. Highland Canal Diversion Weir and Drainage Structure on the landside (LS). Concrete headwall on both landside (LS) and waterside (WS) toe with flap gate on the WS toe. (two 54-inch pipes [HLM 6.05] authorized under Automatic Board Order (ABO) issued as Permit No. 11467, 1975 - Modglin). [Additional Reference(s): DWR Levee Log, 2005 (HLM 6.05). USACE Sacramento O&M Manual, Unit 506 Part 3 (506.3), 1967, (HLM 6.05), listed as two 54-inch pipes]. FS Date: 10/9/2019 3:06:00 PM

Concrete dam/weir and channel on LS toe.

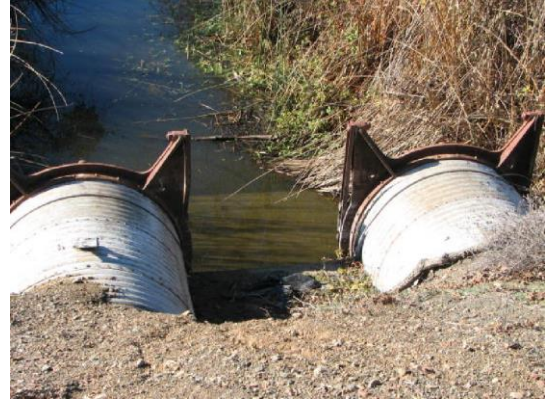
Photo 2 of 3 : UCIP\_FA\_2022\_58608\_46871.jpg

Pipe and flap gate on WS toe.

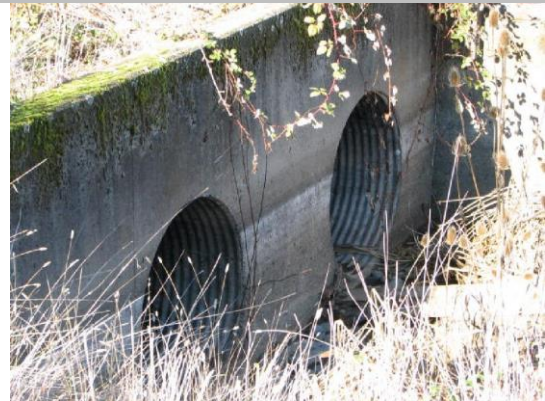
Photo 3 of 3 : UCIP\_FA\_2022\_58608\_46870.jpg

Concrete headwall on LS toe.

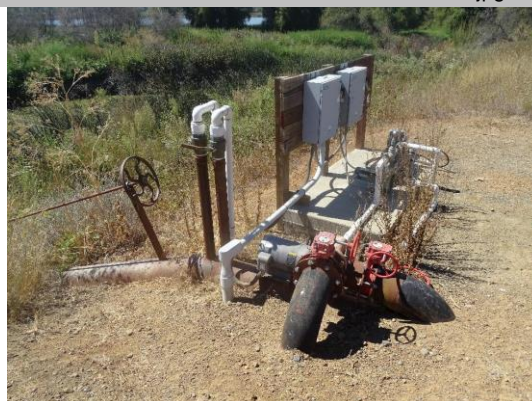
Photo 1 of 3 : UCIP\_FA\_2022\_58637\_77917.jpg

Comment Code					
Inspector Comment					
DS_ID:850 FS_ID:58637 EP_NO: 11467 Repair Type: Urgent EVAL Issue: Crossing Status: Found UCIP Comments: 10/09/2019 The levee is maintained by DWR Sutter Yard. The State is currently working on purchasing adjacent land to eventually pursue the de-activation of this levee. Levee crown width is more than 12 feet. The UCIP inspection was completed with DWR Inspector, L. Dial, and DWR Sutter Yard Supervisor, B. Reniff. Crossing remains Urgent; WS erosion is still present along WS slope. This crossing has been modified. It appears that this pipe is conveying water from WS to LS and LS to WS. Recommend auditing record to determine current owner. (O. Magana - DWR UCIP)09/06/2018 Same as last inspection; WS erosion is still present so the crossing remains Urgent. (D. Sanoski - DWR UCIP).10/19/2016 WS erosion still present. (A. Freitag - DWR Sutter Yard)06/14/2016 WS erosion is still present. (A. Freitag - DWR Sutter Yard)04/23/2015 Same as last inspection. (A. Freitag - DWR Sutter Yard)07/03/2014 Same as last inspection. (A. Freitag - DWR Sutter Yard)12/23/2013 Same as last inspection. (A. Freitag - DWR Sutter Yard)08/02/2013 Same as last inspection. (A. Freitag - DWR Sutter Yard)12/13/2012 The pipe and appurtenances do not match what was described in the permit (PN: 11467). Does not appear to be in compliance with board regulations. (W. Wylie - DWR UCIP) FIELD_STRUCT_DESC: 12-inch steel drainage pipe through the levee, 2 feet below the crown. Butterfly valve on the landside (LS) shoulder. Pump and electrical panel, along with multiple valves and appurtenances, on the LS shoulder. (12-inch pipe [HLM 6.11] authorized under Automatic Board Order (ABO) issued as Permit No. 11467, 1975 - B. F. Modglin). [Additional Reference(s): DWR Levee Log, 2005 (HLM 6.11). USACE Sacramento O&M Manual, Unit 506 Part 3 (506.3), 1967, (HLM 6.11), listed as 12-inch pipe]. FS Date: 10/9/2019 2:56:00 PM

LS view: pump station on shoulder.

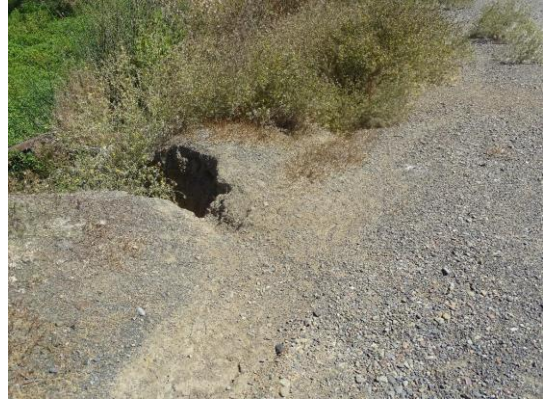
Photo 2 of 3 : UCIP\_FA\_2022\_58637\_77918.jpg

WS view: erosion on levee slope.

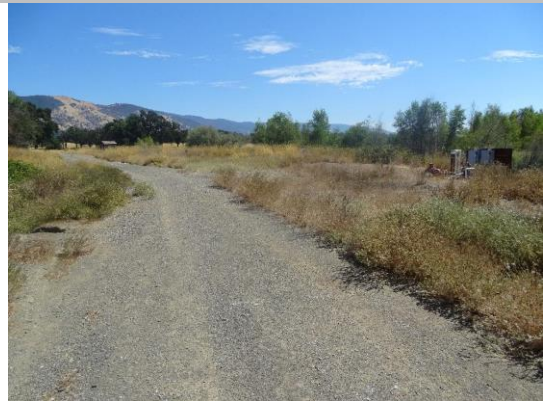
Photo 3 of 3 : UCIP\_FA\_2022\_58637\_77919.jpg

Crown view: WS erosion still a concern.

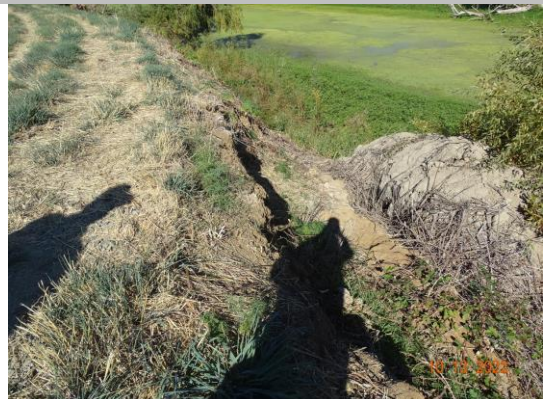
Photo 1 of 1 : FA\_2022\_MA0017\_339\_21\_20221013\_00055.jpg

LM Start	6.11	Rating **	U	Issue No.	21
LM End	6.11	Issue Type +	Ma	Location *	WS
Category	Earthen Levee			GPS Latitude/Longitude	
				Start	End
Item	Trim / Thin Trees			39.126380 °	39.126380 °
				-122.885462 °	-122.885462 °
DWR ID	DWR_MA0017_01_f_2022_21				
Comment Code					
T3 : Fallen tree with root ball.					
Inspector Comment					
Fallen tree with root ball pulled material out of levee slope.

Void in levee from fallen tree. Fall 2022

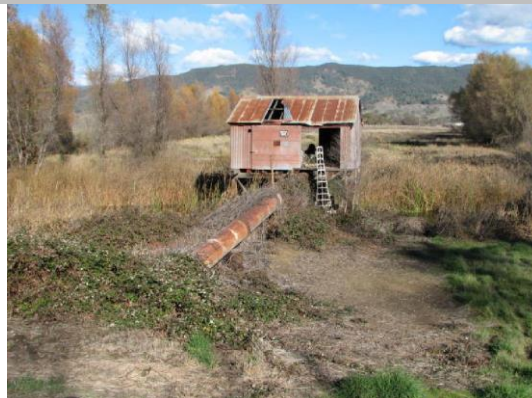
Photo 1 of 3 : UCIP\_FA\_2022\_58638\_46884.jpg

Comment Code						
Inspector Comment						
DS_ID:851 FS_ID:58638 EP_NO: 11467 Repair Type: Non-Urgent EVAL Issue: Crossing Status: Found UCIP Comments: 10/09/2019 The levee is maintained by DWR Sutter Yard. The State is currently working on purchasing adjacent land to eventually pursue the de-activation of this levee. Levee crown width is about 12 feet. The UCIP inspection was completed with DWR Inspector, L. Dial, and DWR Sutter Yard Supervisor, B. Reniff. Crossing remains Non-Urgent; crossing has been abandoned. Owner will need coordinate with the CVFPB to remove or abandon crossing according to Title 23 requirements. (O. Magana - DWR UCIP)10/19/2016 Abandoned- should be done so properly. (A. Freitag - DWR Sutter Yard)06/14/2016 Abandoned crossing. (A. Freitag - DWR Sutter Yard)04/23/2015 Same as last inspection. Pipe still needs to be properly abandoned. (A. Freitag - DWR Sutter Yard)07/03/2014 Same as last inspection. (A. Freitag - DWR Sutter Yard)12/23/2013 Same as last inspection. (A. Freitag - DWR Sutter Yard)08/02/2013 Same as last inspection. (A. Freitag - DWR Sutter Yard)12/13/2012 Pipe should be properly abandoned. (W. Wylie - DWR UCIP) FIELD_STRUCT_DESC: 1 of 2: 16-inch steel drainage pipe through the levee, 8 feet below the crown. Drainage pumping plant on the landside (LS). Flap gate on the waterside (WS) end. Steel plate welded on end of pipe at LS toe. (one 16-inch and one 24-inch pipes [HLM 7.79] authorized under Automatic Board Order (ABO) issued as Permit No. 11467, 1975 - Modglin). [Additional Reference(s): DWR Levee Log, 2005 (HLM 7.19). USACE Sacramento O&M Manual, Unit 506 Part 3 (506.3), 1967, (HLM 7.19), listed as 16-inch pipe]. FS Date: 10/9/2019 3:11:00 PM

Pumping plant in shed on LS at drainage ditch.

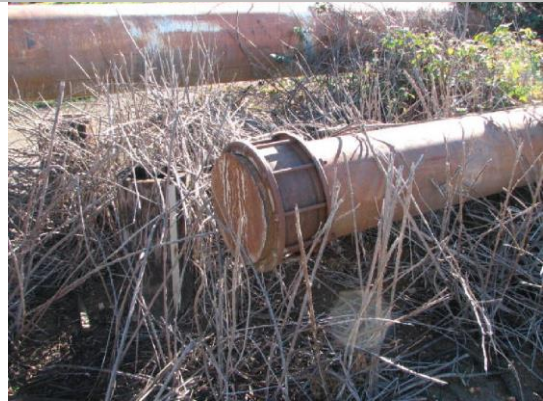
Photo 2 of 3 : UCIP\_FA\_2022\_58638\_46883.jpg

Steel plate welded over end of pipe at LS toe.

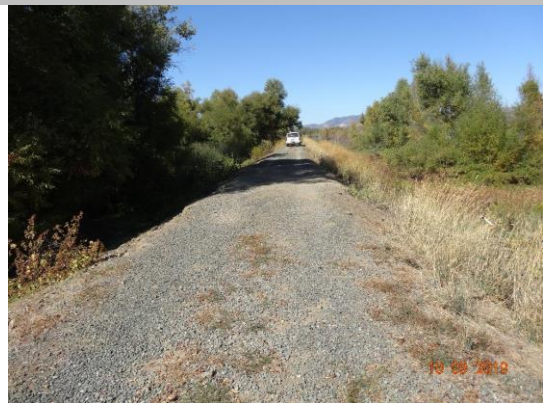
Photo 3 of 3 : UCIP\_FA\_2022\_58638\_82325.jpg

Overview of levee crown looking u/s towards pipe crossing.

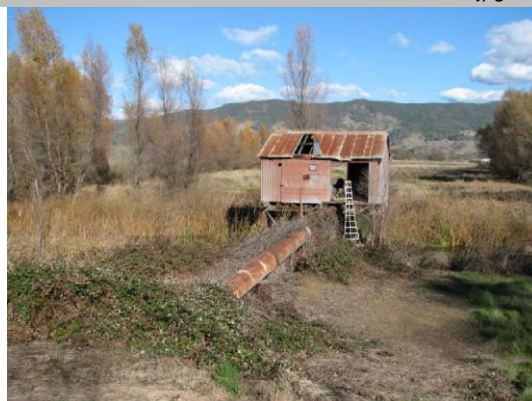
Photo 1 of 3 : UCIP\_FA\_2022\_58639\_46886.jpg

Comment Code					
Inspector Comment					
DS_ID:855 FS_ID:58639 EP_NO: 11467 Repair Type: Non-Urgent EVAL Issue: Crossing Status: Found UCIP Comments: 10/09/2019 The levee is maintained by DWR Sutter Yard. The State is currently working on purchasing adjacent land to eventually pursue the de-activation of this levee. Levee crown width is about 12 feet. The UCIP inspection was completed with DWR Inspector, L. Dial, and DWR Sutter Yard Supervisor, B. Reniff. Crossing remains Non-Urgent; crossing has been abandoned. Owner will need coordinate with the CVFPB to remove or abandon crossing according to Title 23 requirements. (O. Magana - DWR UCIP)10/19/2016 Crossing appears to be in good condition. (A. Freitag - DWR Sutter Yard)06/14/2016 Crossing appears to be in good condition. (A. Freitag - DWR Sutter Yard)04/23/2015 No issues seen with pipe. (A. Freitag - DWR Sutter Yard)07/03/2014 Same as last inspection. (A. Freitag - DWR Sutter Yard)08/02/2013 Same as last inspection. (A. Freitag - DWR Sutter Yard)12/23/2013 Same as last inspection. (A. Freitag - DWR Sutter Yard) FIELD_STRUCT_DESC: 2 of 2: 24-inch steel drainage pipe through the levee, 8 feet below the crown. Drainage pumping plant on the landside (LS). Flap gate on the waterside (WS) end. (one 16-inch and one 24-inch pipes [HLM 7.79] authorized under Automatic Board Order (ABO) issued as Permit No. 11467, 1975 - Modglin). [Additional Reference(s): DWR Levee Log, 2005 (HLM 7.19). USACE Sacramento O&M Manual, Unit 506 Part 3 (506.3), 1967, (HLM 7.19), listed as 24-inch pipe]. FS Date: 10/9/2019 3:12:00 PM

24-inch steel pipe and pump house on LS.

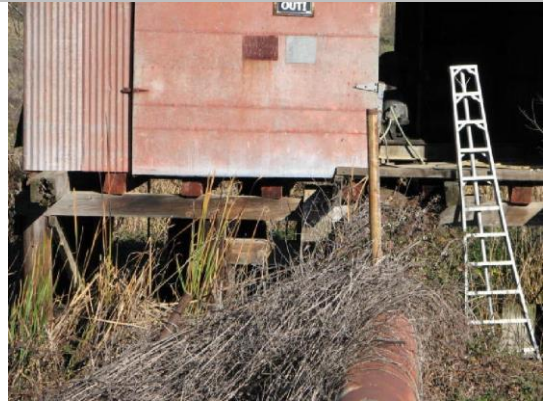
Photo 2 of 3 : UCIP\_FA\_2022\_58639\_46885.jpg

Air vent on pipe at LS pumphouse.

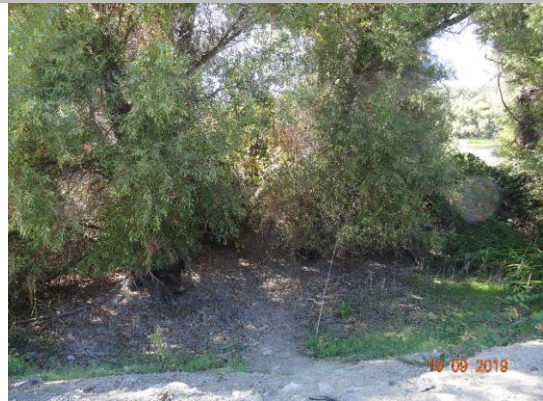
Photo 3 of 3 : UCIP\_FA\_2022\_58639\_82331.jpg

WS view: overview of WS.
