**Flood Control Project Maintenance  
Levee Inspections**

**Maintenance Issue Types Only, Levee Inspection Report By Mile - Fall 2023**

**Sutter Maintenance Yard Maintenance Area 0017**

Waterway	Bank	Unit Miles	Inspection Start/End	Inspector
Unit No. 01 Lake County Sutter Maintenance Yard - Middle Creek	Left	3.87	10/23/2023 10/23/2023	Marvin Marshall

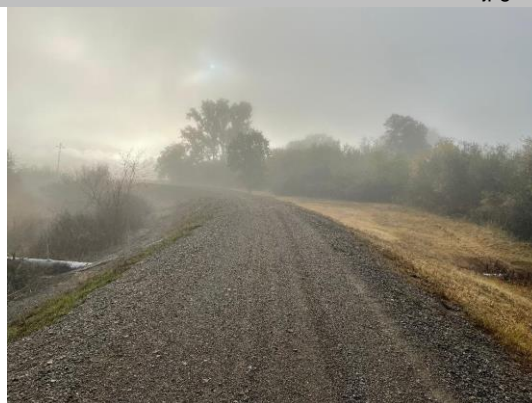
Photo 1 of 3 : UCIP\_FA\_2023\_81417\_117610.jpg

Comment Code						
Inspector Comment						
DS_ID:844 FS_ID:81417 EP_NO: 11463 Repair Type: Non-Urgent EVAL Issue: Crossing Status: Found UCIP Comments: 10/23/2023 Crossing appears to be in good condition.10/09/2019 The levee is maintained by DWR Sutter Yard. The State is currently working on purchasing adjacent land to eventually pursue the de-activation of this levee. Levee crown width through this section is about 12 feet. The UCIP inspection was completed with DWR Inspector, L. Dial, and DWR Sutter Yard Supervisor, B. Reniff. Crossing has been updated from No Action Needed to Non-Urgent; owner has changed [State owns structure]. (O. Magana - DWR UCIP)10/19/2016 Crossing appears to be in good condition. (A. Freitag - DWR Sutter Yard)06/14/2016 crossing appears to be in good condition. (A. Freitag - DWR Sutter Yard)04/23/2015 No issues with pipe. (A. Freitag - DWR Sutter Yard)07/03/2014 Same as last inspection. (A. Freitag - DWR Sutter Yard)12/23/2013 Same as last inspection. (A. Freitag - DWR Sutter Yard)08/02/2013 New flap gate installed. No other issues with pipe. (A. Freitag - DWR Sutter Yard)12/13/2012 Flap gate broken in half and inoperable. (W. Wylie - DWR UCIP) FIELD_STRUCT_DESC: 24-inch corrugated metal drainage pipe through the levee, 12.4 feet below the crown. Flap gate on the waterside (WS) end. Timber walkway on the landside (LS) slope to a timber walkway to pump house mounted on piles in drainage ditch. (24-inch pipe [HLM 3.99] authorized under Automatic Board Order (ABO) issued as Permit No. 11463, 1975 - Audrey Jones). [Additional Reference(s): DWR Levee Log, 2005 (HLM 3.99). USACE Sacramento O&M Manual, Unit 506 Part 2 (SAC506.2), August 1961, Revised 25 May 2011, (HLM 3.99), listed as 24-inch CMP]. FS Date: 10/23/2023 7:21:52 AM

Overview of levee crown looking D/S towards pipe crossing.

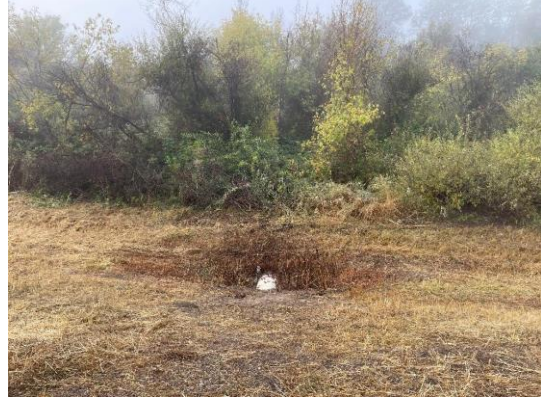
Photo 2 of 3 : UCIP\_FA\_2023\_81417\_117605.jpg

WS view: Overview of WS.

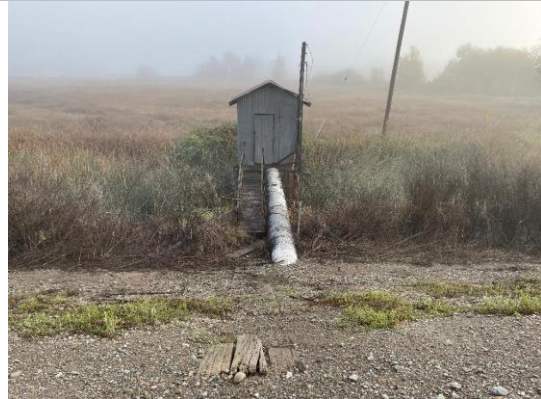
Photo 3 of 3 : UCIP\_FA\_2023\_81417\_117608.jpg

LS view: Overview of landside.

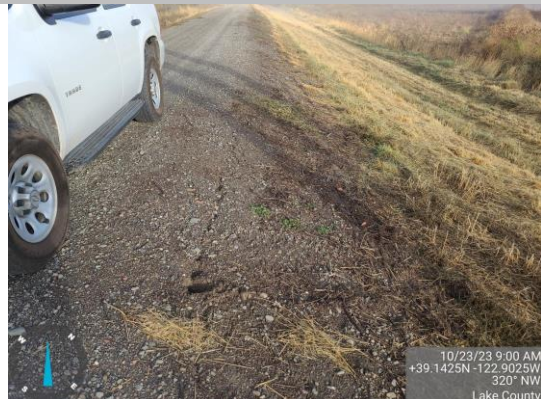
Photo 1 of 1 : FA\_2023\_MA0017\_339\_30\_20231025\_00072.jpg

LM Start	4.12	Rating **	M	Issue No.	30
LM End	4.12	Issue Type +	Ma	Location *	CR
Category	Earthen Levee			GPS Latitude/Longitude	
				Start	End
Item	Cracking			39.142468°	39.142468°
				-122.902557°	-122.902557°
DWR ID	DWR_MA0017_01_f_2023_30				
Comment Code					
CR1 : Monitor and have inspected by geotechnical engineer.					
Inspector Comment					
~15' crack with evidence of rodent activity on the crown

Cracking on the LS shoulder. Fall 2023

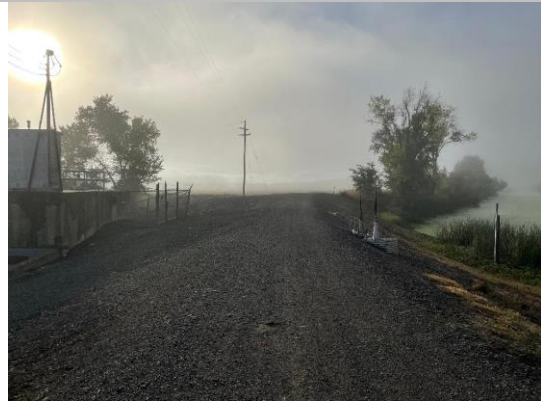
Photo 1 of 3 : UCIP\_FA\_2023\_81418\_117611.jpg

Item	DWR UCIP LMA Responsibility		39.142287°	39.142287°								
			-122.902436°	-122.902436°								
DWR ID	845											
Comment Code												
Inspector Comment												
DS_ID:845 FS_ID:81418 EP_NO: 11464 Repair Type: Non-Urgent EVAL Issue: Crossing Status: Found UCIP Comments: 10/23/2023 Crossing appears to be in good condition. (J. Taylor - DWR UCIP)10/09/2019 The levee is maintained by DWR Sutter Yard. The State is currently working on purchasing adjacent land to eventually pursue the de-activation of this levee. Levee crown width through this section is about 12 feet. The UCIP inspection was completed with DWR Inspector, L. Dial, and DWR Sutter Yard Supervisor, B. Reniff. Crossing has been updated from No Action Needed to Non-Urgent; owner has changed [State maintains structure]. (O. Magana - DWR UCIP)10/27/2017 This structure is inspected annually under the Structure and Channel Summer Inspection (part of the Levee Inspection Program) conducted by the DWR Flood Project Integrity and Inspection Branch (FPIIB). (O. Magana - DWR UCIP)10/19/2016 Crossing appears to be in good condition. (A. Freitag - DWR Sutter Yard)06/14/2016 crossing appears to be in good condition. (A. Freitag - DWR Sutter Yard)04/23/2015 No issues with pipe. (A. Freitag - DWR Sutter Yard)07/03/2014 Same as last inspection. (A. Freitag - DWR Sutter Yard)12/23/2013 Same as last inspection. (A. Freitag - DWR Sutter Yard)08/02/2013 Same as last inspection. (A. Freitag - DWR Sutter Yard) FIELD_STRUCT_DESC: [Bloody Island Pumping Plant] 1 of 2: 42-inch corrugated metal drainage pipe through the levee, 20.2 feet below the crown. Concrete headwall and discharge apron on the waterside (WS) shoulder. Three vertical pump units mounted on a reinforced concrete pump platform in drainage ditch at the landside (LS) toe. Flap gates in concrete discharge well on the LS. Combination flap and slide gate on a gravity pipe from drainage ditch into discharge well. (two 42-inch pipes [HLM 4.18] authorized under Automatic Board Order (ABO) issued as Permit No. 11464, 1975 - Lake County). [Additional Reference(s): DWR Levee Log, 2005 (HLM 4.17). USACE Sacramento O&M Manual, Unit 506, Part 1 (SAC506.1) April 1961, and Part 2 (SAC506.2) August 1961, Revised 25 May 2011, (HLM 4.18), two 42-inch CMP -- referred to as Bloody Island Pumping Plant]. FS Date: 10/23/2023 7:42:17 AM

Overview of levee crown looking D/S towards pipe crossings.

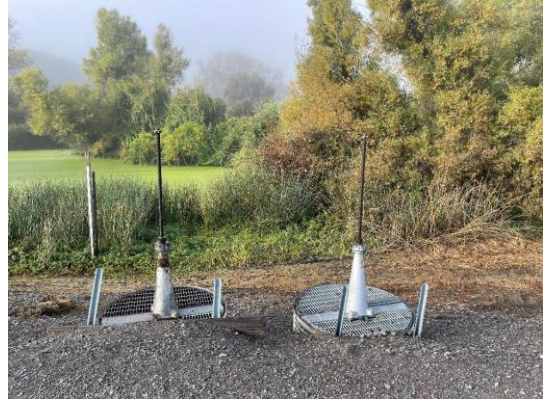
Photo 2 of 3 : UCIP\_FA\_2023\_81418\_117612.jpg

WS view: Overview of WS with two positive closure devices in CMP risers on WS shoulder (DSID 845 right).

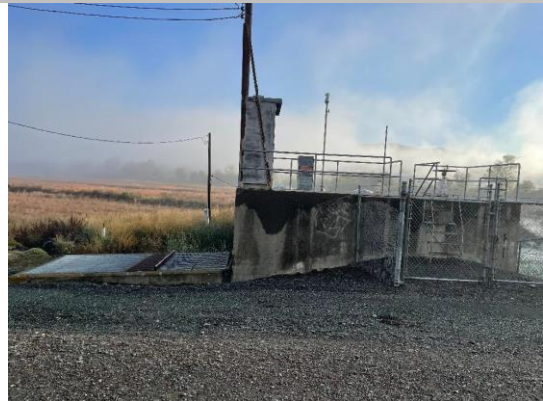
Photo 3 of 3 : UCIP\_FA\_2023\_81418\_117615.jpg

LS view: Overview of LS. Bloody Island Pumping Plant on LS shoulder and toe.

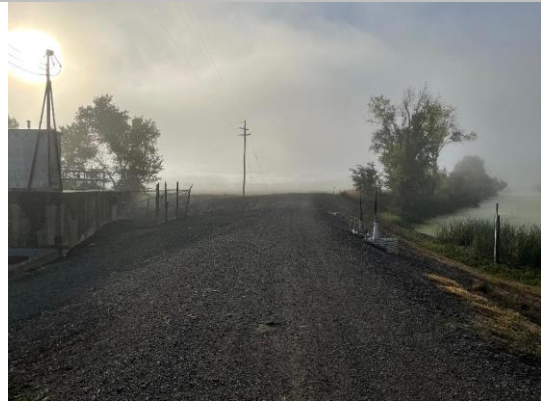
Photo 1 of 3 : UCIP\_FA\_2023\_81419\_117617.jpg

Comment Code					
Inspector Comment					
DS_ID:852 FS_ID:81419 EP_NO: 11464 Repair Type: Non-Urgent EVAL Issue: Crossing Status: Found UCIP Comments: 10/23//2023 Crossing appears to be in good condition. (J. Taylor - DWR UCIP)10/09/2019 The levee is maintained by DWR Sutter Yard. The State is currently working on purchasing adjacent land to eventually pursue the de-activation of this levee. Levee crown width through this section is about 12 feet. The UCIP inspection was completed with DWR Inspector, L. Dial, and DWR Sutter Yard Supervisor, B. Reniff. Crossing has been updated from No Action Needed to Non-Urgent; owner has changed [State maintains structure]. (O. Magana - DWR UCIP)10/27/2017 This structure is inspected annually under the Structure and Channel Summer Inspection (part of the Levee Inspection Program) conducted by the DWR Flood Project Integrity and Inspection Branch (FPIIB). (O. Magana - DWR UCIP)10/19/2016 Crossing appears to be in good condition. (A. Freitag - DWR Sutter Yard)06/14/2016 Crossing appears to be in good condition. (A. Freitag - DWR Sutter Yard)04/23/2015 No issues with pipe. (A. Freitag - DWR Sutter Yard)07/03/2014 Same as last inspection. (A. Freitag - DWR Sutter Yard)12/23/2013 Same as last inspection. (A. Freitag - DWR Sutter Yard)08/02/2013 Same as last inspection. (A. Freitag - DWR Sutter Yard) FIELD_STRUCT_DESC: [Bloody Island Pumping Plant] 2 of 2: 42-inch corrugated metal drainage pipe through the levee, 14.6 feet below the crown. Concrete headwall and discharge apron on the waterside (WS) shoulder. Three vertical pump units mounted on a reinforced concrete pump platform in drainage ditch at the landside (LS) toe. Flap gates in concrete discharge well on the LS. Combination flap and slide gate on a gravity pipe from drainage ditch into discharge well. (two 42-inch pipes [HLM 4.18] authorized under Automatic Board Order (ABO) issued as Permit No. 11464, 1975 - Lake County). [Additional Reference(s): DWR Levee Log, 2005 (HLM 4.17). USACE Sacramento O&M Manual, Unit 506, Part 1 (SAC506.1) April 1961, and Part 2 (SAC506.2) August 1961, Revised 25 May 2011, (HLM 4.18), two 42-inch CMP -- referred to as Bloody Island Pumping Plant]. FS Date: 10/23/2023 7:54:52 AM

Overview of levee crown looking D/S towards pipe crossings.

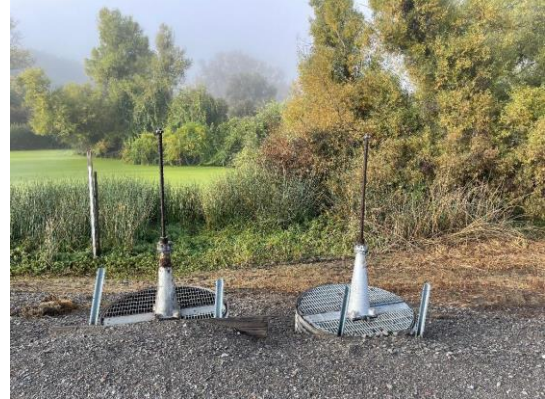
Photo 2 of 3 : UCIP\_FA\_2023\_81419\_117618.jpg

WS view: Overview of WS with two positive closure devices in CMP risers on WS shoulder (DSID 852 left).

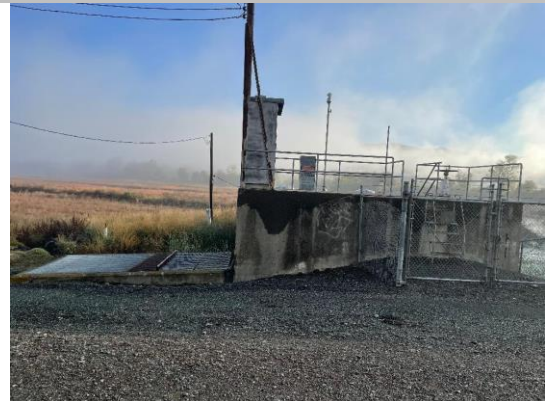
Photo 3 of 3 : UCIP\_FA\_2023\_81419\_117621.jpg

LS view: Overview of LS. Bloody Island Pumping Plant on LS shoulder and toe.

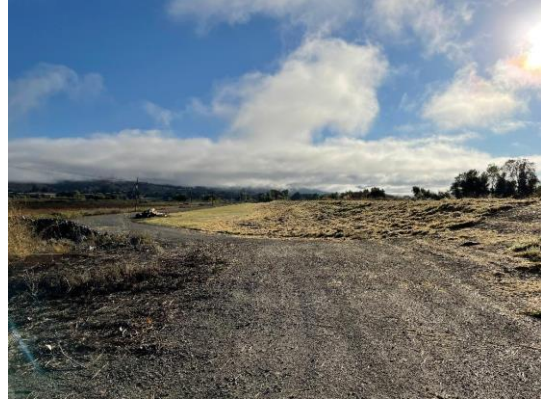
Photo 1 of 3 : UCIP\_FA\_2023\_81421\_117627.jpg

Comment Code					
Inspector Comment					
DS_ID:847 FS_ID:81421 EP_NO: 11469 Repair Type: Non-Urgent EVAL Issue: 11, Maintenance Compliance Issue Crossing Status: Found UCIP Comments: 10/23/2023 Sack ring has deteriorated so thta only sack fill material is left. This may or may not still be an issue so code 11 still applies. (J. Taylor - DWR UCIP)10/09/2019 The levee is maintained by DWR Sutter Yard. The State is currently working on purchasing adjacent land to eventually pursue the de-activation of this levee. Levee crown width ranges from 3 to 4-feet. The UCIP inspection was completed with DWR Inspector, L. Dial, and DWR Sutter Yard Supervisor, B. Reniff. Crossing remains Non-Urgent; sack ring built to control levee seepage has deteriorated and needs to be rebuilt or maintained. Pump station is maintained by RD2070. (O. Magana - DWR UCIP)10/19/2016 Sack ring still in place. (A. Freitag - DWR Sutter Yard)06/14/2016 Sack ring is still built up underneath the pipes. (A. Freitag - DWR Sutter Yard)04/23/2015 Sack ring is still built up underneath the pipes. (A. Freitag - DWR Sutter Yard)07/03/2014 Same as last inspection. (A. Freitag - DWR Sutter Yard)12/23/2013 Same as last inspection. (A. Freitag - DWR Sutter Yard)08/02/2013 Same as last inspection. (A. Freitag - DWR Sutter Yard)12/13/2012 Flood fight materials-ring levees around both LS and WS slopes at pipe crossing. This may or may not be an issue. (W. Wylie - DWR UCIP) FIELD_STRUCT_DESC: 1 of 2: 16-inch steel drainage pipe through the levee, 5 feet below the crown. Drainage pumping plant on the landside (LS). Flap gate on the waterside (WS) end. (one 16-inch and one 36-inch pipes [HLM 5.43] authorized under Automatic Board Order (ABO) issued as Permit No. 11469, 1975 - RD 2070). [Additional Reference(s): DWR Levee Log, 2005 (HLM 5.43). USACE Sacramento O&M Manual, Unit 506 Part 3 (506.3), 1967, (HLM 5.43), listed as 16-inch pipe]. FS Date: 10/23/2023 8:11:16 AM

Overview of levee crown looking D/S at location of crossing.

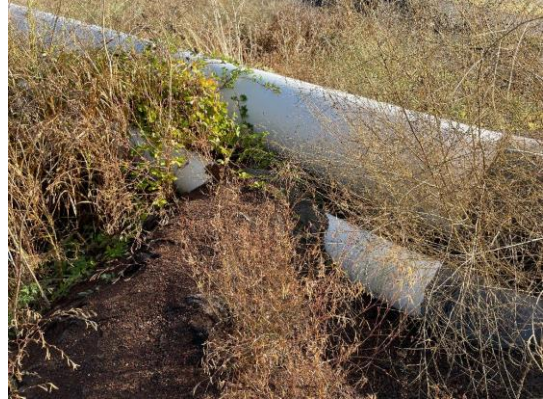
Photo 2 of 3 : UCIP\_FA\_2023\_81421\_117628.jpg

LS View: view of 16-inch pipe still partially covered by sac ring at levee toe.

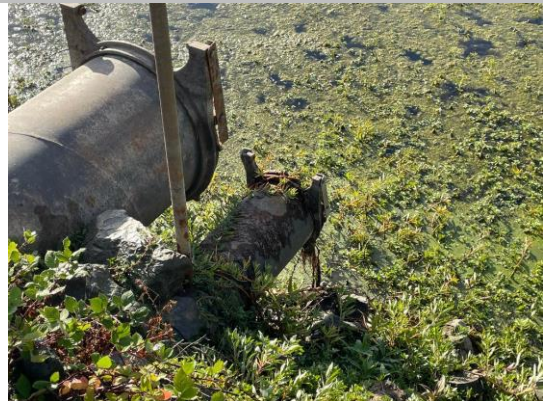
Photo 3 of 3 : UCIP\_FA\_2023\_81421\_117631.jpg

WS view: view of pipe outlet with flap gates. Gates appear to be in working condition but vegetation/water limits inspection access.

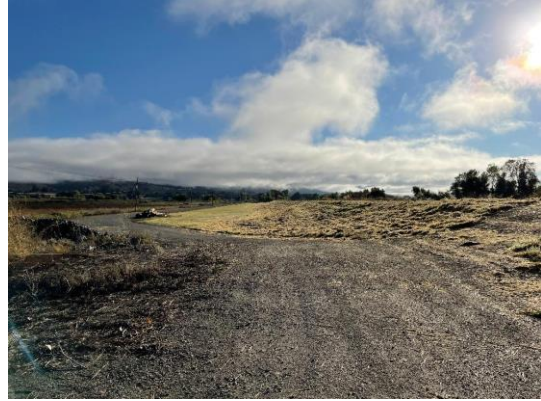
Photo 1 of 3 : UCIP\_FA\_2023\_81422\_117632.jpg

Comment Code						
Inspector Comment						
DS_ID:853 FS_ID:81422 EP_NO: 11469 Repair Type: Non-Urgent EVAL Issue: 11, Maintenance Compliance Issue Crossing Status: Found UCIP Comments: 10/23/2023 Crossing appears to be in good condition other than sack ring material still partially covering crossings, may still be a maintenance compliance issue. (J. Taylor - DWR UCIP)10/09/2019 The levee is maintained by DWR Sutter Yard. The State is currently working on purchasing adjacent land to eventually pursue the de-activation of this levee. Levee crown width ranges from 3 to 4-feet. The UCIP inspection was completed with DWR Inspector, L. Dial, and DWR Sutter Yard Supervisor, B. Reniff. Crossing remains Non-Urgent; sack ring built to control levee seepage has deteriorated and needs to be rebuilt or maintained. Pump station is maintained by RD2070. (O. Magana - DWR UCIP)10/19/2016 Sack ring still in place. (A. Freitag - DWR Sutter Yard)06/14/2016 Sack ring is still built up underneath the pipes. (A. Freitag - DWR Sutter Yard)04/23/2015 Sack ring still built up underneath the pipes. (A. Freitag - DWR Sutter Yard)07/03/2014 Same as last inspection. (A. Freitag - DWR Sutter Yard)12/23/2013 Same as last inspection. (A. Freitag - DWR Sutter Yard)08/02/2013 Same as last inspection. (A. Freitag - DWR Sutter Yard)12/13/2012 flood fight materials-ring levees around both LS and WS slopes at pipe crossing. This may or may not be an issue. (W. Wylie - DWR UCIP) FIELD_STRUCT_DESC: 2 of 2: 36-inch steel drainage pipe through the levee, 5 feet below the crown. Flap gate and air vent on the waterside (WS) slope. (one 36-inch and one 16-inch pipes [HLM 5.43] authorized under Automatic Board Order (ABO) issued as Permit No. 11469, 1975 - RD 2070). [Additional Reference(s): DWR Levee Log, 2005 (HLM 5.43). USACE Sacramento O&M Manual, Unit 506 Part 3 (506.3), 1967, (HLM 5.43), listed as 36-inch pipe]. FS Date: 10/23/2023 8:21:45 AM

Overview of levee crown looking D/S at location of crossing.

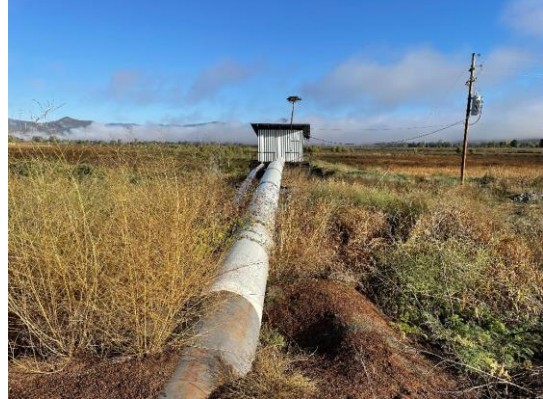
Photo 2 of 3 : UCIP\_FA\_2023\_81422\_117633.jpg

LS view: Overview of LS with 36-inch pipe visible entering pump house at LS toe.

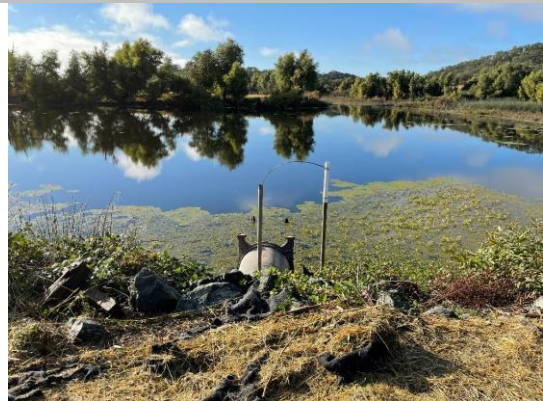
Photo 3 of 3 : UCIP\_FA\_2023\_81422\_117635.jpg

WS view: overview of WS with pipe outlets visible.

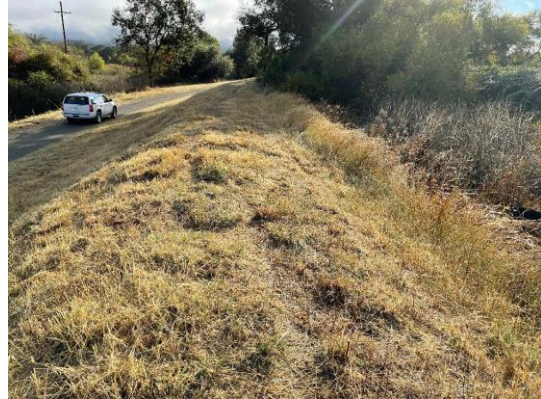
Photo 1 of 3 : UCIP\_FA\_2023\_81423\_117640.jpg

Comment Code					
Inspector Comment					
DS_ID:848 FS_ID:81423 EP_NO: 11457 Repair Type: Non-Urgent EVAL Issue: Crossing Status: Found UCIP Comments: 10/23/2023 Still no wheel to operate slide gate, LS headwall and pipe found see 2023 pictures.10/09/2019 The levee is maintained by DWR Sutter Yard. The State is currently working on purchasing adjacent land to eventually pursue the de-activation of this levee. Levee crown width ranges from 3 to 4-feet. The UCIP inspection was completed with DWR Inspector, L. Dial, and DWR Sutter Yard Supervisor, B. Reniff. Crossing remains Non-Urgent; crossing has been abandoned, no riser lid or slide gate wheel are present. DWR DMP geophysical investigation found signals of potential metal pipe through this section of the levee. Owner will need coordinate with the CVFPB to remove or abandon crossing according to Title 23 requirements. (O. Magana - DWR UCIP) 10/19/2016 No riser lid or slide gate wheel. (A. Freitag - DWR Sutter Yard)06/14/2016 No riser lid and no wheel to operate screw gate. (A. Freitag - DWR Sutter Yard)04/23/2015 No cover on riser and no wheel to operate gate. (A. Freitag - DWR Sutter Yard)07/03/2014 Same as last inspection. (A. Freitag - DWR Sutter Yard)12/23/2013 Same as last inspection. (A. Freitag - DWR Sutter Yard)08/02/2013 Handle to operate gate was in place but still no cover on riser. (A. Freitag - DWR Sutter Yard)12/13/2012 No cover on CMP riser and no handle for actuating gate. This may or may not be an issue. (W. Wylie - DWR UCIP) FIELD_STRUCT_DESC: 24-inch drainage pipe under patrol road and through the levee, 13.5 feet below the crown. Concrete "U" shaped headwall on the landside (LS) end. Slide gate in 36-inch corrugated metal pipe (CMP) riser on the waterside (WS) slope. Riser unit is mounted on concrete base. (24-inch pipe [HLM 5.87] authorized under Automatic Board Order (ABO) issued as Permit No. 11457, 1975 - Crawford). [Additional Reference(s): DWR Levee Log, 2005 (HLM 5.87). USACE Sacramento O&M Manual, Unit 506 Part 3 (506.3), 1967, (HLM 5.87), listed as 24-inch pipe]. FS Date: 10/23/2023 8:31:09 AM

Overview of levee crown looking D/S at location of crossing.

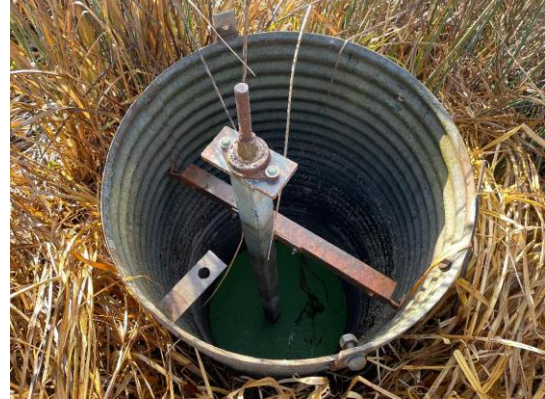
Photo 2 of 3 : UCIP\_FA\_2023\_81423\_117642.jpg

WS view: inside CMP riser, missing handle to operate slide gate.

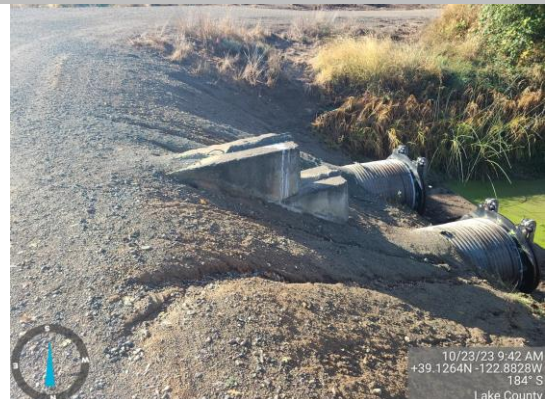
Photo 1 of 1 : FA\_2023\_MA0017\_339\_31\_20231025\_00074.jpg

LM Start	5.95	Rating **	M	Issue No.	31
LM End	5.95	Issue Type +	Ma	Location *	WS
Category	Earthen Levee			GPS Latitude/Longitude	
				Start	End
Item	Erosion / Rills			39.126369°	39.126369°
				-122.882782°	-122.882782°
DWR ID	DWR_MA0017_01_f_2023_31				
Comment Code					
E5 : Schedule repair of rills prior to the next inspection.					
Inspector Comment

Rilling on the WS slope. Fall 2023

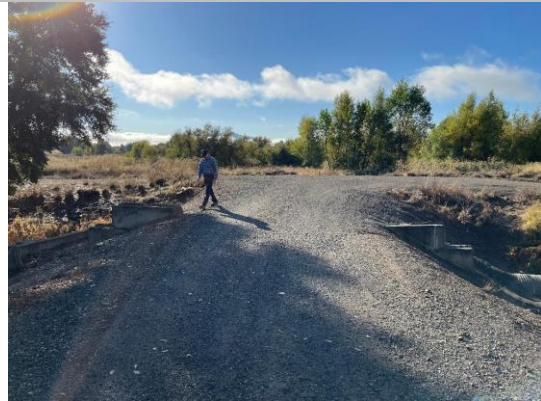
Photo 1 of 3 : UCIP\_FA\_2023\_81424\_117643.jpg

Comment Code						
Inspector Comment						
DS_ID:849 FS_ID:81424 EP_NO: 11467 Repair Type: Urgent EVAL Issue: 3a, Flood Risk Crossing Status: Found UCIP Comments: 10/23/2023 Wood debris opening flap gate on WS leaves crossing vulnerable to flooding. Some erosion on WS due to runoff, not pipe related but should be monitored for maintenance. (J. Taylor - DWR UCIP) 09/25/2023 DMP internal video inspection has found none or minor pipe defects. Recommend next video inspection in 5 years. (J. Taylor - DWR UCIP)10/09/2019 The levee is maintained by DWR Sutter Yard. The State is currently working on purchasing adjacent land to eventually pursue the de-activation of this levee. Levee crown width is about 12 feet. The UCIP inspection was completed with DWR Inspector, L. Dial, and DWR Sutter Yard Supervisor, B. Reniff. Crossing has been updated from No Action Needed to Non-Urgent; need to audit record to confirm if ABO lists current owner for this structure. (O. Magana - DWR UCIP)10/27/2017 This structure is inspected annually under the Structure and Channel Summer Inspection (part of the Levee Inspection Program) conducted by the DWR Flood Project Integrity and Inspection Branch (FPIIB). (O. Magana - DWR UCIP)10/19/2016 Crossing appears to be in good condition. (A. Freitag - DWR Sutter Yard)06/14/2016 Flap gate propped open. Will make sure its closed before flood season. (A. Freitag - DWR Sutter Yard)04/23/2015 Flap gate propped open. Not an issue at this time. Will close it before high water season. (A. Freitag - DWR Sutter Yard)07/03/2014 Same as last inspection. (A. Freitag - DWR Sutter Yard)12/23/2013 Same as last inspection. (A. Freitag - DWR Sutter Yard)08/02/2013 Same as last inspection. (A. Freitag - DWR Sutter Yard) FIELD_STRUCT_DESC: [Highland Canal Diversion Weir and Drainage] 1 of 2: 54-inch CIPP lined corrugated metal drainage pipe through the levee 11.5 feet below the crown. Highland Canal Diversion Weir and Drainage Structure on the landside (LS). Concrete headwall on both landside (LS) and waterside (WS) toe with flap gate on the WS toe. (two 54-inch pipes [HLM 6.05] authorized under Automatic Board Order (ABO) issued as Permit No. 11467, 1975 - Modglin). [Additional Reference(s): DWR Levee Log, 2005 (HLM 6.05). USACE Sacramento O&M Manual, Unit 506 Part 3 (506.3), 1967, (HLM 6.05), listed as two 54-inch pipes]. FS Date: 10/23/2023 8:45:44 AM

Overview of levee crown looking D/S.

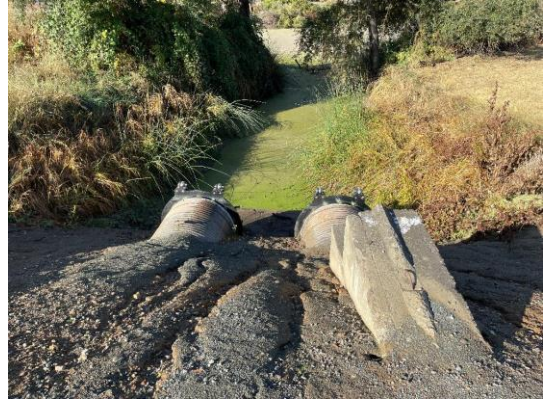
Photo 2 of 3 : UCIP\_FA\_2023\_81424\_117644.jpg

WS view: overview of WS with two 54-inch CIPP lined pipes visible on toe of levee.

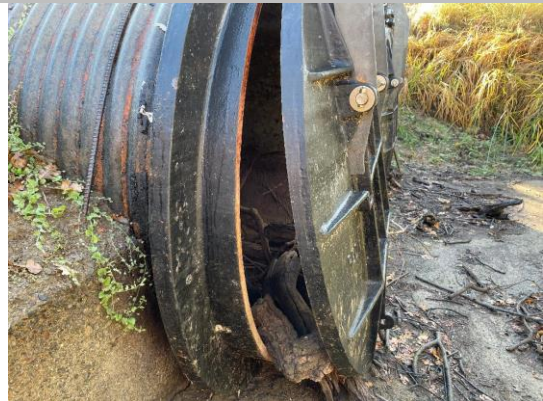
Photo 3 of 3 : UCIP\_FA\_2023\_81424\_117646.jpg

WS view: side view of wooden debris preventing flap gate on WS from closing.

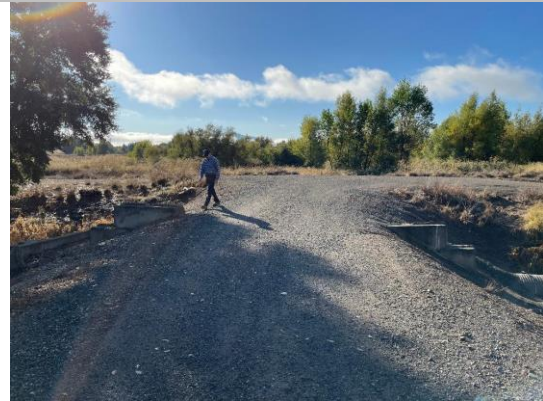
Photo 1 of 3 : UCIP\_FA\_2023\_81426\_117650.jpg

Comment Code					
Inspector Comment					
DS_ID:854 FS_ID:81426 EP_NO: 11467 Repair Type: Urgent EVAL Issue: 3a, Flood Risk Crossing Status: Found UCIP Comments: 10/23/2023 Wood debris opening flap gate on WS leaves crossing vulnerable to flooding. Some erosion on WS due to runoff, not pipe related but should be monitored for maintenance. (J. Taylor - DWR UCIP)09/25/2023 DMP internal video inspection has found none or minor pipe defects. Recommend next video inspection in 5 years. (J. Taylor - DWR UCIP)10/09/2019 The levee is maintained by DWR Sutter Yard. The State is currently working on purchasing adjacent land to eventually pursue the de-activation of this levee. Levee crown width is about 12 feet. The UCIP inspection was completed with DWR Inspector, L. Dial, and DWR Sutter Yard Supervisor, B. Reniff. Crossing has been updated from No Action Needed to Non-Urgent; need to audit record to confirm if ABO lists current owner for this structure. (O. Magana - DWR UCIP)10/27/2017 This structure is inspected annually under the Structure and Channel Summer Inspection (part of the Levee Inspection Program) conducted by the DWR Flood Project Integrity and Inspection Branch (FPIIB). (O. Magana - DWR UCIP)10/19/2016 Crossing appears to be in good condition. (A. Freitag - DWR Sutter Yard)06/14/2016 Flap gate propped open. Will make sure its closed before flood season. (A. Freitag - DWR Sutter Yard)04/23/2015 Flap gate propped open. Not an issue at this time. Will close it before high water season. (A. Freitag - DWR Sutter Yard)07/03/2014 Same as last inspection. (A. Freitag - DWR Sutter Yard)12/23/2013 Same as last inspection. (A. Freitag - DWR Sutter Yard)08/02/2013 Same as last inspection. (A. Freitag - DWR Sutter Yard) FIELD_STRUCT_DESC: [Highland Canal Diversion Weir and Drainage] 2 of 2: 54-inch CIPP lined corrugated metal drainage pipe through the levee, 11.5 feet below the crown. Highland Canal Diversion Weir and Drainage Structure on the landside (LS). Concrete headwall on both landside (LS) and waterside (WS) toe with flap gate on the WS toe. (two 54-inch pipes [HLM 6.05] authorized under Automatic Board Order (ABO) issued as Permit No. 11467, 1975 - Modglin). [Additional Reference(s): DWR Levee Log, 2005 (HLM 6.05). USACE Sacramento O&M Manual, Unit 506 Part 3 (506.3), 1967, (HLM 6.05), listed as two 54-inch pipes]. FS Date: 10/23/2023 9:01:19 AM

Overview of levee crown looking D/S.

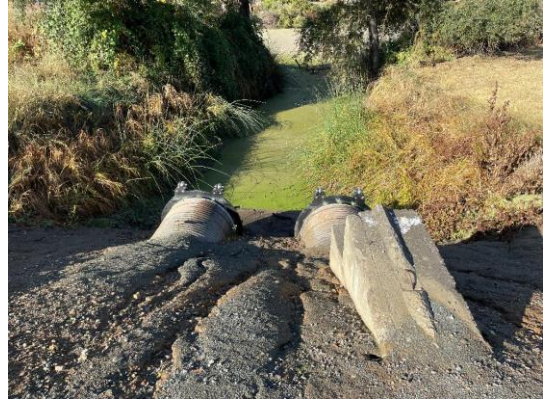
Photo 2 of 3 : UCIP\_FA\_2023\_81426\_117651.jpg

WS view: overview of WS with two 54-inch CIPP lined pipes visible on toe of levee.

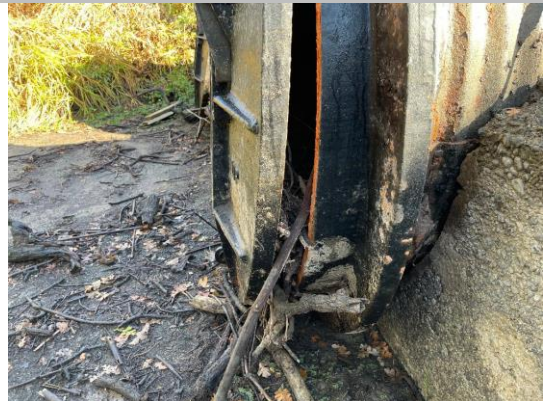
Photo 3 of 3 : UCIP\_FA\_2023\_81426\_117653.jpg

WS view: side view of wooden debris preventing flap gate on WS from closing.

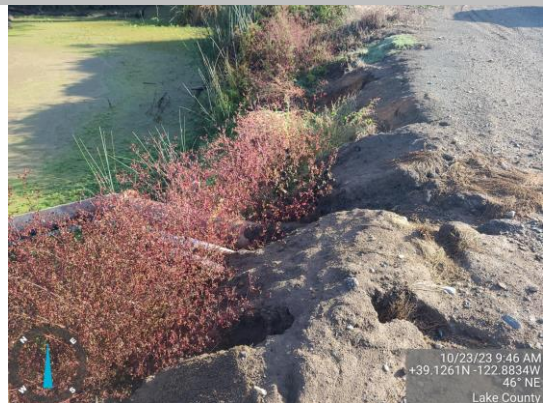
Photo 1 of 1 : FA\_2023\_MA0017\_339\_32\_20231025\_00075.jpg

LM Start	6.00	Rating **	M	Issue No.	32
LM End	6.00	Issue Type +	Ma	Location *	WS
Category	Earthen Levee			GPS Latitude/Longitude	
				Start	End
Item	Erosion / Rills			39.126029°	39.126029°
				-122.883371°	-122.883371°
DWR ID	DWR_MA0017_01_f_2023_32				
Comment Code					
E5 : Schedule repair of rills prior to the next inspection.					
Inspector Comment

Rilling on the WS slope. Fall 2023

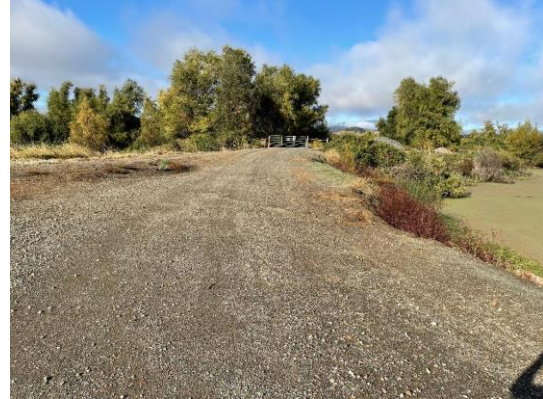
Photo 1 of 3 : UCIP\_FA\_2023\_81430\_117669.jpg

DS\_ID:850  
FS\_ID:81430  
EP\_NO: 11467  
Repair Type: Urgent  
EVAL Issue: 2b, Levee Integrity  
Crossing Status: Found  
UCIP Comments: 10/23/2023 Erosion present on WS.10/09/2019  
The levee is maintained by DWR Sutter Yard. The State is currently working on purchasing adjacent land to eventually pursue the de-activation of this levee. Levee crown width is more than 12 feet. The UCIP inspection was completed with DWR Inspector, L. Dial, and DWR Sutter Yard Supervisor, B. Reniff. Crossing remains Urgent; WS erosion is still present along WS slope. This crossing has been modified. It appears that this pipe is conveying water from WS to LS and LS to WS. Recommend auditing record to determine current owner. (O. Magana - DWR UCIP)09/06/2018 Same as last inspection; WS erosion is still present so the crossing remains Urgent. (D. Sanoski - DWR UCIP).10/19/2016 WS erosion still present. (A. Freitag - DWR Sutter Yard)06/14/2016 WS erosion is still present. (A. Freitag - DWR Sutter Yard)04/23/2015 Same as last inspection. (A. Freitag - DWR Sutter Yard)07/03/2014 Same as last inspection. (A. Freitag - DWR Sutter Yard)12/23/2013 Same as last inspection. (A. Freitag - DWR Sutter Yard)08/02/2013 Same as last inspection. (A. Freitag - DWR Sutter Yard)12/13/2012 The pipe and appurtenances do not match what was described in the permit (PN: 11467). Does not appear to be in compliance with board regulations. (W. Wylie - DWR UCIP)

Overview of levee crown looking D/S.

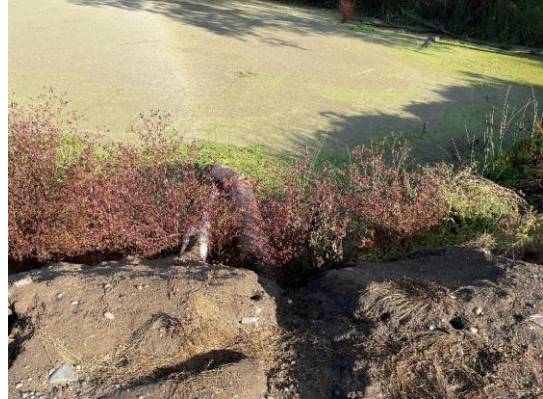
Photo 2 of 3 : UCIP\_FA\_2023\_81430\_117670.jpg

WS view: Overview of WS with erosion present.

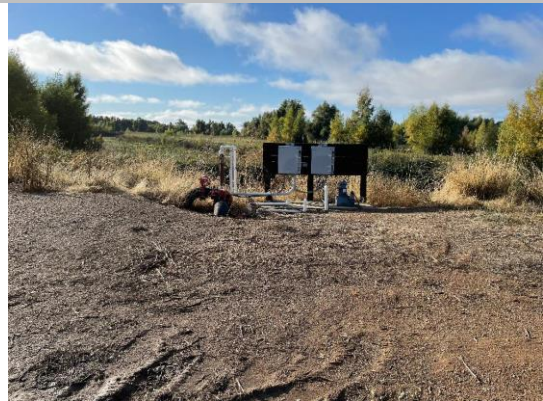
Photo 3 of 3 : UCIP\_FA\_2023\_81430\_117671.jpg

LS view: overview of LS with pump station on shoulder.

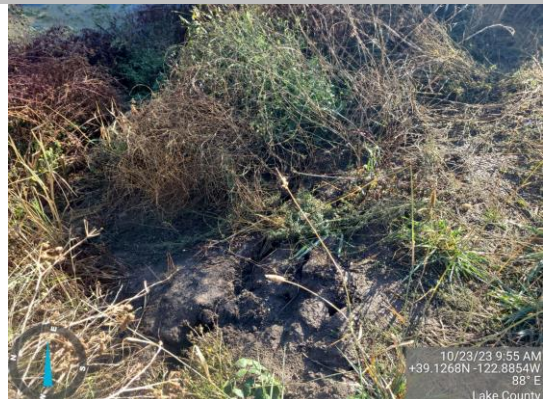
Photo 1 of 1 : FA\_2023\_MA0017\_339\_33\_20231025\_00076.jpg

LM Start	6.11	Rating **	M	Issue No.	33
LM End	6.11	Issue Type +	Ma	Location *	WS
Category	Earthen Levee			GPS Latitude/Longitude	
				Start	End
Item	Erosion / Bank Caving			39.126400°	39.126400°
				-122.885512°	-122.885512°
DWR ID	DWR_MA0017_01_f_2023_33				
Comment Code					
E2 : Schedule repair of erosion site prior to the next inspection.					
Inspector Comment					
Bank is sloughing in area near fallen tree.

Cracking/Sloughing near the down tree on the WS slope. Fall 2023

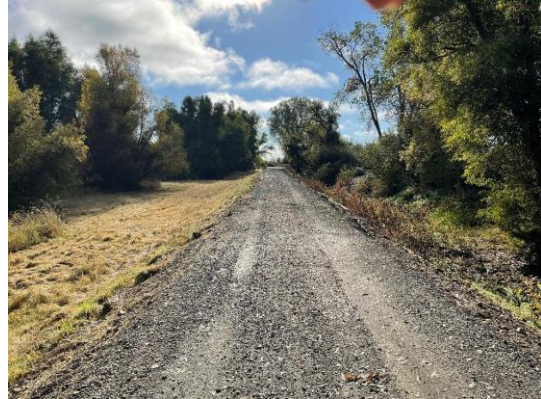
Photo 1 of 3 : UCIP\_FA\_2023\_81432\_117674.jpg

Comment Code						
Inspector Comment						
DS_ID:851 FS_ID:81432 EP_NO: 11467 Repair Type: Non-Urgent EVAL Issue: Crossing Status: Found UCIP Comments: 10/23/2023 Vegetation limited inspection, 16-inch pipe not found. (J. Taylor - DWR UCIP)10/09/2019 The levee is maintained by DWR Sutter Yard. The State is currently working on purchasing adjacent land to eventually pursue the de-activation of this levee. Levee crown width is about 12 feet. The UCIP inspection was completed with DWR Inspector, L. Dial, and DWR Sutter Yard Supervisor, B. Reniff. Crossing remains Non-Urgent; crossing has been abandoned. Owner will need coordinate with the CVFPB to remove or abandon crossing according to Title 23 requirements. (O. Magana - DWR UCIP)10/19/2016 Abandoned- should be done so properly. (A. Freitag - DWR Sutter Yard)06/14/2016 Abandoned crossing. (A. Freitag - DWR Sutter Yard)04/23/2015 Same as last inspection. Pipe still needs to be properly abandoned. (A. Freitag - DWR Sutter Yard)07/03/2014 Same as last inspection. (A. Freitag - DWR Sutter Yard)12/23/2013 Same as last inspection. (A. Freitag - DWR Sutter Yard)08/02/2013 Same as last inspection. (A. Freitag - DWR Sutter Yard)12/13/2012 Pipe should be properly abandoned. (W. Wylie - DWR UCIP) FIELD_STRUCT_DESC: 1 of 2: 16-inch steel drainage pipe through the levee, 8 feet below the crown. Drainage pumping plant on the landside (LS). Flap gate on the waterside (WS) end. Steel plate welded on end of pipe at LS toe. (one 16-inch and one 24-inch pipes [HLM 7.79] authorized under Automatic Board Order (ABO) issued as Permit No. 11467, 1975 - Modglin). [Additional Reference(s): DWR Levee Log, 2005 (HLM 7.19). USACE Sacramento O&M Manual, Unit 506 Part 3 (506.3), 1967, (HLM 7.19), listed as 16-inch pipe]. FS Date: 10/23/2023 9:44:51 AM

Overview of levee crown looking D/S.

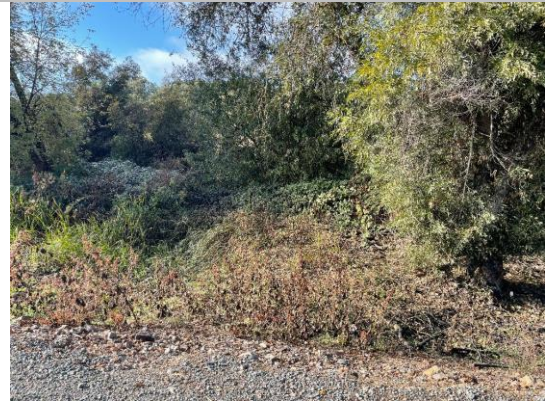
Photo 2 of 3 : UCIP\_FA\_2023\_81432\_117675.jpg

WS view: overview of WS with heavy vegetation limiting inspection.

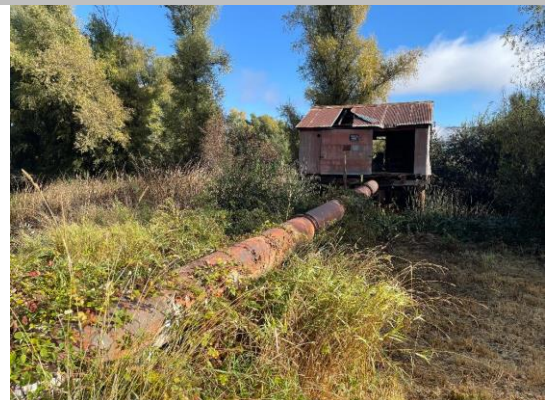
Photo 3 of 3 : UCIP\_FA\_2023\_81432\_117676.jpg

LS view: Overview of LS with 24-inch pipe visible but dense vegetation limit inspection of 16-inch pipe.

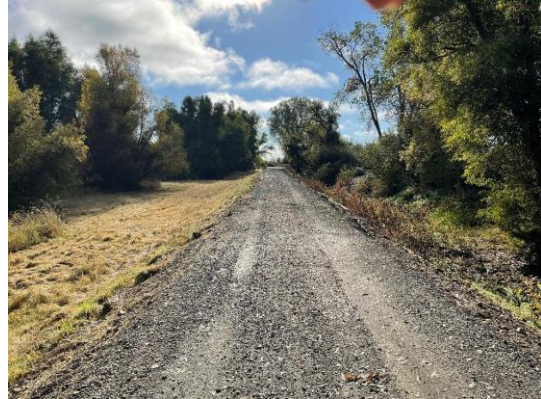
Photo 1 of 3 : UCIP\_FA\_2023\_81433\_117678.jpg

Comment Code					
Inspector Comment					
DS_ID:855 FS_ID:81433 EP_NO: 11467 Repair Type: Non-Urgent EVAL Issue: Crossing Status: Found UCIP Comments: 10/23/2023 Pipe structure is deteriorating, pipe needs to be removed or abandoned according to Title 23 requirements. (J. Taylor - DWR UCIP)10/09/2019 The levee is maintained by DWR Sutter Yard. The State is currently working on purchasing adjacent land to eventually pursue the de-activation of this levee. Levee crown width is about 12 feet. The UCIP inspection was completed with DWR Inspector, L. Dial, and DWR Sutter Yard Supervisor, B. Reniff. Crossing remains Non-Urgent; crossing has been abandoned. Owner will need coordinate with the CVFPB to remove or abandon crossing according to Title 23 requirements. (O. Magana - DWR UCIP)10/19/2016 Crossing appears to be in good condition. (A. Freitag - DWR Sutter Yard)06/14/2016 Crossing appears to be in good condition. (A. Freitag - DWR Sutter Yard)04/23/2015 No issues seen with pipe. (A. Freitag - DWR Sutter Yard)07/03/2014 Same as last inspection. (A. Freitag - DWR Sutter Yard)08/02/2013 Same as last inspection. (A. Freitag - DWR Sutter Yard)12/23/2013 Same as last inspection. (A. Freitag - DWR Sutter Yard) FIELD_STRUCT_DESC: 2 of 2: 24-inch steel drainage pipe through the levee, 8 feet below the crown. Drainage pumping plant on the landside (LS). Flap gate on the waterside (WS) end. (one 16-inch and one 24-inch pipes [HLM 7.79] authorized under Automatic Board Order (ABO) issued as Permit No. 11467, 1975 - Modglin). [Additional Reference(s): DWR Levee Log, 2005 (HLM 7.19). USACE Sacramento O&M Manual, Unit 506 Part 3 (506.3), 1967, (HLM 7.19), listed as 24-inch pipe]. FS Date: 10/23/2023 9:49:26 AM

Overview of levee crown looking D/S.

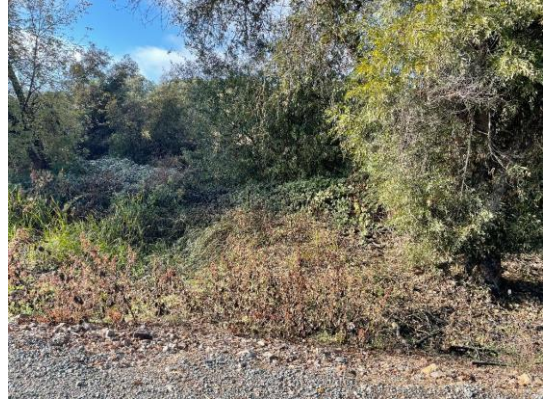
Photo 2 of 3 : UCIP\_FA\_2023\_81433\_117679.jpg

WS view: overview of WS with heavy vegetation limiting inspection.

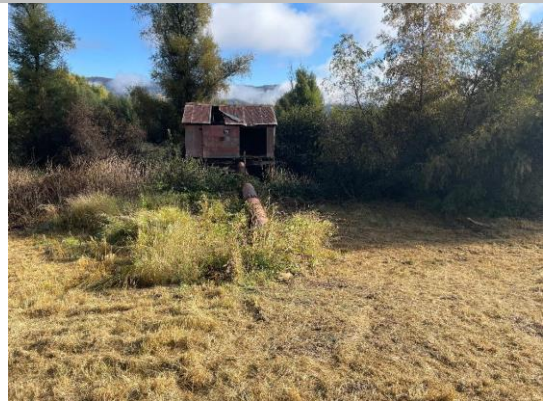
Photo 3 of 3 : UCIP\_FA\_2023\_81433\_117680.jpg

LS view: Overview of LS with 24-inch pipe visible and pump house on levee toe.

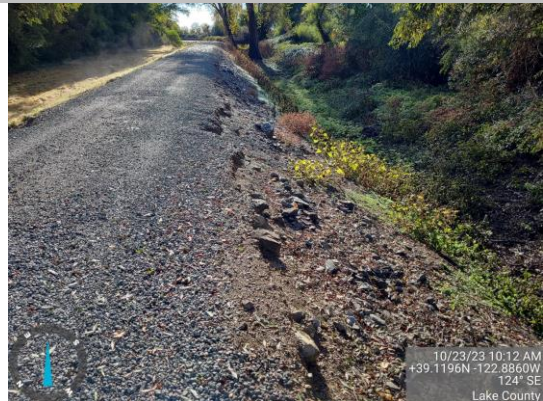
Photo 1 of 1 : FA\_2023\_MA0017\_339\_34\_20231025\_00077.jpg

LM Start	7.19	Rating **	M	Issue No.	34
LM End	7.20	Issue Type +	Ma	Location *	WS
Category	Earthen Levee			GPS Latitude/Longitude	
				Start	End
Item	Erosion / Rills			39.119670°	39.119554°
				-122.886027°	-122.885885°
DWR ID	DWR_MA0017_01_f_2023_34				
Comment Code					
E5 : Schedule repair of rills prior to the next inspection.					
Inspector Comment					
Repair rilling/erosion on the WS slope.

Erosion on the WS slope. Fall 2023
