**Flood Control Project Maintenance
Levee Inspections**

Maintenance Issue Types Only, Levee Inspection Report By Mile - Fall 2024

Sutter Maintenance Yard Maintenance Area 0017

Waterway	Bank	Unit Miles	Inspection Start/End	Inspector
Unit No. 01 Lake County Sutter Maintenance Yard - Middle Creek	Left	3.87	09/16/2024 09/16/2024	Marvin Marshall

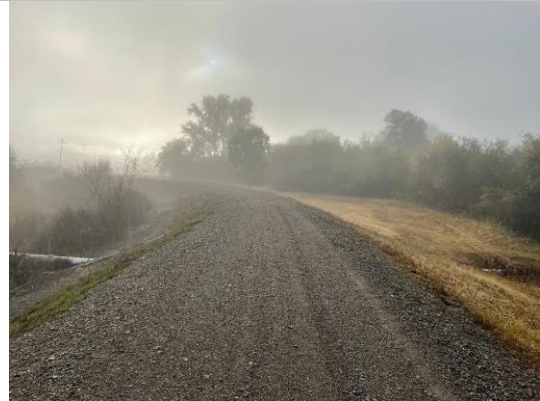
Photo 1 of 3 : UCIP_FA_2024_81940_117610.jpg

Comment Code						
Inspector Comment						
DS_ID:844 FS_ID:81940 EP_NO: 11463 Repair Type: No Action Needed EVAL Issue: Crossing Status: Found UCIP Comments: 10/23/2023 Record updated from Non-Urgent to No Action Needed. No issues observed during inspection. (J. Taylor - DWR UCIP)10/09/2019 The levee is maintained by DWR Sutter Yard. The State is currently working on purchasing adjacent land to eventually pursue the de-activation of this levee. Levee crown width through this section is about 12 feet. The UCIP inspection was completed with DWR Inspector, L. Dial, and DWR Sutter Yard Supervisor, B. Reniff. Crossing has been updated from No Action Needed to Non-Urgent; owner has changed [State owns structure]. (O. Magana - DWR UCIP)10/19/2016 Crossing appears to be in good condition. (A. Freitag - DWR Sutter Yard)06/14/2016 crossing appears to be in good condition. (A. Freitag - DWR Sutter Yard)04/23/2015 No issues with pipe. (A. Freitag - DWR Sutter Yard)07/03/2014 Same as last inspection. (A. Freitag - DWR Sutter Yard)12/23/2013 Same as last inspection. (A. Freitag - DWR Sutter Yard)08/02/2013 New flap gate installed. No other issues with pipe. (A. Freitag - DWR Sutter Yard)12/13/2012 Flap gate broken in half and inoperable. (W. Wylie - DWR UCIP) FIELD_STRUCT_DESC: 24-inch corrugated metal drainage pipe through the levee, 12.4 feet below the crown. Flap gate on the waterside (WS) end. Timber walkway on the landside (LS) slope to a timber walkway to pump house mounted on piles in drainage ditch. (24-inch pipe [HLM 3.99] authorized under Automatic Board Order (ABO) issued as Permit No. 11463, 1975 - Audrey Jones). [Additional Reference(s): DWR Levee Log, 2005 (HLM 3.99). USACE Sacramento O&M Manual, Unit 506 Part 2 (SAC506.2), August 1961, Revised 25 May 2011, (HLM 3.99), listed as 24-inch CMP]. FS Date: 10/23/2023 7:21:52 AM

Overview of levee crown looking D/S towards pipe crossing.

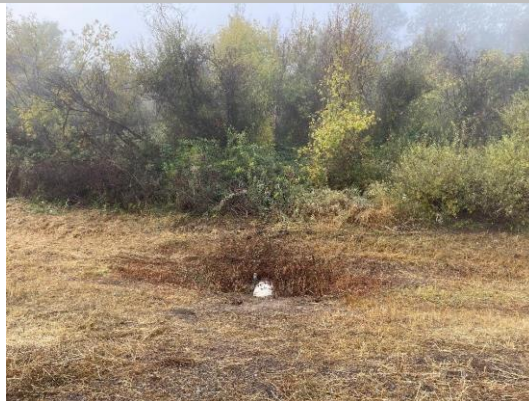
Photo 2 of 3 : UCIP_FA_2024_81940_117605.jpg

WS view: Overview of WS.

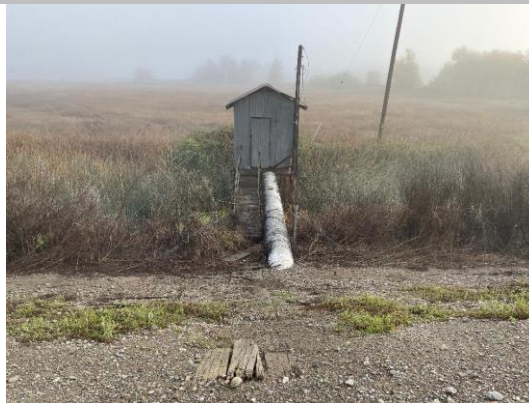
Photo 3 of 3 : UCIP_FA_2024_81940_117608.jpg

LS view: Overview of landside.

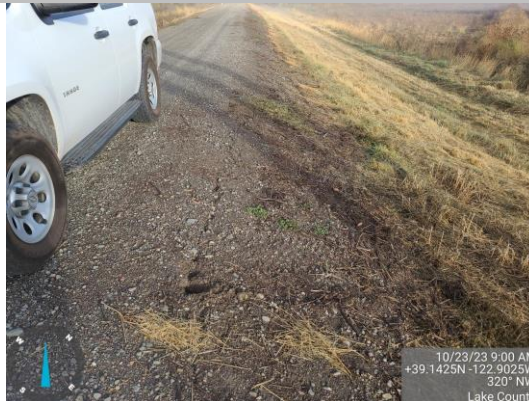
Photo 1 of 1 : FA_2024_MA0017_339_30_20240911_00006.jpg

LM Start	4.12	Rating **	M	Issue No.	30
LM End	4.12	Issue Type +	Ma	Location *	CR
Category	Earthen Levee			GPS Latitude/Longitude	
				Start	End
Item	Cracking			39.142468°	39.142468°
				-122.902557°	-122.902557°
DWR ID	DWR_MA0017_01_f_2023_30				
Comment Code					
CR1 : Monitor and have inspected by geotechnical engineer.					
Inspector Comment

Cracking on the LS shoulder. Fall 2023

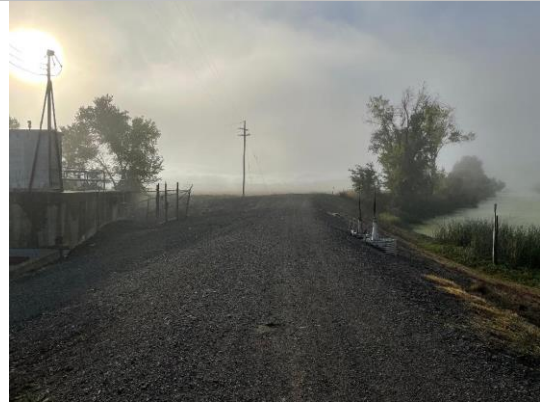
Photo 1 of 3 : UCIP_FA_2024_81941_117611.jpg

Comment Code					
Inspector Comment					
DS_ID:845 FS_ID:81941 EP_NO: 11464 Repair Type: No Action Needed EVAL Issue: Crossing Status: Found UCIP Comments: 10/23/2023 Record updated from Non-Urgent to No Action Needed. No issues observed during inspection. (J. Taylor - DWR UCIP)10/09/2019 The levee is maintained by DWR Sutter Yard. The State is currently working on purchasing adjacent land to eventually pursue the de-activation of this levee. Levee crown width through this section is about 12 feet. The UCIP inspection was completed with DWR Inspector, L. Dial, and DWR Sutter Yard Supervisor, B. Reniff. Crossing has been updated from No Action Needed to Non-Urgent; owner has changed [State maintains structure]. (O. Magana - DWR UCIP)10/27/2017 This structure is inspected annually under the Structure and Channel Summer Inspection (part of the Levee Inspection Program) conducted by the DWR Flood Project Integrity and Inspection Branch (FPIIB). (O. Magana - DWR UCIP)10/19/2016 Crossing appears to be in good condition. (A. Freitag - DWR Sutter Yard)06/14/2016 crossing appears to be in good condition. (A. Freitag - DWR Sutter Yard)04/23/2015 No issues with pipe. (A. Freitag - DWR Sutter Yard)07/03/2014 Same as last inspection. (A. Freitag - DWR Sutter Yard)12/23/2013 Same as last inspection. (A. Freitag - DWR Sutter Yard)08/02/2013 Same as last inspection. (A. Freitag - DWR Sutter Yard) FIELD_STRUCT_DESC: [Bloody Island Pumping Plant] 1 of 2: 42-inch corrugated metal drainage pipe through the levee, 20.2 feet below the crown. Concrete headwall and discharge apron on the waterside (WS) shoulder. Three vertical pump units mounted on a reinforced concrete pump platform in drainage ditch at the landside (LS) toe. Flap gates in concrete discharge well on the LS. Combination flap and slide gate on a gravity pipe from drainage ditch into discharge well. (Two 42-inch pipes [HLM 4.18] authorized under Automatic Board Order (ABO) issued as Permit No. 11464, 1975 - Lake County). [Additional Reference(s): DWR Levee Log, 2005 (HLM 4.17). USACE Sacramento O&M Manual, Unit 506, Part 1 (SAC506.1) April 1961, and Part 2 (SAC506.2) August 1961, Revised 25 May 2011, (HLM 4.18), two 42-inch CMP -- referred to as Bloody Island Pumping Plant]. FS Date: 10/23/2023 7:42:17 AM

Overview of levee crown looking D/S towards pipe crossings.

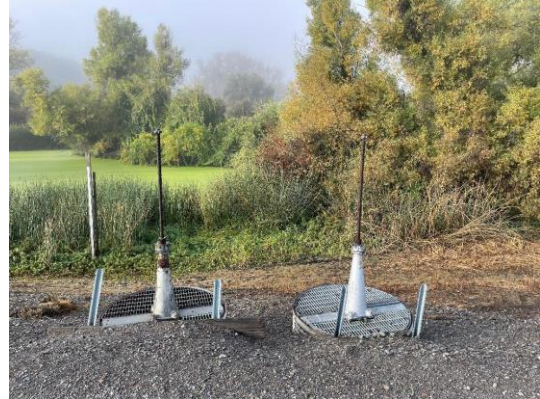
Photo 2 of 3 : UCIP_FA_2024_81941_117612.jpg

WS view: Overview of WS with two positive closure devices in CMP risers on WS shoulder (DSID 845 right).

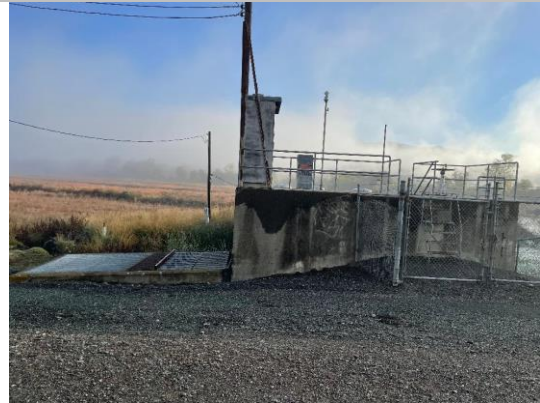
Photo 3 of 3 : UCIP_FA_2024_81941_117615.jpg

LS view: Overview of LS. Bloody Island Pumping Plant on LS shoulder and toe.

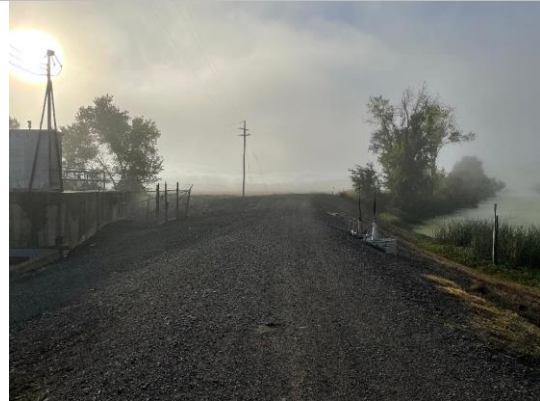
Photo 1 of 3 : UCIP_FA_2024_81942_117617.jpg

DS_ID:852
FS_ID:81942
EP_NO: 11464
Repair Type: No Action Needed
EVAL Issue:
Crossing Status: Found
UCIP Comments: 10/23/2023 Record updated from Non-Urgent to No Action Needed. No issues observed during inspection. (J. Taylor - DWR UCIP)10/09/2019 The levee is maintained by DWR Sutter Yard. The State is currently working on purchasing adjacent land to eventually pursue the de-activation of this levee. Levee crown width through this section is about 12 feet. The UCIP inspection was completed with DWR Inspector, L. Dial, and DWR Sutter Yard Supervisor, B. Reniff. Crossing has been updated from No Action Needed to Non-Urgent; owner has changed [State maintains structure]. (O. Magana - DWR UCIP)10/27/2017 This structure is inspected annually under the Structure and Channel Summer Inspection (part of the Levee Inspection Program) conducted by the DWR Flood Project Integrity and Inspection Branch (FPIIB). (O. Magana - DWR UCIP)10/19/2016 Crossing appears to be in good condition. (A. Freitag - DWR Sutter Yard)06/14/2016 Crossing appears to be in good condition. (A. Freitag - DWR Sutter Yard)04/23/2015 No issues with pipe. (A. Freitag - DWR Sutter Yard)07/03/2014 Same as last inspection. (A. Freitag - DWR Sutter Yard)12/23/2013 Same as last inspection. (A. Freitag - DWR Sutter Yard)08/02/2013 Same as last inspection. (A. Freitag - DWR Sutter Yard)

FIELD_STRUCT_DESC: [Bloody Island Pumping Plant] 2 of 2: 42-inch corrugated metal drainage pipe through the levee, 14.6 feet below the crown. Concrete headwall and discharge apron on the waterside (WS) shoulder. Three vertical pump units mounted on a reinforced concrete pump platform in drainage ditch at the landside (LS) toe. Flap gates in concrete discharge well on the LS. Combination flap and slide gate on a gravity pipe from drainage ditch into discharge well. (Two 42-inch pipes [HLM 4.18] authorized under Automatic Board Order (ABO) issued as Permit No. 11464, 1975 - Lake County). [Additional Reference(s): DWR Levee Log, 2005 (HLM 4.17). USACE Sacramento O&M Manual, Unit 506, Part 1 (SAC506.1) April 1961, and Part 2 (SAC506.2) August 1961, Revised 25 May 2011, (HLM 4.18), two 42-inch CMP -- referred to as Bloody Island Pumping Plant].
FS Date: 10/23/2023 7:54:52 AM

Overview of levee crown looking D/S towards pipe crossings.

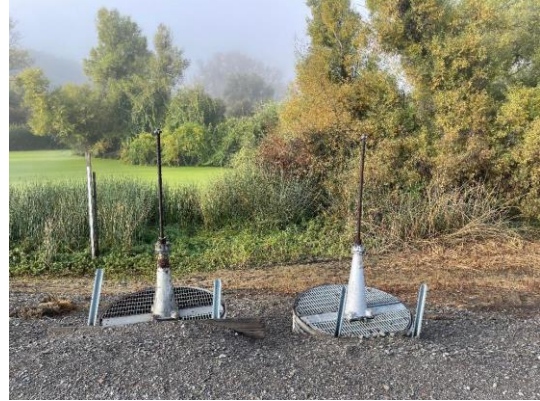
Photo 2 of 3 : UCIP_FA_2024_81942_117618.jpg

WS view: Overview of WS with two positive closure devices in CMP risers on WS shoulder (DSID 852 left).

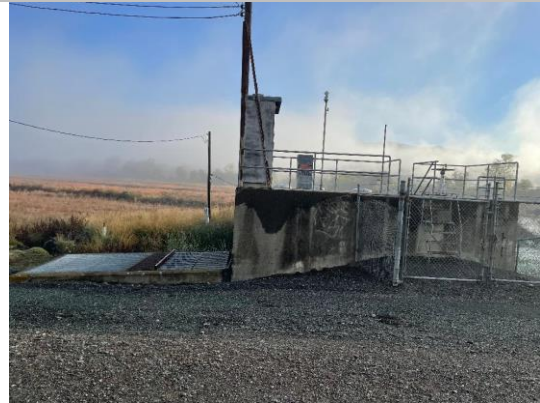
Photo 3 of 3 : UCIP_FA_2024_81942_117621.jpg

LS view: Overview of LS. Bloody Island Pumping Plant on LS shoulder and toe.

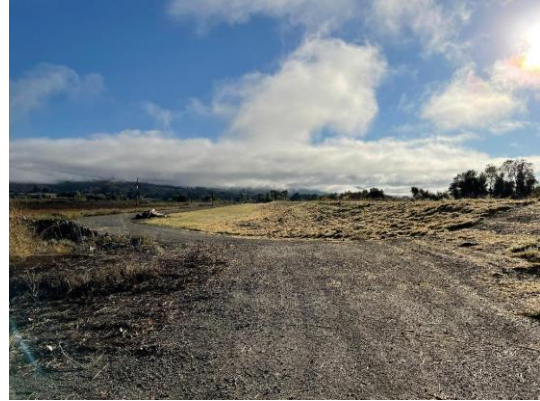
Photo 1 of 3 : UCIP_FA_2024_81945_117627.jpg

Comment Code					
Inspector Comment					
DS_ID:847 FS_ID:81945 EP_NO: 11469 Repair Type: No Action Needed EVAL Issue: Crossing Status: Found UCIP Comments: 10/23/2023 Record updated from Non-Urgent to No Action Needed. Sack ring has deteriorated so that only sack fill material is left. This does not affect the operation of the pipe. (J. Taylor - DWR UCIP)10/09/2019 The levee is maintained by DWR Sutter Yard. The State is currently working on purchasing adjacent land to eventually pursue the de-activation of this levee. Levee crown width ranges from 3 to 4-feet. The UCIP inspection was completed with DWR Inspector, L. Dial, and DWR Sutter Yard Supervisor, B. Reniff. Crossing remains Non-Urgent; sack ring built to control levee seepage has deteriorated and needs to be rebuilt or maintained. Pump station is maintained by RD2070. (O. Magana - DWR UCIP)10/19/2016 Sack ring still in place. (A. Freitag - DWR Sutter Yard)06/14/2016 Sack ring is still built up underneath the pipes. (A. Freitag - DWR Sutter Yard)04/23/2015 Sack ring is still built up underneath the pipes. (A. Freitag - DWR Sutter Yard)07/03/2014 Same as last inspection. (A. Freitag - DWR Sutter Yard)12/23/2013 Same as last inspection. (A. Freitag - DWR Sutter Yard)08/02/2013 Same as last inspection. (A. Freitag - DWR Sutter Yard)12/13/2012 Flood fight materials-ring levees around both LS and WS slopes at pipe crossing. This may or may not be an issue. (W. Wylie - DWR UCIP) FIELD_STRUCT_DESC: 1 of 2: 16-inch steel drainage pipe through the levee, 5 feet below the crown. Drainage pumping plant on the landside (LS). Flap gate on the waterside (WS) end. (One 16-inch and one 36-inch pipe [HLM 5.43] authorized under Automatic Board Order (ABO) issued as Permit No. 11469, 1975 - RD 2070). [Additional Reference(s): DWR Levee Log, 2005 (HLM 5.43). USACE Sacramento O&M Manual, Unit 506 Part 3 (506.3), 1967, (HLM 5.43), listed as 16-inch pipe]. FS Date: 10/23/2023 8:11:16 AM

Overview of levee crown looking D/S at location of crossing.

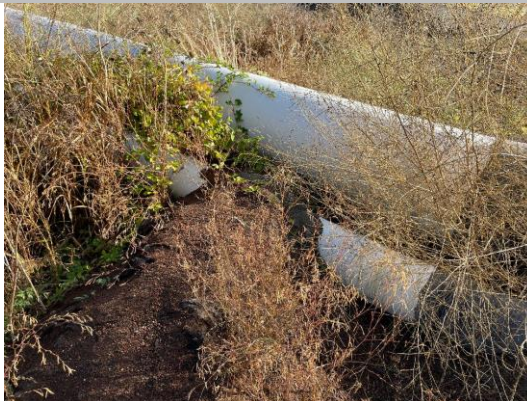
Photo 2 of 3 : UCIP_FA_2024_81945_117628.jpg

LS View: view of 16-inch pipe still partially covered by sac ring at levee toe.

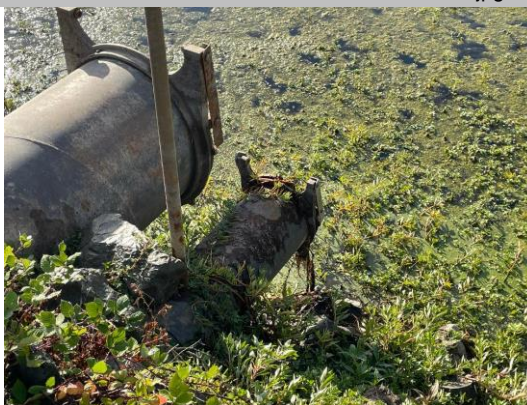
Photo 3 of 3 : UCIP_FA_2024_81945_117631.jpg

WS view: view of pipe outlet with flap gates. Gates appear to be in working condition but vegetation/water limits inspection access.

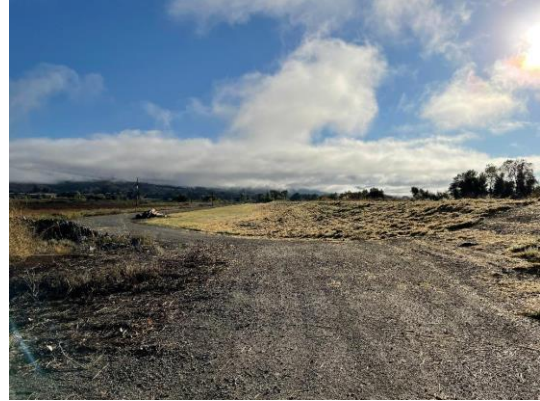
Photo 1 of 3 : UCIP_FA_2024_81946_117632.jpg

Comment Code					
Inspector Comment					
DS_ID:853 FS_ID:81946 EP_NO: 11469 Repair Type: No Action Needed EVAL Issue: Crossing Status: Found UCIP Comments: 10/23/2023 Record updated from Non-Urgent to No Action Needed. Sack ring has deteriorated so that only sack fill material is left. This does not affect the operation of the pipe. (J. Taylor - DWR UCIP)10/09/2019 The levee is maintained by DWR Sutter Yard. The State is currently working on purchasing adjacent land to eventually pursue the de-activation of this levee. Levee crown width ranges from 3 to 4-feet. The UCIP inspection was completed with DWR Inspector, L. Dial, and DWR Sutter Yard Supervisor, B. Reniff. Crossing remains Non-Urgent; sack ring built to control levee seepage has deteriorated and needs to be rebuilt or maintained. Pump station is maintained by RD2070. (O. Magana - DWR UCIP)10/19/2016 Sack ring still in place. (A. Freitag - DWR Sutter Yard)06/14/2016 Sack ring is still built up underneath the pipes. (A. Freitag - DWR Sutter Yard)04/23/2015 Sack ring still built up underneath the pipes. (A. Freitag - DWR Sutter Yard)07/03/2014 Same as last inspection. (A. Freitag - DWR Sutter Yard)12/23/2013 Same as last inspection. (A. Freitag - DWR Sutter Yard)08/02/2013 Same as last inspection. (A. Freitag - DWR Sutter Yard)12/13/2012 flood fight materials-ring levees around both LS and WS slopes at pipe crossing. This may or may not be an issue. (W. Wylie - DWR UCIP) FIELD_STRUCT_DESC: 2 of 2: 36-inch steel drainage pipe through the levee, 5 feet below the crown. Flap gate and air vent on the waterside (WS) slope. (One 36-inch and one 16-inch pipes [HLM 5.43] authorized under Automatic Board Order (ABO) issued as Permit No. 11469, 1975 - RD 2070). [Additional Reference(s): DWR Levee Log, 2005 (HLM 5.43). USACE Sacramento O&M Manual, Unit 506 Part 3 (506.3), 1967, (HLM 5.43), listed as 36-inch pipe]. FS Date: 10/23/2023 8:21:45 AM

Overview of levee crown looking D/S at location of crossing.

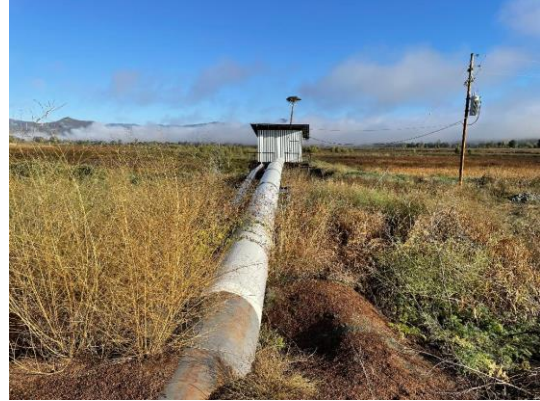
Photo 2 of 3 : UCIP_FA_2024_81946_117633.jpg

LS view: Overview of LS with 36-inch pipe visible entering pump house at LS toe.

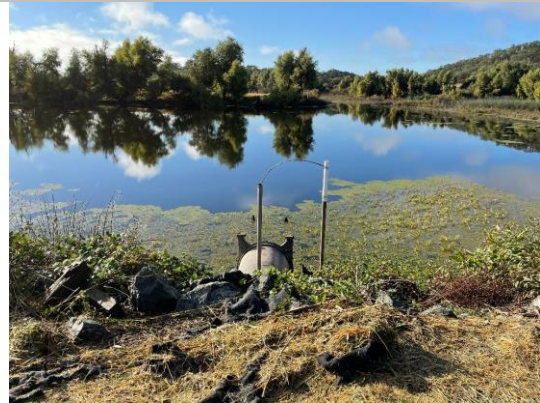
Photo 3 of 3 : UCIP_FA_2024_81946_117635.jpg

WS view: overview of WS with pipe outlets visible.

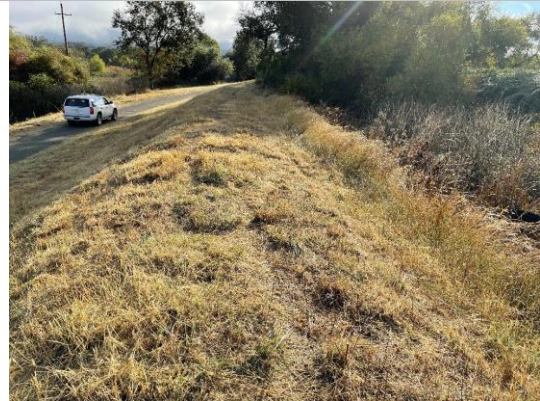
Photo 1 of 3 : UCIP_FA_2024_81947_117640.jpg

DS_ID:848
FS_ID:81947
EP_NO: 11457
Repair Type: Urgent
EVAL Issue: 3a, Flood Risk
Crossing Status: Found
UCIP Comments: 10/23/2023 Record updated from Non-Urgent to Urgent. Still no wheel to operate slide gate. Because it is in open position allowing water through it is a flood risk. LS headwall and pipe found see 2023 pictures. (J. Taylor - DWR UCIP)10/09/2019 The levee is maintained by DWR Sutter Yard. The State is currently working on purchasing adjacent land to eventually pursue the de-activation of this levee. Levee crown width ranges from 3 to 4-feet. The UCIP inspection was completed with DWR Inspector, L. Dial, and DWR Sutter Yard Supervisor, B. Reniff. Crossing remains Non-Urgent; crossing has been abandoned, no riser lid or slide gate wheel are present. DWR DMP geophysical investigation found signals of potential metal pipe through this section of the levee. Owner will need coordinate with the CVFPB to remove or abandon crossing according to Title 23 requirements. (O. Magana - DWR UCIP) 10/19/2016 No riser lid or slide gate wheel. (A. Freitag - DWR Sutter Yard)06/14/2016 No riser lid and no wheel to operate screw gate. (A. Freitag - DWR Sutter Yard)04/23/2015 No cover on riser and no wheel to operate gate. (A. Freitag - DWR Sutter Yard)07/03/2014 Same as last inspection. (A. Freitag - DWR Sutter Yard)12/23/2013 Same as last inspection. (A. Freitag - DWR Sutter Yard)08/02/2013 Handle to operate gate was in place but still no cover on riser. (A. Freitag - DWR Sutter Yard)12/13/2012 No cover on CMP riser and no handle for actuating gate. This may or may not be an issue. (W. Wylie - DWR UCIP) FIELD_STRUCT_DESC: 24-inch drainage pipe under patrol road and through the levee, 13.5 feet below the crown. Concrete "U" shaped headwall on the landside (LS) end. Slide gate in 36-inch corrugated metal pipe (CMP) riser on the waterside (WS) slope. Riser unit is mounted on concrete base. (24-inch pipe [HLM 5.87] authorized under Automatic Board Order (ABO) issued as Permit No. 11457, 1975 - Crawford). [Additional Reference(s): DWR Levee Log, 2005 (HLM 5.87). USACE Sacramento O&M Manual, Unit 506 Part 3 (506.3), 1967, (HLM 5.87), listed as 24-inch pipe].

Overview of levee crown looking D/S at location of crossing.

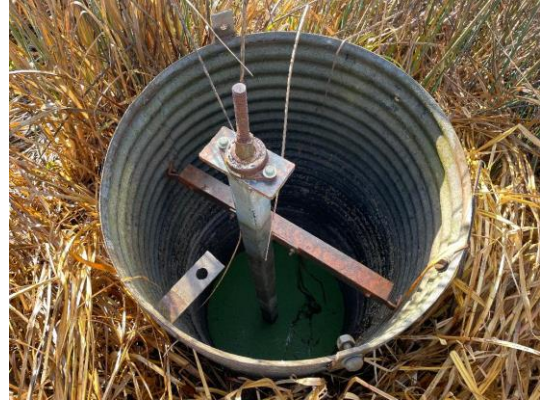
Photo 2 of 3 : UCIP_FA_2024_81947_117642.jpg

WS view: inside CMP riser, missing handle to operate slide gate.

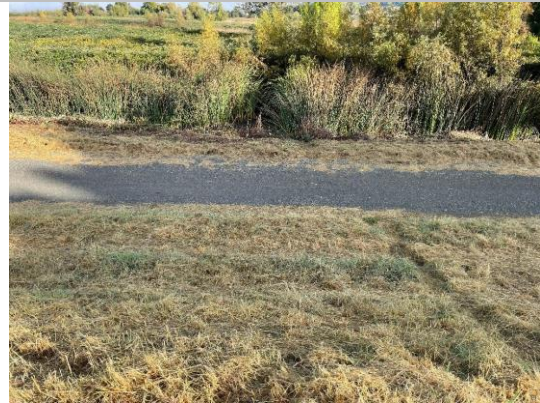
Photo 3 of 3 : UCIP_FA_2024_81947_117637.jpg

LS view: overview of LS, concrete headwall at levee toe.

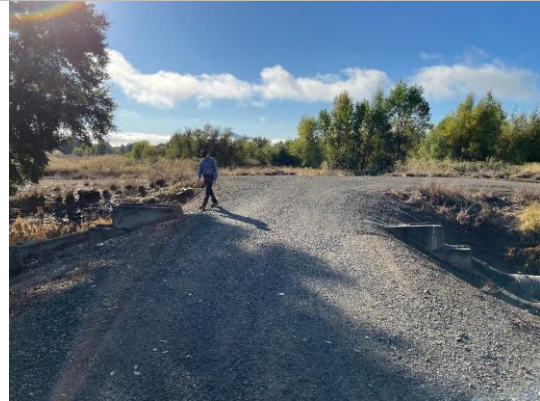
Photo 1 of 3 : UCIP_FA_2024_81424_117643.jpg

DS_ID:849
FS_ID:81424
EP_NO: 11467
Repair Type: Urgent
EVAL Issue: 3a, Flood Risk
Crossing Status: Found
UCIP Comments: 10/23/2023 Record updated from Non-Urgent to Urgent. Wood debris opening flap gate on WS leaves crossing vulnerable to flooding. Some erosion on WS due to runoff, not pipe related but should be monitored for maintenance. DMP internal video inspection has found none or minor pipe defects. Recommend next video inspection in 5 years. (J. Taylor - DWR UCIP)10/09/2019 The levee is maintained by DWR Sutter Yard. The State is currently working on purchasing adjacent land to eventually pursue the de-activation of this levee. Levee crown width is about 12 feet. The UCIP inspection was completed with DWR Inspector, L. Dial, and DWR Sutter Yard Supervisor, B. Reniff. Crossing has been updated from No Action Needed to Non-Urgent; need to audit record to confirm if ABO lists current owner for this structure. (O. Magana - DWR UCIP)10/27/2017 This structure is inspected annually under the Structure and Channel Summer Inspection (part of the Levee Inspection Program) conducted by the DWR Flood Project Integrity and Inspection Branch (FPIIB). (O. Magana - DWR UCIP)10/19/2016 Crossing appears to be in good condition. (A. Freitag - DWR Sutter Yard)06/14/2016 Flap gate propped open. Will make sure its closed before flood season. (A. Freitag - DWR Sutter Yard)04/23/2015 Flap gate propped open. Not an issue at this time. Will close it before high water season. (A. Freitag - DWR Sutter Yard)07/03/2014 Same as last inspection. (A. Freitag - DWR Sutter Yard)12/23/2013 Same as last inspection. (A. Freitag - DWR Sutter Yard)08/02/2013 Same as last inspection. (A. Freitag - DWR Sutter Yard)

Overview of levee crown looking D/S.

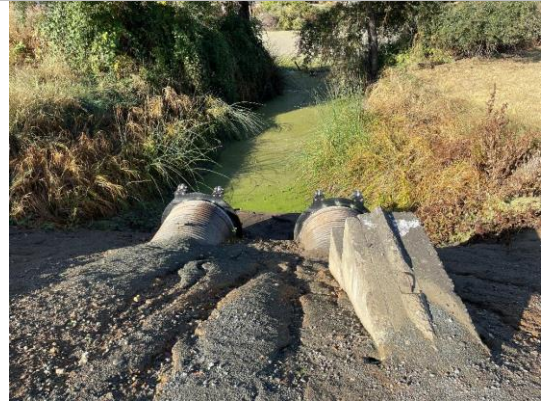
Photo 2 of 3 : UCIP_FA_2024_81424_117644.jpg

WS view: overview of WS with two 54-inch CIPP lined pipes visible on toe of levee.

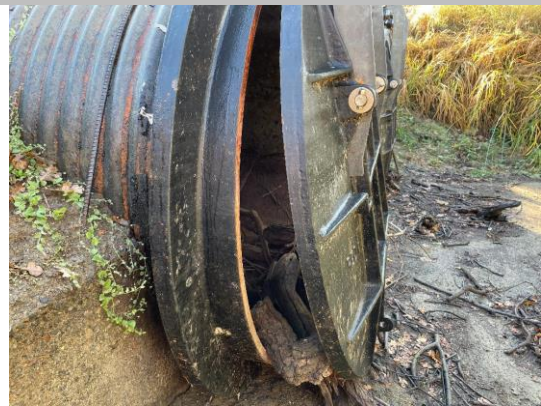
Photo 3 of 3 : UCIP_FA_2024_81424_117646.jpg

WS view: side view of wooden debris preventing flap gate on WS from closing.

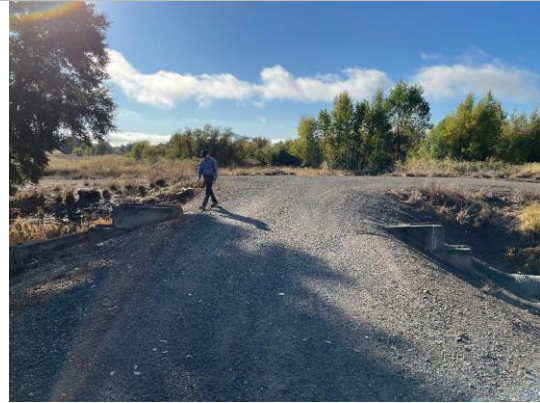
Photo 1 of 3 : UCIP_FA_2024_81426_117650.jpg

DS_ID:854
FS_ID:81426
EP_NO: 11467
Repair Type: Urgent
EVAL Issue: 3a, Flood Risk
Crossing Status: Found
UCIP Comments: 10/23/2023 Record updated from Non-Urgent to Urgent. Wood debris opening flap gate on WS leaves crossing vulnerable to flooding. Some erosion on WS due to runoff, not pipe related but should be monitored for maintenance. DMP internal video inspection has found none or minor pipe defects. Recommend next video inspection in 5 years. (J. Taylor - DWR UCIP)10/09/2019 The levee is maintained by DWR Sutter Yard. The State is currently working on purchasing adjacent land to eventually pursue the de-activation of this levee. Levee crown width is about 12 feet. The UCIP inspection was completed with DWR Inspector, L. Dial, and DWR Sutter Yard Supervisor, B. Reniff. Crossing has been updated from No Action Needed to Non-Urgent; need to audit record to confirm if ABO lists current owner for this structure. (O. Magana - DWR UCIP)10/27/2017 This structure is inspected annually under the Structure and Channel Summer Inspection (part of the Levee Inspection Program) conducted by the DWR Flood Project Integrity and Inspection Branch (FPIIB). (O. Magana - DWR UCIP)10/19/2016 Crossing appears to be in good condition. (A. Freitag - DWR Sutter Yard)06/14/2016 Flap gate propped open. Will make sure its closed before flood season. (A. Freitag - DWR Sutter Yard)04/23/2015 Flap gate propped open. Not an issue at this time. Will close it before high water season. (A. Freitag - DWR Sutter Yard)07/03/2014 Same as last inspection. (A. Freitag - DWR Sutter Yard)12/23/2013 Same as last inspection. (A. Freitag - DWR Sutter Yard)08/02/2013 Same as last inspection. (A. Freitag - DWR Sutter Yard)

Overview of levee crown looking D/S.

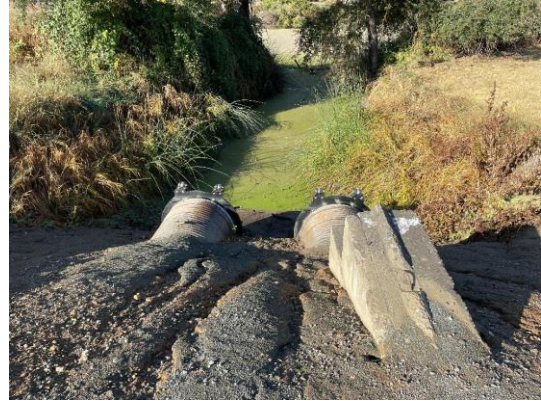
Photo 2 of 3 : UCIP_FA_2024_81426_117651.jpg

WS view: overview of WS with two 54-inch CIPP lined pipes visible on toe of levee.

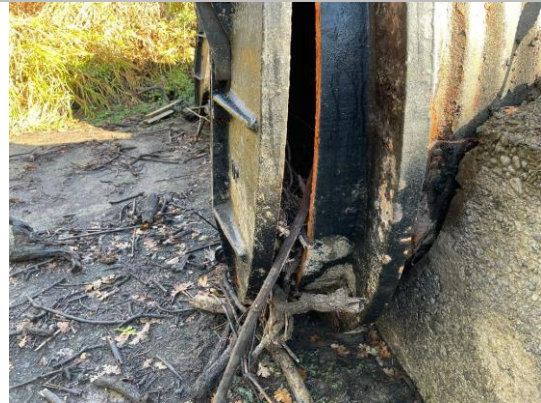
Photo 3 of 3 : UCIP_FA_2024_81426_117653.jpg

WS view: side view of wooden debris preventing flap gate on WS from closing.

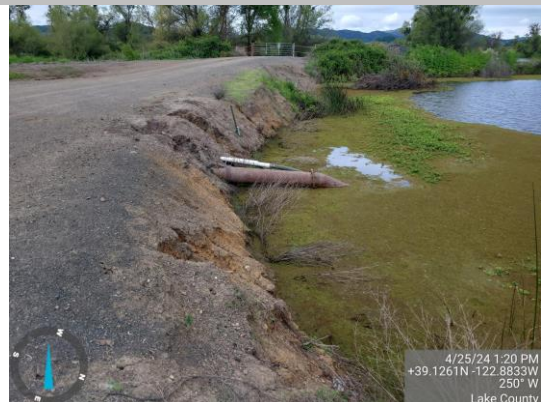
Photo 1 of 2 : FA_2024_MA0017_339_31_20240911_00007.jpg

LM Start	5.98	Rating **	M	Issue No.	31
LM End	6.02	Issue Type +	Ma	Location *	WS
Category	Earthen Levee			GPS Latitude/Longitude	
				Start	End
Item	Erosion / Rills			39.126111°	39.126045°
				-122.883011°	-122.883707°
DWR ID	DWR_MA0017_01_f_2023_31				
Comment Code					
E5 : Schedule repair of rills prior to the next inspection.					
Inspector Comment					
Repair erosion on the WS slope.

Erosion on the WS slope. Spring 2024

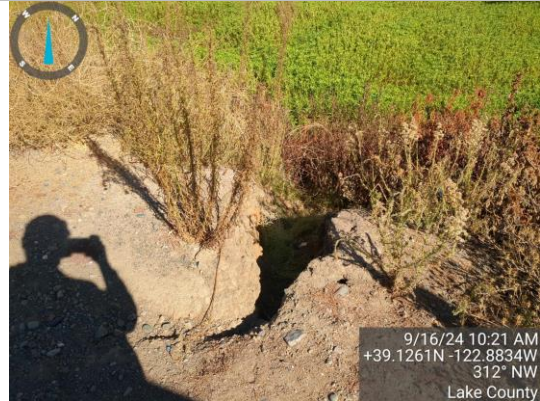
Photo 2 of 2 : FA_2024_MA0017_339_31_20240917_00053.jpg

Erosion on the WS slope. Fall 2024

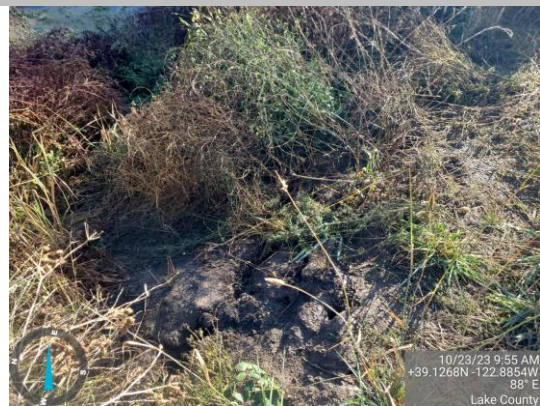
Photo 1 of 1 : FA_2024_MA0017_339_33_20240911_00008.jpg

Bank is sloughing in area near fallen tree.

Cracking/Sloughing near the down tree on the WS slope. Fall 2023

E2 : Schedule repair of erosion site prior to the next inspection.

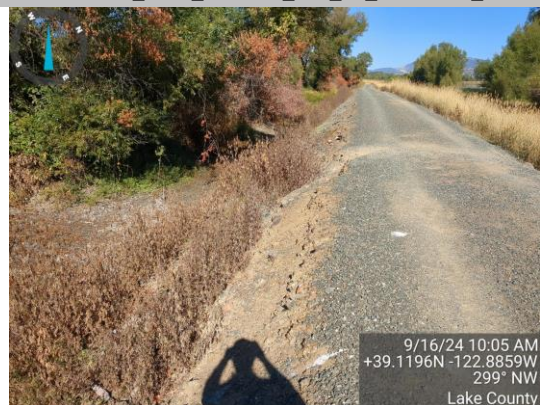
Photo 1 of 1 : FA_2024_MA0017_339_34_20240917_00054.jpg

Erosion on the WS slope. Fall 2024

E5 : Schedule repair of rills prior to the next inspection.

Repair rilling/erosion on the WS slope.

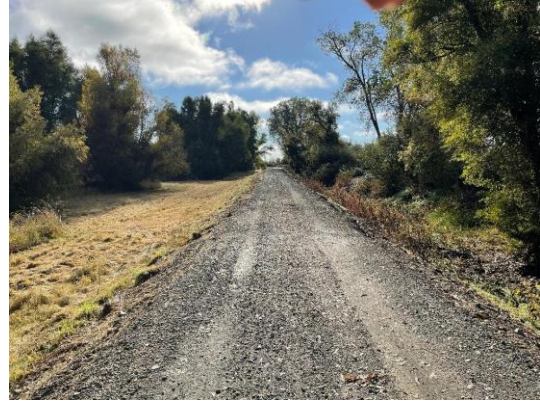
Photo 1 of 3 : UCIP_FA_2024_81949_117674.jpg

Comment Code					
Inspector Comment					
DS_ID:851 FS_ID:81949 EP_NO: 11467 Repair Type: Non-Urgent EVAL Issue: Crossing Status: Found UCIP Comments: 10/23/2023 Record remains Non-Urgent. Vegetation limited inspection, 16-inch pipe not found. (J. Taylor - DWR UCIP)10/09/2019 The levee is maintained by DWR Sutter Yard. The State is currently working on purchasing adjacent land to eventually pursue the de-activation of this levee. Levee crown width is about 12 feet. The UCIP inspection was completed with DWR Inspector, L. Dial, and DWR Sutter Yard Supervisor, B. Reniff. Crossing remains Non-Urgent; crossing has been abandoned. Owner will need coordinate with the CVFPB to remove or abandon crossing according to Title 23 requirements. (O. Magana - DWR UCIP)10/19/2016 Abandoned-should be done so properly. (A. Freitag - DWR Sutter Yard)06/14/2016 Abandoned crossing. (A. Freitag - DWR Sutter Yard)04/23/2015 Same as last inspection. Pipe still needs to be properly abandoned. (A. Freitag - DWR Sutter Yard)07/03/2014 Same as last inspection. (A. Freitag - DWR Sutter Yard)12/23/2013 Same as last inspection. (A. Freitag - DWR Sutter Yard)08/02/2013 Same as last inspection. (A. Freitag - DWR Sutter Yard)12/13/2012 Pipe should be properly abandoned. (W. Wylie - DWR UCIP) FIELD_STRUCT_DESC: 1 of 2: 16-inch steel drainage pipe through the levee, 8 feet below the crown. Drainage pumping plant on the landside (LS). Flap gate on the waterside (WS) end. Steel plate welded on end of pipe at LS toe. (One 16-inch and one 24-inch pipes [HLM 7.79] authorized under Automatic Board Order (ABO) issued as Permit No. 11467, 1975 - Modglin). [Additional Reference(s): DWR Levee Log, 2005 (HLM 7.19). USACE Sacramento O&M Manual, Unit 506 Part 3 (506.3), 1967, (HLM 7.19), listed as 16-inch pipe]. FS Date: 10/23/2023 9:44:51 AM

Overview of levee crown looking D/S.

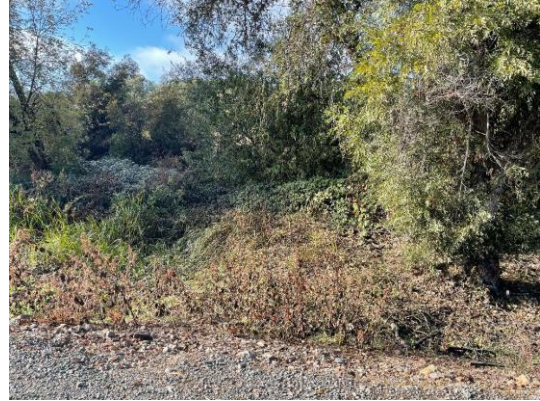
Photo 2 of 3 : UCIP_FA_2024_81949_117675.jpg

WS view: overview of WS with heavy vegetation limiting inspection.

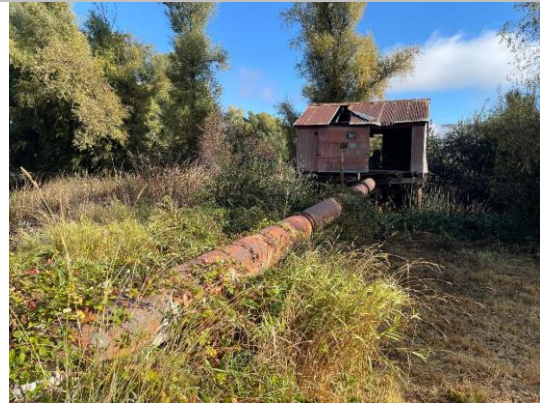
Photo 3 of 3 : UCIP_FA_2024_81949_117676.jpg

LS view: Overview of LS with 24-inch pipe visible but dense vegetation limit inspection of 16-inch pipe.

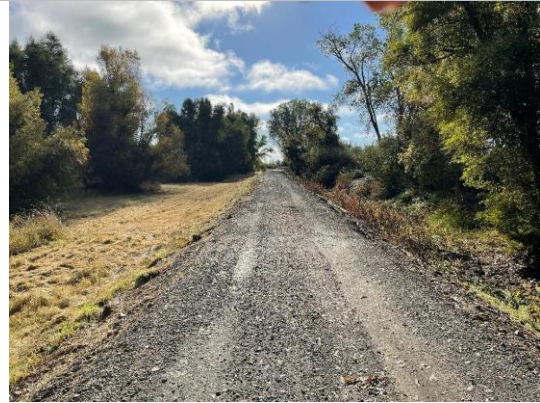
Photo 1 of 3 : UCIP_FA_2024_81950_117678.jpg

Comment Code					
Inspector Comment					
DS_ID:855 FS_ID:81950 EP_NO: 11467 Repair Type: Non-Urgent EVAL Issue: Crossing Status: Found UCIP Comments: 10/23/2023 Record remains Urgent. Crossing appears abandoned. Recommend owner to contact CVFPB to abandon or remove pipe from levee. (J. Taylor - DWR UCIP)10/09/2019 The levee is maintained by DWR Sutter Yard. The State is currently working on purchasing adjacent land to eventually pursue the de-activation of this levee. Levee crown width is about 12 feet. The UCIP inspection was completed with DWR Inspector, L. Dial, and DWR Sutter Yard Supervisor, B. Reniff. Crossing remains Non-Urgent; crossing has been abandoned. Owner will need coordinate with the CVFPB to remove or abandon crossing according to Title 23 requirements. (O. Magana - DWR UCIP)10/19/2016 Crossing appears to be in good condition. (A. Freitag - DWR Sutter Yard)06/14/2016 Crossing appears to be in good condition. (A. Freitag - DWR Sutter Yard)04/23/2015 No issues seen with pipe. (A. Freitag - DWR Sutter Yard)07/03/2014 Same as last inspection. (A. Freitag - DWR Sutter Yard)08/02/2013 Same as last inspection. (A. Freitag - DWR Sutter Yard)12/23/2013 Same as last inspection. (A. Freitag - DWR Sutter Yard) FIELD_STRUCT_DESC: 2 of 2: 24-inch steel drainage pipe through the levee, 8 feet below the crown. Drainage pumping plant on the landside (LS). Flap gate on the waterside (WS) end. (one 16-inch and one 24-inch pipes [HLM 7.79] authorized under Automatic Board Order (ABO) issued as Permit No. 11467, 1975 - Modglin). [Additional Reference(s): DWR Levee Log, 2005 (HLM 7.19). USACE Sacramento O&M Manual, Unit 506 Part 3 (506.3), 1967, (HLM 7.19), listed as 24-inch pipe]. FS Date: 10/23/2023 9:49:26 AM

Overview of levee crown looking D/S.

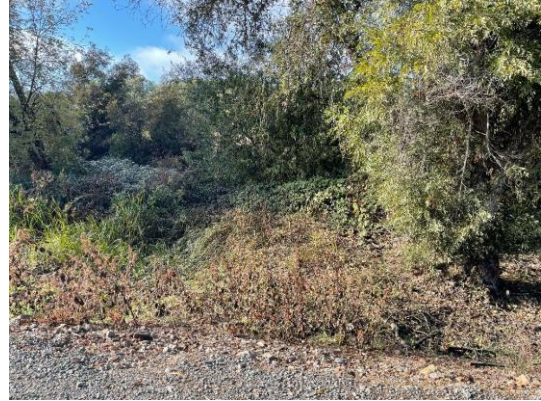
Photo 2 of 3 : UCIP_FA_2024_81950_117679.jpg

WS view: overview of WS with heavy vegetation limiting inspection.

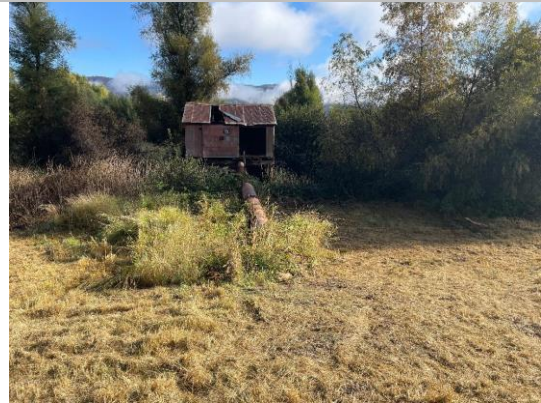
Photo 3 of 3 : UCIP_FA_2024_81950_117680.jpg

LS view: Overview of LS with 24-inch pipe visible and pump house on levee toe.
