**Flood Control Project Maintenance  
Levee Inspections**

**Maintenance Issue Types Only, Levee Inspection Report By Mile - Spring 2016**

**Sutter Maintenance Yard Maintenance Area 0017**

Waterway	Bank	Unit Miles	Inspection Start/End	Inspector
Unit No. 01 Lake County Sutter Maintenance Yard - Middle Creek	Left	3.87	05/02/2016 05/02/2016	Keith Millard

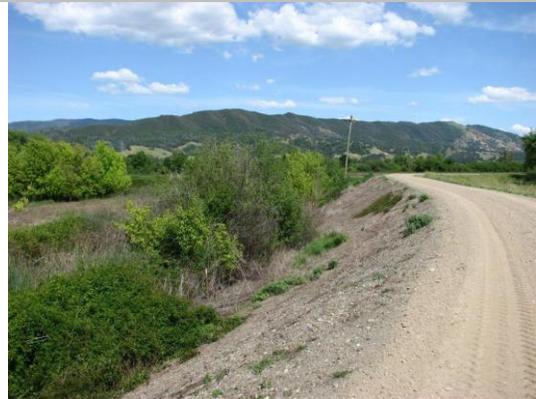
Photo 1 of 1 : SP\_2016\_MA0017\_339\_16\_20160509\_00028.jpg

LM Start	<b>3.96</b>	Rating **	M	Issue No.	<b>16</b>
LM End	<b>4.03</b>	Issue Type +	Ma	Location *	LS
Category	Earthen Levee		GPS Latitude/Longitude		
			Start	End	
Item	Vegetation		39.143741 °	39.143585 °	
			-122.904705 °	-122.903482 °	
DWR ID	DWR_MA0017_01_s_2016_16				
Comment Code					
V2 : Remove the wild growth other than native grasses from the levee slopes.					
Inspector Comment					
Large bushes and brambles growing on wire fence on LS toe limiting visibility and access.

5/2/2016: Remove or trim dense vegetation growing on fence to allow visibility and access to L/S toe.

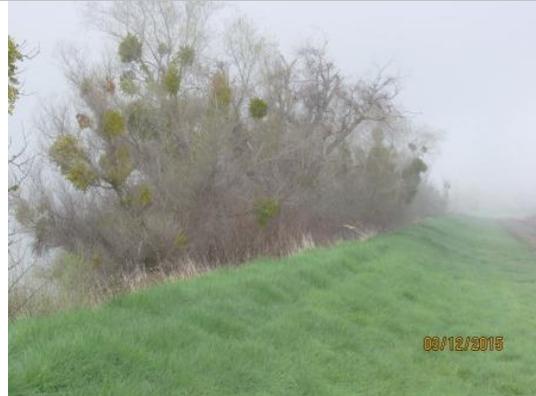
Photo 1 of 7 : SP\_2016\_MA0017\_339\_2\_20160321\_00001.jpg

LM Start	<b>4.16</b>	Rating **	U	Issue No.	<b>2</b>
LM End	<b>7.23</b>	Issue Type +	Ma	Location *	WS
Category	Earthen Levee		GPS Latitude/Longitude		
			Start	End	
Item	Trim / Thin Trees		39.141894 °	39.118735 °	
			-122.902201 °	-122.884892 °	
DWR ID	DWR_MA0017_01_s_2012_2				
Comment Code					
T2 : Thin trees to allow visibility of the ground and room to flood fight.					
Inspector Comment					
Trees and limbs are completely obstructing visibility on crown and WS. Crown is too narrow to drive, and overgrown with weeds, brush and trees. Road follows LS toe.

View of the trees along the waterside slope and toe.

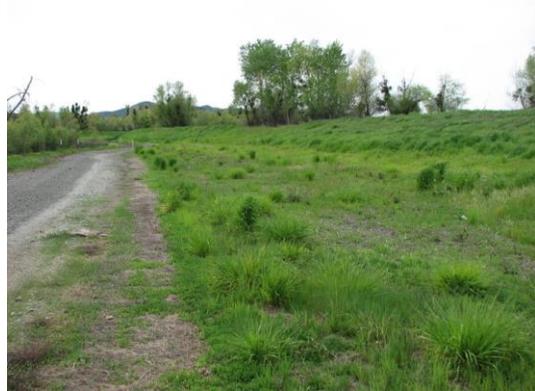
Photo 2 of 7 : SP\_2016\_MA0017\_339\_2\_20160420\_00022.jpg

Photo taken at LM 6.41 looking west showing overgrown LS slope of levee at right and toe road at left. Note trees obstructing visibility and access at levee crown. Crown is +/- 5 feet wide, and impassible to vehicles due to vegetation, and in some places, to pedestrians.  
4/19/2016

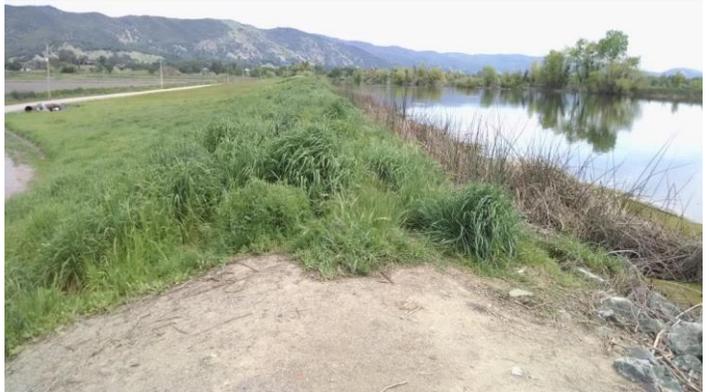
Photo 3 of 7 : SP\_2016\_MA0017\_339\_2\_20160420\_00024.jpg

LM Start	<b>4.16</b>	Rating **	U	Issue No.	<b>2 (cont)</b>
LM End	<b>7.23</b>	Issue Type +	Ma	Location *	WS

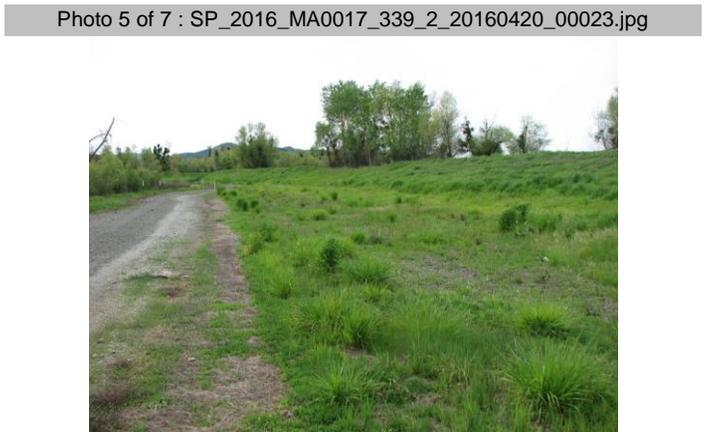
Photo taken at LM 5.34 looking east showing narrow, overgrown, impassible condition of levee. WS is to right. 4/19/2016

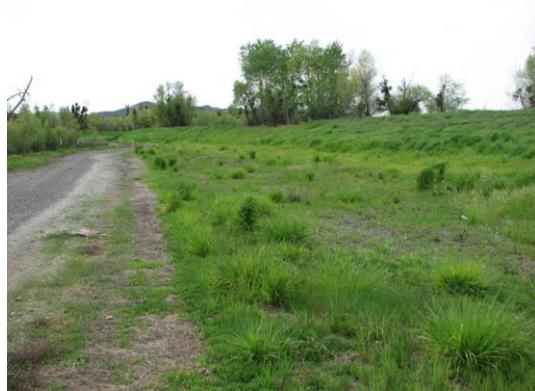
Photo 7 of 7 : SP\_2016\_MA0017\_339\_2\_20160420\_00025.jpg

Photo taken at LM 5.34 looking west showing narrow, overgrown, impassible condition of levee. WS is to left. 4/19/2016
