**Flood Control Project Maintenance
Levee Inspections**

Fall 2011 Levee Maintenance Deficiency Summary Report

Sacramento River Basin

| NA0001 | | Overall LMA Rating | Total LMA Miles | | | | |
|--|---|---|---|---|---|---|--|
| American River Flood Control District | | A | 32.51 | | | | |

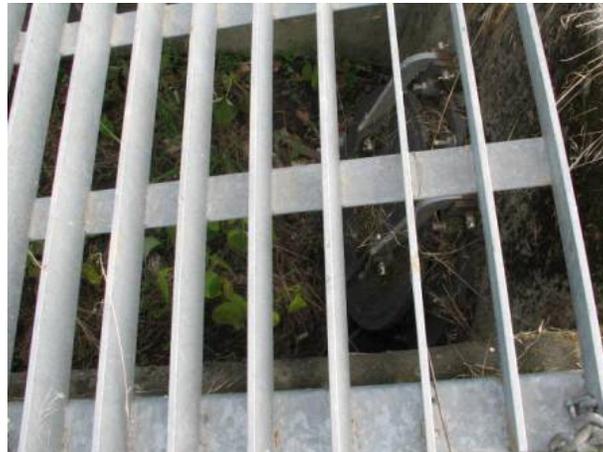
| Levee Mile Report Line | 37 |

| 11/17/2011 Flap gate held open by debris, issue also noted in USACE PI. | |

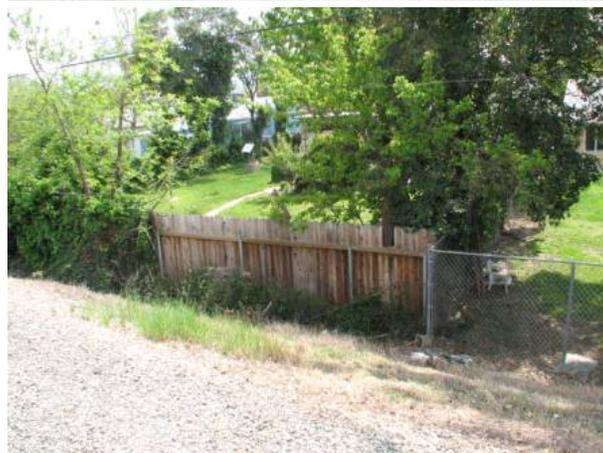
| 04/13/2011 Portion of fence has been replaced, assume that this is the portion that fell down and was referenced in the fall '10 inspection. | |

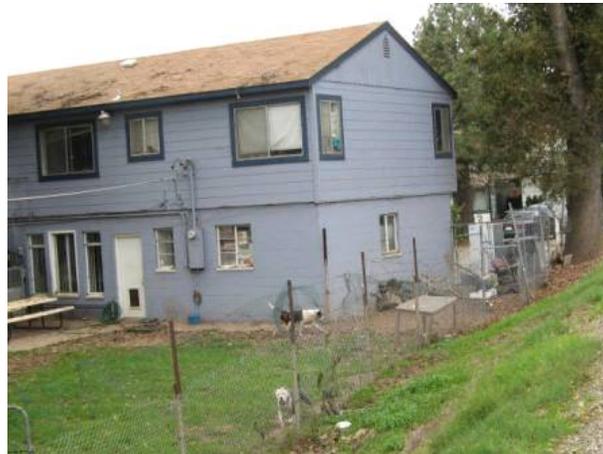
| Levee Mile Report Line | 59 |

| 11/17/2011 Building foundation is within 15' of the levee toe. | |

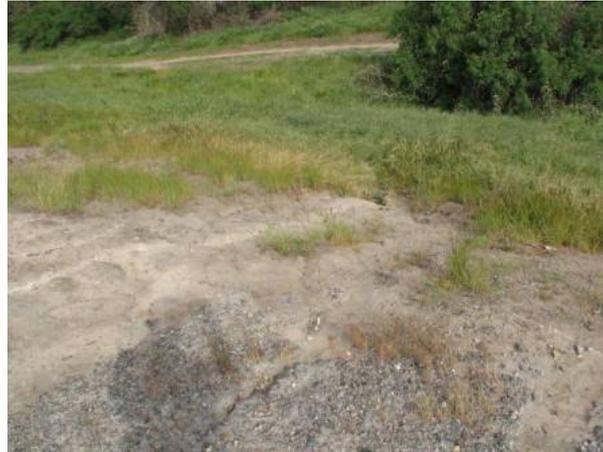
| Levee Mile Report Line | 14 |

| LMIR No. | Levee Mile | | Category | Item | Location | Rating | Action/Comment | GPS Latitude/Longitude | | Issue No. Photo |
|---|---|---|---|---|---|---|--|---|---|---|
| 14 | 2.99 | 2.99 | Earthen Levee | Erosion / Bank Caving | CR | M | Note and monitor erosion site. Inspector Comments: Erosion looks to be caused by runoff from adjacent parking area. Erosion begins in crown and continues down water side of levee. | 38.587394 ° -121.462030 ° | 38.587394 ° -121.462030 ° | 174 Y |

| 04/14/2011 Erosion caused by runoff from adjacent parking lot. | |
