**Flood Control Project Maintenance
Levee Inspections**

Fall 2010 Levee Maintenance Deficiency Summary Report

**Flood Control Project Maintenance
Levee Inspections**
LMA District Cover Sheet
Fall 2010 Levee Inspection Results

American River Flood Control District

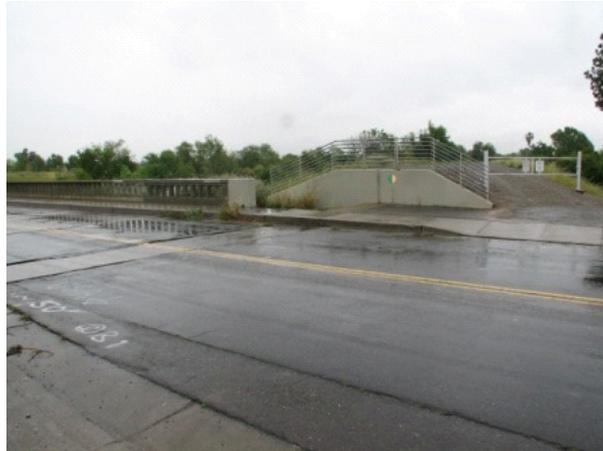
Levee Mile Report Line	7
Start Levee Mile	0.66
End Levee Mile	0.66
Location	Land Side
Category	Earthen Levee
Item	Slope Stability
Slope erosion due in part to foot traffic needs to be monitored. Repair will be needed if condition worsens.	
cathom_f_20100928_067.jpg

7	0.66	0.66	Earthen Levee	Slope Stability	LS	W	Repair the levee slope damaged by vehicle traffic and prevent access where possible.	38.623675 ° -121.457146 °	38.623675 ° -121.457146 °	59 Y
8	0.66	0.66	Earthen Levee	Slope Stability	LS	A	Repair slope instability. Inspector Comments: Slope repaired.	38.623675 ° -121.457146 °	38.623675 ° -121.457146 °	36 Y
9	0.72	0.72	Earthen Levee	Encroachments	LS	CO	Fences Inspector Comments: Wooden privacy fence within 10-ft of levee toe.	38.623824 ° -121.456037 °	38.623824 ° -121.456037 °	43 Y
10	0.81	0.81	Earthen Levee	Slope Stability	LS	A	Repair slope instability. Inspector Comments: Slope damage repaired.	38.624305 ° -121.454510 °	38.624305 ° -121.454510 °	31 Y
11	0.81	0.81	Earthen Levee	Slope Stability	LS	C	Repair the levee slope damaged by foot traffic and prevent access where possible. Inspector Comments: Repairs made.	38.624305 ° -121.454506 °	38.624305 ° -121.454506 °	42

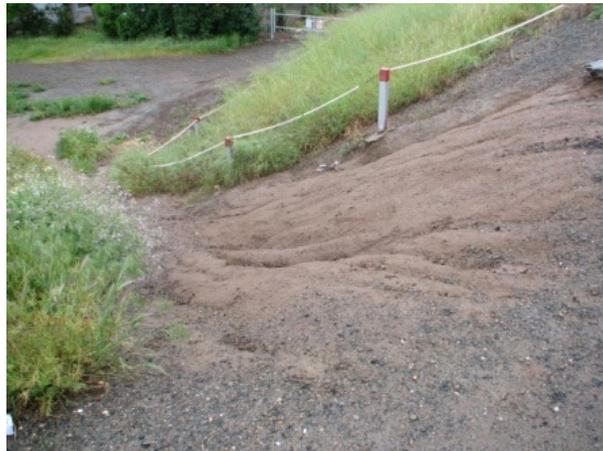
Levee Mile Report Line	8
Start Levee Mile	0.66
End Levee Mile	0.66
Location	Land Side
Category	Earthen Levee
Item	Slope Stability
Levee mile 0.66, slope repaired.	
cathom_f_20101122_219.jpg

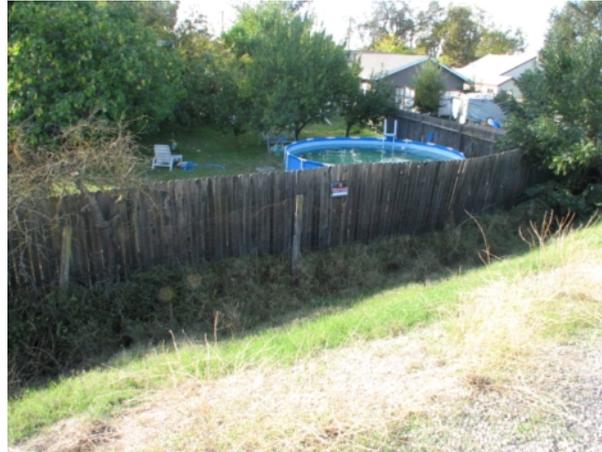
Levee Mile Report Line	26
Start Levee Mile	1.43
End Levee Mile	1.43
Location	Land Side
Category	Earthen Levee
Item	Trim / Thin Trees
Vegetation removed from slope.	
cathom_f_20101122_217.jpg

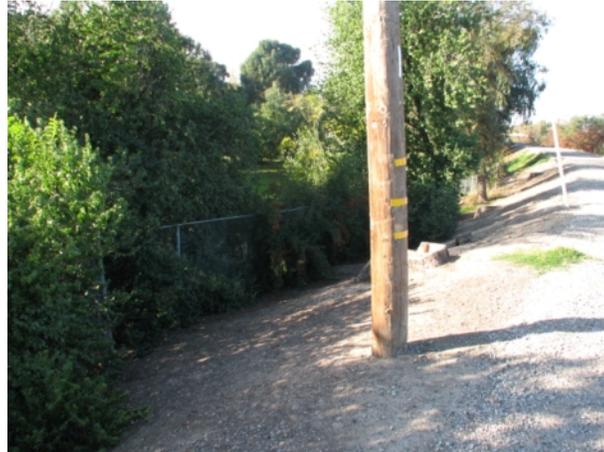
Levee Mile Report Line	30
Start Levee Mile	1.55
End Levee Mile	1.55
Location	Land Side
Category	Earthen Levee
Item	Encroachments
Fall 2009 photo: Photinias and other plants planted near levee toe.	
cathom_f_20100928_052.jpg

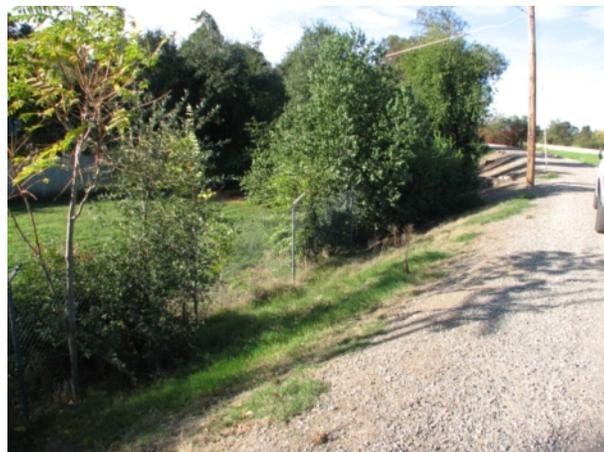
Levee Mile Report Line	32
Start Levee Mile	1.58
End Levee Mile	1.58
Location	Land Side
Category	Earthen Levee
Item	Slope Stability
Slope stability due to foot traffic needs to be monitored.	
cathom_f_20100928_064.jpg

LMR No.	Levee Mile		Category	Item	* Location	** Rating	Action/Comment	GPS Latitude/Longitude		Issue No. Photo
	Start	End						Start	End	
32	1.58	1.58	Earthen Levee	Slope Stability	LS	W	Repair the levee slope damaged by foot traffic and prevent access where possible.	38.627251 ° -121.441460 °	38.627251 ° -121.441460 °	54 Y
33	1.69	1.69	Earthen Levee	Trim / Thin Trees	WS	N	Tree stumps. Inspector Comments: Tree stump >2" with new growth.	38.627592 ° -121.439528 °	38.627592 ° -121.439528 °	53 Y
34	1.78	1.78	Interior Drainage & Piping Systems	Culverts: Inlets / Outlets	WS	A		38.627927 ° -121.437956 °	38.627927 ° -121.437956 °	51
35	1.82	1.82	Earthen Levee	Encroachments	LS	CO	Buildings Inspector Comments: Wooden animal pen is built against levee slope.	38.627915 ° -121.437246 °	38.627915 ° -121.437246 °	33
36	1.83	1.83	Earthen Levee	Encroachments	LS	PO	Fences Inspector Comments: Dog-eared wooden fence is built near the levee slope and has partially fallen. Bushes are overgrown. Fence has fallen over.	38.627880 ° -121.437368 °	38.627880 ° -121.437368 °	9

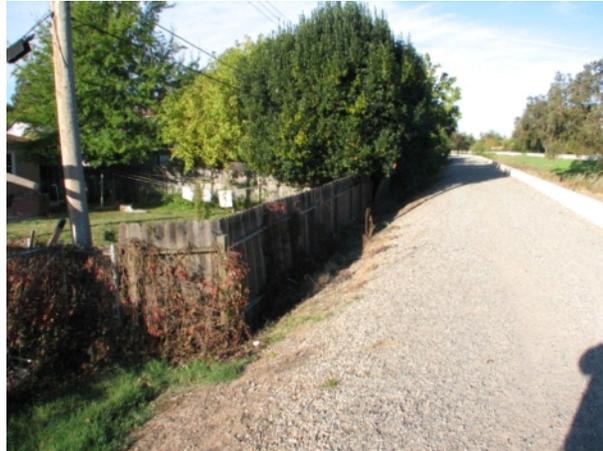
Levee Mile Report Line	47
Start Levee Mile	1.96
End Levee Mile	1.96
Location	Land Side
Category	Earthen Levee
Item	Slope Stability
Levee mile 1.96, slope stability repaired.	
cathom_f_20101122_216.jpg

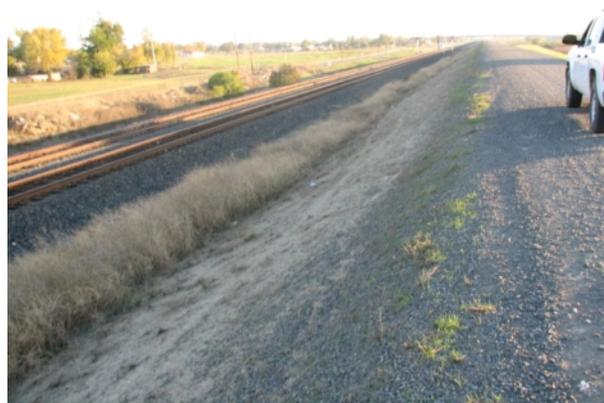
Levee Mile Report Line	7
Start Levee Mile	3.90
End Levee Mile	3.90
Location	Land Side
Category	Earthen Levee
Item	Vegetation
Levee mile 3.93, land side vegetation.	
cathom_f_20101122_209.jpg

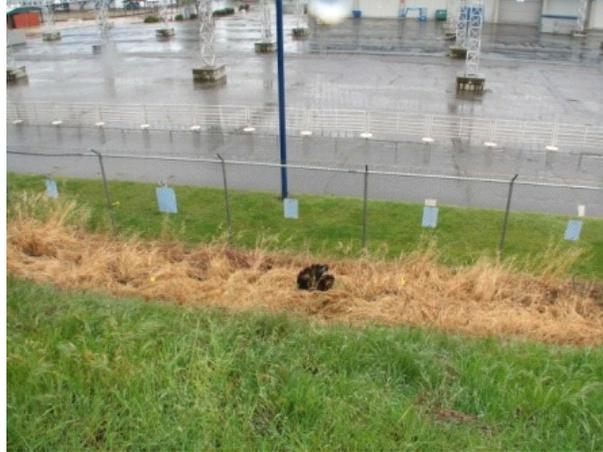
Levee Mile Report Line	2
Start Levee Mile	1.52
End Levee Mile	1.52
Location	Land Side
Category	Interior Drainage & Piping Systems
Item	Culverts: Inlets / Outlets
Drainage pump plant at Cal Expo.	
cathom_f_20100928_076.jpg

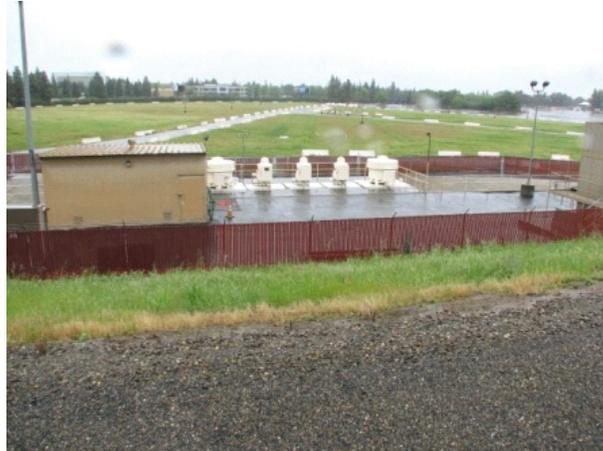
Levee Mile Report Line	2
Start Levee Mile	1.52
End Levee Mile	1.52
Location	Land Side
Category	Interior Drainage & Piping Systems
Item	Culverts: Inlets / Outlets
Drainage discharge to American River.	
cathom_f_20100928_077.jpg

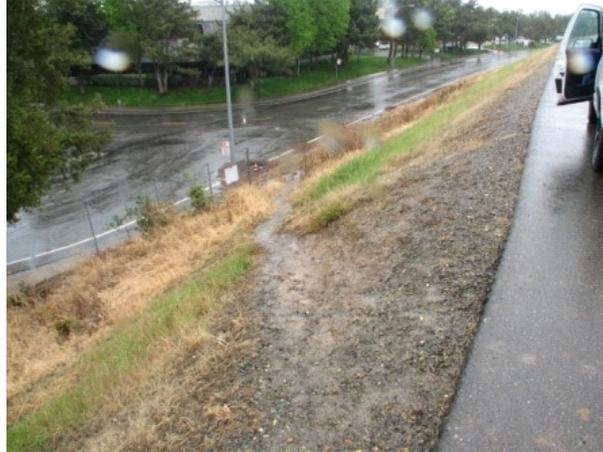
Levee Mile Report Line	4
Start Levee Mile	2.32
End Levee Mile	2.32
Location	Water Side
Category	Interior Drainage & Piping Systems
Item	Culverts: Inlets / Outlets
Drainage outfall to American River.	
cathom_f_20100928_074.jpg

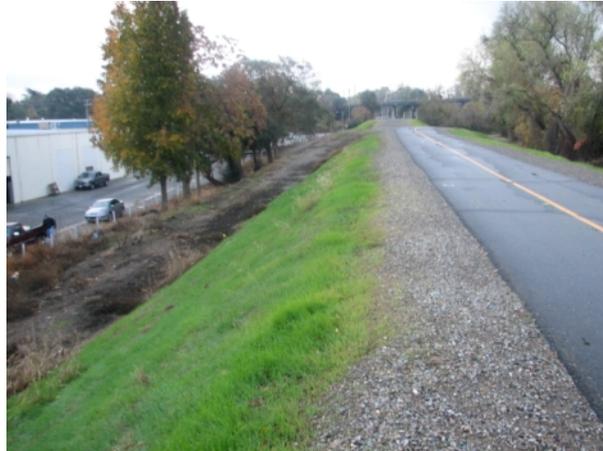
Levee Mile Report Line	11
Start Levee Mile	3.35
End Levee Mile	3.35
Location	Water Side
Category	Earthen Levee
Item	Vegetation
Levee mile 3.34, water side vegetation.	
cathom_f_20101129_229.jpg

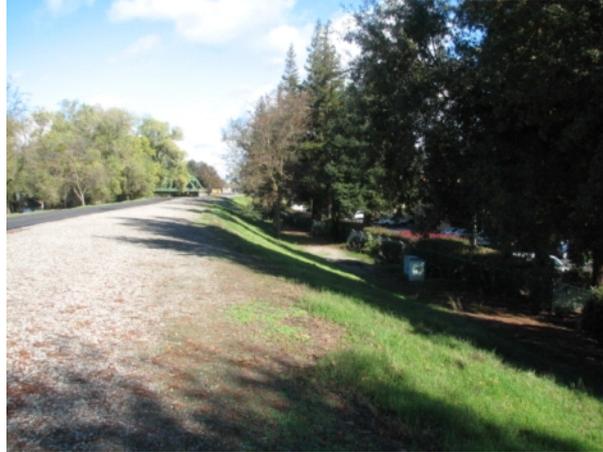
Levee Mile Report Line	2
Start Levee Mile	0.02
End Levee Mile	0.02
Location	Water Side
Category	Earthen Levee
Item	Vegetation
Levee mile 0.02, water side vegetation.	
cathom_f_20101129_233.jpg

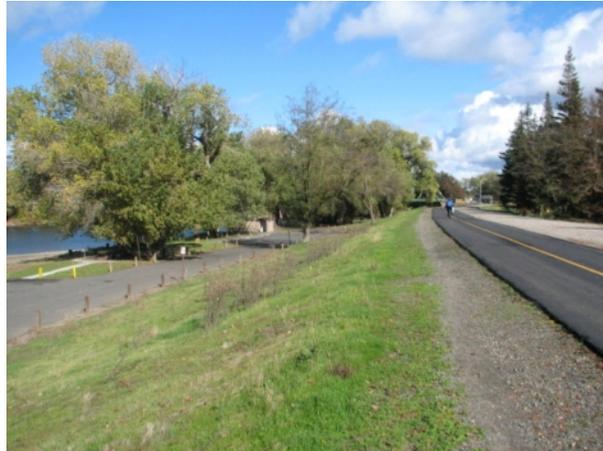
Levee Mile Report Line	6
Start Levee Mile	0.93
End Levee Mile	0.93
Location	Water Side
Category	Interior Drainage & Piping Systems
Item	Culverts: Inlets / Outlets
Outlet of storm drain to American River.	
cathom_f_20100928_085.jpg

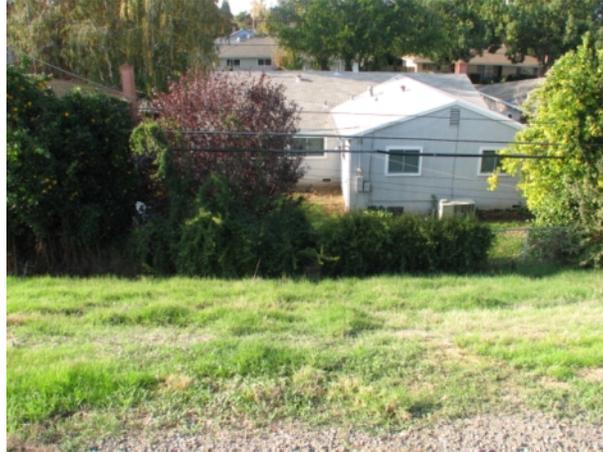
Levee Mile Report Line	66
Start Levee Mile	4.58
End Levee Mile	4.58
Location	Water Side
Category	Interior Drainage & Piping Systems
Item	Culverts: Inlets / Outlets
Storm water discharge to American River.	
cathom_f_20100928_088.jpg

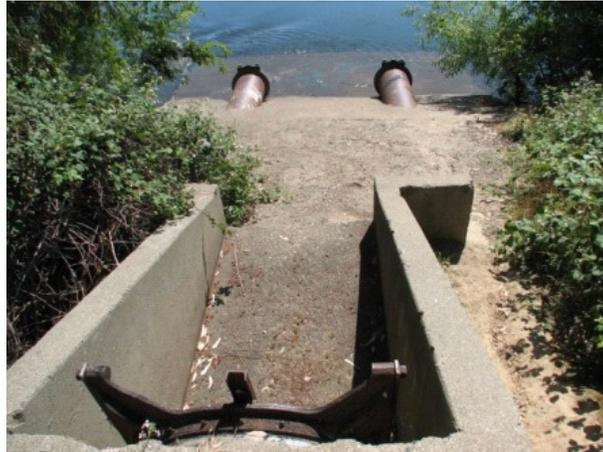
Levee Mile Report Line	172
Start Levee Mile	9.49
End Levee Mile	9.49
Location	Water Side
Category	Earthen Levee
Item	Encroachments
Drainage outfall to American River.	
cathom_f_20100928_083.jpg

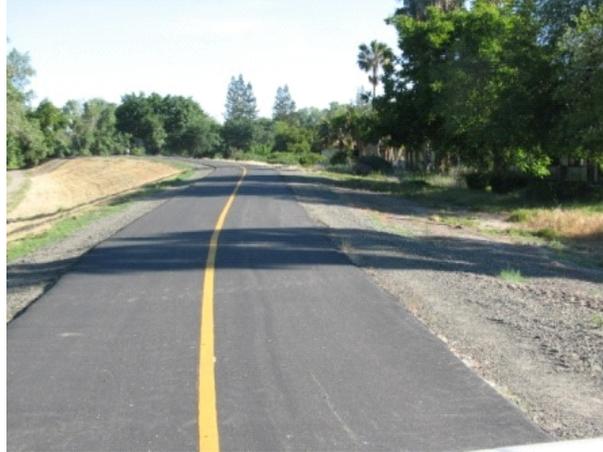
Levee Mile Report Line	3
Start Levee Mile	0.12
End Levee Mile	0.12
Location	Land Side
Category	Earthen Levee
Item	Vegetation
Levee mile 0.11, land side vegetation.	
cathom_f_20101129_230.jpg

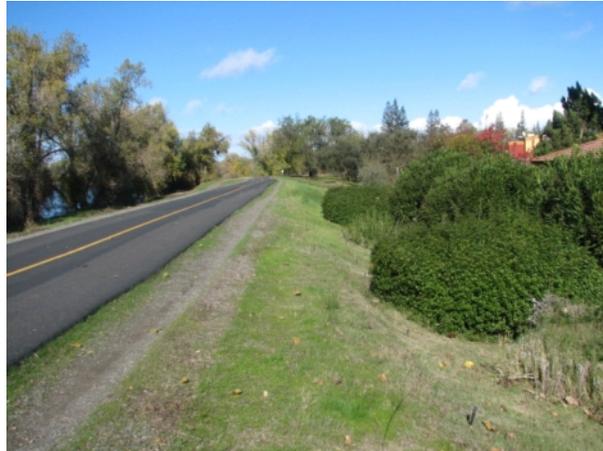
Levee Mile Report Line	4
Start Levee Mile	0.12
End Levee Mile	0.12
Location	Water Side
Category	Earthen Levee
Item	Vegetation
Levee mile 0.11, water side vegetation.	
cathom_f_20101129_231.jpg

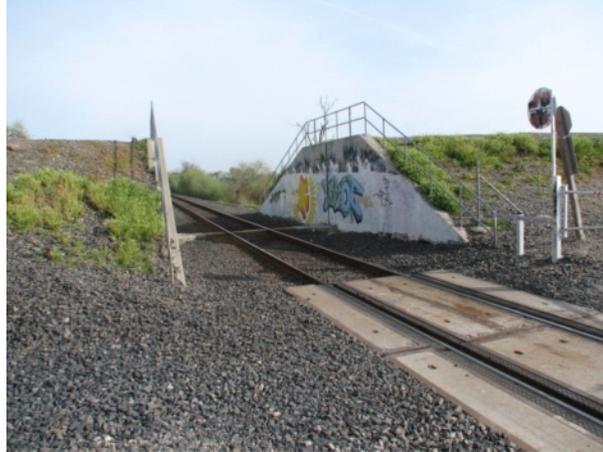
Levee Mile Report Line	2
Start Levee Mile	0.96
End Levee Mile	0.96
Location	Water Side
Category	Earthen Levee
Item	Vegetation
Levee mile 0.96, water side vegetation.	
cathom_f_20101129_227.jpg

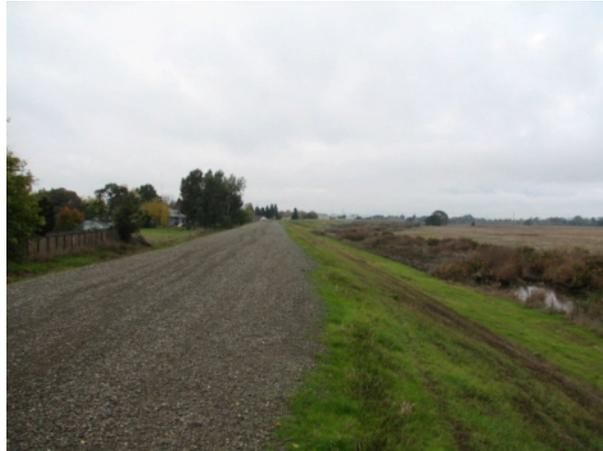
Levee Mile Report Line	3
Start Levee Mile	0.96
End Levee Mile	0.96
Location	Land Side
Category	Earthen Levee
Item	Vegetation
Levee mile 0.96, land side vegetation.	
cathom_f_20101129_226.jpg

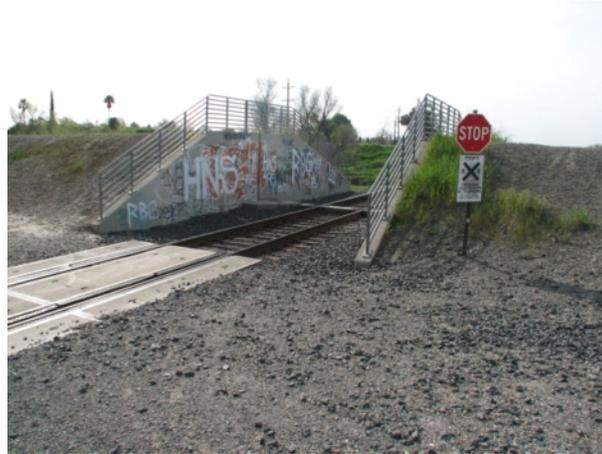
Levee Mile Report Line	2
Start Levee Mile	0.06
End Levee Mile	0.06
Location	Land Side
Category	Earthen Levee
Item	Vegetation
Levee mile 0.00, land side vegetation.	
cathom_f_20101122_212.jpg

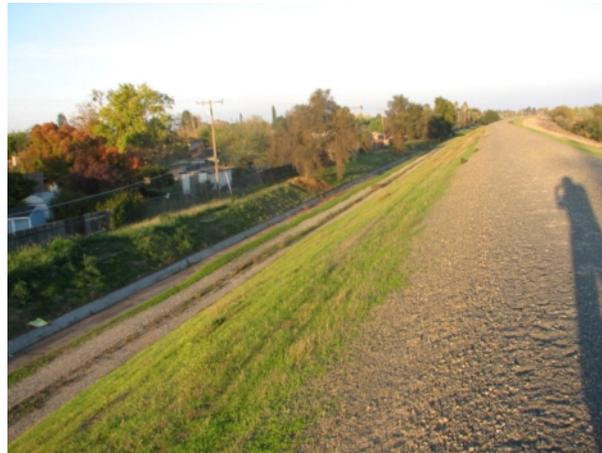
Levee Mile Report Line	3
Start Levee Mile	0.06
End Levee Mile	0.06
Location	Water Side
Category	Earthen Levee
Item	Vegetation
Levee mile 0.00, water side vegetation.	
cathom_f_20101122_213.jpg
