**Flood Control Project Maintenance  
Levee Inspections**

**Fall 2014 Levee Maintenance Deficiency Summary Report**

**Sacramento River Basin**

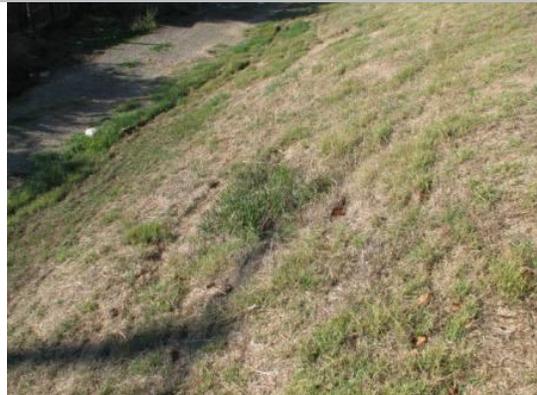
Photo 1 of 1 : FA\_2014\_NA0001\_51\_164\_20141001\_00035.jpg

11/17/2011 Hole/depression approximately mid-slope.

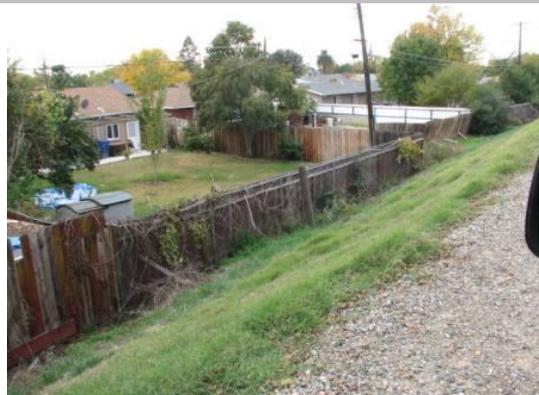
Photo 1 of 1 : FA\_2014\_NA0001\_51\_23\_20141001\_00020.jpg

11/17/2011 Fence built on the levee slope.

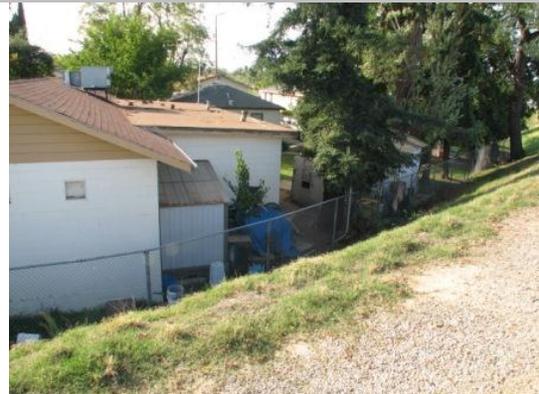
Photo 1 of 1 : FA\_2014\_NA0001\_51\_18\_20141001\_00016.jpg

Fall 2009 photo: Buildings and fence near levee toe.

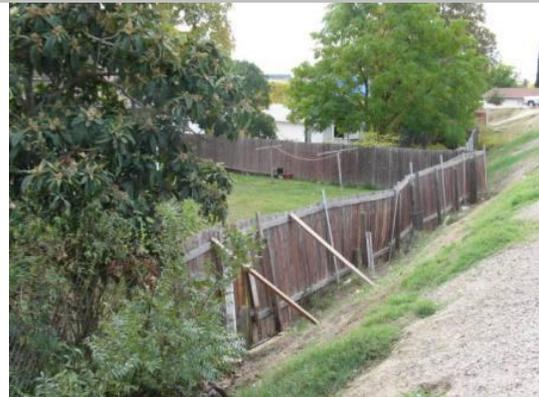
Photo 1 of 1 : FA\_2014\_NA0001\_51\_17\_20141001\_00015.jpg

11/17/2011 Wooden privacy fence built at the levee toe. Levee slope is being used to support the fence.

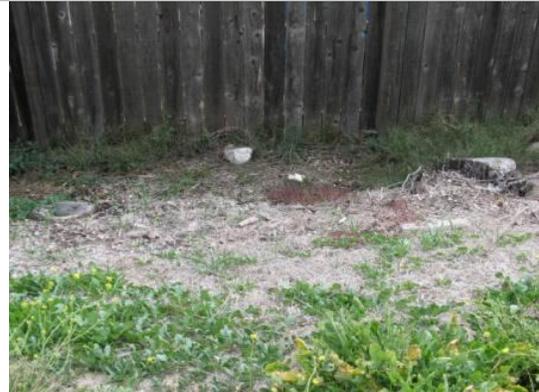
Photo 1 of 1 : FA\_2014\_NA0001\_51\_178\_20141001\_00044.jpg

11/17/2011 Two stumps at levee toe.

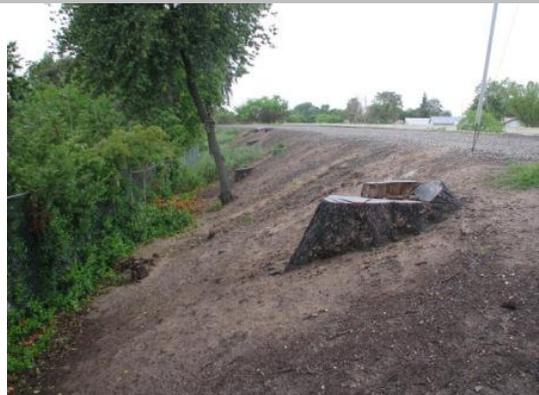
Photo 1 of 1 : FA\_2014\_NA0001\_51\_56\_20141001\_00033.jpg

Several large stumps on levee slope.

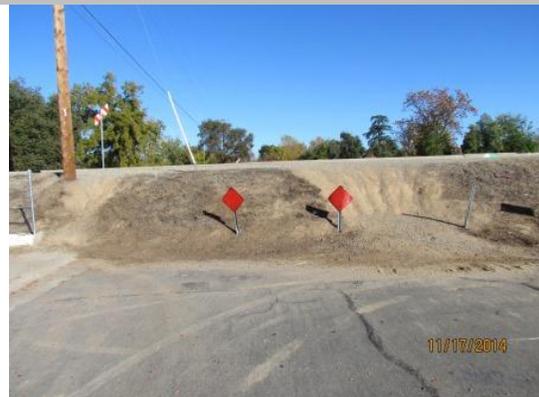
Photo 1 of 1 : FA\_2014\_NA0001\_51\_54\_20141119\_00054.jpg

LM Start	<b>1.58</b>	Rating **	A/W	Issue No.	<b>54</b>
LM End	<b>1.58</b>	Issue Type +	Ma	Location *	LS
Category	Earthen Levee		GPS Latitude/Longitude		
			Start	End	
Item	Slope Stability		38.627251 °	38.627251 °	
			-121.441460 °	-121.441460 °	
DWR ID	DWR_NA0001_01_s_2012_54				
Action/Comments					
Repair the levee slope damaged by foot traffic and prevent access where possible.

Slope stability due to foot traffic needs to be monitored.

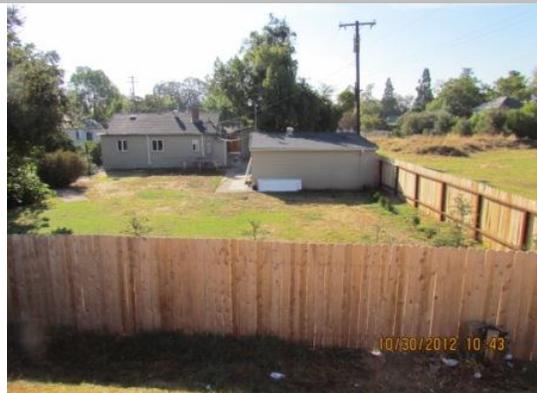
Photo 1 of 1 : FA\_2014\_NA0001\_51\_10\_20141001\_00009.jpg

View of new fence constructed at levee toe and 7 redwood trees planted behind fence within easement.

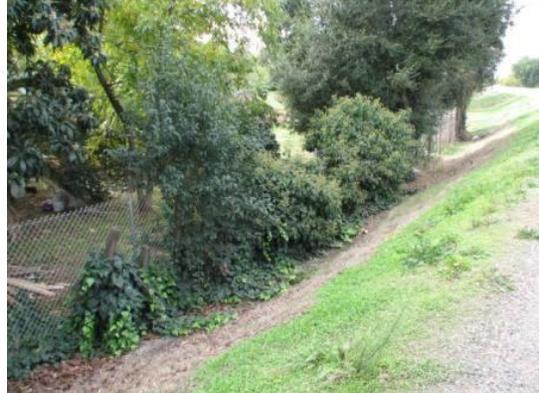
Photo 1 of 1 : FA\_2014\_NA0001\_51\_170\_20141001\_00039.jpg

11/17/2011 Growth on existing wooden fence is obstructive.

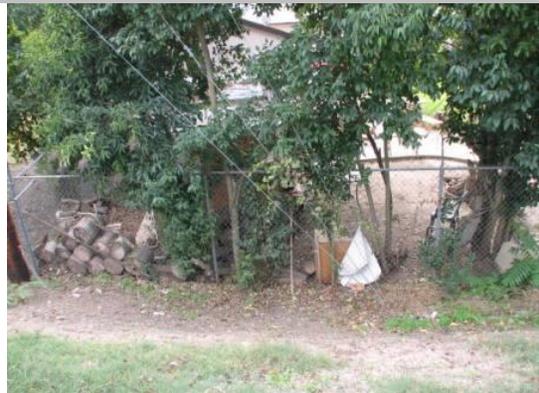
Photo 1 of 1 : FA\_2014\_NA0001\_51\_33\_20141001\_00026.jpg

11/17/2011 Wooden structure is built within 15' of the levee toe.

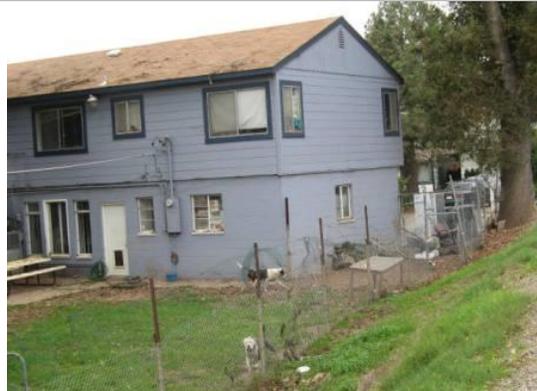
Photo 1 of 1 : FA\_2014\_NA0001\_51\_29\_20141001\_00023.jpg

11/17/2011 Building foundation is within 15' of the levee toe.

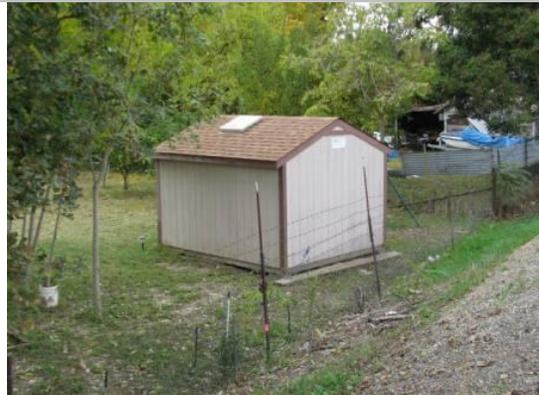
Photo 1 of 1 : FA\_2014\_NA0001\_51\_27\_20141001\_00021.jpg

11/17/2011 Wooden structure is within 15' of the levee toe.

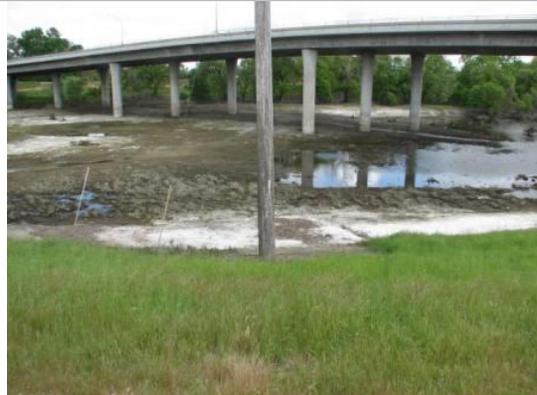
Photo 1 of 1 : FA\_2014\_NA0001\_52\_2\_20141001\_00001.jpg

04/13/2011 Power pole is in the levee on the water side.

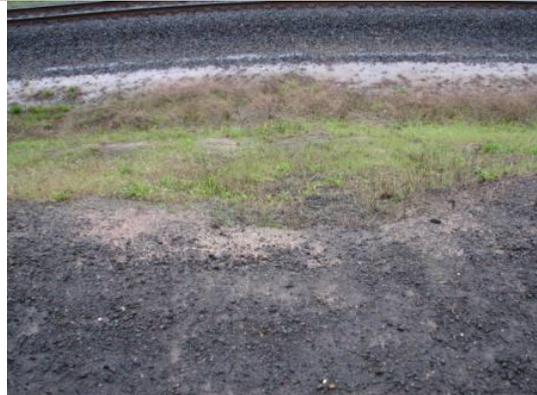
Photo 1 of 2 : FA\_2014\_NA0001\_52\_150\_20141001\_00006.jpg

03/14/2012 Photo shows depression, the issue has not gotten any worse since the fall 2011 inspection.

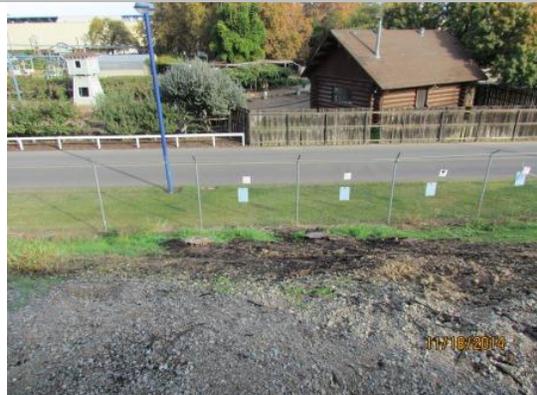
Photo 1 of 1 : FA\_2014\_NA0001\_490\_23\_20141119\_00011.jpg

View of the tree stump on the landside levee slope.

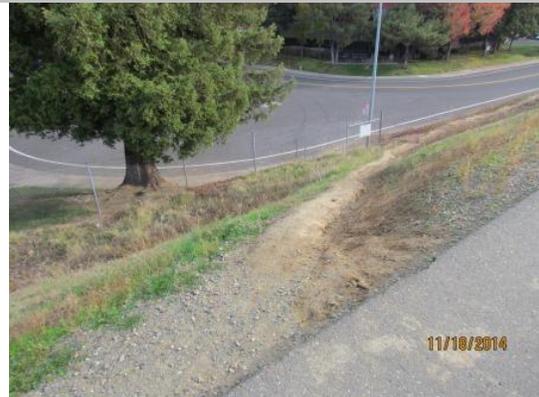
Photo 1 of 1 : FA\_2014\_NA0001\_490\_9\_20141119\_00010.jpg

View of the erosion on landside levee slope due to pedestrian traffic.

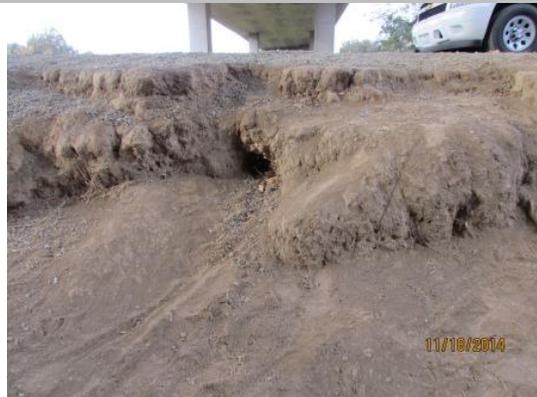
Photo 1 of 1 : FA\_2014\_NA0001\_490\_1\_20141119\_00009.jpg

View of the rodent holes on the landside levee slope.

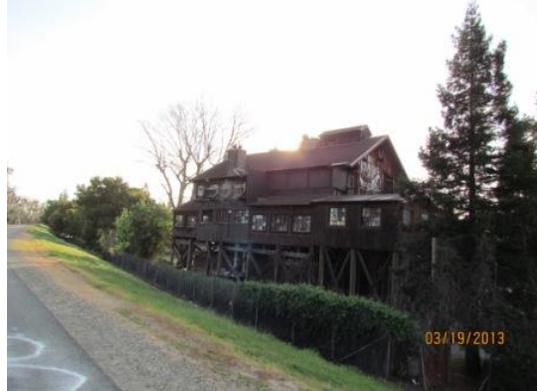
Photo 1 of 1 : FA\_2014\_NA0001\_55\_1\_20141001\_00001.jpg

View of the vines obstructing visibility.

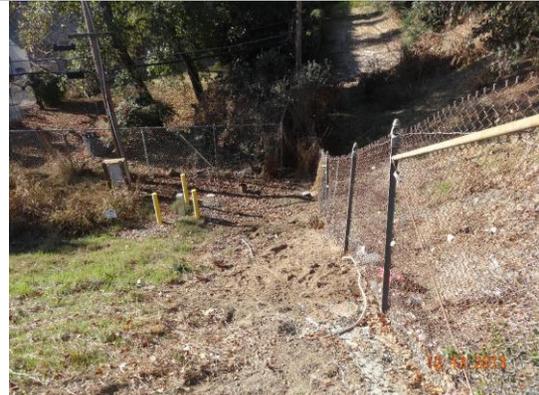
Photo 1 of 1 : UCIP\_6253.jpg

Sewer line along fence line on landward side--riser near back fence.

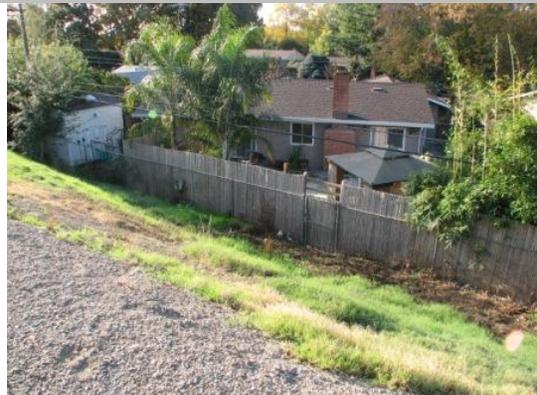
Photo 2 of 2 : FA\_2014\_NA0001\_55\_8\_20141001\_00009.jpg

Fall 2009 photo: Fence and landscaping within 10-ft of levee toe obstructs access and visibility.

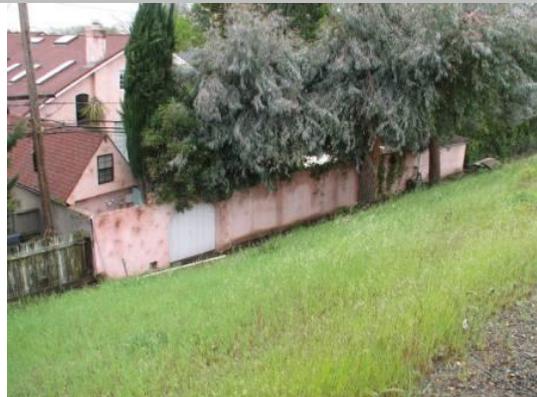
Photo 1 of 1 : FA\_2014\_NA0001\_55\_13\_20141001\_00013.jpg

03/16/2012 Concrete wall obstructs access and visibility.

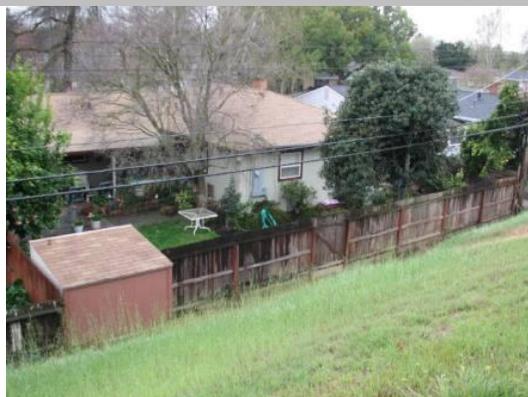
Photo 1 of 1 : FA\_2014\_NA0001\_55\_20\_20141001\_00020.jpg

03/16/2012 Wood privacy fence completely obstructs access and visibility.

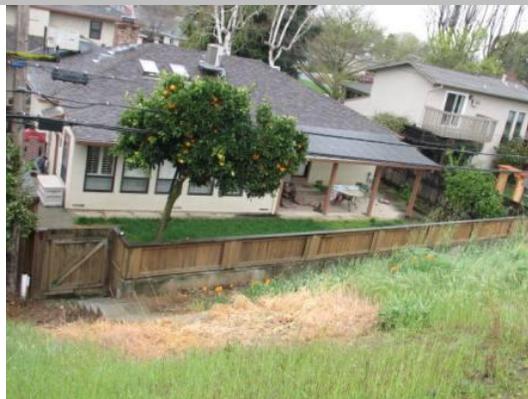
Photo 1 of 1 : FA\_2014\_NA0001\_55\_23\_20141001\_00023.jpg

03/16/2012 Wooden fence on cement wall obstructs access and visibility.

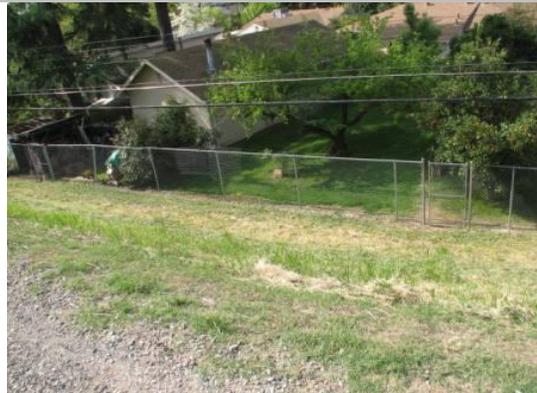
Photo 1 of 1 : FA\_2014\_NA0001\_55\_194\_20141001\_00167.jpg

04/14/2011 Planter boxes have been removed. Chainlink fence partially blocks access.

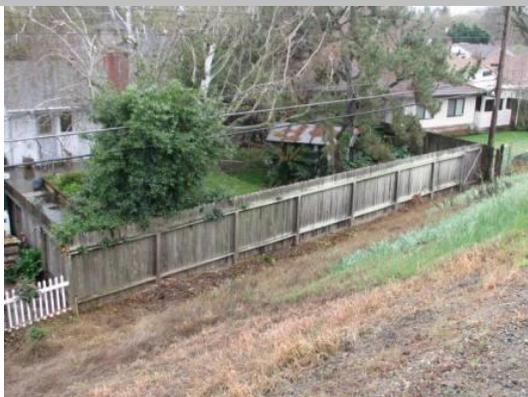
Photo 1 of 1 : FA\_2014\_NA0001\_55\_31\_20141001\_00030.jpg

03/16/2012 Wood privacy fence completely obstructs access and visibility.

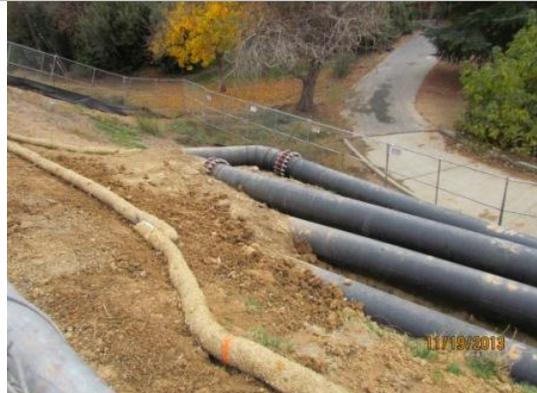
Photo 1 of 1 : FA\_2014\_NA0001\_55\_204\_20141001\_00176.jpg

View of the temporary pipes penetrating the landside levee slope.

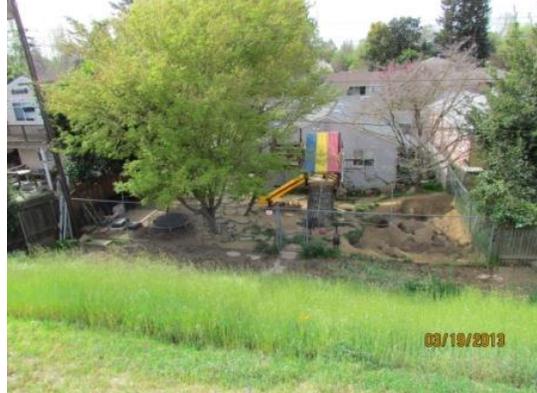
Photo 1 of 2 : FA\_2014\_NA0001\_55\_739\_20141001\_00193.jpg

View of the previously noted debris stored in the upstream corner of the property. Note extensive burrowing in the backyard on the downstream (right) corner of the property.

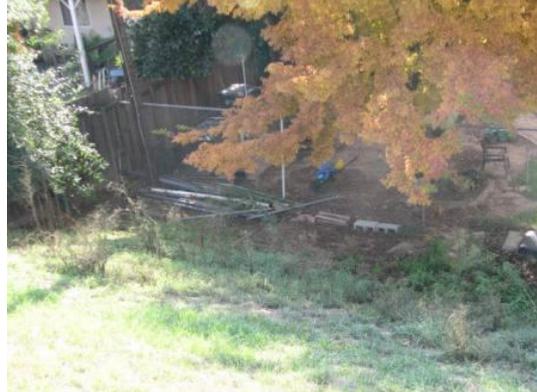
Photo 2 of 2 : FA\_2014\_NA0001\_55\_739\_20141001\_00194.jpg

11/15/2011 Debris on levee side of fence. This item was noted in the USACE PI.

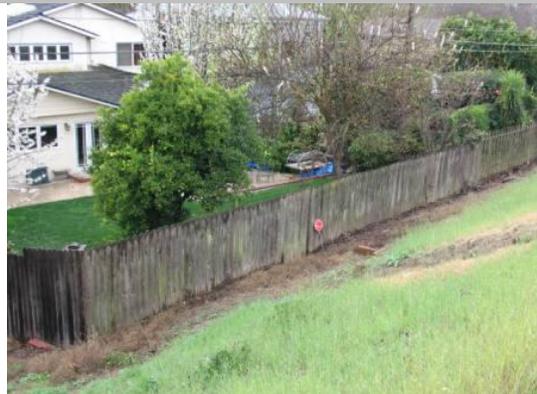
Photo 1 of 1 : FA\_2014\_NA0001\_55\_42\_20141001\_00033.jpg

03/16/2012 Wood privacy fence completely obstructs access and visibility.

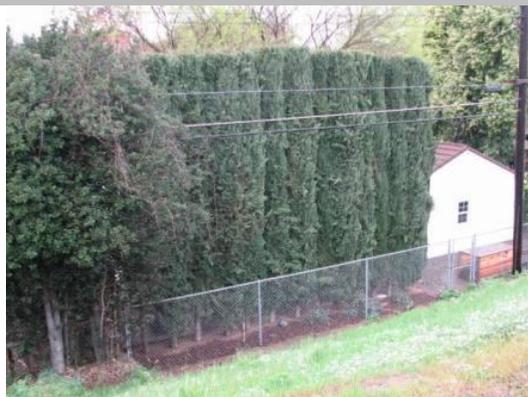
Photo 1 of 1 : FA\_2014\_NA0001\_55\_52\_20141001\_00041.jpg

03/16/2012 Landscaping obstructs visibility and access.

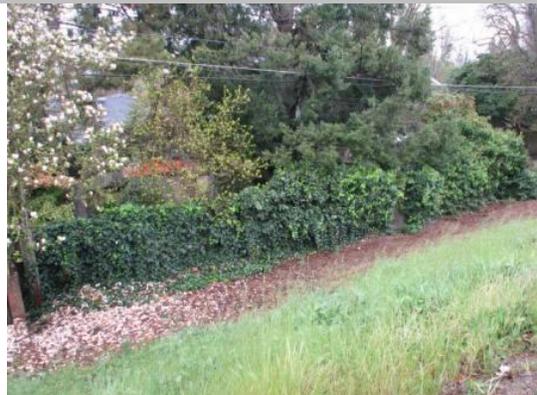
Photo 1 of 1 : FA\_2014\_NA0001\_55\_61\_20141001\_00048.jpg

03/16/2012 Landscaping obstructs access and visibility.

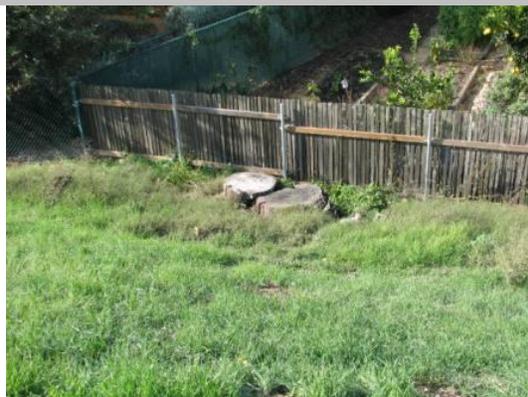
Photo 1 of 1 : FA\_2014\_NA0001\_55\_741\_20141001\_00196.jpg

11/15/2011 Stump at levee toe.

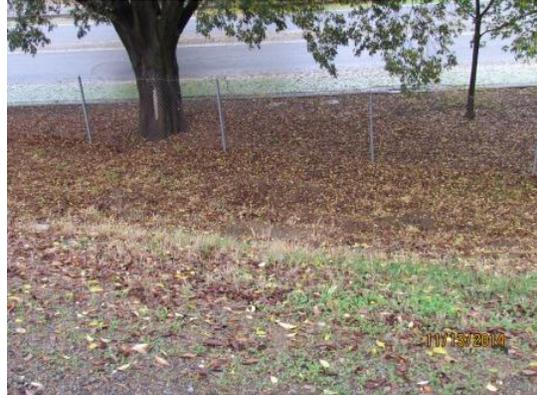
Photo 1 of 1 : FA\_2014\_NA0001\_55\_240\_20141119\_00215.jpg

View of a rodent burrow at the landside levee toe.

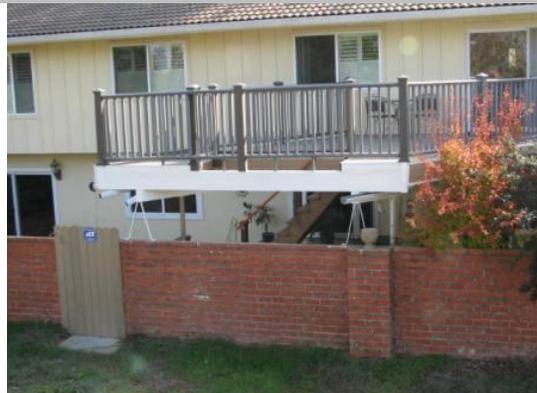
Photo 1 of 1 : FA\_2014\_NA0001\_55\_745\_20141001\_00197.jpg

11/15/2011 Gutter drains that are suspended from the balcony direct flow onto the levee toe.

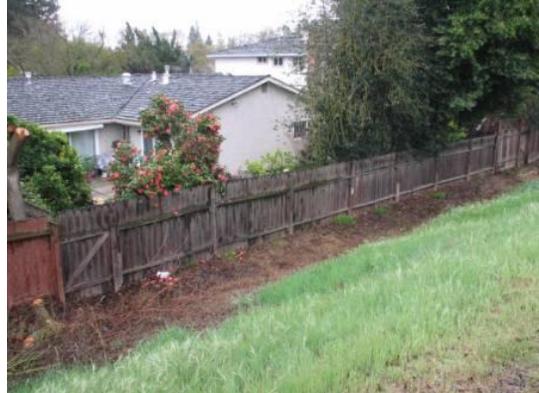
Photo 1 of 1 : FA\_2014\_NA0001\_55\_99\_20141001\_00082.jpg

03/16/2012 Wood privacy fence completely obstructs access and visibility.

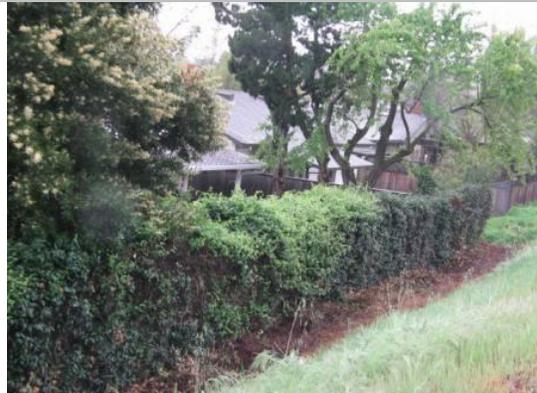
Photo 1 of 1 : FA\_2014\_NA0001\_55\_107\_20141001\_00090.jpg

03/16/2012 Landscaping obstructs visibility and access.

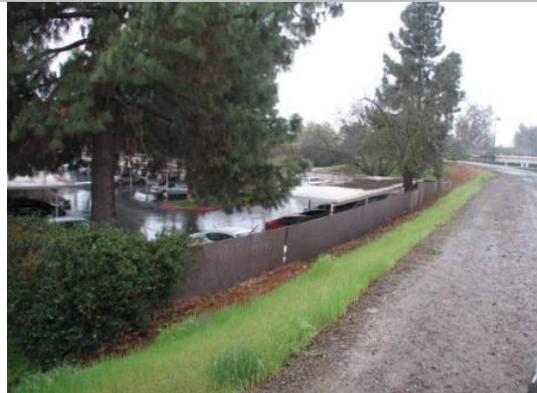
Photo 1 of 1 : FA\_2014\_NA0001\_55\_235\_20141001\_00185.jpg

03/16/2012 Chainlink fence with privacy slats and barbed wire obstruct visibility and access.

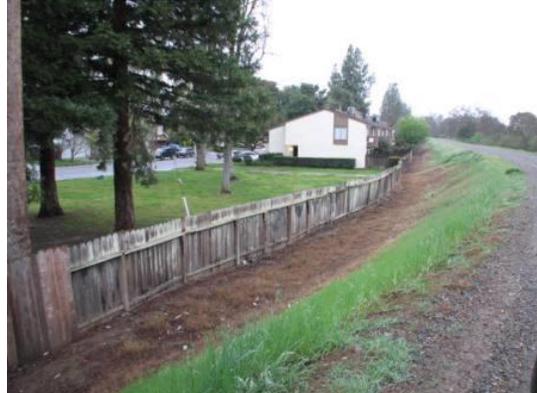
Photo 1 of 1 : FA\_2014\_NA0001\_55\_147\_20141001\_00127.jpg

03/16/2012 Wood privacy fence completely obstructs access and visibility.

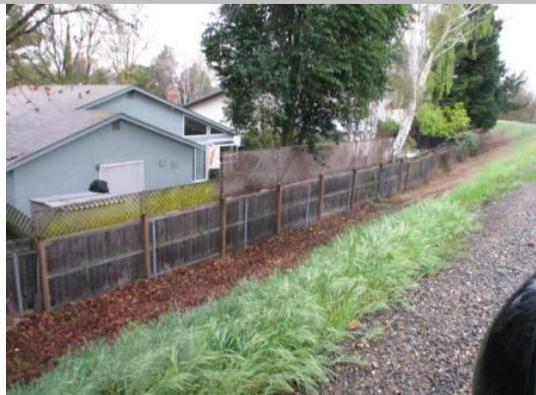
Photo 1 of 1 : FA\_2014\_NA0001\_55\_152\_20141001\_00132.jpg

03/16/2012 Wood privacy fence completely obstructs access and visibility.

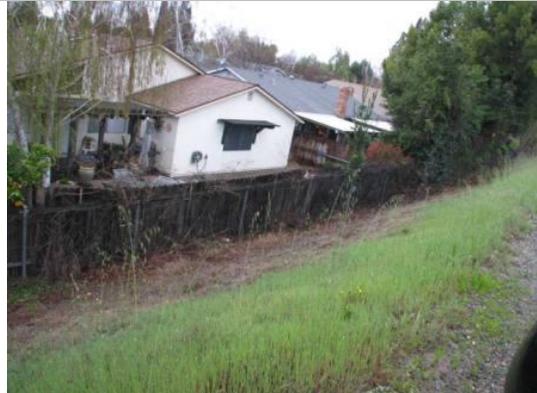
Photo 1 of 1 : FA\_2014\_NA0001\_55\_158\_20141001\_00138.jpg

03/16/2012 Wood privacy fence completely obstructs access and visibility.

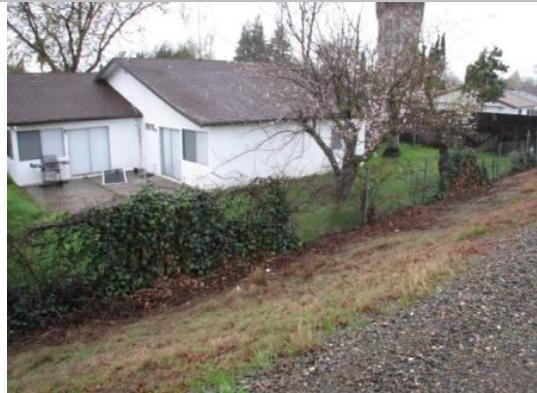
Photo 1 of 1 : FA\_2014\_NA0001\_55\_178\_20141001\_00156.jpg

03/16/2012 Chainlink fence partially blocks visibility.

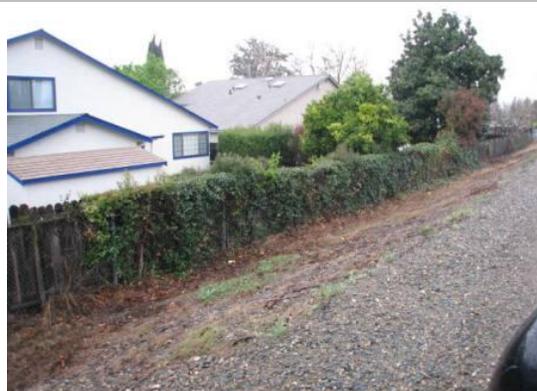
Photo 1 of 1 : FA\_2014\_NA0001\_55\_172\_20141001\_00151.jpg

03/16/2012 Wood privacy fence completely obstructs access and visibility.

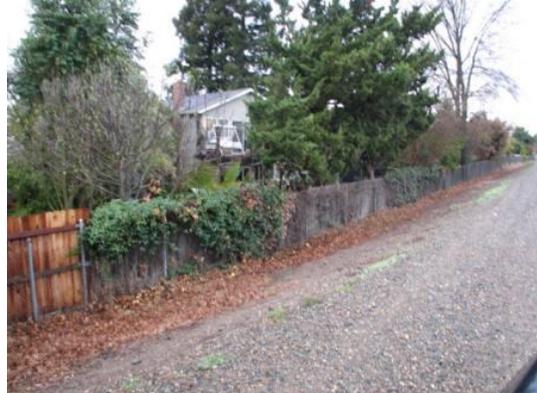
Photo 1 of 1 : FA\_2014\_NA0001\_55\_167\_20141001\_00146.jpg

03/16/2012 Wood privacy fence completely obstructs access and visibility.

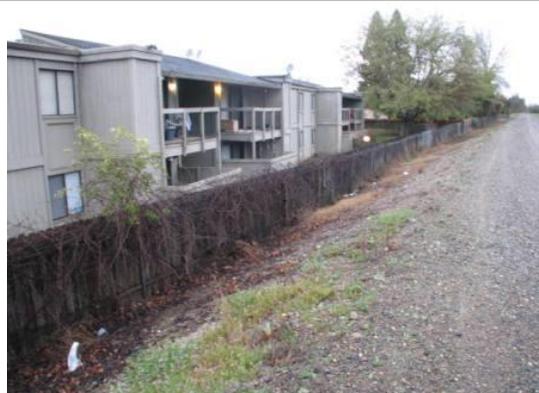
Photo 1 of 1 : FA\_2014\_NA0001\_55\_168\_20141001\_00147.jpg

03/16/2012 Wood privacy fence completely obstructs access and visibility.

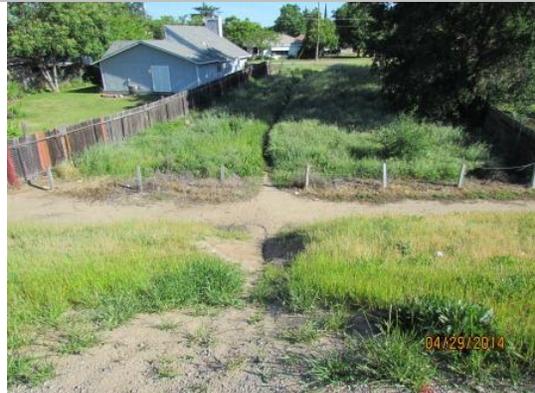
Photo 1 of 1 : FA\_2014\_NA0001\_58\_34\_20141001\_00029.jpg

View of the landside levee slope damaged by foot traffic.

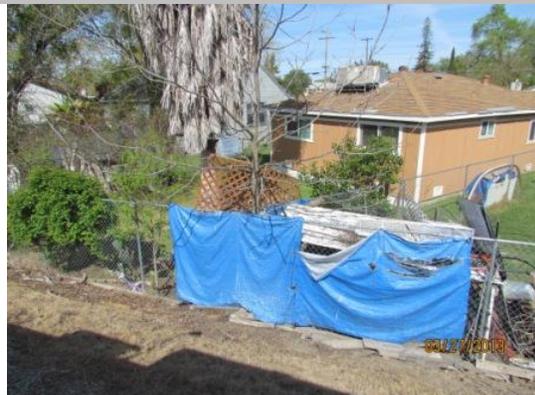
Photo 1 of 1 : FA\_2014\_NA0001\_58\_8\_20141001\_00006.jpg

View of the fence obstruction visibility and access at the landside levee toe.

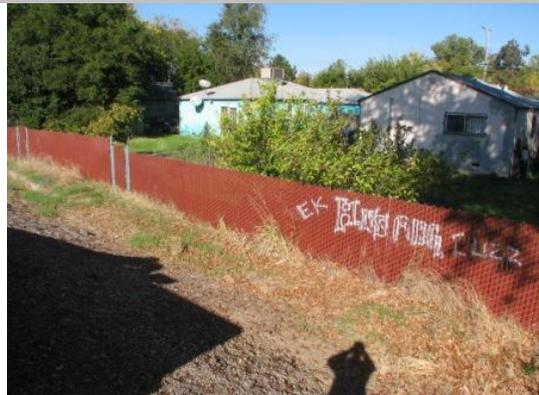
Photo 1 of 1 : FA\_2014\_NA0001\_58\_14\_20141001\_00012.jpg

Fall 2009 photo of privacy fence within 10-ft of the levee toe obstructs visibility and access.

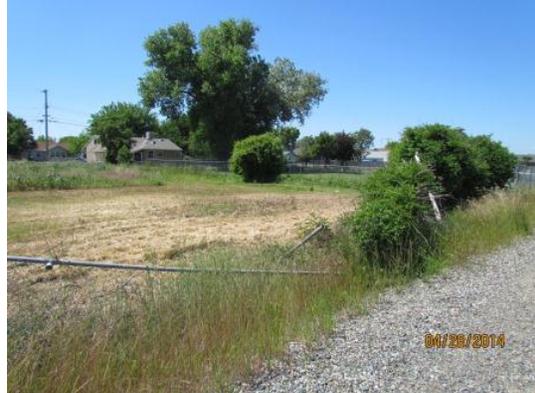
Photo 1 of 1 : FA\_2014\_NA0001\_59\_22\_20141001\_00013.jpg

View of the broken fence on landside levee toe.

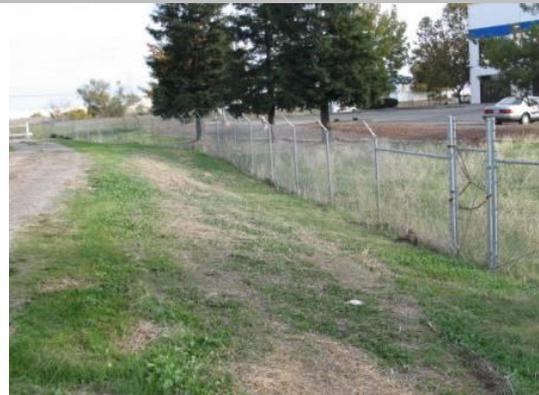
Photo 1 of 1 : FA\_2014\_NA0001\_59\_8\_20141001\_00007.jpg

11/17/2011 Chainlink fence alignment returns to the levee toe.

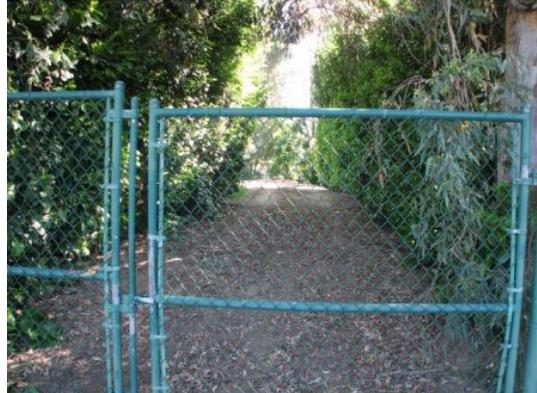
Photo 1 of 1 : FA\_2014\_NA0001\_61\_16\_20141001\_00006.jpg

Levee encroached on by property owners north of Arden Way. This section is not reasonably accessible.

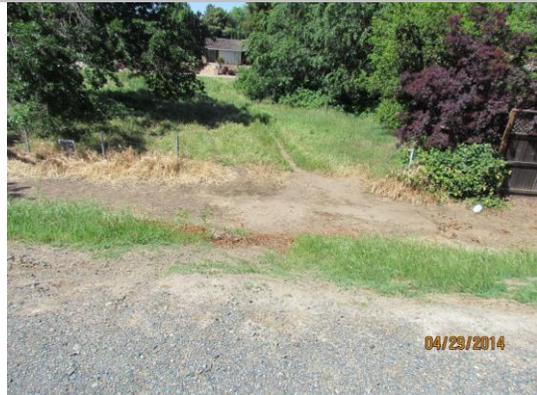
Photo 1 of 1 : FA\_2014\_NA0001\_61\_22\_20141001\_00007.jpg

View of the erosion on the landside levee slope caused by pedestrian foot traffic.

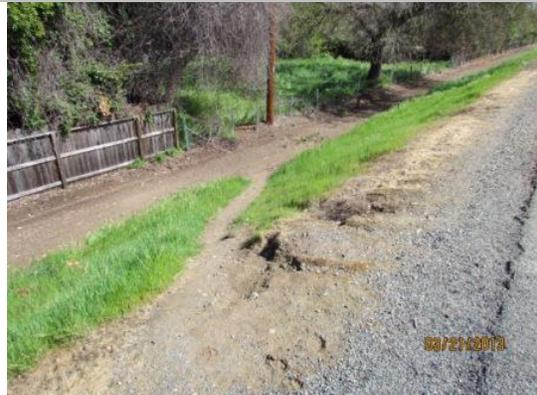
Photo 1 of 2 : FA\_2014\_NA0001\_61\_114\_20141001\_00008.jpg

View of the erosion on the landside levee slope from pedestrian traffic.

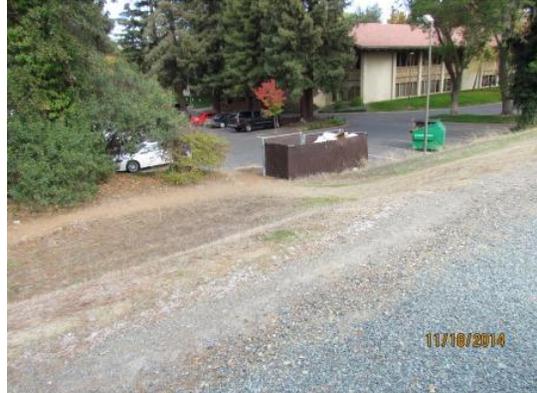
Photo 1 of 1 : FA\_2014\_NA0001\_61\_116\_20141119\_00016.jpg

View of the erosion on the landside levee slope caused by pedestrian foot traffic.
