**Flood Control Project Maintenance
Levee Inspections**

Maintenance Issue Types Only, Levee Inspection Report By Mile - Fall 2014

American River Flood Control District

Waterway	Bank	Unit Miles	Inspection Start/End	Inspector
Unit No. 01 Arcade Creek	Left	2.08	11/17/2014 11/17/2014	Maksim Khashchuk

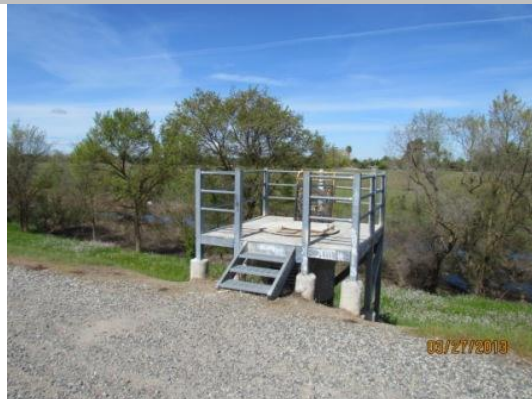
Photo 1 of 1 : FA_2014_NA0001_51_60_20141001_00034.jpg

LM Start	0.40	Rating **	A/W	Issue No.	60
LM End	0.40	Issue Type +	Ma	Location *	WS
Category	Earthen Levee			GPS Latitude/Longitude	
				Start	End
Item	Encroachments			38.622579 °	38.622579 °
				-121.461567 °	-121.461567 °
DWR ID	DWR_NA0001_01_s_2012_60				
Action/Comments					
Pipe

View of the pipe at the waterside levee hinge.

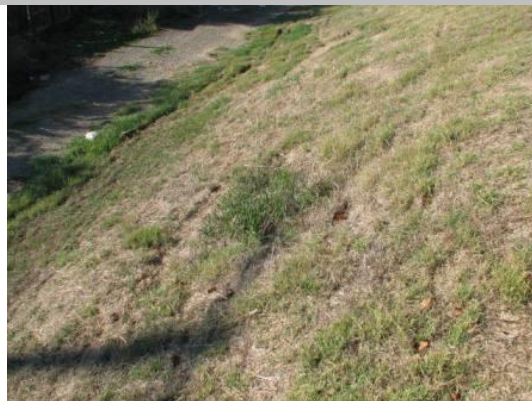
Photo 1 of 1 : FA_2014_NA0001_51_164_20141001_00035.jpg

LM Start	0.48	Rating **	A/W	Issue No.	164
LM End	0.48	Issue Type +	Ma	Location *	LS
Category	Earthen Levee			GPS Latitude/Longitude	
				Start	End
Item	Erosion / Bank Caving			38.623227 °	38.623227 °
				-121.460399 °	-121.460399 °
DWR ID	DWR_NA0001_01_s_2012_164				
Action/Comments					
Note and monitor erosion site. Inspector Comments: 4'-5' diameter by 1' deep hole mid-slope on the lanside.

11/17/2011 Hole/depression approximately mid-slope.

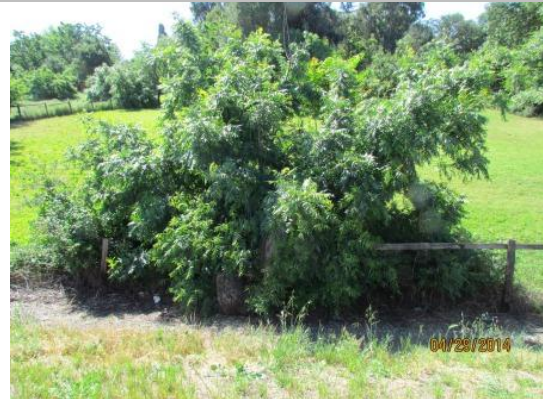
Photo 1 of 1 : FA_2014_NA0001_51_48_20141001_00030.jpg

LM Start	1.69	Rating **	A/W	Issue No.	48
LM End	1.69	Issue Type +	Ma	Location *	LS
Category	Earthen Levee			GPS Latitude/Longitude	
				Start	End
Item	Vegetation			38.627594 °	38.627594 °
				-121.439540 °	-121.439540 °
DWR ID	DWR_NA0001_01_s_2014_48				
Action/Comments					
Trees / Woody Vegetation					
Inspector Comments: Tree obstructing visibility and access.

View of the overgrown tree at the landside levee toe.

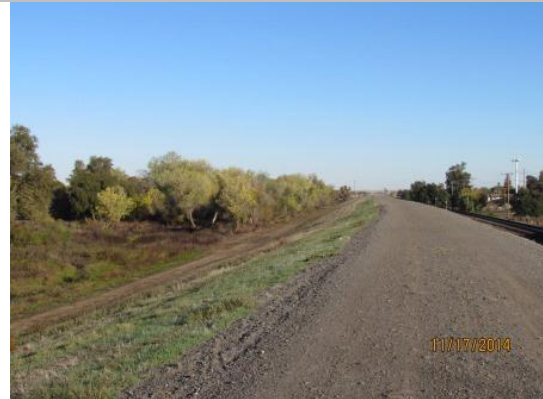
Photo 1 of 1 : FA_2014_NA0001_52_24_20141119_00013.jpg

LM Start	0.82	Rating **	A	Issue No.	24
LM End	0.82	Issue Type +	Ma	Location *	WS
Category	Earthen Levee			GPS Latitude/Longitude	
				Start	End
Item	Vegetation			38.613285 °	38.613285 °
				-121.466542 °	-121.466542 °
DWR ID	DWR_NA0001_02_f_2014_24				
Action/Comments					
Control annual grass and weeds on the levee slopes and easements.

View of acceptable vegetation control.

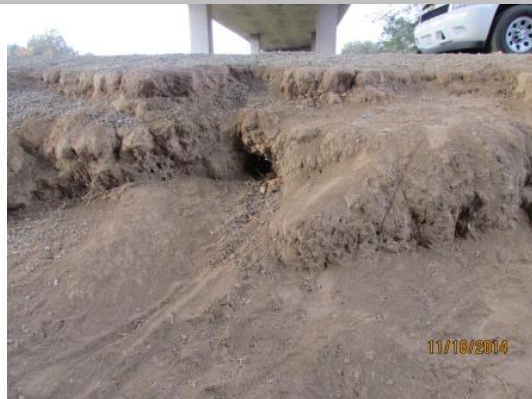
Photo 1 of 1 : FA_2014_NA0001_490_1_20141119_00009.jpg

LM Start	3.14	Rating **	M	Issue No.	1
LM End	3.14	Issue Type +	Ma	Location *	LS
Category	Earthen Levee			GPS Latitude/Longitude	
				Start	End
Item	Animal Control			38.599141 °	38.599141 °
				-121.470227 °	-121.470227 °
DWR ID	DWR_NA0001_03_f_2013_1				
Action/Comments					
No rodents visible, but rodent burrows visible; need to backfill and compact or grout burrows.

View of the rodent holes on the landside levee slope.

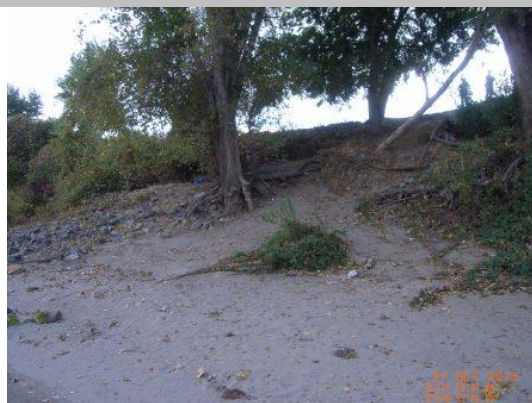
Photo 1 of 1 : FA_2014_NA0001_55_7_20141001_00007.jpg

LM Start	1.62	Rating **	M	Issue No.	7
LM End	1.62	Issue Type +	Ma	Location *	WS
Category	Supplemental			GPS Latitude/Longitude	
				Start	End
Item	USACE Erosion Survey			38.599095 °	38.598791 °
				-121.480337 °	-121.479799 °
DWR ID	DWR_NA0001_04_f_2014_7				
Action/Comments					
Inspector Comments: 2012 - Located just downstream of older repair. Failing rock at the upstream end. Erosion of the bank has exposed large tree roots. 2013: No observed changes. [2013 Site ID: LAR_1-8_L]

USACE 2013 Photo #1

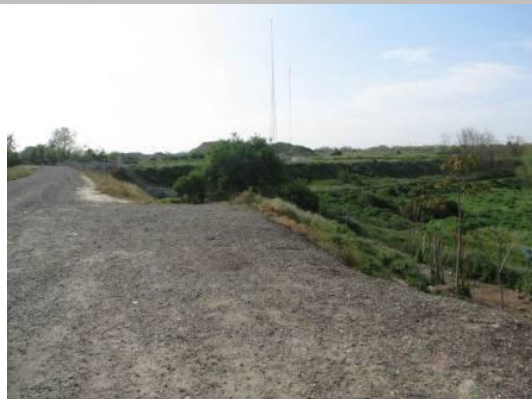
Photo 1 of 1 : FA_2014_NA0001_55_184_20141001_00160.jpg

LM Start	2.50	Rating **	M	Issue No.	184
LM End	2.50	Issue Type +	Ma	Location *	LS
Category	Earthen Levee			GPS Latitude/Longitude	
				Start	End
Item	Vegetation			38.589590 °	38.589590 °
				-121.470524 °	-121.470524 °
DWR ID	DWR_NA0001_04_s _ 2012_184				
Action/Comments					
Elderberries are blocking visibility and flood fight capability.

04/14/2011 Elderberry bush prevents visibility of levee toe.

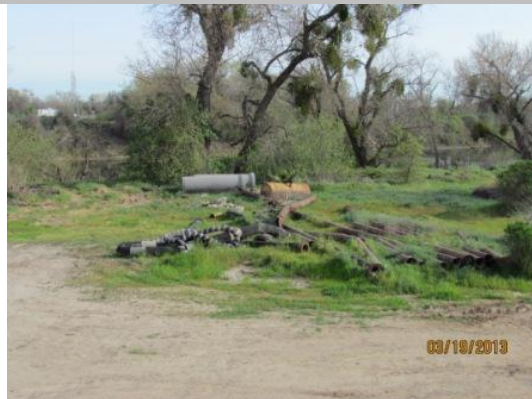
Photo 1 of 1 : FA_2014_NA0001_55_4_20141001_00004.jpg

LM Start	2.84	Rating **	M	Issue No.	4
LM End	2.84	Issue Type +	Ma	Location *	WS
Category	Earthen Levee			GPS Latitude/Longitude	
				Start	End
Item	Encroachments			38.587272 °	38.587272 °
				-121.464768 °	-121.464768 °
DWR ID	DWR_NA0001_04_s _ 2012_4				
Action/Comments					
Debris					
Inspector Comments: Bell Marine, LMA sent a letter to the property owner for this violation.

View of the debris stored in floodway.

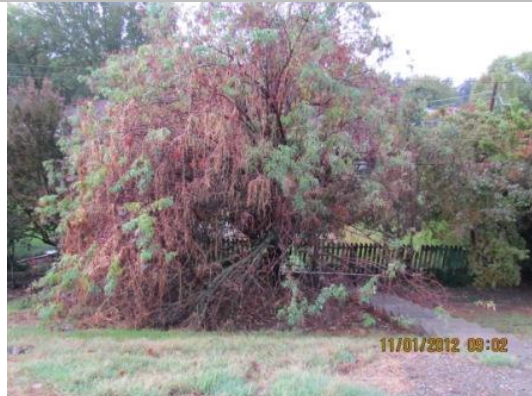
Photo 1 of 1 : FA_2014_NA0001_55_253_20141001_00192.jpg

LM Start	4.50	Rating **	M	Issue No.	253
LM End	4.50	Issue Type +	Ma	Location *	WS
Category	Earthen Levee			GPS Latitude/Longitude	
				Start	End
Item	Vegetation			38.581320 °	38.581320 °
				-121.438263 °	-121.438263 °
DWR ID	DWR_NA0001_04_s_2012_253				
Action/Comments					
Elderberries are blocking visibility and flood fight capability.

View of large elderberry bush obstructing visibility and access.

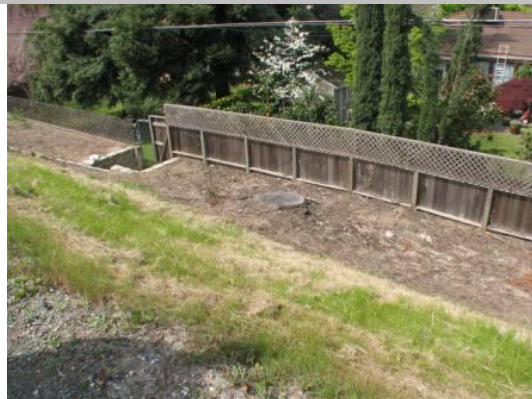
Photo 1 of 1 : FA_2014_NA0001_55_181_20141001_00159.jpg

LM Start	5.85	Rating **	N	Issue No.	181
LM End	5.85	Issue Type +	Ma	Location *	LS
Category	Earthen Levee			GPS Latitude/Longitude	
				Start	End
Item	Trim / Thin Trees			38.572032 °	38.572032 °
				-121.423981 °	-121.423981 °
DWR ID	DWR_NA0001_04_s_2012_181				
Action/Comments					
Tree stumps.					
Inspector Comments: 04/14/2011 Large stump at toe of levee.

04/14/2011 Large stump at toe of levee.

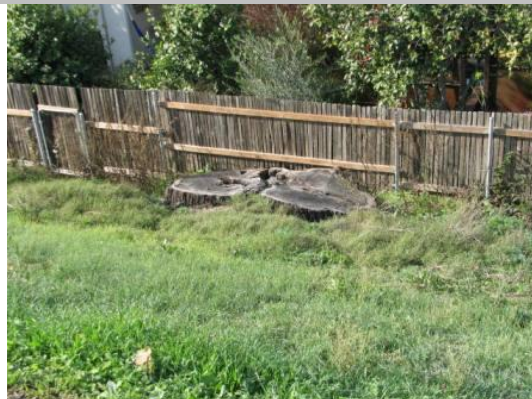
Photo 1 of 1 : FA_2014_NA0001_55_740_20141001_00195.jpg

LM Start	5.93	Rating **	N	Issue No.	740
LM End	5.93	Issue Type +	Ma	Location *	LS
Category	Earthen Levee			GPS Latitude/Longitude	
				Start	End
Item	Trim / Thin Trees			38.570940 °	38.570940 °
				-121.424173 °	-121.424173 °
DWR ID	DWR_NA0001_04_s_2012_740				
Action/Comments					
Tree stumps.					
Inspector Comments: Large stump

11/15/2011 Large stump at levee toe.

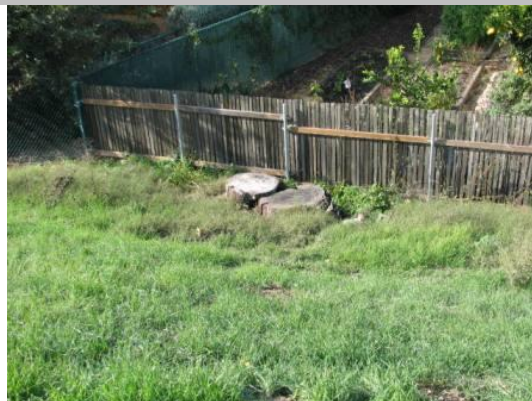
Photo 1 of 1 : FA_2014_NA0001_55_741_20141001_00196.jpg

LM Start	5.94	Rating **	N	Issue No.	741
LM End	5.94	Issue Type +	Ma	Location *	LS
Category	Earthen Levee			GPS Latitude/Longitude	
				Start	End
Item	Trim / Thin Trees			38.570800 °	38.570800 °
				-121.424184 °	-121.424184 °
DWR ID	DWR_NA0001_04_s_2012_741				
Action/Comments					
Tree stumps.					
Inspector Comments: Stump.

11/15/2011 Stump at levee toe.

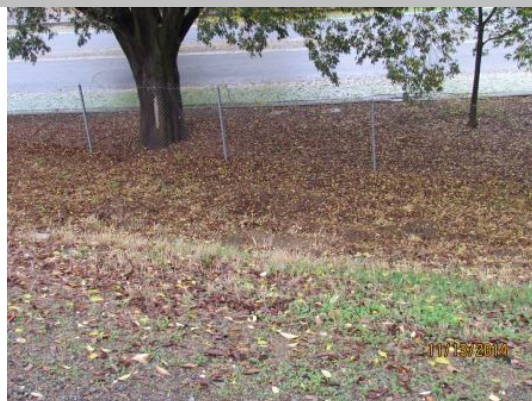
Photo 1 of 1 : FA_2014_NA0001_55_240_20141119_00215.jpg

LM Start	6.68	Rating **	M	Issue No.	240
LM End	6.68	Issue Type +	Ma	Location *	LS
Category	Earthen Levee			GPS Latitude/Longitude	
				Start	End
Item	Animal Control			38.560883 °	38.560883 °
				-121.420514 °	-121.420514 °
DWR ID	DWR_NA0001_04_f_2014_240				
Action/Comments					
Exterminate rodents and backfill and compact or grout burrows.

View of a rodent burrow at the landside levee toe.

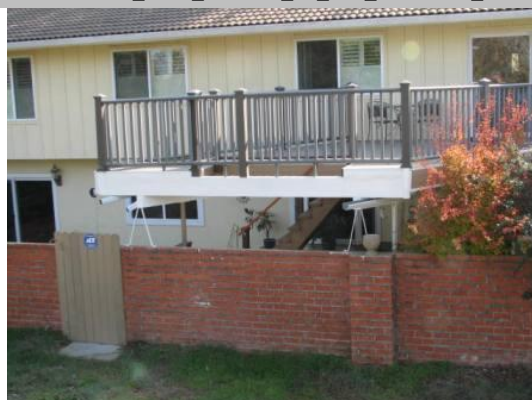
Photo 1 of 1 : FA_2014_NA0001_55_745_20141001_00197.jpg

LM Start	8.13	Rating **	A/W	Issue No.	745
LM End	8.13	Issue Type +	Ma	Location *	LS
Category	Earthen Levee			GPS Latitude/Longitude	
				Start	End
Item	Encroachments			38.560830 °	38.560830 °
				-121.396232 °	-121.396232 °
DWR ID	DWR_NA0001_04_s_2012_745				
Action/Comments					
Urban					
Inspector Comments: Drains direct gutter flow onto levee toe.

11/15/2011 Gutter drains that are suspended from the balcony direct flow onto the levee toe.

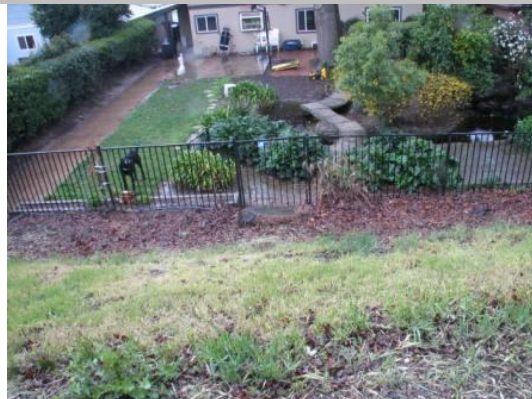
Photo 1 of 1 : FA_2014_NA0001_55_123_20141001_00105.jpg

LM Start	9.66	Rating **	N	Issue No.	123
LM End	9.66	Issue Type +	Ma	Location *	LS
Category	Earthen Levee			GPS Latitude/Longitude	
				Start	End
Item	Trim / Thin Trees			38.567285 °	38.567285 °
				-121.369964 °	-121.369964 °
DWR ID	DWR_NA0001_04_s_2012_123				
Action/Comments					
Tree stumps. Inspector Comments: Trees, bushes and ground cover within 10-ft of levee toe.

03/16/2012 Large tree stump at levee toe.

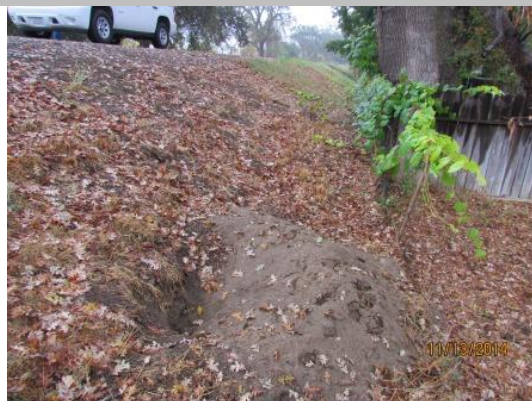
Photo 1 of 1 : FA_2014_NA0001_55_239_20141119_00214.jpg

LM Start	10.06	Rating **	M	Issue No.	239
LM End	10.06	Issue Type +	Ma	Location *	LS
Category	Earthen Levee			GPS Latitude/Longitude	
				Start	End
Item	Animal Control			38.568773 °	38.568773 °
				-121.363057 °	-121.363057 °
DWR ID	DWR_NA0001_04_f_2014_239				
Action/Comments					
Exterminate rodents and backfill and compact or grout burrows.

View of several large rodent burrows.

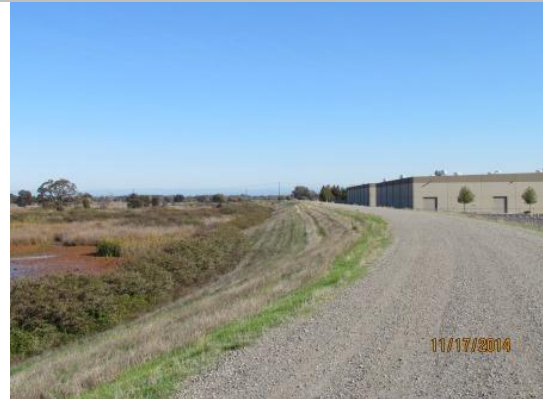
Photo 1 of 1 : FA_2014_NA0001_57_9_20141119_00005.jpg

LM Start	0.18	Rating **	A	Issue No.	9
LM End	0.18	Issue Type +	Ma	Location *	WS
Category	Earthen Levee			GPS Latitude/Longitude	
				Start	End
Item	Vegetation			38.657256 °	38.657256 °
				-121.471372 °	-121.471372 °
DWR ID	DWR_NA0001_06_f_2014_9				
Action/Comments					
Control annual grass and weeds on the levee slopes and easements.

View of acceptable vegetation control.

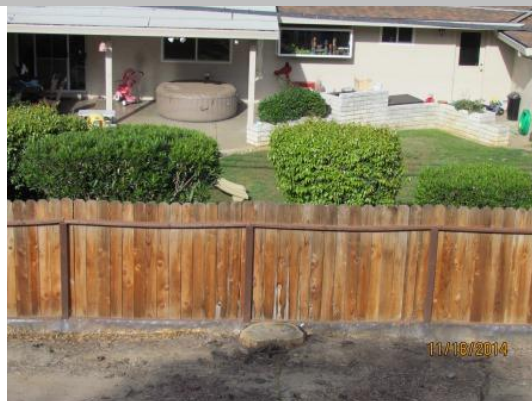
Photo 1 of 1 : FA_2014_NA0001_60_12_20141119_00015.jpg

LM Start	0.40	Rating **	N	Issue No.	12
LM End	0.40	Issue Type +	Ma	Location *	LS
Category	Earthen Levee			GPS Latitude/Longitude	
				Start	End
Item	Trim / Thin Trees			38.566725 °	38.566725 °
				-121.389935 °	-121.389935 °
DWR ID	DWR_NA0001_09_f_2013_12				
Action/Comments					
Tree stumps.

View of the tree stump at the landside levee toe.

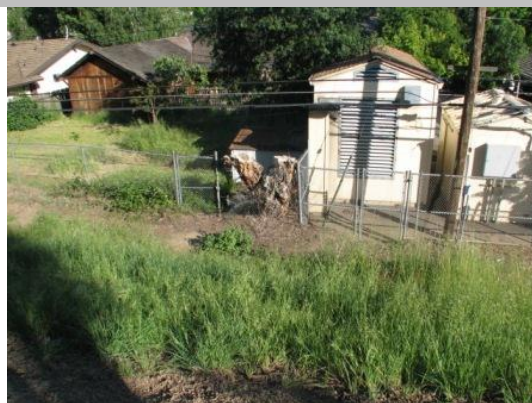
Photo 1 of 1 : FA_2014_NA0001_60_14_20141001_00007.jpg

LM Start	0.45	Rating **	N	Issue No.	14
LM End	0.45	Issue Type +	Ma	Location *	LS
Category	Earthen Levee			GPS Latitude/Longitude	
				Start	End
Item	Trim / Thin Trees			38.566298 °	38.566298 °
				-121.390680 °	-121.390680 °
DWR ID	DWR_NA0001_09_s_2012_14				
Action/Comments					
Tree stumps.					
Inspector Comments: Tree trunk at fence line.

Tree trunk at fence line.

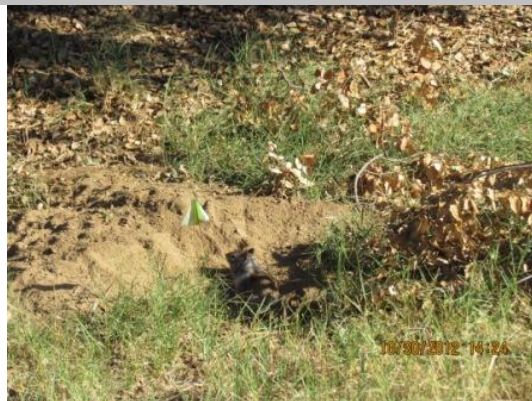
Photo 1 of 1 : FA_2014_NA0001_60_6_20141001_00004.jpg

LM Start	3.01	Rating **	M	Issue No.	6
LM End	3.01	Issue Type +	Ma	Location *	LS
Category	Earthen Levee			GPS Latitude/Longitude	
				Start	End
Item	Animal Control			38.575035 °	38.575035 °
				-121.419802 °	-121.419802 °
DWR ID	DWR_NA0001_09_f_2012_6				
Action/Comments					
Exterminate rodents and backfill and compact or grout burrows.

View of active rodent burrow at landside levee toe.

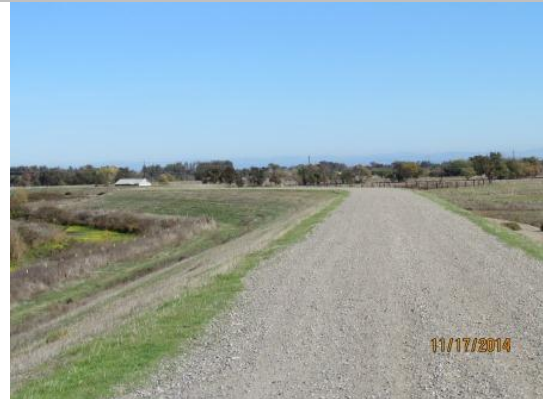
Photo 1 of 1 : FA_2014_NA0001_436_5_20141119_00005.jpg

LM Start	0.09	Rating **	A	Issue No.	5
LM End	0.09	Issue Type +	Ma	Location *	WS
Category	Earthen Levee			GPS Latitude/Longitude	
				Start	End
Item	Vegetation			38.663024 °	38.663024 °
				-121.456367 °	-121.456367 °
DWR ID	DWR_NA0001_11_f_2014_5				
Action/Comments					
Control annual grass and weeds on the levee slopes and easements.

View of acceptable vegetation control.
