**Flood Control Project Maintenance
Levee Inspections**

Maintenance Issue Types Only, Levee Inspection Report By Mile - Fall 2015

American River Flood Control District

Waterway	Bank	Unit Miles	Inspection Start/End	Inspector
Unit No. 01 Arcade Creek	Left	2.08	10/28/2015 11/09/2015	Maksim Khashchuk

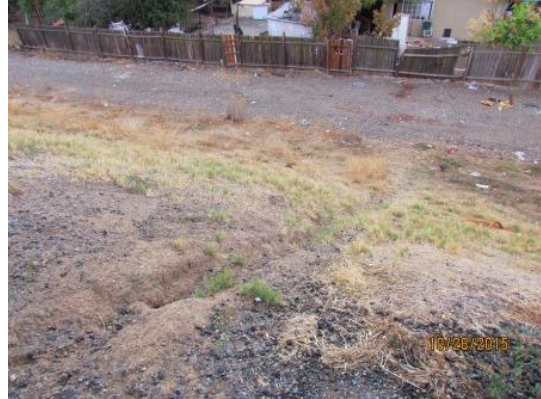
Photo 1 of 1 : FA_2015_NA0001_51_81_20151112_00063.jpg

LM Start	0.46	Rating **	M	Issue No.	81
LM End	0.46	Issue Type +	Ma	Location *	LS
Category	Earthen Levee			GPS Latitude/Longitude	
				Start	End
Item	Slope Stability			38.623101 °	38.623101 °
				-121.460573 °	-121.460573 °
DWR ID	DWR_NA0001_01_f _ 2015_81				
Action/Comments					
Repair the levee slope damaged by foot traffic and prevent access where possible.

View of the landside levee slope damaged by foot traffic.

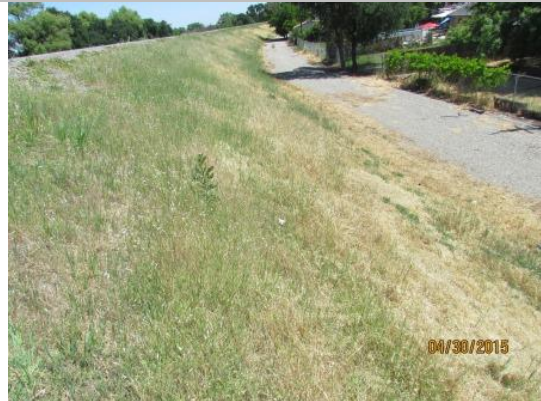
Photo 1 of 2 : FA_2015_NA0001_51_164_20150910_00034.jpg

LM Start	0.48	Rating **	A/W	Issue No.	164
LM End	0.48	Issue Type +	Ma	Location *	LS
Category	Earthen Levee			GPS Latitude/Longitude	
				Start	End
Item	Erosion / Bank Caving			38.623227 °	38.623227 °
				-121.460399 °	-121.460399 °
DWR ID	DWR_NA0001_01_s_2012_164				
Action/Comments					
Note and monitor erosion site. Inspector Comments: 4'-5' diameter by 1' deep hole mid-slope on the landside.

Another view of the depression on the landside levee slope.

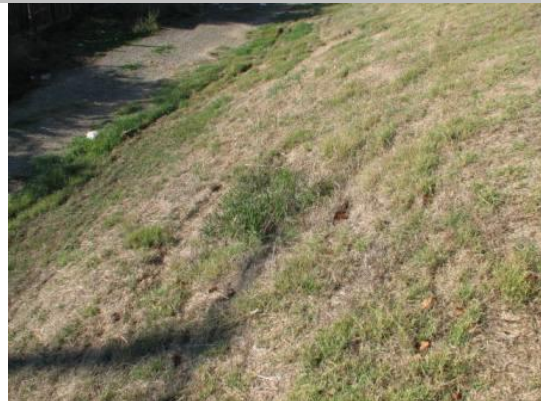
Photo 2 of 2 : FA_2015_NA0001_51_164_20150910_00035.jpg

11/17/2011 Hole/depression approximately mid-slope.

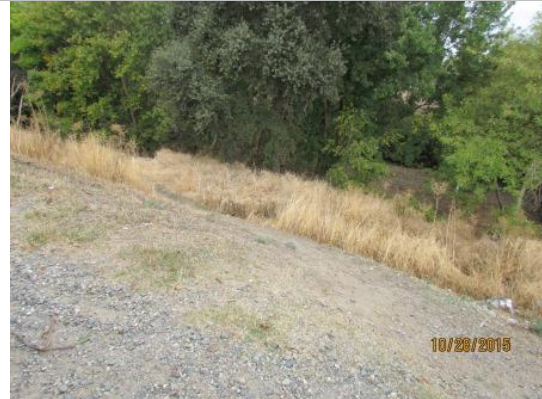
Photo 1 of 1 : FA_2015_NA0001_51_76_20151112_00062.jpg

LM Start	1.05	Rating **	M	Issue No.	76
LM End	1.05	Issue Type +	Ma	Location *	WS
Category	Earthen Levee			GPS Latitude/Longitude	
				Start	End
Item	Slope Stability			38.625069 °	38.625069
				-121.450360 °	-121.450360
DWR ID	DWR_NA0001_01_f_2015_76				
Action/Comments					
Repair the levee slope damaged by foot traffic and prevent access where possible.

View of the waterside levee slope damaged by foot traffic.

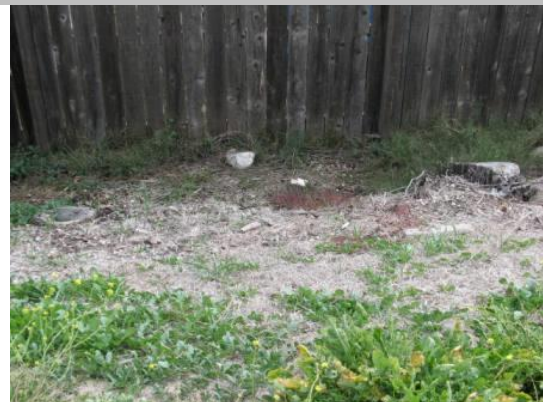
Photo 1 of 1 : FA_2015_NA0001_51_178_20150910_00043.jpg

11/17/2011 Two stumps at levee toe.

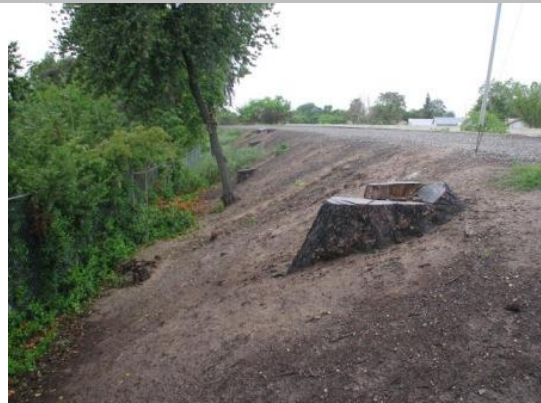
Photo 1 of 1 : FA_2015_NA0001_51_56_20150910_00032.jpg

Several large stumps on levee slope.

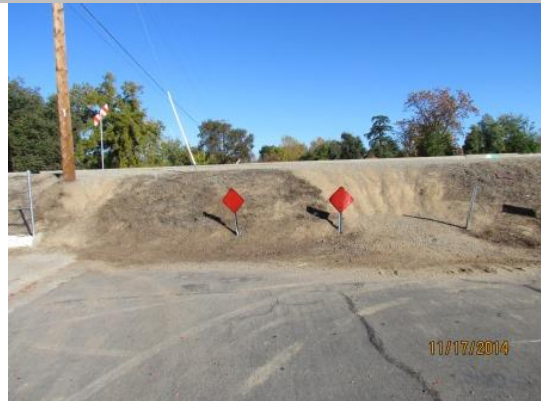
Photo 1 of 1 : FA_2015_NA0001_51_54_20150910_00031.jpg

LM Start	1.58	Rating **	A/W	Issue No.	54
LM End	1.58	Issue Type +	Ma	Location *	LS
Category	Earthen Levee			GPS Latitude/Longitude	
				Start	End
Item	Slope Stability			38.627251 °	38.627251 °
				-121.441460 °	-121.441460 °
DWR ID	DWR_NA0001_01_s_2012_54				
Action/Comments					
Repair the levee slope damaged by foot traffic and prevent access where possible.

Slope stability due to foot traffic needs to be monitored.

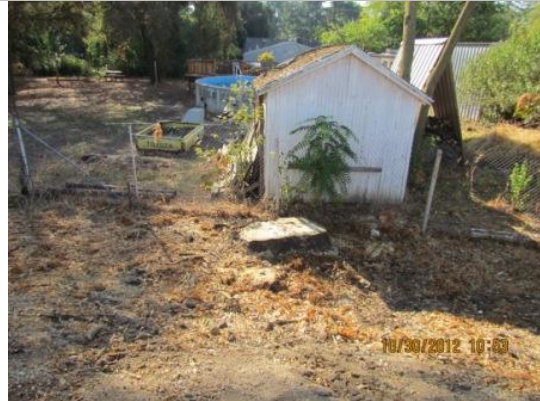
Photo 1 of 1 : FA_2015_NA0001_51_31_20150910_00025.jpg

View of large tree stump at levee toe.

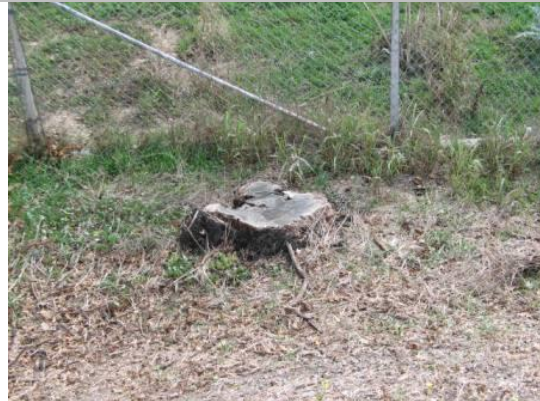
Photo 1 of 1 : FA_2015_NA0001_51_173_20150910_00040.jpg

LM Start	1.65	Rating **	N	Issue No.	173
LM End	1.65	Issue Type +	Ma	Location *	LS
Category	Earthen Levee			GPS Latitude/Longitude	
				Start	End
Item	Trim / Thin Trees			38.627297 °	38.627297 °
				-121.440188 °	-121.440188 °
DWR ID	DWR_NA0001_01_f_2015_173				
Action/Comments					
Tree stumps. Inspector Comments: Large stump at levee toe. Remove stump next construction season.

11/17/2011 Stump at levee toe.

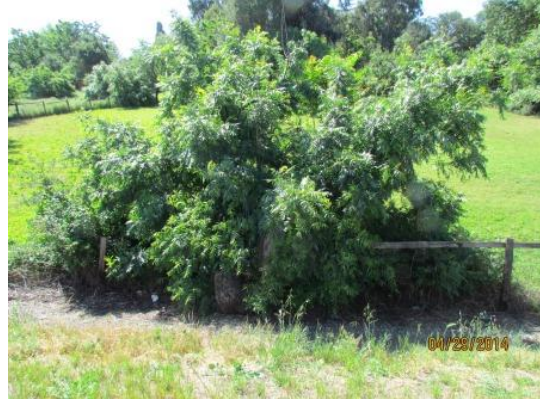
Photo 1 of 1 : FA_2015_NA0001_51_48_20150910_00029.jpg

View of the overgrown tree at the landside levee toe.

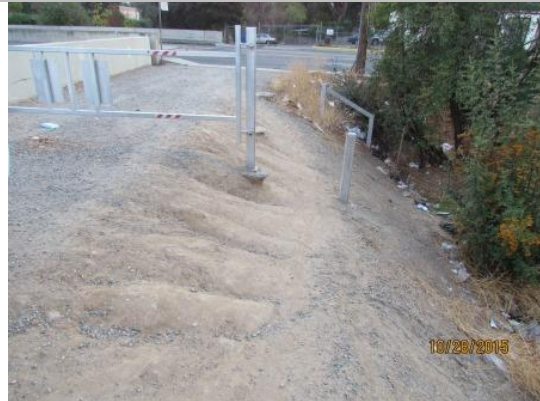
Photo 1 of 1 : FA_2015_NA0001_51_46_20151112_00053.jpg

LM Start	2.07	Rating **	M	Issue No.	46
LM End	2.07	Issue Type +	Ma	Location *	LS
Category	Earthen Levee			GPS Latitude/Longitude	
				Start	End
Item	Slope Stability			38.627246 °	38.627246 °
				-121.432673 °	-121.432673 °
DWR ID	DWR_NA0001_01_f_2015_46				
Action/Comments					
Repair the levee slope damaged by foot traffic and prevent access where possible.

View of the damaged landside levee slope.

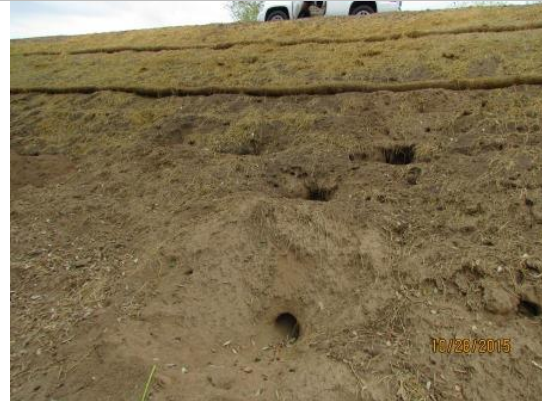
Photo 1 of 1 : FA_2015_NA0001_52_28_20151112_00018.jpg

View of the rodent holes on the landside levee slope.

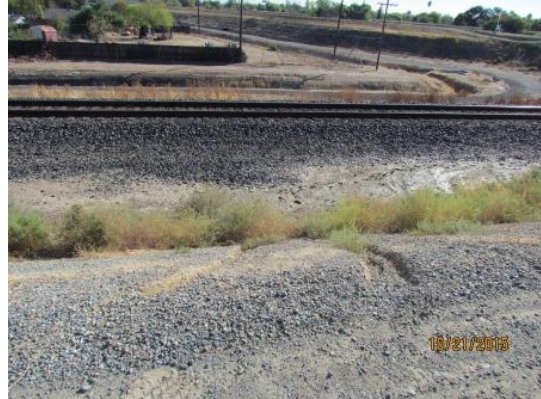
Photo 1 of 1 : FA_2015_NA0001_52_26_20151112_00015.jpg

LM Start	1.40	Rating **	M	Issue No.	26
LM End	1.40	Issue Type +	Ma	Location *	LS
Category	Earthen Levee			GPS Latitude/Longitude	
				Start	End
Item	Slope Stability			38.621054 °	38.621054
				-121.468008 °	-121.468008
DWR ID	DWR_NA0001_02_f _ 2015_26				
Action/Comments					
Repair the levee slope damaged by vehicle traffic and prevent access where possible.

View of the damaged landside levee slope.

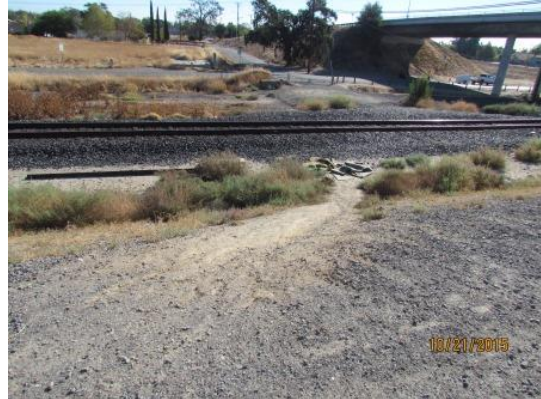
Photo 1 of 1 : FA_2015_NA0001_52_25_20151112_00014.jpg

LM Start	2.05	Rating **	M	Issue No.	25
LM End	2.05	Issue Type +	Ma	Location *	LS
Category	Earthen Levee			GPS Latitude/Longitude	
				Start	End
Item	Slope Stability			38.630425 °	38.630425 °
				-121.469807 °	-121.469807 °
DWR ID	DWR_NA0001_02_f_2015_25				
Action/Comments					
Repair the levee slope damaged by foot traffic and prevent access where possible.

View of the landside levee slope damaged by foot traffic.

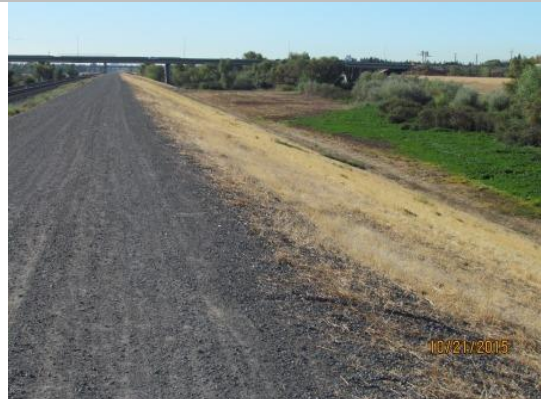
Photo 1 of 1 : FA_2015_NA0001_52_24_20151112_00013.jpg

LM Start	3.19	Rating **	A	Issue No.	24
LM End	3.19	Issue Type +	Ma	Location *	WS
Category	Earthen Levee			GPS Latitude/Longitude	
				Start	End
Item	Vegetation			38.646814 °	38.646814 °
				-121.472937 °	-121.472937 °
DWR ID	DWR_NA0001_02_f_2015_24				
Action/Comments					
Control annual grass and weeds on the levee slopes and easements.

View of the acceptable vegetation control on the waterside levee slope.

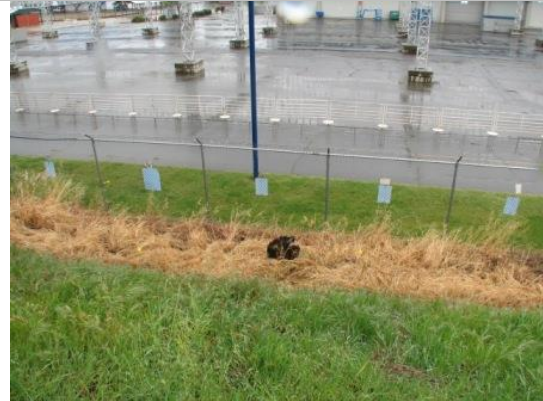
Photo 1 of 1 : FA_2015_NA0001_490_11_20150910_00003.jpg

Tree stump on levee slope greater than 2" Dia.

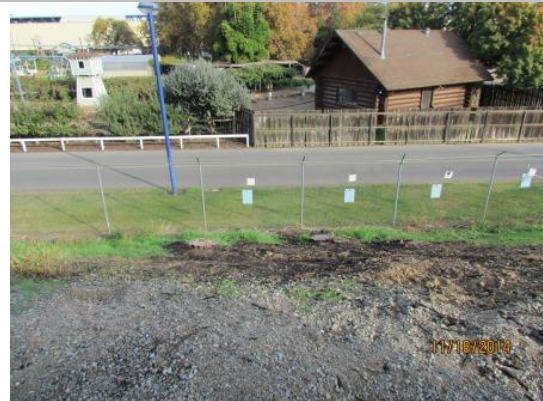
Photo 1 of 1 : FA_2015_NA0001_490_23_20150910_00004.jpg

LM Start	0.85	Rating **	N	Issue No.	23
LM End	0.85	Issue Type +	Ma	Location *	LS
Category	Earthen Levee			GPS Latitude/Longitude	
				Start	End
Item	Trim / Thin Trees			38.589624 °	38.589624 °
				-121.432935 °	-121.432935 °
DWR ID	DWR_NA0001_03_f_2014_23				
Action/Comments					
Tree stumps.

View of the tree stump on the landside levee slope.

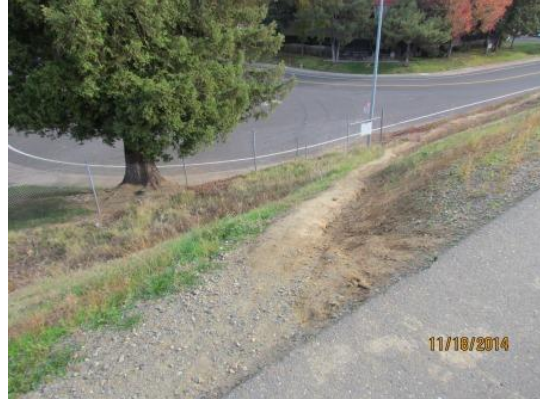
Photo 1 of 1 : FA_2015_NA0001_490_9_20150910_00002.jpg

LM Start	1.82	Rating **	A/W	Issue No.	9
LM End	1.82	Issue Type +	Ma	Location *	LS
Category	Earthen Levee			GPS Latitude/Longitude	
				Start	End
Item	Slope Stability			38.595700 °	38.595700 °
				-121.448198 °	-121.448198 °
DWR ID	DWR_NA0001_03_s _ 2012_9				
Action/Comments					
Repair the levee slope damaged by foot traffic and prevent access where possible.					
Inspector Comments: Slope repaired. Monitor for possible future erosion.

View of the erosion on landside levee slope due to pedestrian traffic.

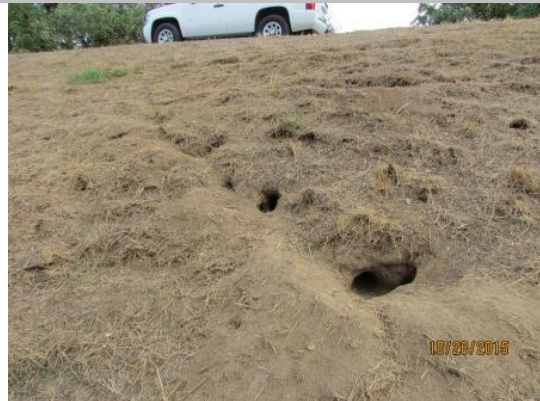
Photo 1 of 1 : FA_2015_NA0001_490_25_20151112_00011.jpg

View of the rodent holes on the landside levee slope.

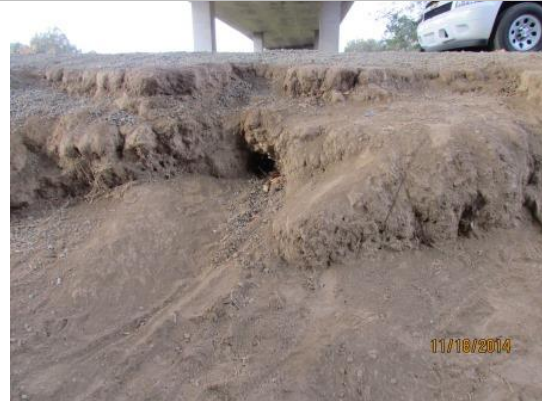
Photo 1 of 1 : FA_2015_NA0001_490_1_20150910_00001.jpg

View of the rodent holes on the landside levee slope.

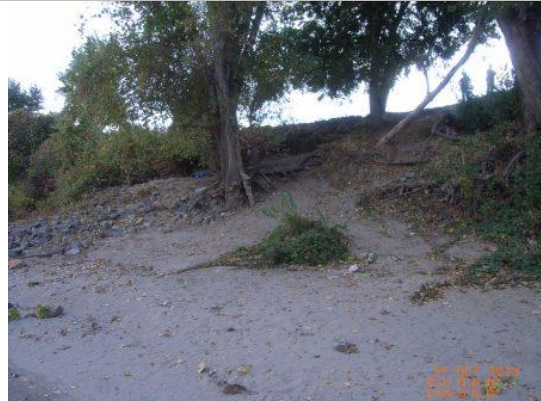
Photo 1 of 1 : USACE2013A_LAR_1-8_L_2.jpg

LM Start	1.61	Rating **	M	Issue No.	7
LM End	1.65	Issue Type +	Ma	Location *	WS
Category	Supplemental			GPS Latitude/Longitude	
				Start	End
Item	2015 USACE Erosion Survey, DRAFT			38.599095 °	38.598791 °
				-121.480337 °	-121.479799 °
DWR ID					
Action/Comments					
Inspector Comments: 2012 - Located just downstream of older repair. Failing rock at the upstream end. Erosion of the bank has exposed large tree roots. 2015: No observed changes. [2015 Site ID: LAR_1-8_L]

USACE 2013 Photo #1

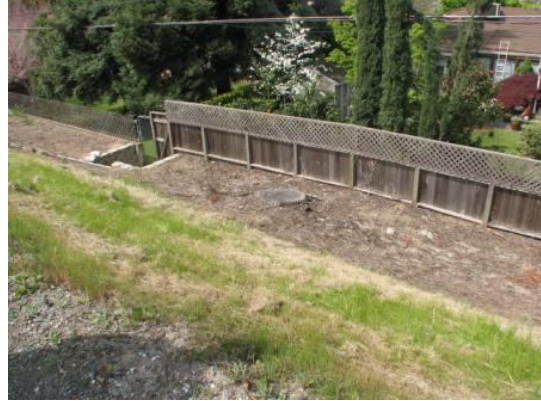
Photo 1 of 1 : FA_2015_NA0001_55_181_20150910_00157.jpg

04/14/2011 Large stump at toe of levee.

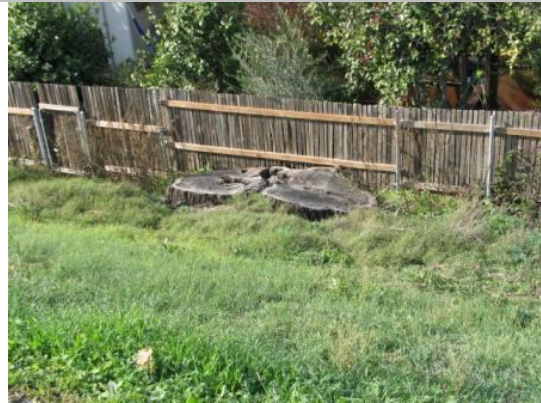
Photo 1 of 1 : FA_2015_NA0001_55_740_20150910_00194.jpg

LM Start	5.91	Rating **	N	Issue No.	740
LM End	5.91	Issue Type +	Ma	Location *	LS
Category	Earthen Levee			GPS Latitude/Longitude	
				Start	End
Item	Trim / Thin Trees			38.570940 °	38.570940 °
				-121.424173 °	-121.424173 °
DWR ID	DWR_NA0001_04_s _ 2012_740				
Action/Comments					
Tree stumps.					
Inspector Comments: Large stump

11/15/2011 Large stump at levee toe.

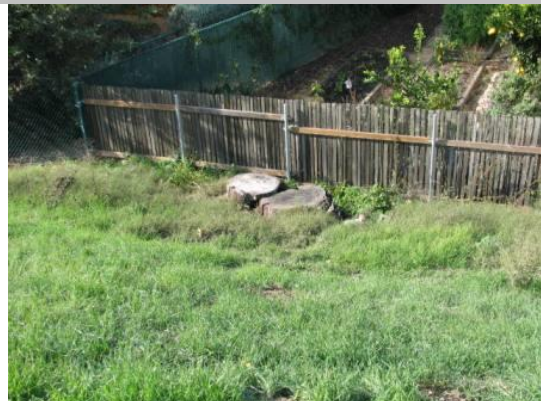
Photo 1 of 1 : FA_2015_NA0001_55_741_20150910_00195.jpg

LM Start	5.92	Rating **	N	Issue No.	741
LM End	5.92	Issue Type +	Ma	Location *	LS
Category	Earthen Levee			GPS Latitude/Longitude	
				Start	End
Item	Trim / Thin Trees			38.570800 °	38.570800 °
				-121.424184 °	-121.424184 °
DWR ID	DWR_NA0001_04_s _ 2012_741				
Action/Comments					
Tree stumps.					
Inspector Comments: Stump.

11/15/2011 Stump at levee toe.

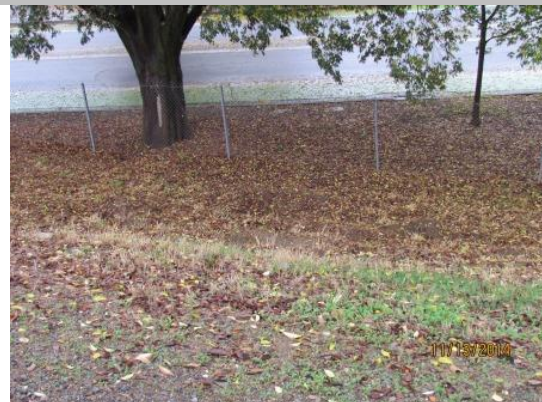
Photo 1 of 1 : FA_2015_NA0001_55_240_20150910_00185.jpg

View of a rodent burrow at the landside levee toe.

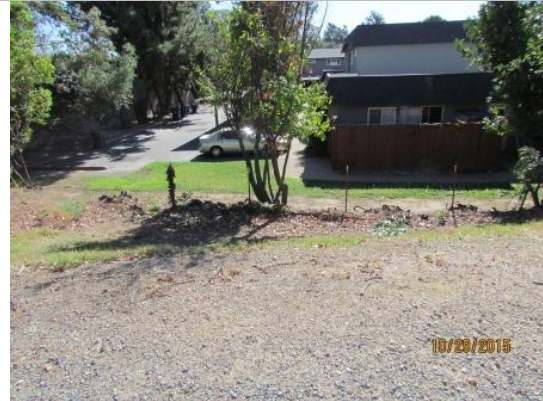
Photo 1 of 1 : FA_2015_NA0001_55_230_20151112_00213.jpg

View of the multiple tree stumps at the landside levee toe.

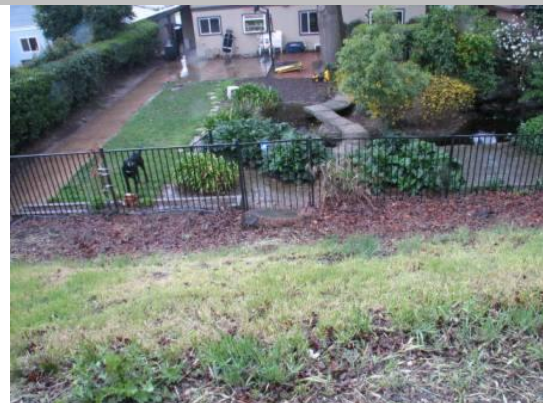
Photo 1 of 1 : FA_2015_NA0001_55_123_20150910_00105.jpg

03/16/2012 Large tree stump at levee toe.

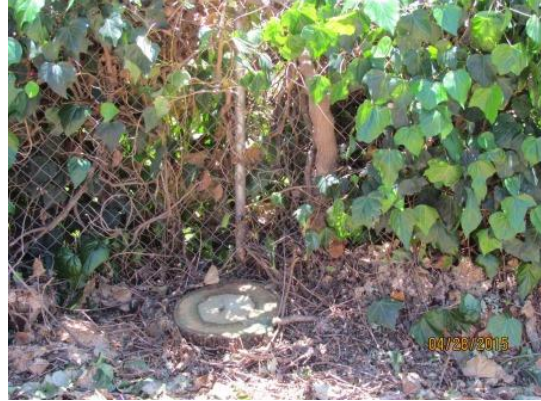
Photo 1 of 1 : FA_2015_NA0001_55_234_20150910_00180.jpg

View of the tree stump at the landside levee toe.

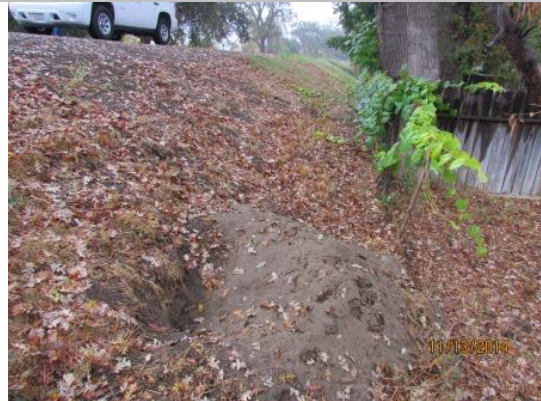
Photo 1 of 1 : FA_2015_NA0001_55_239_20150910_00184.jpg

LM Start	9.96	Rating **	M	Issue No.	239
LM End	9.96	Issue Type +	Ma	Location *	LS
Category	Earthen Levee			GPS Latitude/Longitude	
				Start	End
Item	Animal Control			38.568773 °	38.568773 °
				-121.363057 °	-121.363057 °
DWR ID	DWR_NA0001_04_f _ 2014_239				
Action/Comments					
Exterminate rodents and backfill and compact or grout burrows.

View of several large rodent burrows.

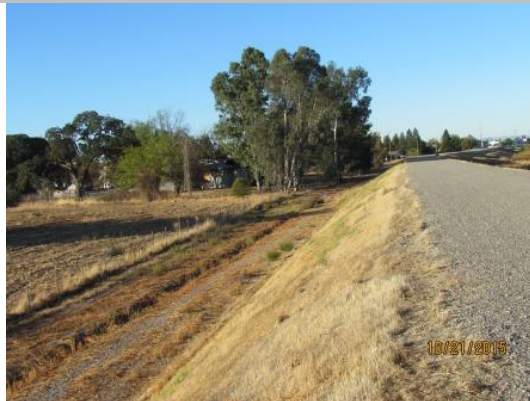
Photo 1 of 1 : FA_2015_NA0001_57_9_20151112_00005.jpg

View of the acceptable vegetation control.

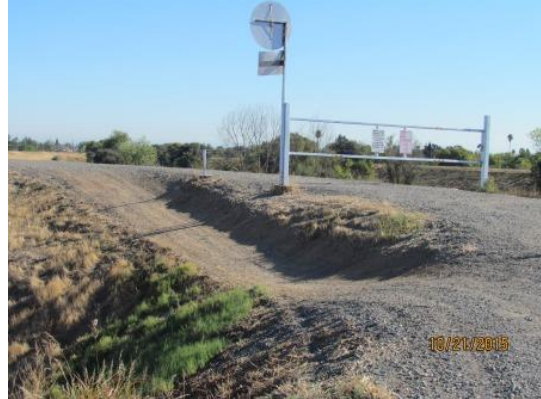
Photo 1 of 1 : FA_2015_NA0001_58_38_20151112_00034.jpg

LM Start	0.04	Rating **	M	Issue No.	38
LM End	0.04	Issue Type +	Ma	Location *	LS
Category	Earthen Levee			GPS Latitude/Longitude	
				Start	End
Item	Slope Stability			38.620569 °	38.620569 °
				-121.467117 °	-121.467117 °
DWR ID	DWR_NA0001_07_f _ 2015_38				
Action/Comments					
Repair the levee slope damaged by vehicle traffic and prevent access where possible.

View of the landside levee slope damaged by motorized traffic.

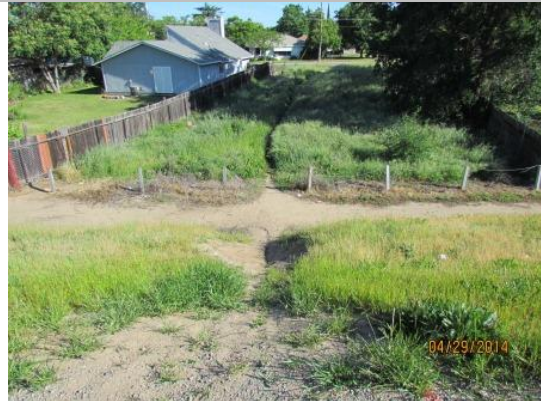
Photo 1 of 1 : FA_2015_NA0001_58_34_20150910_00027.jpg

LM Start	1.39	Rating **	A/W	Issue No.	34
LM End	1.39	Issue Type +	Ma	Location *	LS
Category	Earthen Levee			GPS Latitude/Longitude	
				Start	End
Item	Slope Stability			38.626601 °	38.626601 °
				-121.445016 °	-121.445016 °
DWR ID	DWR_NA0001_07_s_2012_34				
Action/Comments					
Repair the levee slope damaged by foot traffic and prevent access where possible.					
Inspector Comments: Damage caused by foot traffic.

View of the landside levee slope damaged by foot traffic.

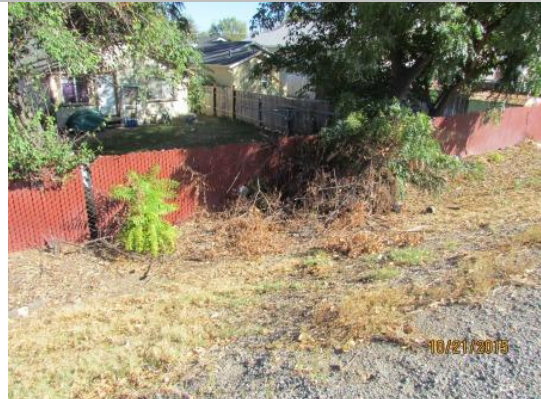
Photo 1 of 1 : FA_2015_NA0001_58_39_20151112_00035.jpg

View of the prunings at the landside levee toe.

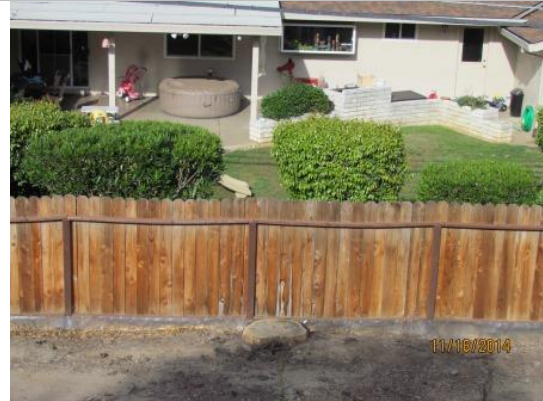
Photo 1 of 1 : FA_2015_NA0001_60_12_20150910_00004.jpg

View of the tree stump at the landside levee toe.

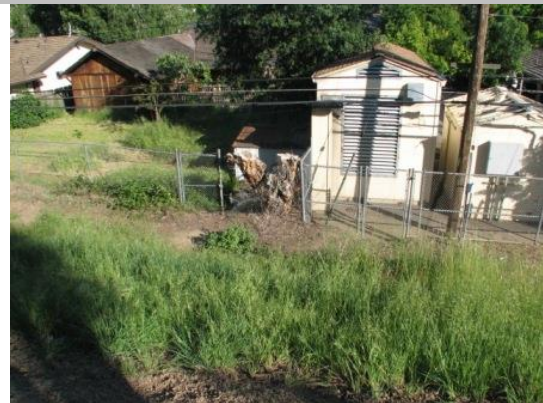
Photo 1 of 1 : FA_2015_NA0001_60_14_20150910_00006.jpg

Tree trunk at fence line.

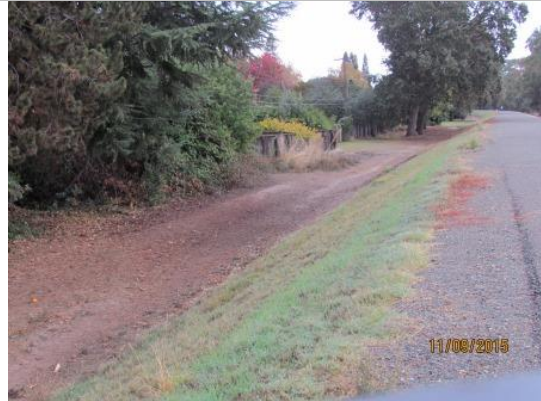
Photo 1 of 1 : FA_2015_NA0001_61_11_20151112_00014.jpg

View of the acceptable vegetation control on the landside levee slope.

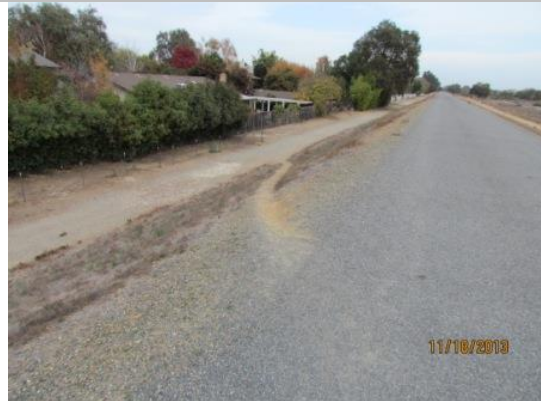
Photo 1 of 1 : FA_2015_NA0001_61_7_20150910_00003.jpg

LM Start	2.41	Rating **	A/W	Issue No.	7
LM End	2.41	Issue Type +	Ma	Location *	LS
Category	Earthen Levee			GPS Latitude/Longitude	
				Start	End
Item	Slope Stability			38.575126 °	38.575126 °
				-121.357575 °	-121.357575 °
DWR ID	DWR_NA0001_10_f_2013_7				
Action/Comments					
Repair the levee slope damaged by foot traffic and prevent access where possible.

View of the pathway on the landside levee slope.

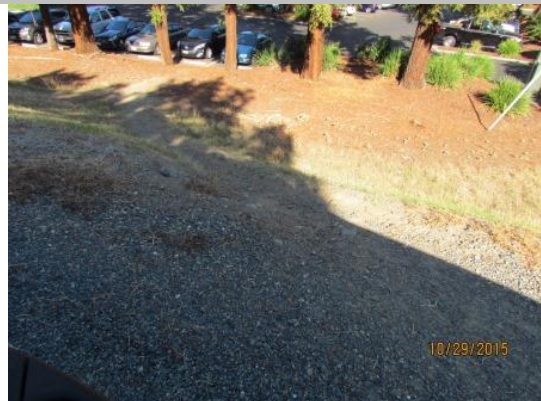
Photo 1 of 1 : FA_2015_NA0001_61_21_20151112_00013.jpg

LM Start	3.49	Rating **	A/W	Issue No.	21
LM End	3.49	Issue Type +	Ma	Location *	LS
Category	Earthen Levee			GPS Latitude/Longitude	
				Start	End
Item	Slope Stability			38.569484 °	38.569484 °
				-121.375841 °	-121.375841 °
DWR ID	DWR_NA0001_10_f_2015_21				
Action/Comments					
Repair the levee slope damaged by foot traffic and prevent access where possible.

View of the footpath on the landside levee slope.

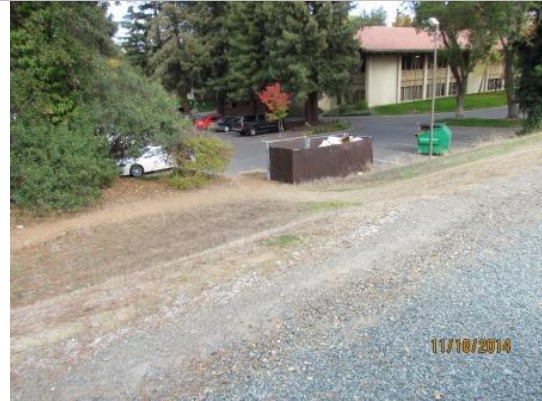
Photo 1 of 1 : FA_2015_NA0001_61_116_20150910_00007.jpg

LM Start	3.74	Rating **	A/W	Issue No.	116
LM End	3.74	Issue Type +	Ma	Location *	LS
Category	Earthen Levee			GPS Latitude/Longitude	
				Start	End
Item	Slope Stability			38.568526 °	38.568526 °
				-121.380331 °	-121.380331 °
DWR ID	DWR_NA0001_10_s_2012_116				
Action/Comments					
Repair the levee slope damaged by foot traffic and prevent access where possible.					
Inspector Comments: Foot traffic is eroding the landside slope.

View of the erosion on the landside levee slope caused by pedestrian foot traffic.

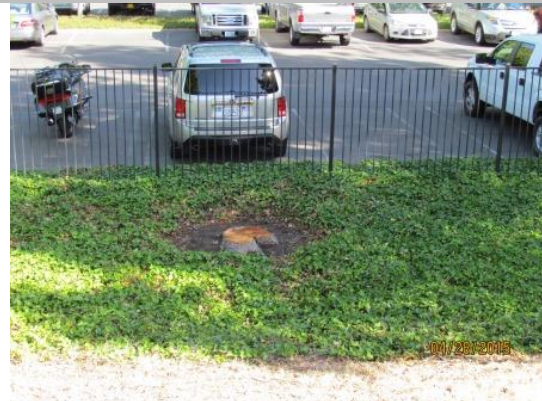
Photo 1 of 1 : FA_2015_NA0001_61_23_20150910_00006.jpg

View of the tree stump at the landside levee toe.

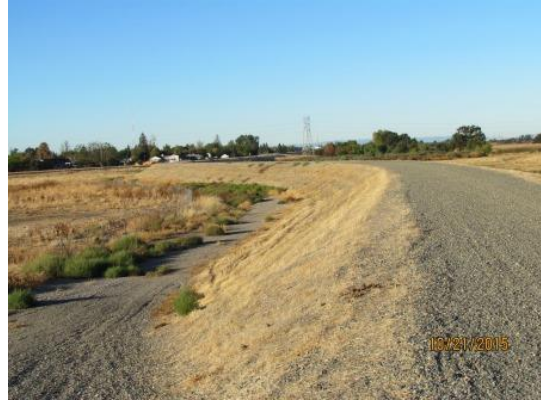
Photo 1 of 1 : FA_2015_NA0001_436_6_20151112_00007.jpg

View of the acceptable vegetation control on the landside levee slope.

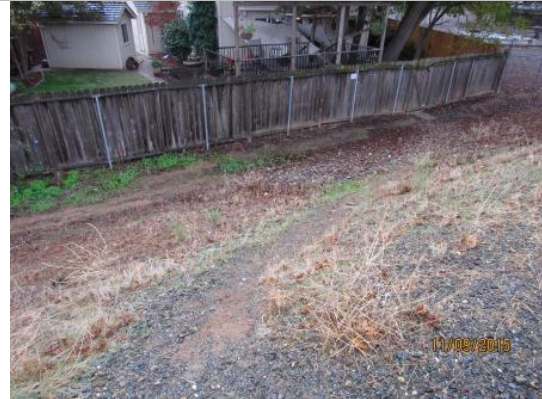
Photo 1 of 1 : FA_2015_NA0001_438_3_20151112_00006.jpg

View of the footpath on the landside levee slope.
