**Flood Control Project Maintenance
Levee Inspections**

Maintenance Issue Types Only, Levee Inspection Report By Mile - Fall 2016

American River Flood Control District

Waterway	Bank	Unit Miles	Inspection Start/End	Inspector
Unit No. 01 Arcade Creek	Left	2.08	10/21/2016 10/21/2016	Maksim Khashchuk

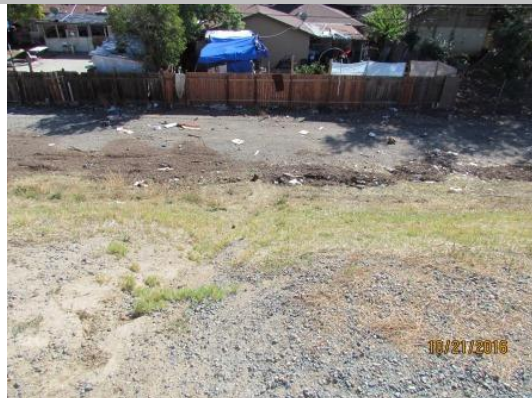
Photo 1 of 2 : FA_2016_NA0001_51_81_20161031_00094.jpg

LM Start	0.46	Rating **	M	Issue No.	81
LM End	0.46	Issue Type +	Ma	Location *	LS
Category	Earthen Levee			GPS Latitude/Longitude	
				Start	End
Item	Slope Stability			38.623101°	38.623101°
				-121.460573°	-121.460573°
DWR ID	DWR_NA0001_01_f_2015_81				
Comment Code					
S2 : Repair the levee slope damaged by foot traffic and prevent access where possible.					
Inspector Comment

View of the landside levee slope damaged by foot traffic. Fall 2016.

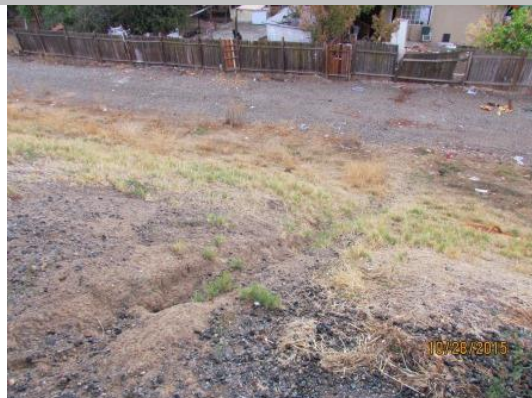
Photo 2 of 2 : FA_2016_NA0001_51_81_20160914_00048.jpg

View of the landside levee slope damaged by foot traffic.

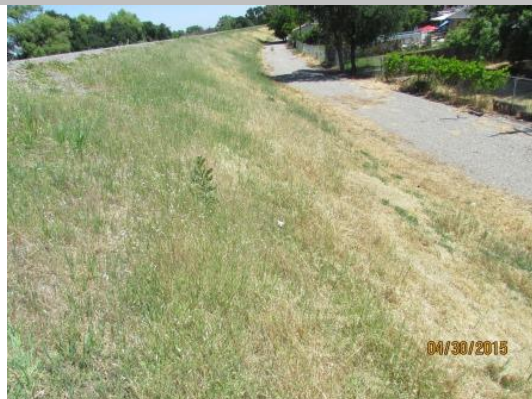
Photo 1 of 2 : FA_2016_NA0001_51_164_20160914_00051.jpg

Another view of the depression on the landside levee slope.

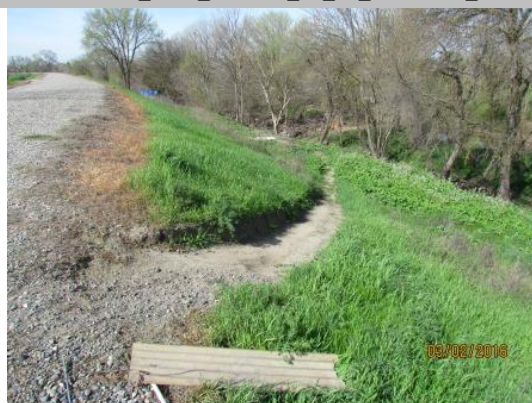
Photo 1 of 1 : FA_2016_NA0001_51_60_20160914_00039.jpg

LM Start	1.00	Rating **	M	Issue No.	60
LM End	1.00	Issue Type +	Ma	Location *	WS
Category	Earthen Levee			GPS Latitude/Longitude	
				Start	End
Item	Slope Stability			38.625161°	38.625161°
				-121.451302°	-121.451302°
DWR ID	DWR_NA0001_01_f_2015_60				
Comment Code					
S2 : Repair the levee slope damaged by foot traffic and prevent access where possible.					
Inspector Comment					
Backfill the cut made by the footpath.

View of the foot path on the waterside levee slope.

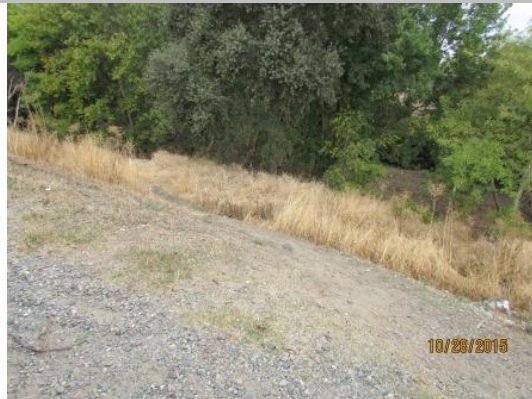
Photo 1 of 1 : FA_2016_NA0001_51_76_20160914_00047.jpg

LM Start	1.05	Rating **	M	Issue No.	76
LM End	1.05	Issue Type +	Ma	Location *	WS
Category	Earthen Levee			GPS Latitude/Longitude	
				Start	End
Item	Slope Stability			38.625069 °	38.625069 °
				-121.450360 °	-121.450360 °
DWR ID	DWR_NA0001_01_f_2015_76				
Comment Code					
S2 : Repair the levee slope damaged by foot traffic and prevent access where possible.					
Inspector Comment

View of the waterside levee slope damaged by foot traffic.

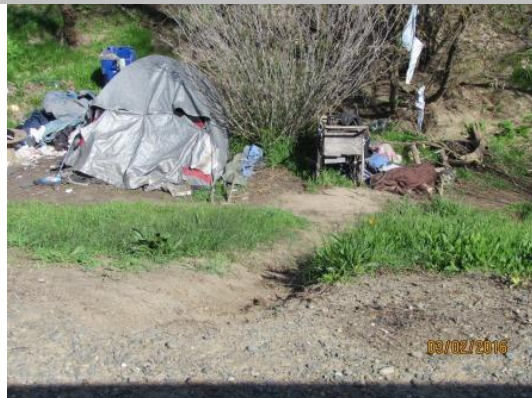
Photo 1 of 1 : FA_2016_NA0001_51_82_20160914_00049.jpg

LM Start	1.15	Rating **	A/W	Issue No.	82
LM End	1.15	Issue Type +	Ma	Location *	WS
Category	Earthen Levee			GPS Latitude/Longitude	
				Start	End
Item	Slope Stability			38.624866 °	38.624866 °
				-121.448555 °	-121.448555 °
DWR ID	DWR_NA0001_01_s_2016_82				
Comment Code					
S2 : Repair the levee slope damaged by foot traffic and prevent access where possible.					
Inspector Comment					
Homeless have created foot path.

View of the waterside levee slope erosion.

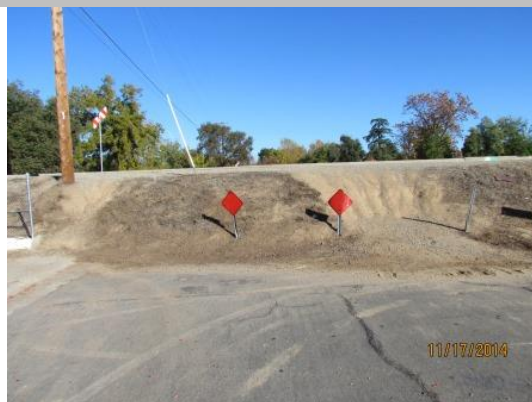
Photo 1 of 1 : FA_2016_NA0001_51_54_20160914_00034.jpg

LM Start	1.58	Rating **	A/W	Issue No.	54
LM End	1.58	Issue Type +	Ma	Location *	LS
Category	Earthen Levee			GPS Latitude/Longitude	
				Start	End
Item	Slope Stability			38.627251 °	38.627251 °
				-121.441460 °	-121.441460 °
DWR ID	DWR_NA0001_01_s_2012_54				
Comment Code					
S2 : Repair the levee slope damaged by foot traffic and prevent access where possible.					
Inspector Comment

Slope stability due to foot traffic needs to be monitored.

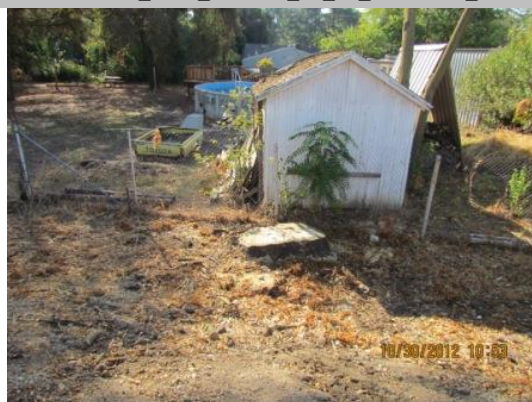
Photo 1 of 1 : FA_2016_NA0001_51_31_20160914_00025.jpg

LM Start	1.61	Rating **	N	Issue No.	31
LM End	1.61	Issue Type +	Ma	Location *	LS
Category	Earthen Levee			GPS Latitude/Longitude	
				Start	End
Item	Trim / Thin Trees			38.627191 °	38.627191 °
				-121.440861 °	-121.440861 °
DWR ID	DWR_NA0001_01_f_2012_31				
Comment Code					
T5 : Tree stumps.					
Inspector Comment

View of large tree stump at levee toe.

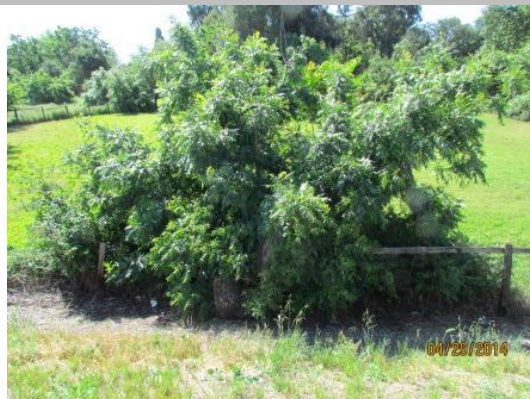
Photo 1 of 1 : FA_2016_NA0001_51_48_20160914_00031.jpg

View of the overgrown tree at the landside levee toe.

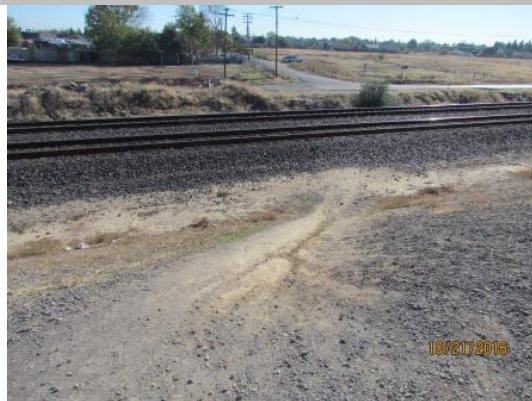
Photo 1 of 1 : FA_2016_NA0001_52_27_20161031_00047.jpg

LM Start	2.59	Rating **	M	Issue No.	27
LM End	2.59	Issue Type +	Ma	Location *	LS
Category	Earthen Levee			GPS Latitude/Longitude	
				Start	End
Item	Slope Stability			38.638109°	38.638109°
				-121.471254°	-121.471254°
DWR ID	DWR_NA0001_02_f_2016_27				
Comment Code					
S2 : Repair the levee slope damaged by foot traffic and prevent access where possible.					
Inspector Comment

View of the foot path on the landside levee slope.

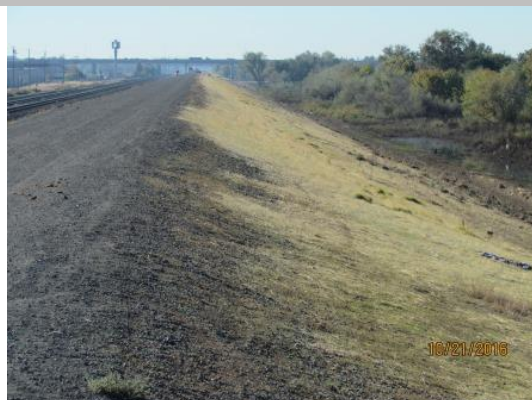
Photo 1 of 1 : FA_2016_NA0001_52_21_20161031_00046.jpg

LM Start	2.88	Rating **	A	Issue No.	21
LM End	3.73	Issue Type +	Ma	Location *	WS
Category	Earthen Levee			GPS Latitude/Longitude	
				Start	End
Item	Vegetation			38.642283 °	38.654472 °
				-121.472065 °	-121.474411 °
DWR ID	DWR_NA0001_02_f_2016_21				
Comment Code					
V1 : Control annual grass and weeds on the levee slopes and easements.					
Inspector Comment					
LMA has exceptional vegetation control program.

View of the vegetation on the waterside levee slope.

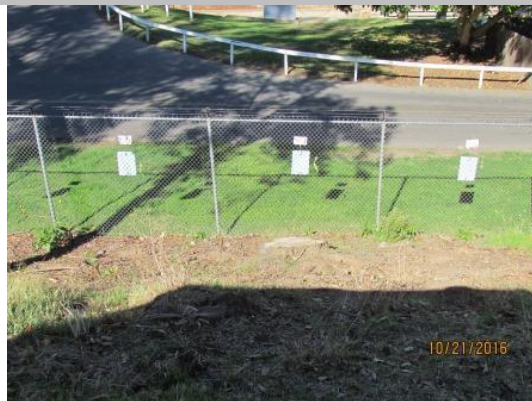
Photo 1 of 1 : FA_2016_NA0001_490_22_20161031_00036.jpg

View of the tree stump on the landside levee slope.

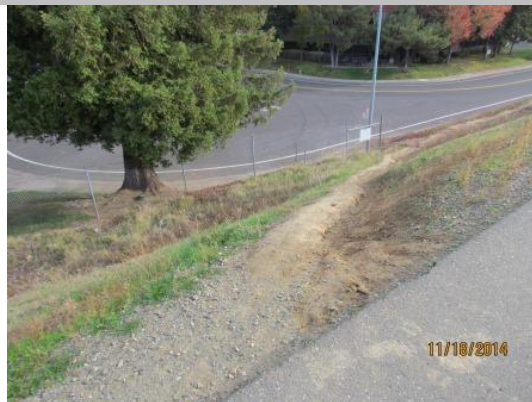
Photo 1 of 1 : FA_2016_NA0001_490_9_20160914_00002.jpg

LM Start	1.82	Rating **	A/W	Issue No.	9
LM End	1.82	Issue Type +	Ma	Location *	LS
Category	Earthen Levee			GPS Latitude/Longitude	
				Start	End
Item	Slope Stability			38.595700 °	38.595700 °
				-121.448198 °	-121.448198 °
DWR ID	DWR_NA0001_03_s_2012_9				
Comment Code					
S2 : Repair the levee slope damaged by foot traffic and prevent access where possible.					
Inspector Comment					
Slope repaired. Monitor for possible future erosion.

View of the erosion on landside levee slope due to pedestrian traffic.

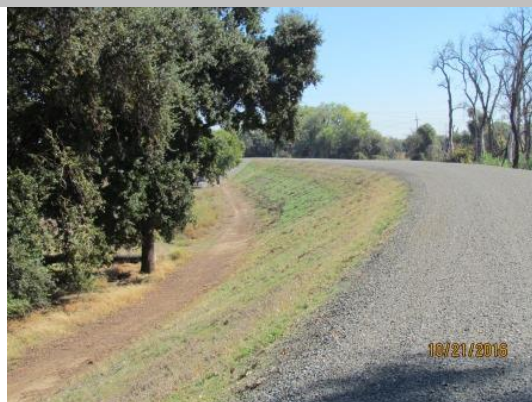
Photo 1 of 1 : FA_2016_NA0001_490_27_20161031_00034.jpg

View of the vegetation on the landside levee slope.

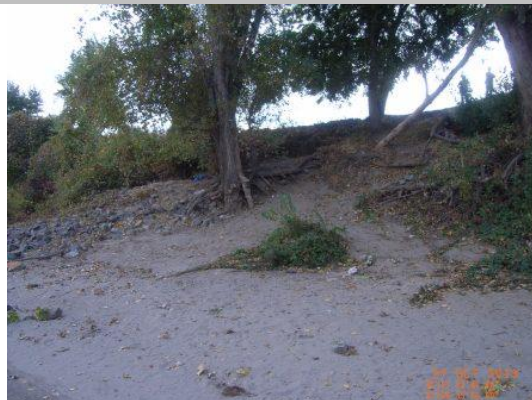
Photo 1 of 1 : FA_2016_NA0001_55_7_20160914_00008.jpg

LM Start	1.61	Rating **	M	Issue No.	7
LM End	1.65	Issue Type +	Ma	Location *	WS
Category	Supplemental			GPS Latitude/Longitude	
				Start	End
Item	2015 USACE Erosion Survey, DRAFT			38.599095 °	38.598791 °
				-121.480337 °	-121.479799 °
DWR ID	DWR_NA0001_04_s_2016_7				
Comment Code					
Inspector Comment					
2012 - Located just downstream of older repair. Failing rock at the upstream end. Erosion of the bank has exposed large tree roots. 2015: No observed changes. [2015 Site ID: LAR_1-8_L]

USACE 2013 Photo #1

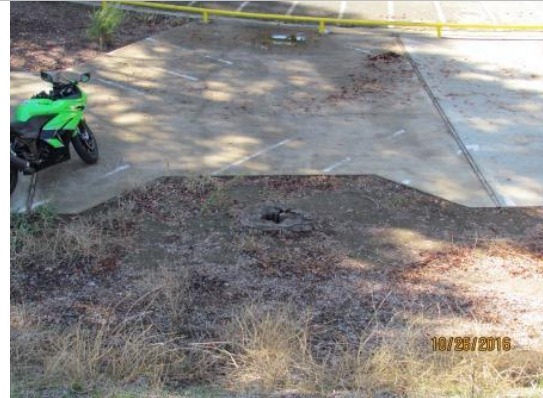
Photo 1 of 1 : FA_2016_NA0001_55_238_20161031_00248.jpg

View of the tree stump at the landside levee toe.

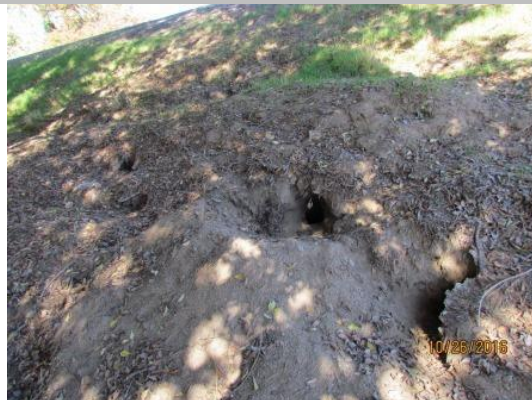
Photo 1 of 1 : FA_2016_NA0001_55_240_20161031_00247.jpg

View of a rodent burrows at the landside levee toe.

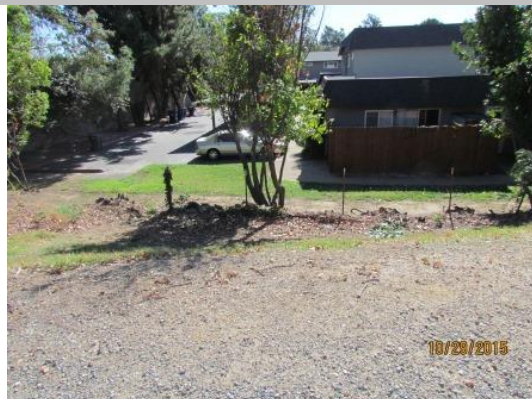
Photo 1 of 1 : FA_2016_NA0001_55_230_20160914_00181.jpg

View of the multiple tree stumps at the landside levee toe.

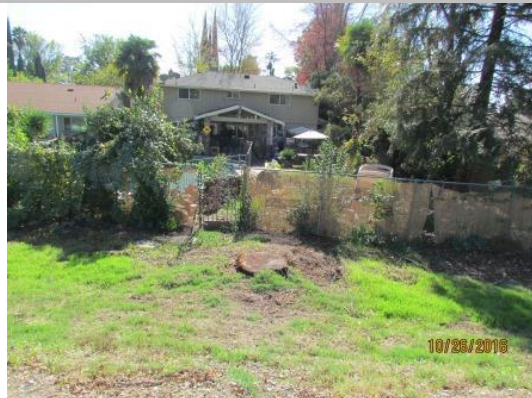
Photo 1 of 1 : FA_2016_NA0001_55_222_20161031_00245.jpg

View of the tree stump at the landside levee toe.

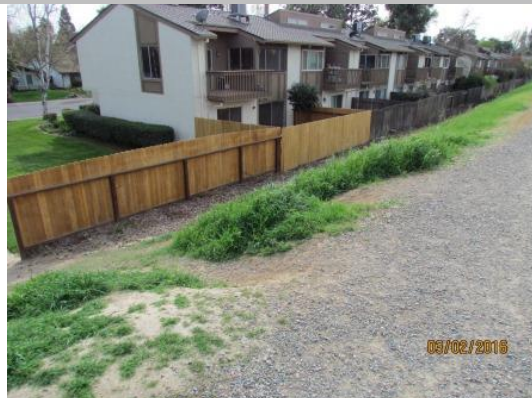
Photo 1 of 1 : FA_2016_NA0001_55_228_20160914_00180.jpg

LM Start	10.42	Rating **	A/W	Issue No.	228
LM End	10.42	Issue Type +	Ma	Location *	LS
Category	Earthen Levee			GPS Latitude/Longitude	
				Start	End
Item	Slope Stability			38.570536 °	38.570536 °
				-121.354957 °	-121.354957 °
DWR ID	DWR_NA0001_04_s_2016_228				
Comment Code					
S2 : Repair the levee slope damaged by foot traffic and prevent access where possible.					
Inspector Comment

View of the fence at the landside levee toe.

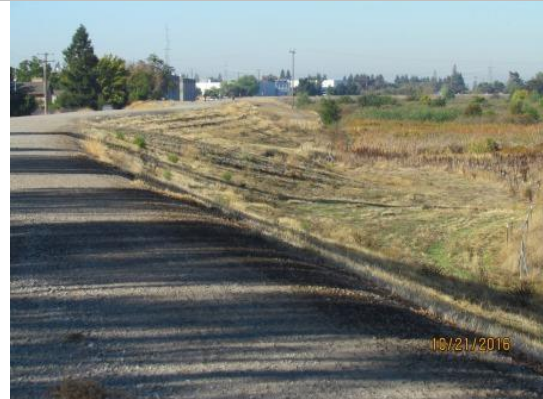
Photo 1 of 1 : FA_2016_NA0001_57_8_20161031_00007.jpg

View of the vegetation on the waterside levee slope.

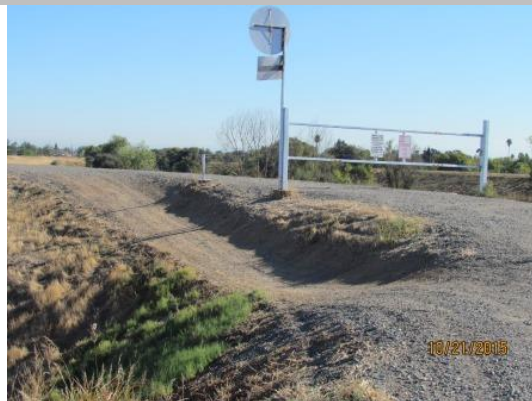
Photo 1 of 1 : FA_2016_NA0001_58_38_20160914_00031.jpg

LM Start	0.04	Rating **	M	Issue No.	38
LM End	0.04	Issue Type +	Ma	Location *	LS
Category	Earthen Levee			GPS Latitude/Longitude	
				Start	End
Item	Slope Stability			38.620569 °	38.620569 °
				-121.467117 °	-121.467117 °
DWR ID	DWR_NA0001_07_f_2015_38				
Comment Code					
S3 : Repair the levee slope damaged by vehicle traffic and prevent access where possible.					
Inspector Comment

View of the landside levee slope damaged by motorized traffic.

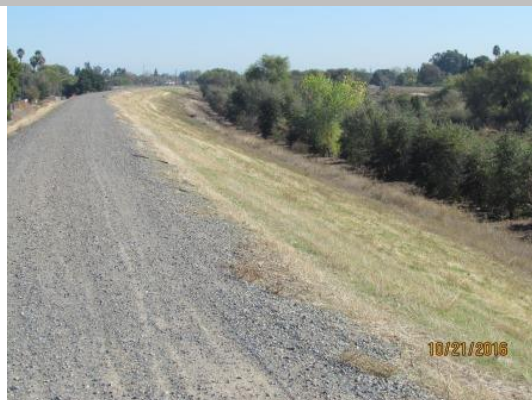
Photo 1 of 1 : FA_2016_NA0001_58_36_20161031_00049.jpg

LM Start	0.07	Rating **	A	Issue No.	36
LM End	0.68	Issue Type +	Ma	Location *	WS
Category	Earthen Levee			GPS Latitude/Longitude	
				Start	End
Item	Vegetation			38.620848 °	38.624987 °
				-121.466817 °	-121.457526 °
DWR ID	DWR_NA0001_07_f_2016_36				
Comment Code					
V1 : Control annual grass and weeds on the levee slopes and easements.					
Inspector Comment					
Acceptable vegetation control.

View of the vegetation on the waterside levee slope.

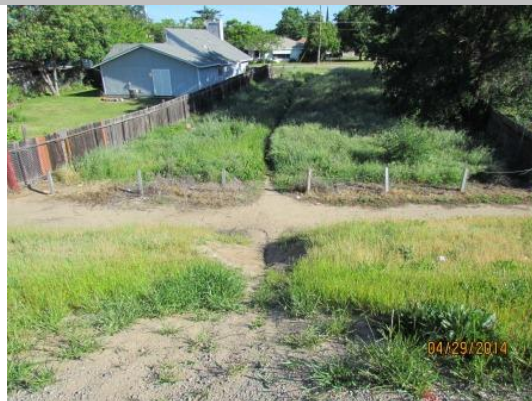
Photo 1 of 1 : FA_2016_NA0001_58_34_20160914_00029.jpg

LM Start	1.39	Rating **	A/W	Issue No.	34
LM End	1.39	Issue Type +	Ma	Location *	LS
Category	Earthen Levee			GPS Latitude/Longitude	
				Start	End
Item	Slope Stability			38.626601 °	38.626601 °
				-121.445016 °	-121.445016 °
DWR ID	DWR_NA0001_07_s_2012_34				
Comment Code					
S2 : Repair the levee slope damaged by foot traffic and prevent access where possible.					
Inspector Comment					
Damage caused by foot traffic.

View of the landside levee slope damaged by foot traffic.

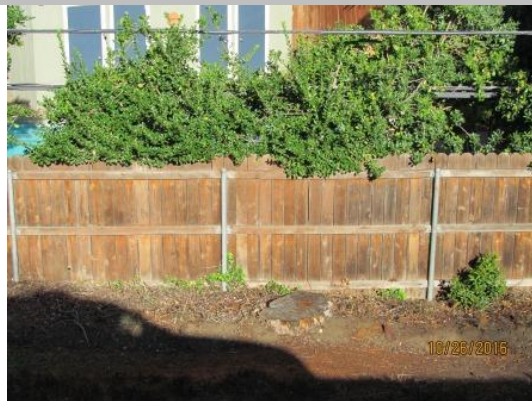
Photo 1 of 1 : FA_2016_NA0001_60_30_20161031_00044.jpg

View of the tree stump on the landside levee toe.

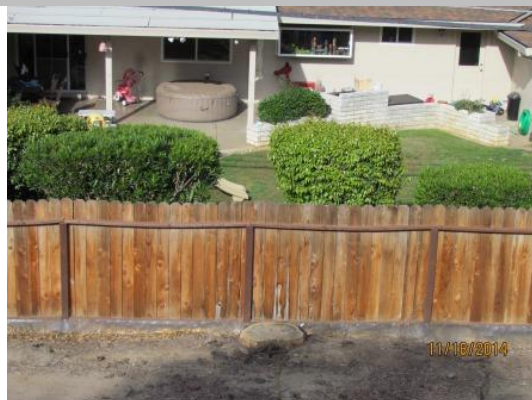
Photo 1 of 1 : FA_2016_NA0001_60_12_20160914_00003.jpg

LM Start	0.40	Rating **	N	Issue No.	12
LM End	0.40	Issue Type +	Ma	Location *	LS
Category	Earthen Levee			GPS Latitude/Longitude	
				Start	End
Item	Trim / Thin Trees			38.566725 °	38.566725 °
				-121.389935 °	-121.389935 °
DWR ID	DWR_NA0001_09_f_2013_12				
Comment Code					
T5 : Tree stumps.					
Inspector Comment

View of the tree stump at the landside levee toe.

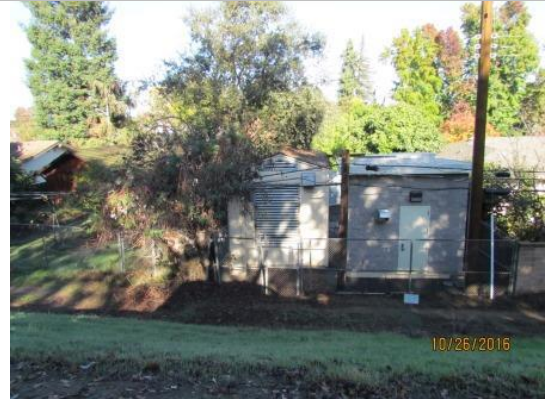
Photo 1 of 1 : FA_2016_NA0001_60_14_20161031_00043.jpg

Tree trunk at fence line.

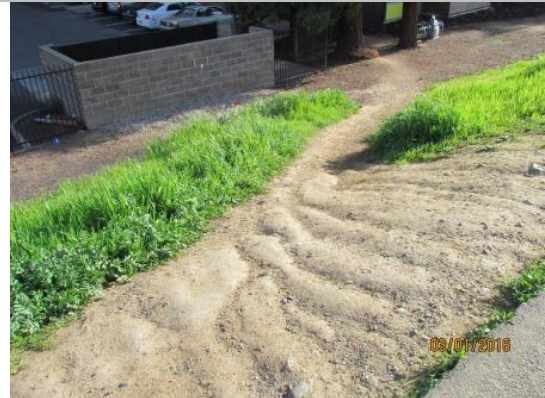
Photo 1 of 1 : FA_2016_NA0001_60_28_20160914_00007.jpg

View of the landside levee slope.

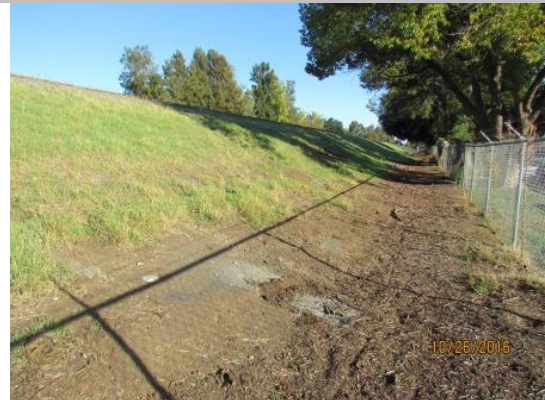
Photo 1 of 1 : FA_2016_NA0001_60_27_20161031_00041.jpg

View of the rodent holes on the landside levee slope.

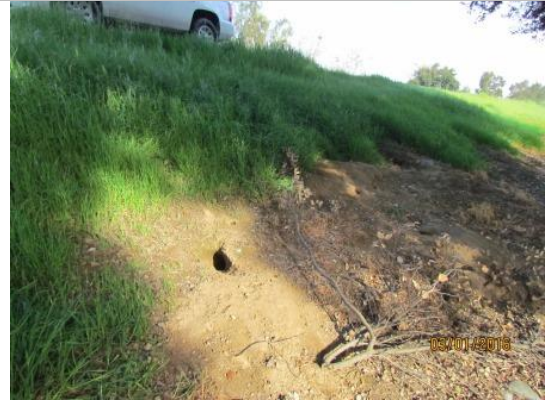
Photo 1 of 1 : FA_2016_NA0001_60_26_20160914_00006.jpg

View of the rodent holes in the landside levee slope.

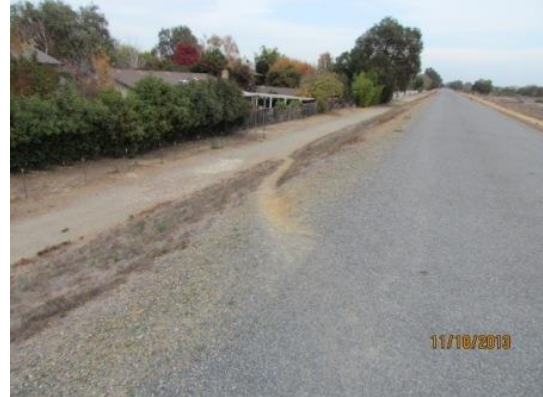
Photo 1 of 1 : FA_2016_NA0001_61_7_20160914_00003.jpg

LM Start	2.41	Rating **	A/W	Issue No.	7
LM End	2.41	Issue Type +	Ma	Location *	LS
Category	Earthen Levee			GPS Latitude/Longitude	
				Start	End
Item	Slope Stability			38.575126 °	38.575126 °
				-121.357575 °	-121.357575 °
DWR ID	DWR_NA0001_10_f _ 2013_7				
Comment Code					
S2 : Repair the levee slope damaged by foot traffic and prevent access where possible.					
Inspector Comment

View of the pathway on the landside levee slope.

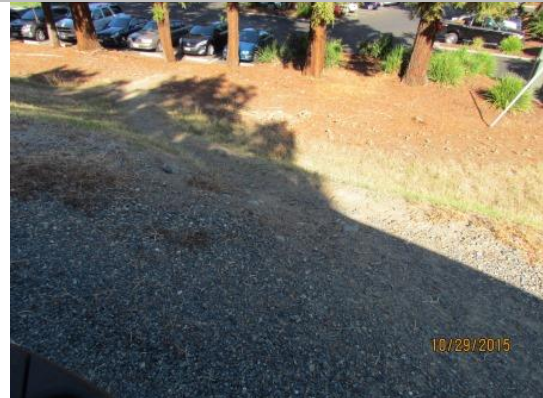
Photo 1 of 1 : FA_2016_NA0001_61_21_20160914_00005.jpg

LM Start	3.49	Rating **	A/W	Issue No.	21	
LM End	3.49	Issue Type +	Ma	Location *	LS	
Category	Earthen Levee			GPS Latitude/Longitude		
				Start	End	
Item	Slope Stability			38.569484 °	38.569484 °	
				-121.375841 °	-121.375841 °	
DWR ID	DWR_NA0001_10_f_2015_21					
Comment Code						
S2 : Repair the levee slope damaged by foot traffic and prevent access where possible.						
Inspector Comment

View of the footpath on the landside levee slope.

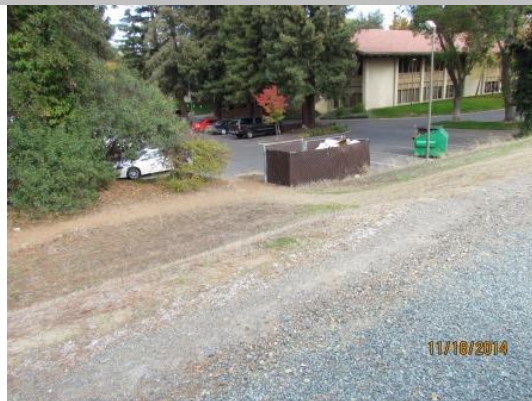
Photo 1 of 1 : FA_2016_NA0001_61_116_20160914_00008.jpg

LM Start	3.74	Rating **	A/W	Issue No.	116
LM End	3.74	Issue Type +	Ma	Location *	LS
Category	Earthen Levee			GPS Latitude/Longitude	
				Start	End
Item	Slope Stability			38.568526 °	38.568526 °
				-121.380331 °	-121.380331 °
DWR ID	DWR_NA0001_10_s_2012_116				
Comment Code					
S2 : Repair the levee slope damaged by foot traffic and prevent access where possible.					
Inspector Comment					
Foot traffic is eroding the landside slope.

View of the erosion on the landside levee slope caused by pedestrian foot traffic.

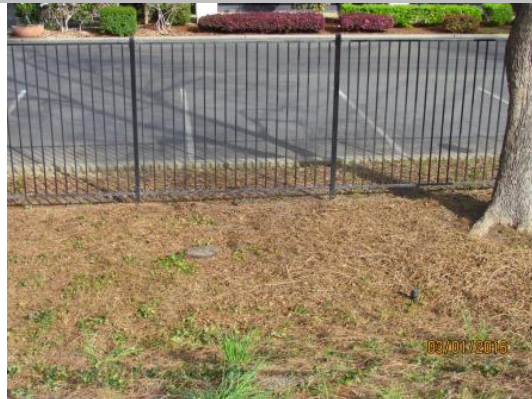
Photo 1 of 1 : FA_2016_NA0001_61_26_20160914_00007.jpg

LM Start	3.81	Rating **	N	Issue No.	26
LM End	3.81	Issue Type +	Ma	Location *	LS
Category	Earthen Levee			GPS Latitude/Longitude	
				Start	End
Item	Trim / Thin Trees			38.568190°	38.568190°
				-121.381510°	-121.381510°
DWR ID	DWR_NA0001_10_s_2016_26				
Comment Code					
T5 : Tree stumps.					
Inspector Comment

View of the tree stump at the landside levee toe.

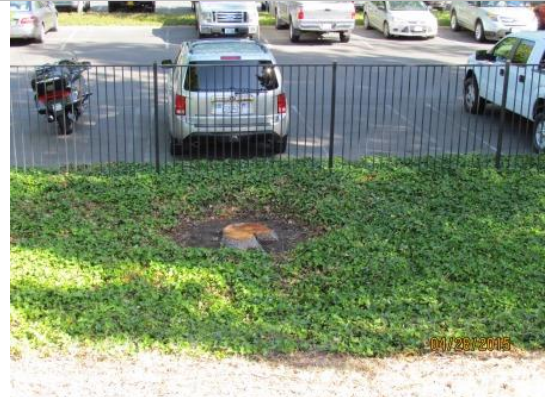
Photo 1 of 1 : FA_2016_NA0001_61_23_20160914_00006.jpg

View of the tree stump at the landside levee toe.

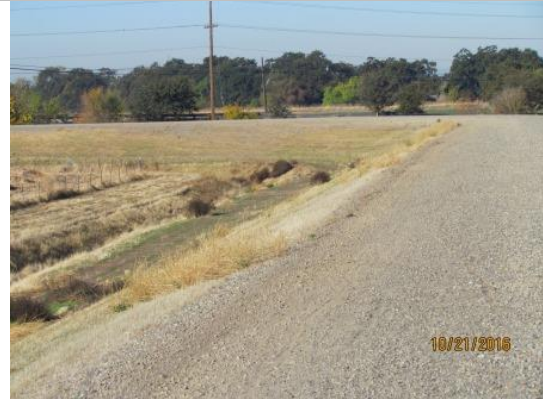
Photo 1 of 1 : FA_2016_NA0001_436_5_20161031_00009.jpg

View of the vegetation on the landside levee slope.

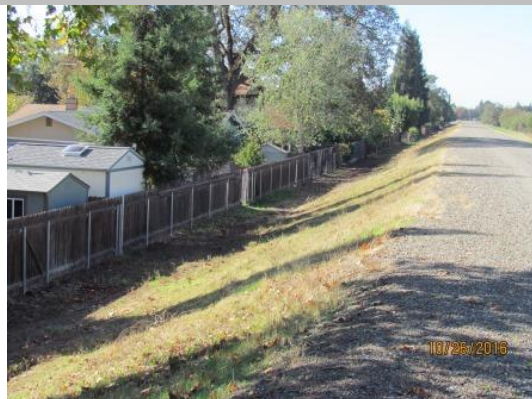
Photo 1 of 1 : FA_2016_NA0001_438_8_20161031_00014.jpg

View of the vegetation on the landside levee slope.

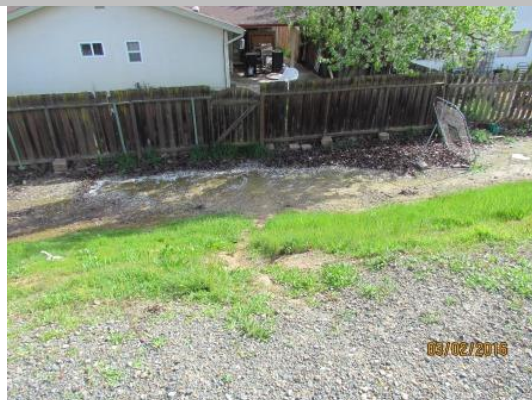
Photo 1 of 1 : FA_2016_NA0001_438_4_20160914_00004.jpg

View of the footpath on the landside levee slope.

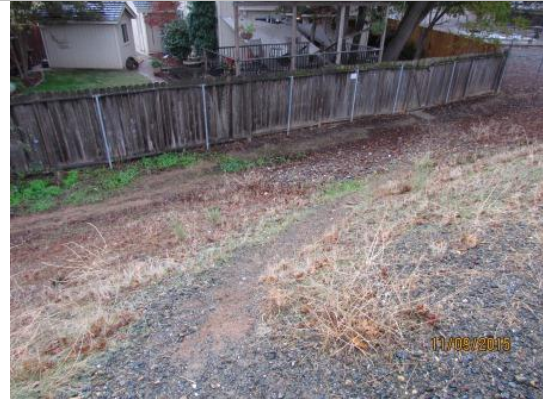
Photo 1 of 1 : FA_2016_NA0001_438_3_20160914_00003.jpg

View of the footpath on the landside levee slope.
