**Flood Control Project Maintenance
Levee Inspections**

Maintenance Issue Types Only, Levee Inspection Report By Mile - Fall 2017

American River Flood Control District

Waterway	Bank	Unit Miles	Inspection Start/End	Inspector
Unit No. 01 Arcade Creek	Left	2.08	09/20/2017 10/30/2017	Maksim Khashchuk

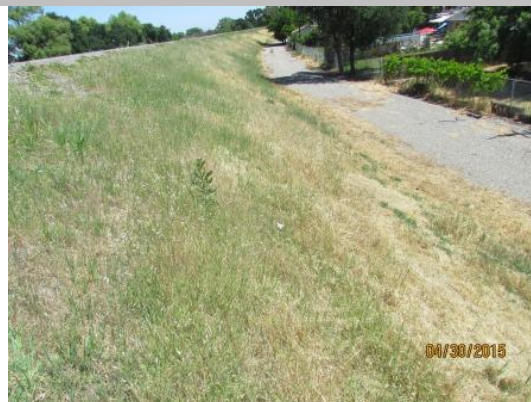
Photo 1 of 2 : FA_2017_NA0001_51_164_20170911_00055.jpg

Another view of the depression on the landside levee slope.

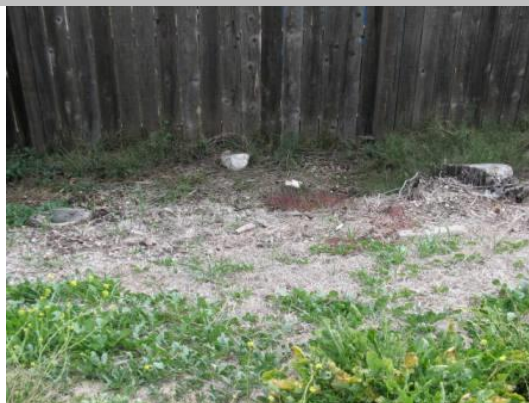
Photo 1 of 1 : FA_2017_NA0001_51_178_20170911_00063.jpg

11/17/2011 Two stumps at levee toe.

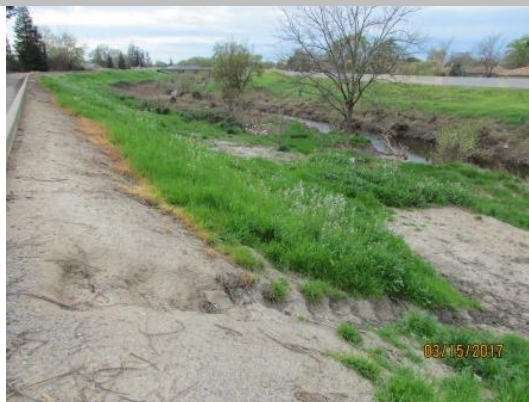
Photo 1 of 1 : FA_2017_NA0001_51_75_20170911_00049.jpg

LM Start	1.48	Rating **	M	Issue No.	75
LM End	1.48	Issue Type +	Ma	Location *	WS
Category	Earthen Levee			GPS Latitude/Longitude	
				Start	End
Item	Slope Stability			38.626912 °	38.626912 °
				-121.443229 °	-121.443229 °
DWR ID	DWR_NA0001_01_s_2017_75				
Comment Code					
S2 : Repair the levee slope damaged by foot traffic and prevent access where possible.					
Inspector Comment					
Stairs dug into waterside levee slope.

View of the stairs in the levee slope, looking downstream.

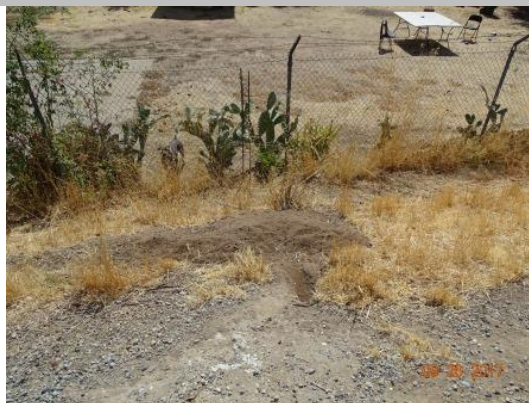
Photo 1 of 1 : FA_2017_NA0001_51_11_20171106_00095.jpg

View of the rodent activity on the levee slope.

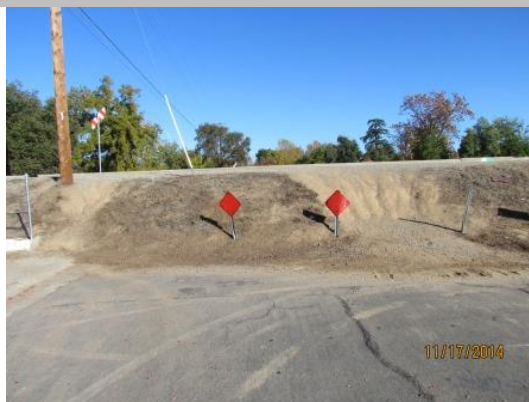
Photo 1 of 1 : FA_2017_NA0001_51_54_20170911_00034.jpg

LM Start	1.58	Rating **	A/W	Issue No.	54
LM End	1.58	Issue Type +	Ma	Location *	LS
Category	Earthen Levee			GPS Latitude/Longitude	
				Start	End
Item	Slope Stability			38.627251 °	38.627251 °
				-121.441460 °	-121.441460 °
DWR ID	DWR_NA0001_01_s_2012_54				
Comment Code					
S2 : Repair the levee slope damaged by foot traffic and prevent access where possible.					
Inspector Comment

Slope stability due to foot traffic needs to be monitored.

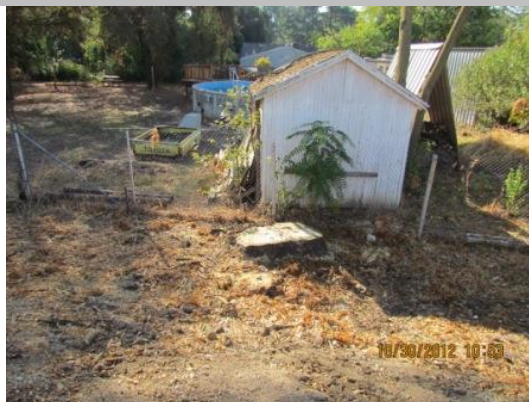
Photo 1 of 1 : FA_2017_NA0001_51_31_20170911_00024.jpg

LM Start	1.61	Rating **	N	Issue No.	31
LM End	1.61	Issue Type +	Ma	Location *	LS
Category	Earthen Levee			GPS Latitude/Longitude	
				Start	End
Item	Trim / Thin Trees			38.627191 °	38.627191 °
				-121.440861 °	-121.440861 °
DWR ID	DWR_NA0001_01_f_2012_31				
Comment Code					
T5 : Tree stumps.					
Inspector Comment

View of large tree stump at levee toe.

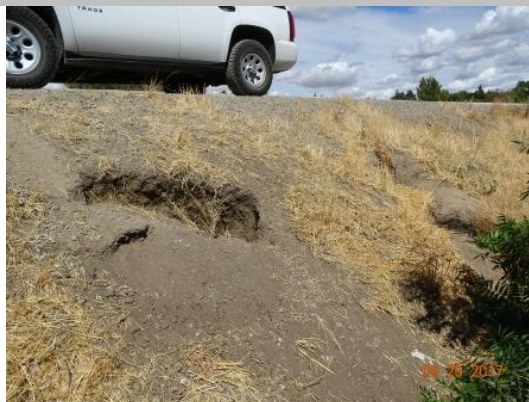
Photo 1 of 1 : FA_2017_NA0001_51_65_20171106_00094.jpg

View of the animal activity on the levee slope.

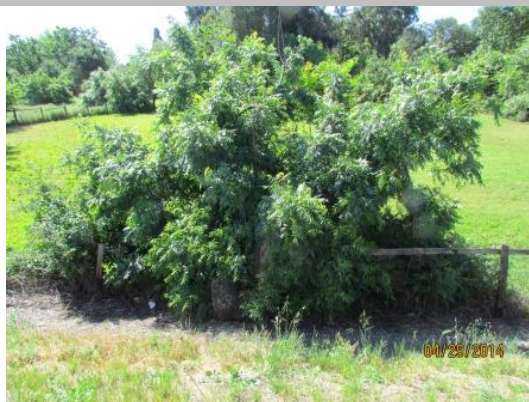
Photo 1 of 1 : FA_2017_NA0001_51_48_20170911_00030.jpg

LM Start	1.69	Rating **	M	Issue No.	48
LM End	1.69	Issue Type +	Ma	Location *	LS
Category	Earthen Levee			GPS Latitude/Longitude	
				Start	End
Item	Vegetation			38.627594 °	38.627594 °
				-121.439540 °	-121.439540 °
DWR ID	DWR_NA0001_01_s_2014_48				
Comment Code					
V2 : Remove the wild growth other than native grasses from the levee slopes.					
Inspector Comment					
Tree obstructing visibility and access.

View of the overgrown tree at the landside levee toe.

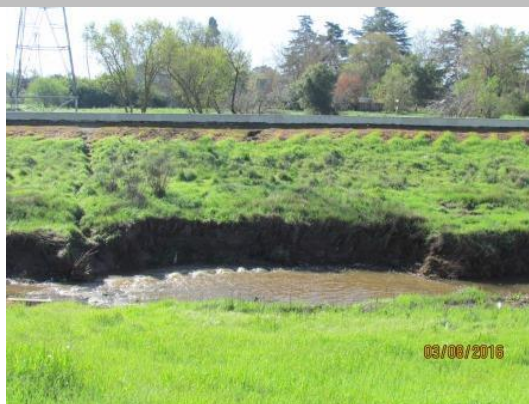
Photo 1 of 1 : FA_2017_NA0001_51_84_20170911_00054.jpg

LM Start	1.74	Rating **	A	Issue No.	84	
LM End	1.74	Issue Type +	Ma	Location *	WS	
Category	Rivers, Channels & Designated Floodways			GPS Latitude/Longitude		
				Start		End
Item	Erosion / Bank Caving			38.627882 °		38.627882 °
				-121.438602 °		-121.438602 °
DWR ID	DWR_NA0001_01_s_2017_84					
Comment Code						
Inspector Comment						
The LMA repaired this site.

View of the erosion on the waterside levee berm.

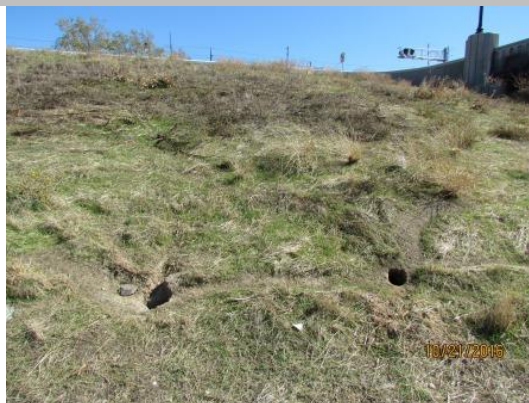
Photo 1 of 1 : FA_2017_NA0001_52_24_20170911_00005.jpg

View of the rodent holes in the waterside levee slope.

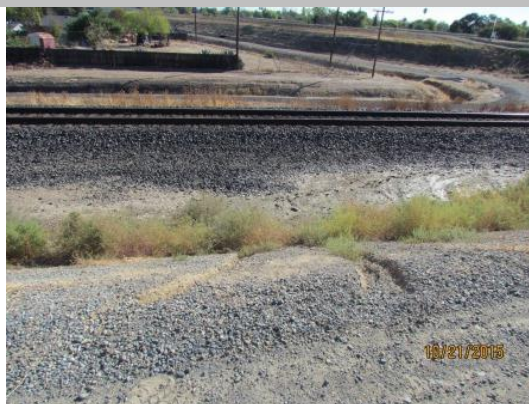
Photo 1 of 1 : FA_2017_NA0001_52_26_20170911_00007.jpg

LM Start	1.40	Rating **	M	Issue No.	26	
LM End	1.40	Issue Type +	Ma	Location *	LS	
Category	Earthen Levee			GPS Latitude/Longitude		
				Start		End
Item	Slope Stability			38.621054 °		38.621054 °
				-121.468008 °		-121.468008 °
DWR ID	DWR_NA0001_02_f_2015_26					
Comment Code						
S3 : Repair the levee slope damaged by vehicle traffic and prevent access where possible.						
Inspector Comment

View of the damaged landside levee slope.

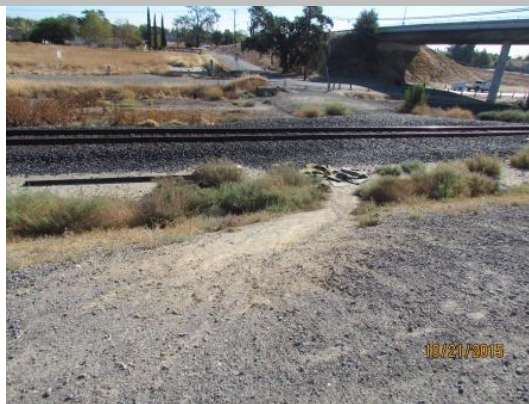
Photo 1 of 1 : FA_2017_NA0001_52_25_20170911_00006.jpg

LM Start	2.05	Rating **	M	Issue No.	25	
LM End	2.05	Issue Type +	Ma	Location *	LS	
Category	Earthen Levee			GPS Latitude/Longitude		
				Start		End
Item	Slope Stability			38.630425 °		38.630425 °
				-121.469807 °		-121.469807 °
DWR ID	DWR_NA0001_02_f_2015_25					
Comment Code						
S2 : Repair the levee slope damaged by foot traffic and prevent access where possible.						
Inspector Comment

View of the landside levee slope damaged by foot traffic.

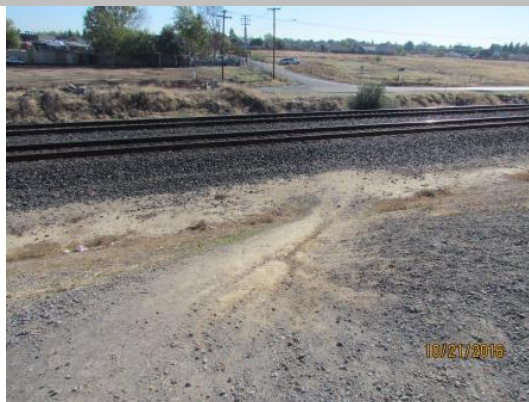
Photo 1 of 1 : FA_2017_NA0001_52_27_20170911_00008.jpg

LM Start	2.59	Rating **	M	Issue No.	27
LM End	2.59	Issue Type +	Ma	Location *	LS
Category	Earthen Levee			GPS Latitude/Longitude	
				Start	End
Item	Slope Stability			38.638109 °	38.638109 °
				-121.471254 °	-121.471254 °
DWR ID	DWR_NA0001_02_f_2016_27				
Comment Code					
S2 : Repair the levee slope damaged by foot traffic and prevent access where possible.					
Inspector Comment

View of the foot path on the landside levee slope.

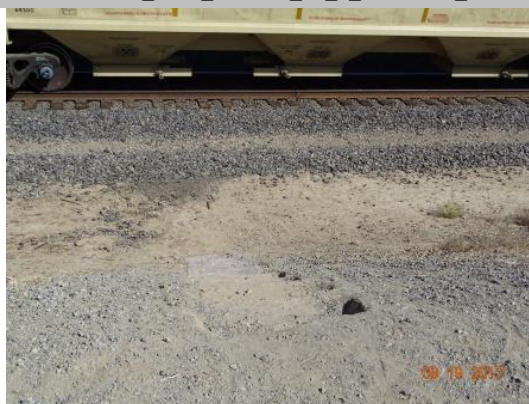
Photo 1 of 1 : FA_2017_NA0001_52_1_20171106_00042.jpg

View of the unpermitted steps in the levee.

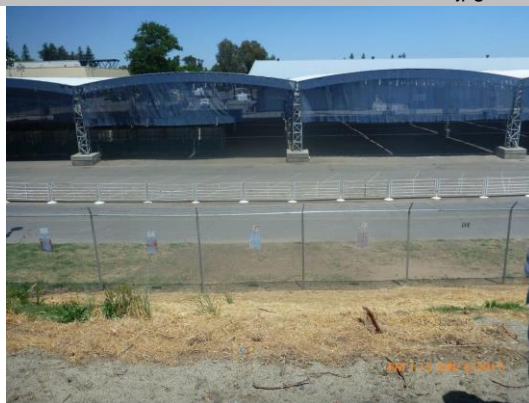
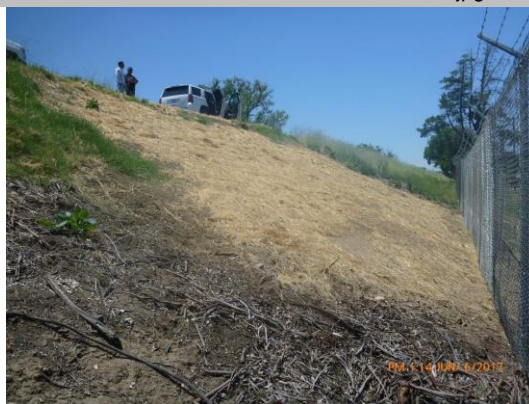
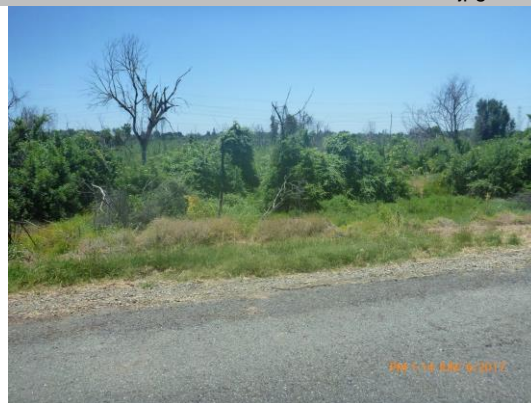
LM Start	0.76	Rating **	A	Issue No.	25
LM End		Issue Type +	Ma	Location *	
Category	Supplemental			GPS Latitude/Longitude	
				Start	End
Item	2017 Storm Damage			38.589401 °	°
				-121.431231 °	°
DWR ID	DWR NA0001 03 f 2017 25

Repair Type: Erosion

Notes: site repaired by lma, no further action required

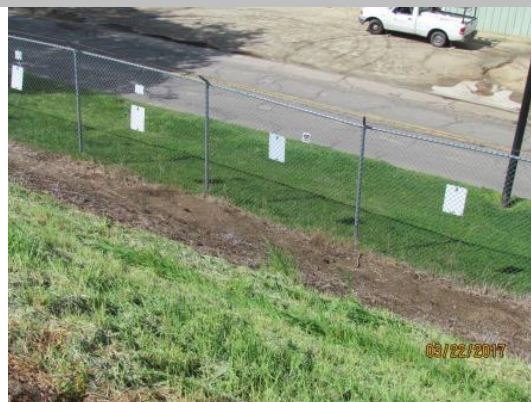
Photo 1 of 1 : FA_2017_NA0001_490_23_20170911_00006.jpg

LM Start	0.81	Rating **	A/W	Issue No.	23
LM End	0.81	Issue Type +	Ma	Location *	LS
Category	Earthen Levee			GPS Latitude/Longitude	
				Start	End
Item	Animal Control			38.589531 °	38.589531 °
				-121.432133 °	-121.432133 °
DWR ID	DWR_NA0001_03_s_2017_23				
Comment Code					
A3 : No rodents visible, but rodent burrows visible; need to backfill and compact or grout burrows.					
Inspector Comment					
Rodent burrows at levee toe were backfilled, but need to be monitored.

View of the rodent burrow at the levee toe.

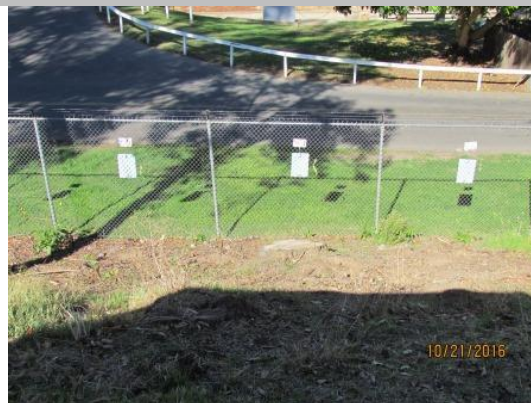
Photo 1 of 1 : FA_2017_NA0001_490_22_20170911_00005.jpg

View of the tree stump on the landside levee slope.

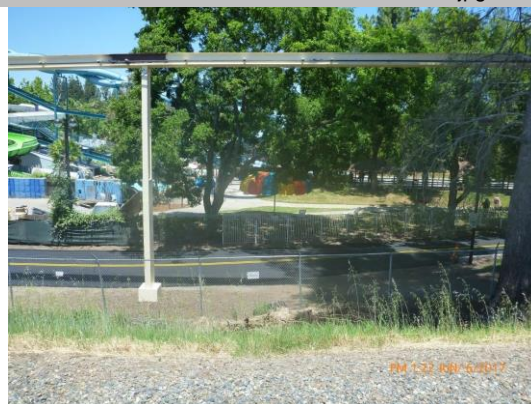
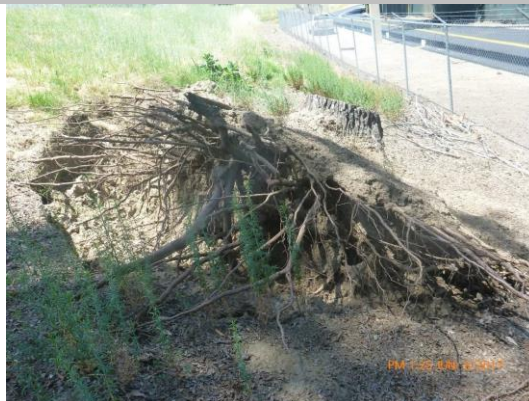
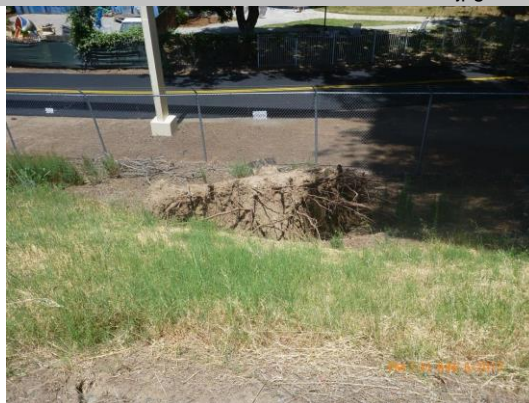
LM Start	1.04	Rating **	A	Issue No.	26	
LM End		Issue Type +	Ma	Location *		
Category	Supplemental			GPS Latitude/Longitude		
				Start		End
Item	2017 Storm Damage			38.590073 °		°
				-121.436362 °		°
DWR ID	DWR_NA0001_03_f_2017_26					
Comment Code						
Inspector Comment						
Levee Evaluation Comments						
Description:						
Site ID No:47						
Site Designation:LMA-14						
Repair Type: Erosion						
Rating:Area of Concern						
Field Date:6/6/2017						
Notes: site to be repaired by lma after state fair, no assistance required.						
LMA repaired the site.

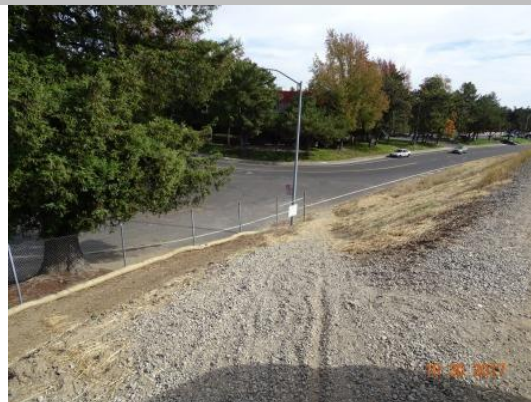
Photo 1 of 1 : FA_2017_NA0001_490_9_20171106_00041.jpg

LM Start	1.82	Rating **	A	Issue No.	9
LM End	1.82	Issue Type +	Ma	Location *	LS
Category	Earthen Levee			GPS Latitude/Longitude	
				Start	End
Item	Slope Stability			38.595700 °	38.595700 °
				-121.448198 °	-121.448198 °
DWR ID	DWR_NA0001_03_s _ 2012_9				
Comment Code					
S2 : Repair the levee slope damaged by foot traffic and prevent access where possible.					
Inspector Comment					
Site repaired but should be monitored for a season.

View of the repaired levee slope.

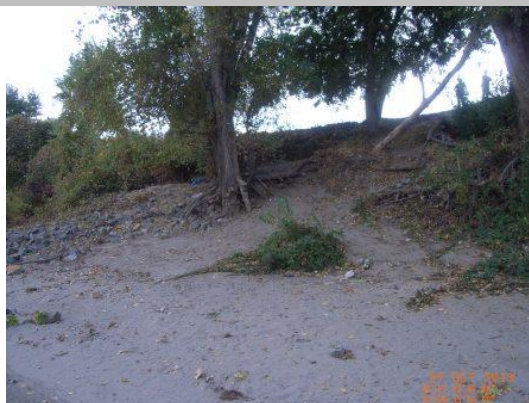
Photo 1 of 1 : FA_2017_NA0001_55_7_20170911_00010.jpg

LM Start	1.61	Rating **	M	Issue No.	7
LM End	1.65	Issue Type +	Ma	Location *	WS
Category	Supplemental			GPS Latitude/Longitude	
				Start	End
Item	2015 USACE Erosion Survey, DRAFT			38.599095 °	38.598791 °
				-121.480337 °	-121.479799 °
DWR ID	DWR_NA0001_04_s_2016_7				
Comment Code					
Inspector Comment					
2012 - Located just downstream of older repair. Failing rock at the upstream end. Erosion of the bank has exposed large tree roots. 2015: No observed changes. [2015 Site ID: LAR_1-8_L]

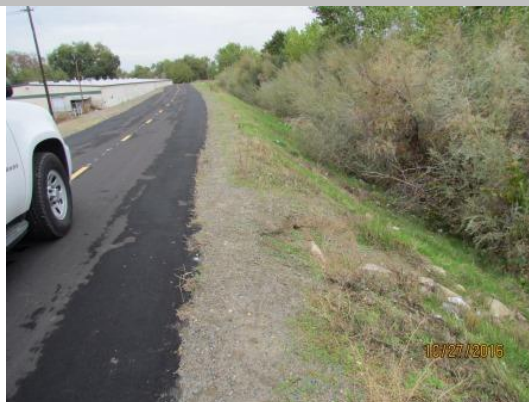
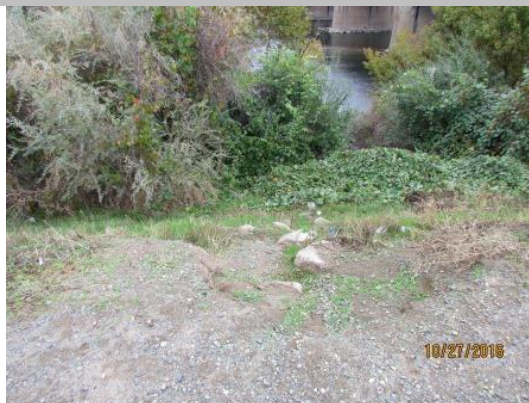
LM Start	1.85	Rating **	A/W	Issue No.	250
LM End	1.85	Issue Type +	Ma	Location *	WS
Category	Earthen Levee			GPS Latitude/Longitude	
				Start	End
Item	Slope Stability			38.596220 °	38.596220 °
				-121.477713 °	-121.477713 °
DWR ID	DWR_NA0001_04_s_2016_250				
Comment Code					
S2 : Repair the levee slope damaged by foot traffic and prevent access where possible.					
Inspector Comment					
The erosion of the levee slope from the footpath appears to be stable at this time and should be monitored.

View of the footpath on the waterside levee slope, looking downstream.

View of the footpath on the waterside levee slope, looking at the slope.

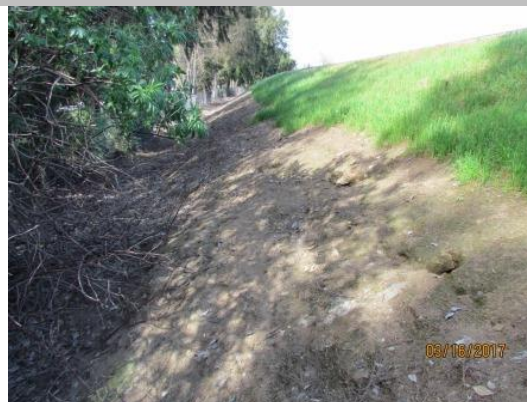
Photo 1 of 1 : FA_2017_NA0001_55_260_20170911_00213.jpg

View of the rodent burrows at the levee toe.

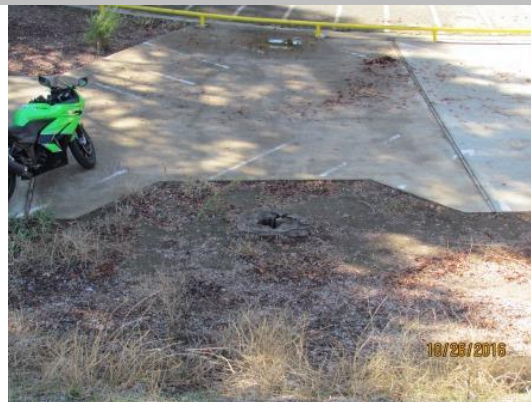
Photo 1 of 1 : FA_2017_NA0001_55_238_20170911_00195.jpg

View of the tree stump at the landside levee toe.

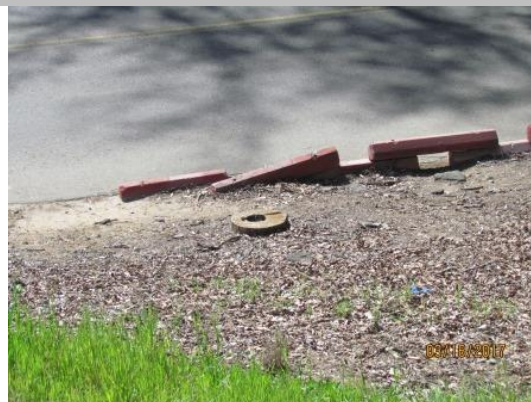
Photo 1 of 1 : FA_2017_NA0001_55_233_20170911_00190.jpg

View of the tree stump at the levee toe.

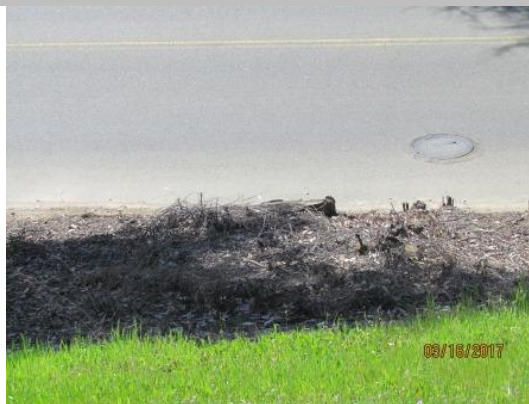
Photo 1 of 1 : FA_2017_NA0001_55_256_20170911_00212.jpg

View of the stump at the levee toe.

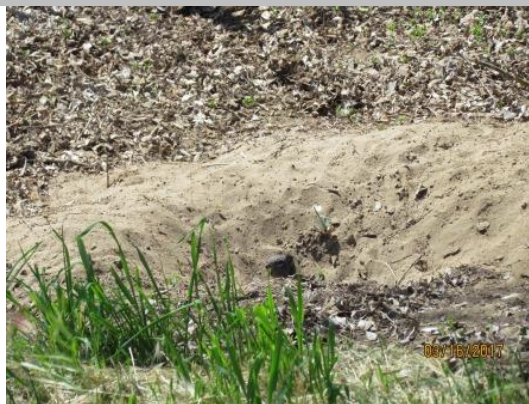
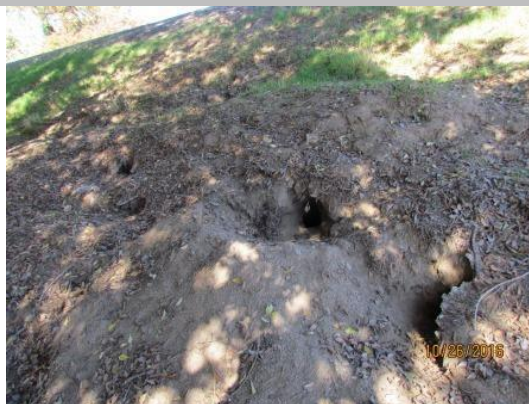
Another view of the rodent burrow at the levee toe.

View of a rodent burrows at the landside levee toe.

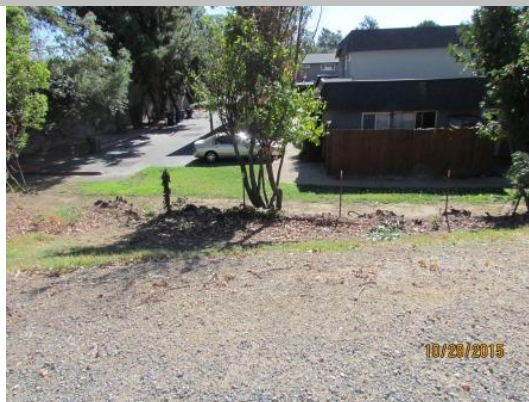
Photo 1 of 1 : FA_2017_NA0001_55_230_20170911_00189.jpg

View of the multiple tree stumps at the landside levee toe.

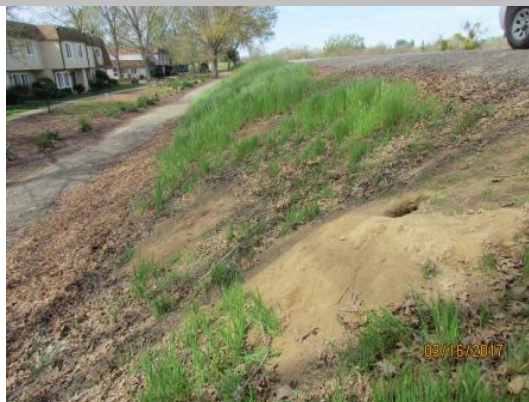
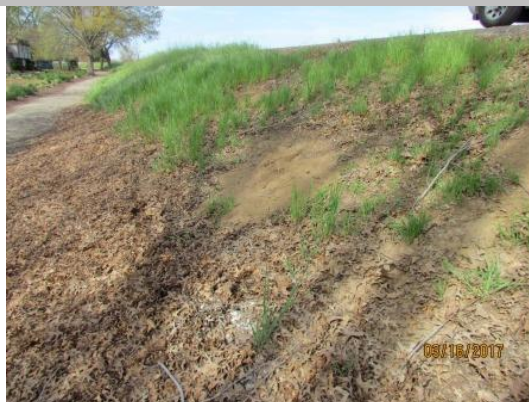
View of the rodent burrows on the levee slope, looking upstream.

Another view of the rodent burrows on the levee slope.

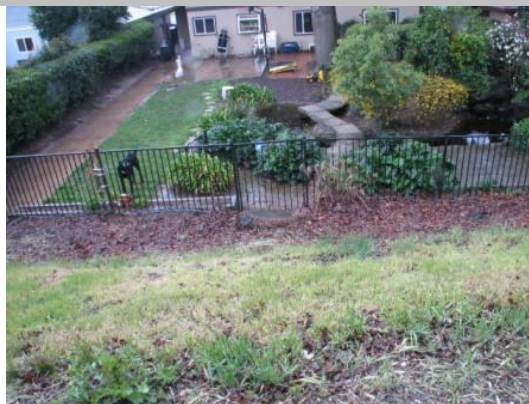
Photo 1 of 1 : FA_2017_NA0001_55_123_20170911_00111.jpg

03/16/2012 Large tree stump at levee toe.

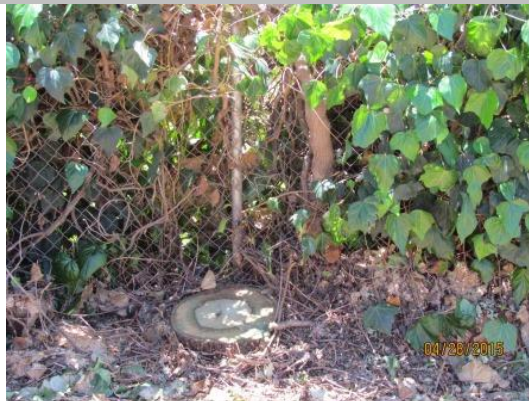
Photo 1 of 1 : FA_2017_NA0001_55_234_20170911_00191.jpg

View of the tree stump at the landside levee toe.

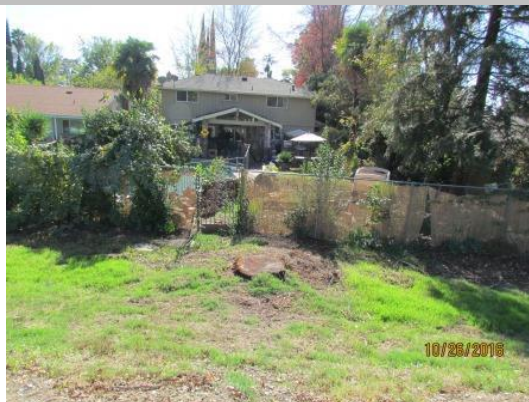
Photo 1 of 1 : FA_2017_NA0001_55_222_20170911_00182.jpg

View of the tree stump at the landside levee toe.

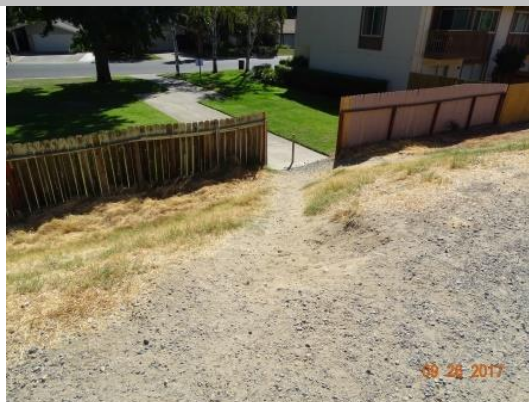
Photo 1 of 1 : FA_2017_NA0001_55_228_20171106_00274.jpg

View of the footpath on the levee slope.

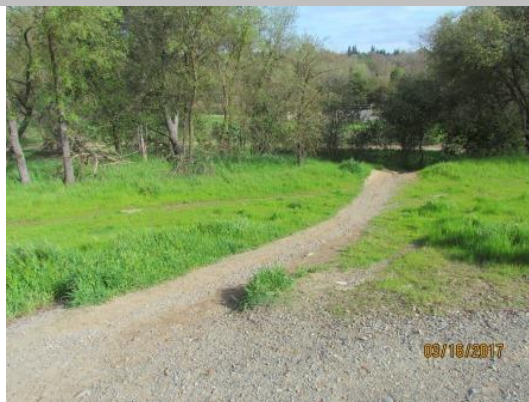
Photo 1 of 1 : FA_2017_NA0001_55_219_20170911_00180.jpg

View of the footpath on the levee slope.

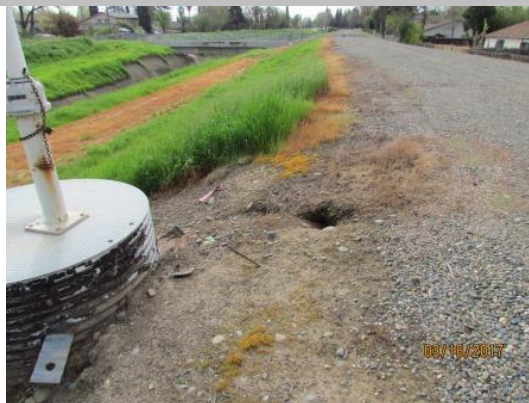
Photo 1 of 1 : FA_2017_NA0001_55_227_20170911_00187.jpg

View of the rodent burrow on the levee slope, looking upstream.

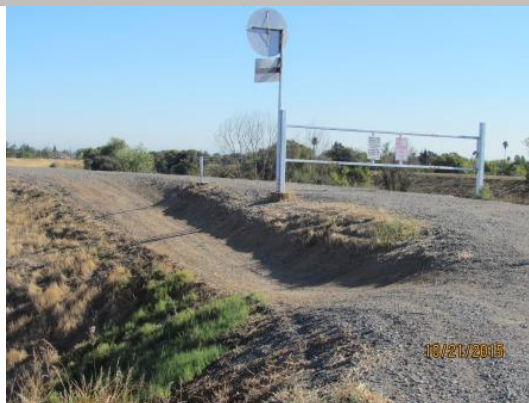
Photo 1 of 1 : FA_2017_NA0001_58_38_20170919_00029.jpg

View of the landside levee slope damaged by motorized traffic.

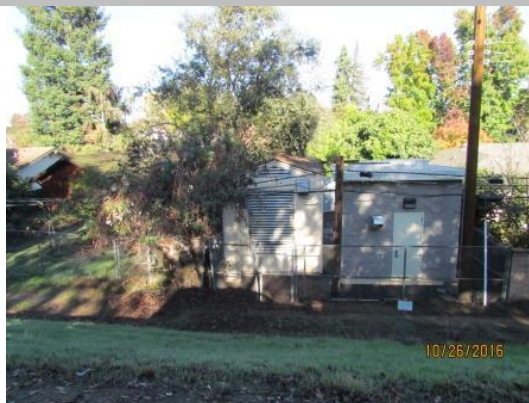
Photo 1 of 1 : FA_2017_NA0001_60_14_20170919_00004.jpg

Tree trunk at fence line.

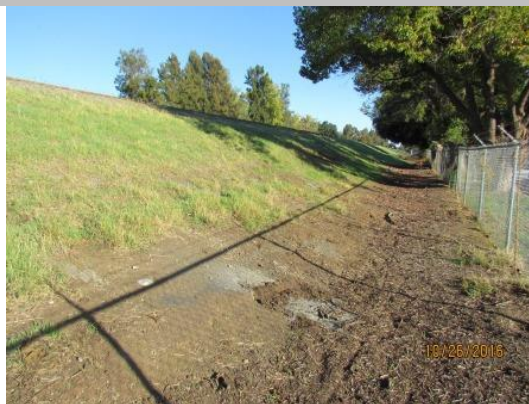
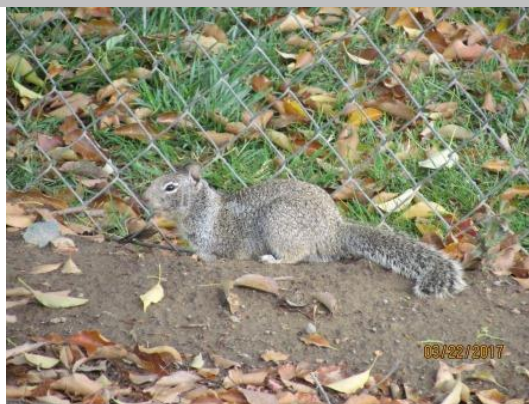
View of the rodent holes on the landside levee slope.

View of the rodent at the levee toe causing levee damage.

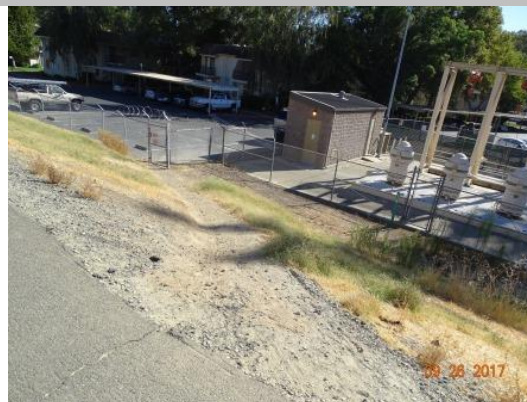
Photo 1 of 1 : FA_2017_NA0001_60_9_20171106_00047.jpg

View of the footpath on the levee slope.

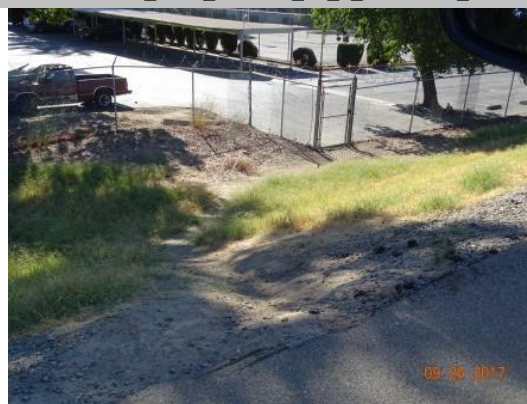
Photo 1 of 1 : FA_2017_NA0001_60_8_20171106_00046.jpg

View of the footpath on the levee slope.

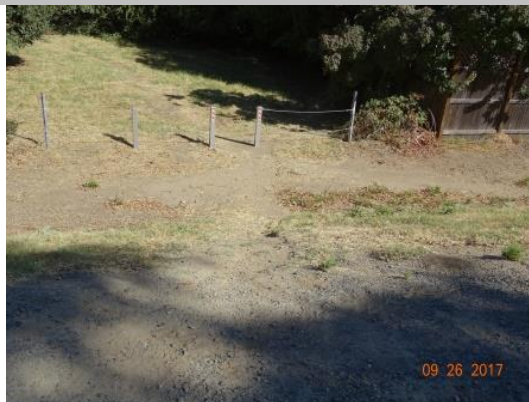
Photo 1 of 1 : FA_2017_NA0001_61_2_20171106_00047.jpg

View of the footpath on the levee slope.

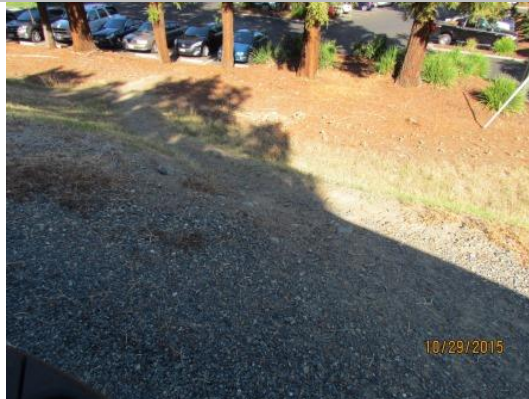
Photo 1 of 1 : FA_2017_NA0001_61_21_20170919_00003.jpg

View of the footpath on the landside levee slope.

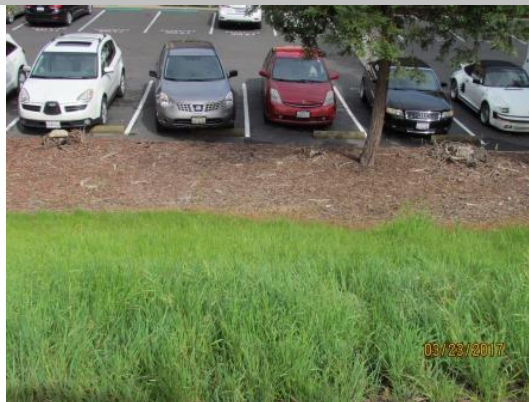
Photo 1 of 1 : FA_2017_NA0001_61_29_20170919_00008.jpg

View of the tree stump within the levee easement.

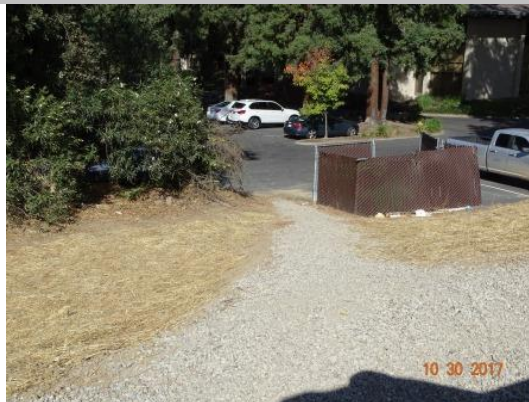
Photo 1 of 1 : FA_2017_NA0001_61_116_20171106_00048.jpg

View of the repaired levee slope.

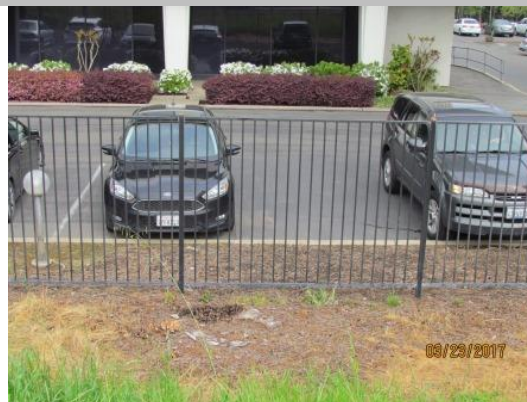
Photo 1 of 1 : FA_2017_NA0001_61_28_20170919_00007.jpg

View of the tree stump at the levee toe.

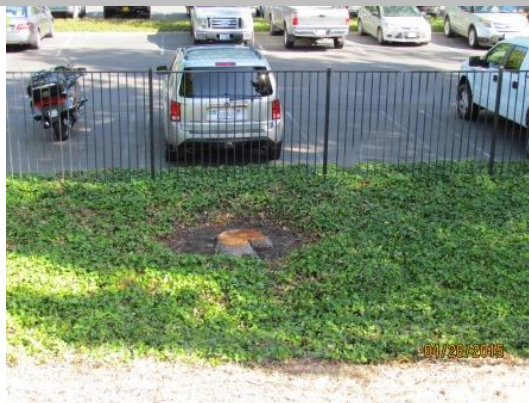
Photo 1 of 1 : FA_2017_NA0001_61_23_20170919_00004.jpg

View of the tree stump at the landside levee toe.

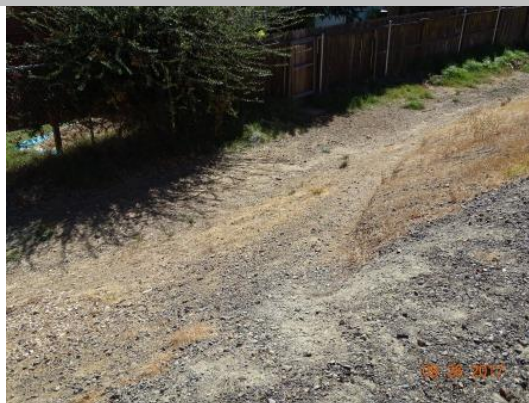
Photo 1 of 1 : FA_2017_NA0001_438_8_20171106_00015.jpg

View of the footpath on the levee slope.

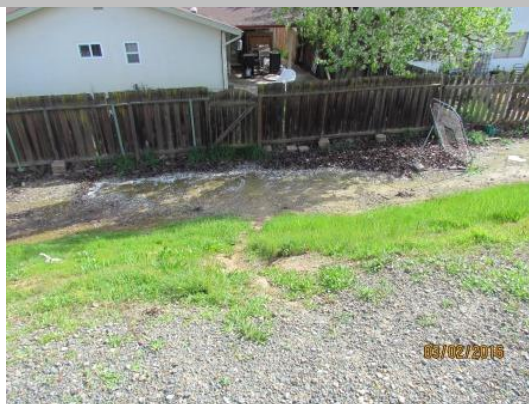
Photo 1 of 1 : FA_2017_NA0001_438_4_20170919_00004.jpg

View of the footpath on the landside levee slope.

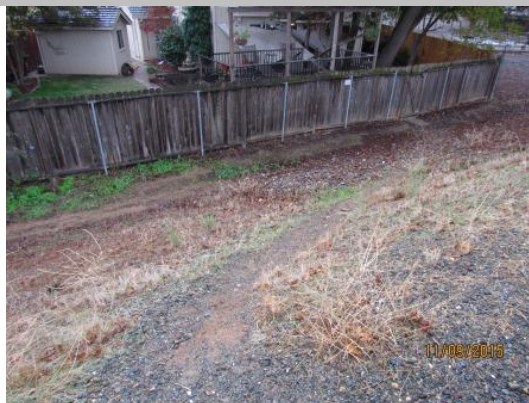
Photo 1 of 1 : FA_2017_NA0001_438_3_20170919_00003.jpg

View of the footpath on the landside levee slope.
