**Flood Control Project Maintenance  
Levee Inspections**

**Maintenance Issue Types Only, Levee Inspection Report By Mile - Fall 2018**

**American River Flood Control District**

Waterway	Bank	Unit Miles	Inspection Start/End	Inspector
Unit No. 01 Arcade Creek	Left	2.08		Luz Dial

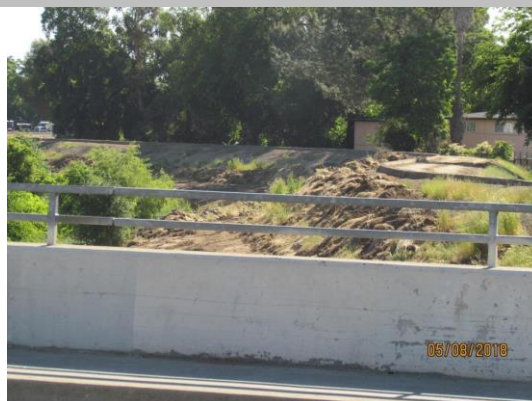
Photo 1 of 1 : FA\_2018\_NA0001\_51\_45\_20180911\_00029.jpg

LM Start	0.02	Rating **	A/W	Issue No.	45
LM End	2.07	Issue Type +	Ma	Location *	CR
Category	Earthen Levee			GPS Latitude/Longitude	
				Start	End
Item	Crown Surface / Depressions / Rutting			38.619443 °	38.627293 °
				-121.467339 °	-121.432635 °
DWR ID	DWR_NA0001_01_s_2018_45				
Comment Code					
C2 : Repair depressions or ruts in the crown or slope.					
Inspector Comment					
This Unit is under construction and not accessible. All the issues for Unit 1 will have to be reassessed when construction is complete and turned back over to ARFCD to maintain. Spring 2018.

View looking upstream from Norwood Ave. This Unit is under construction and not accessible. All the issues for Unit 1 will have to be reassessed when construction is complete and turn back over to ARFCD to maintain. Spring 2018.

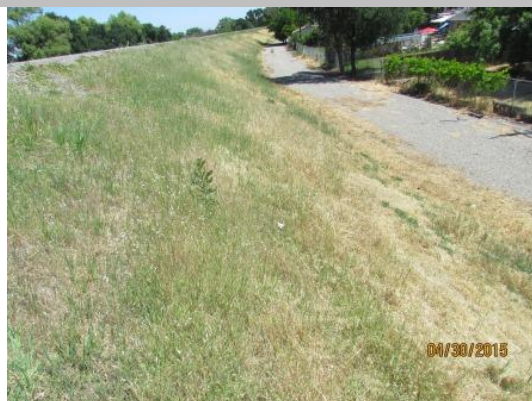
Photo 1 of 2 : FA\_2018\_NA0001\_51\_164\_20180911\_00050.jpg

Another view of the depression on the landside levee slope.

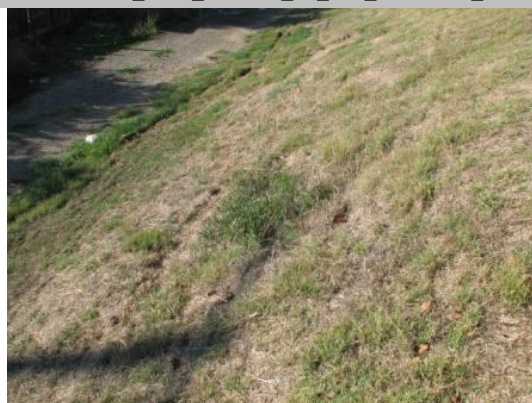
Photo 2 of 2 : FA\_2018\_NA0001\_51\_164\_20180911\_00051.jpg

LM Start	<b>0.48</b>	Rating **	A/W	Issue No.	<b>164 (cont)</b>
LM End	<b>0.48</b>	Issue Type +	Ma	Location *	LS

11/17/2011 Hole/depression approximately mid-slope.

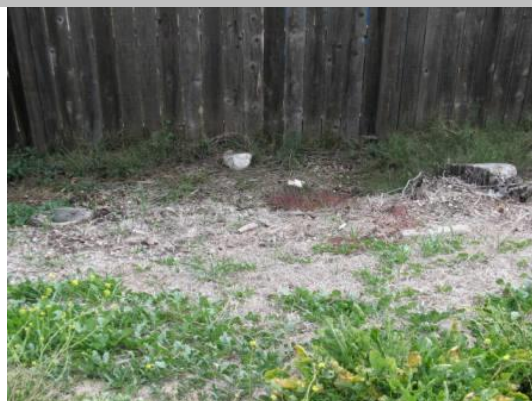
Photo 1 of 1 : FA\_2018\_NA0001\_51\_178\_20180911\_00058.jpg

11/17/2011 Two stumps at levee toe.

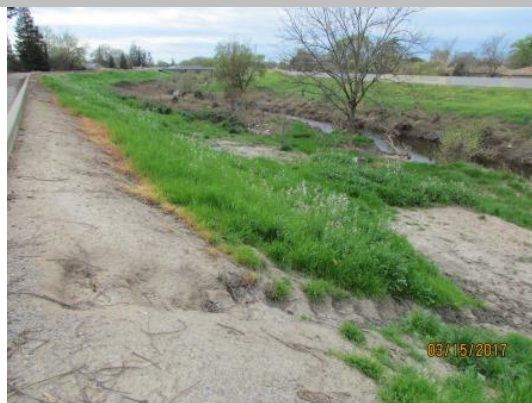
Photo 1 of 1 : FA\_2018\_NA0001\_51\_75\_20180911\_00049.jpg

LM Start	1.48	Rating **	M	Issue No.	75
LM End	1.48	Issue Type +	Ma	Location *	WS
Category	Earthen Levee			GPS Latitude/Longitude	
				Start	End
Item	Slope Stability			38.626912 °	38.626912 °
				-121.443229 °	-121.443229 °
DWR ID	DWR_NA0001_01_s_2017_75				
Comment Code					
S2 : Repair the levee slope damaged by foot traffic and prevent access where possible.					
Inspector Comment					
Stairs dug into waterside levee slope.

View of the stairs in the levee slope, looking downstream.

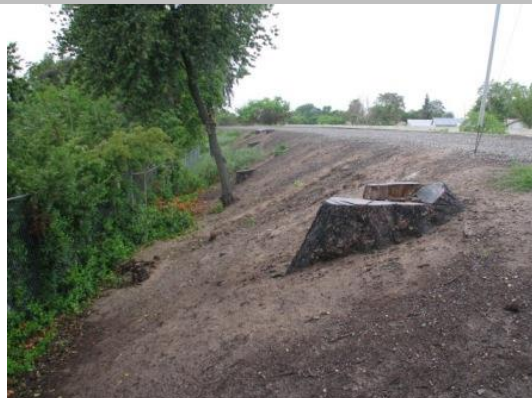
Photo 1 of 1 : FA\_2018\_NA0001\_51\_56\_20180911\_00036.jpg

Several large stumps on levee slope.

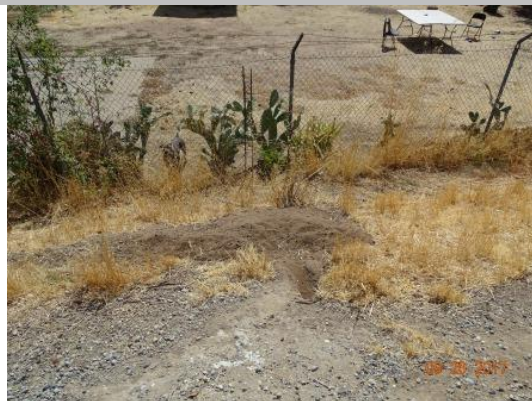
Photo 1 of 1 : FA\_2018\_NA0001\_51\_11\_20180911\_00010.jpg

LM Start	1.52	Rating **	M	Issue No.	19
LM End	1.52	Issue Type +	Ma	Location *	LS
Category	Earthen Levee			GPS Latitude/Longitude	
				Start	End
Item	Animal Control			38.627237 °	38.627237 °
				-121.442516 °	-121.442516 °
DWR ID	DWR_NA0001_01_f_2017_19				
Comment Code					
A3 : No rodents visible, but rodent burrows visible; need to backfill and compact or grout burrows.					
Inspector Comment

View of the rodent activity on the levee slope.

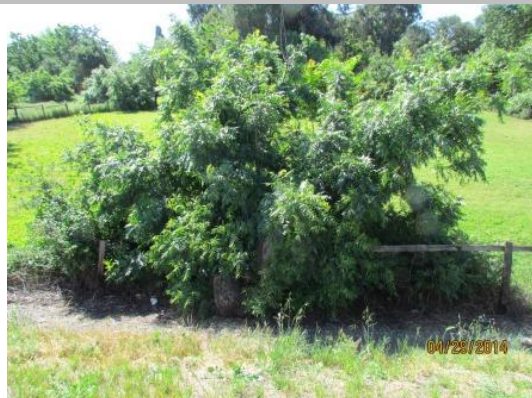
Photo 1 of 1 : FA\_2018\_NA0001\_51\_48\_20180911\_00031.jpg

View of the overgrown tree at the landside levee toe.

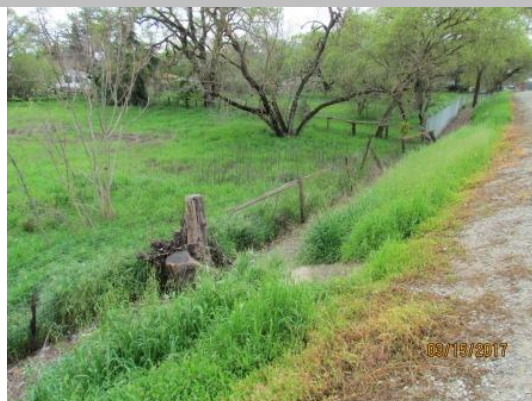
Photo 1 of 1 : FA\_2018\_NA0001\_51\_74\_20180911\_00048.jpg

LM Start	1.69	Rating **	N	Issue No.	74
LM End	1.69	Issue Type +	Ma	Location *	LS
Category	Earthen Levee			GPS Latitude/Longitude	
				Start	End
Item	Trim / Thin Trees			38.627607 °	38.627607 °
				-121.439545 °	-121.439545 °
DWR ID	DWR_NA0001_01_s_2017_74				
Comment Code					
T5 : Tree stumps.					
Inspector Comment					
24 inch large tree stump at levee toe.

View of the tree stump at the levee toe.

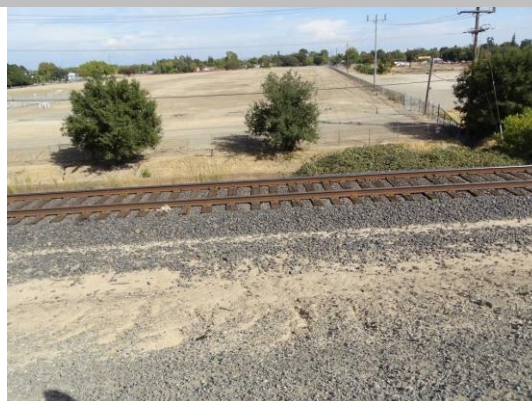
Photo 1 of 1 : FA\_2018\_NA0001\_52\_40\_20181015\_00051.jpg

View of erosion rills on slope. Fall 2018

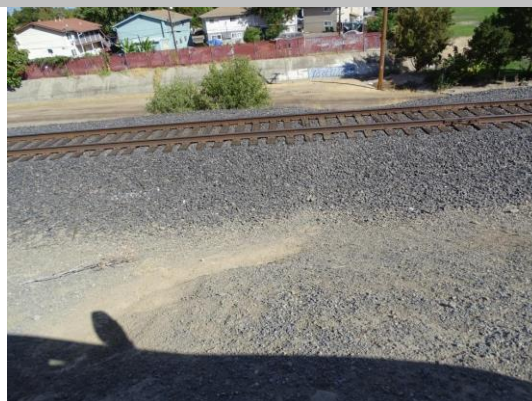
Photo 1 of 1 : FA\_2018\_NA0001\_52\_38\_20181015\_00050.jpg

LM Start	1.18	Rating **	A/W	Issue No.	38
LM End	1.18	Issue Type +	Ma	Location *	LS
Category	Earthen Levee			GPS Latitude/Longitude	
				Start	End
Item	Slope Stability			38.617956 °	38.617956 °
				-121.467355 °	-121.467355 °
DWR ID	DWR_NA0001_02_f_2018_38				
Comment Code					
S2 : Repair the levee slope damaged by foot traffic and prevent access where possible.					
Inspector Comment					
Monitor footpath on slope.

View of footpath on levee slope. Fall 2018

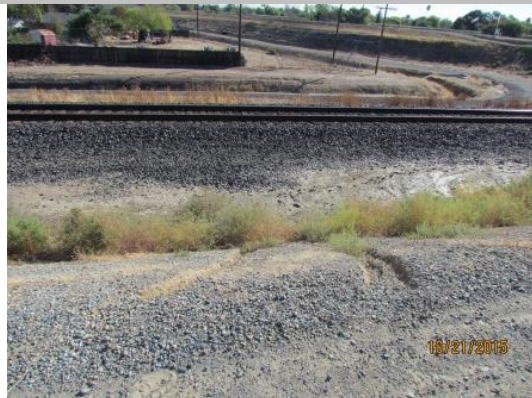
Photo 1 of 1 : FA\_2018\_NA0001\_52\_26\_20180911\_00008.jpg

LM Start	1.40	Rating **	A/W	Issue No.	26
LM End	1.40	Issue Type +	Ma	Location *	LS
Category	Earthen Levee			GPS Latitude/Longitude	
				Start	End
Item	Slope Stability			38.621054 °	38.621054 °
				-121.468008 °	-121.468008 °
DWR ID	DWR_NA0001_02_f_2015_26				
Comment Code					
S3 : Repair the levee slope damaged by vehicle traffic and prevent access where possible.					
Inspector Comment					
Monitor slope damage from vehicle traffic.

View of the damaged landside levee slope. Fall 2015

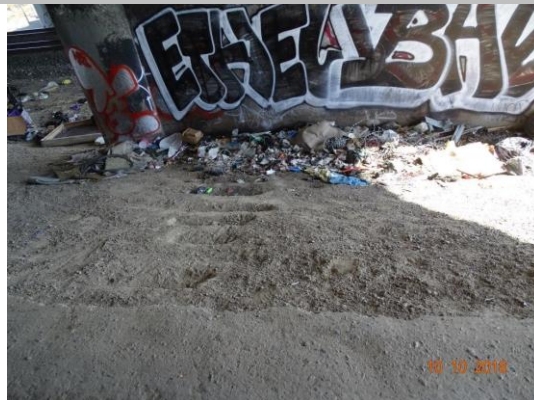
Photo 1 of 1 : FA\_2018\_NA0001\_52\_22\_20181015\_00046.jpg

LM Start	2.81	Rating **	M	Issue No.	22
LM End	2.81	Issue Type +	Ma	Location *	LS
Category	Earthen Levee			GPS Latitude/Longitude	
				Start	End
Item	Slope Stability			38.641309 °	38.641309 °
				-121.471798 °	-121.471798 °
DWR ID	DWR_NA0001_02_f_2018_22				
Comment Code					
S2 : Repair the levee slope damaged by foot traffic and prevent access where possible.					
Inspector Comment					
Steps cut into levee slope.

View of foot path steps cut into levee. Fall 2018

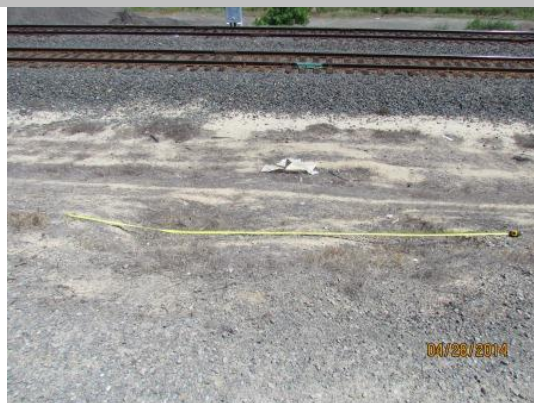
Photo 1 of 1 : FA\_2018\_NA0001\_52\_6\_20180911\_00003.jpg

LM Start	2.92	Rating **	A/W	Issue No.	6
LM End	2.92	Issue Type +	Ma	Location *	LS
Category	Earthen Levee			GPS Latitude/Longitude	
				Start	End
Item	Slope Stability			38.642950 °	38.642950 °
				-121.472166 °	-121.472166 °
DWR ID	DWR_NA0001_02_f_2018_6				
Comment Code					
S1 : Repair slope instability.					
Inspector Comment					
Monitor this location.

View of landside slope instability. Spring 2014

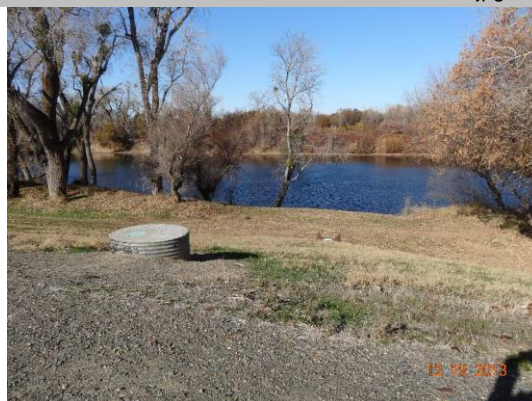
Photo 3 of 3 : UCIP\_FA\_2018\_31249\_57210.jpg

Item	DWR UCIP LMA Responsibility		38.600436 °	38.600436 °						
			-121.502058 °	-121.502058 °						
DWR ID	24303									
Comment Code										
Inspector Comment										
FS_ID:31249 DS_ID:24303 EP_NO: N/A Repair Type: Non-Urgent Crossing Status: Found UCIP Comments: 08/16/2017 DWR Deferred Maintenance Project (DMP), Vince Rodriguez, forwarded email received from Tim Kerr, General Manager of American River Flood Control District (ARFCD) with file "DWR Eligible Pipes Found in ARFCD" from ARFCD that shows the ownership and location of the pipes Tim Kerr investigated. No owner was identified, ARFCD Staff Notes indicate Abandoned (ARFCD/Bill) - No As-builts. (DWR UCIP - O. Magana) 12/19/2013 Non-functional crossing--need additional information about how crossing was abandoned. (DWR UCIP - O. Magana) FIELD_STRUCT_DESC: *ABANDONED* 42-inch corrugated metal drainage pipe through the levee, 16.5 feet below the crown. Gravel filled with both ends welded shut. Flap gate on the waterside (WS) end. Slide gate in corrugated metal riser and splash board drain structure on the landside (LS). (no permit has been identified authorizing this structure, no owner has been identified) [Additional Reference(s): DWR Levee Log, 2002. USACE Sacramento O&M Manual Unit 118 Part 1, August 1955, (Station 10+00)]. FS Date: 12/19/2013

View of waterward side--standpipe located on waterward slope.  
Standpipe filled with concrete.

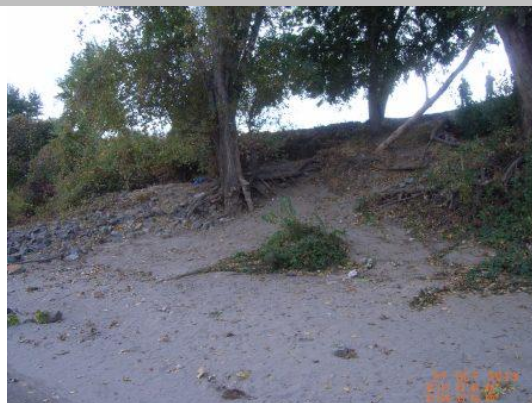
Photo 1 of 1 : FA\_2018\_NA0001\_55\_214\_20181105\_00136.jpg

LM Start	<b>1.49</b>	Rating **	M	Issue No.	<b>214</b>					
LM End	<b>1.65</b>	Issue Type +	Ma	Location *	WS					
Category	Supplemental		GPS Latitude/Longitude							
			Start	End						
Item	2017 USACE Erosion Survey, DRAFT		38.599878 °	38.598791 °						
			-121.482483 °	-121.479799 °						
DWR ID	DWR_NA0001_04_f_2018_214									
Comment Code										
Inspector Comment										
2017 Site ID: LAR 1.8 L Status: Eroding 2017 Field Notes: Site littered with homeless camps. Hard to survey. Site extended downstream. Site History: 2012 - Located just downstream of older repair. Failing rock at the upstream end. Erosion of the bank has exposed large tree roots.

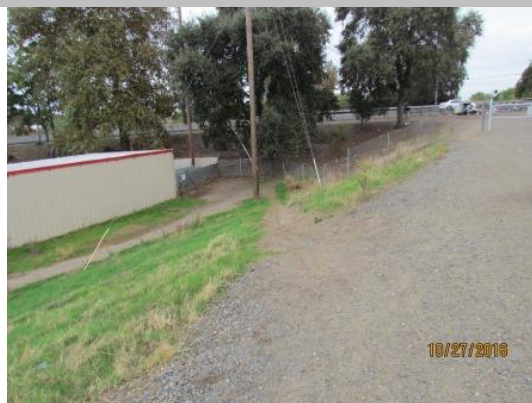
Photo 1 of 1 : FA\_2018\_NA0001\_55\_244\_20180911\_00196.jpg

LM Start	1.95	Rating **	A/W	Issue No.	244
LM End	1.95	Issue Type +	Ma	Location *	LS
Category	Earthen Levee			GPS Latitude/Longitude	
				Start	End
Item	Slope Stability			38.595040 °	38.595040 °
				-121.476882 °	-121.476882 °
DWR ID	DWR_NA0001_04_f_2015_244				
Comment Code					
S2 : Repair the levee slope damaged by foot traffic and prevent access where possible.					
Inspector Comment					
The erosion of the levee slope from the footpath appears to be stable at this time and should be monitored.

View of the footpath on the landside levee slope. Fall 2016

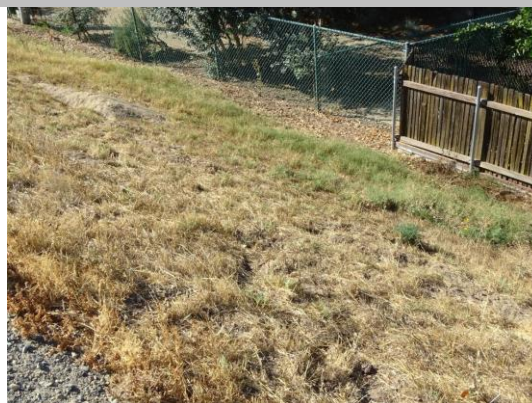
Photo 1 of 1 : FA\_2018\_NA0001\_55\_273\_20181024\_00282.jpg

View of animal burrows. Fall 2018

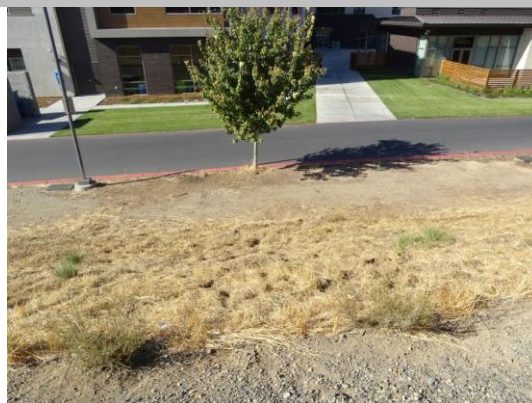
Photo 1 of 1 : FA\_2018\_NA0001\_55\_271\_20181024\_00279.jpg

View of animal holes. Fall 2018

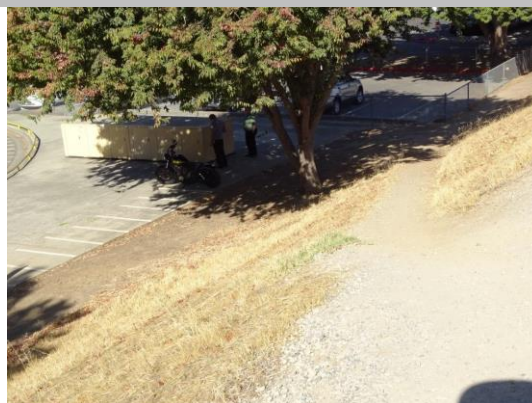
Photo 1 of 1 : FA\_2018\_NA0001\_55\_270\_20181024\_00278.jpg

LM Start	6.34	Rating **	A/W	Issue No.	270
LM End	6.34	Issue Type +	Ma	Location *	LS
Category	Earthen Levee			GPS Latitude/Longitude	
				Start	End
Item	Slope Stability			38.564833 °	38.564833 °
				-121.422947 °	-121.422947 °
DWR ID	DWR_NA0001_04_f_2018_270				
Comment Code					
S2 : Repair the levee slope damaged by foot traffic and prevent access where possible.					
Inspector Comment					
Monitor footpath.

View of footpath on slope. Fall 2018

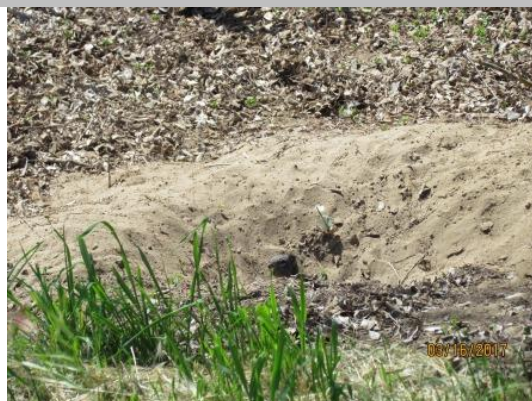
Photo 1 of 2 : FA\_2018\_NA0001\_55\_240\_20180911\_00193.jpg

LM Start	6.62	Rating **	M	Issue No.	240
LM End	6.65	Issue Type +	Ma	Location *	LS
Category	Earthen Levee			GPS Latitude/Longitude	
				Start	End
Item	Animal Control			38.561121°	38.560883°
				-121.420766°	-121.420514°
DWR ID	DWR_NA0001_04_s_2017_240				
Comment Code					
A3 : No rodents visible, but rodent burrows visible; need to backfill and compact or grout burrows.					
Inspector Comment					
Rodent burrows still visible despite repairs.

Another view of the rodent burrow at the levee toe.

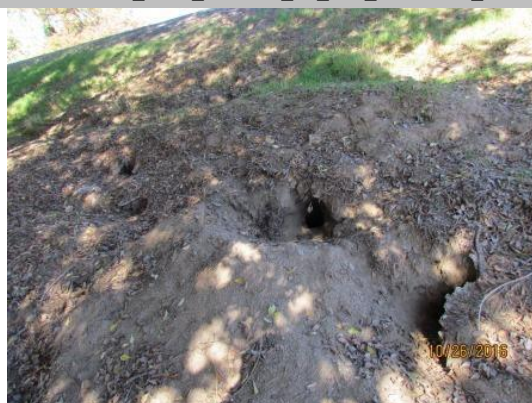
Photo 2 of 2 : FA\_2018\_NA0001\_55\_240\_20180911\_00194.jpg

View of a rodent burrows at the landside levee toe.

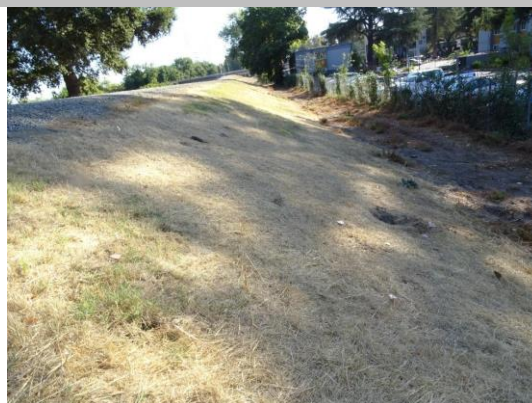
Photo 1 of 1 : FA\_2018\_NA0001\_55\_266\_20181024\_00276.jpg

View of animal burrows. Fall 2018

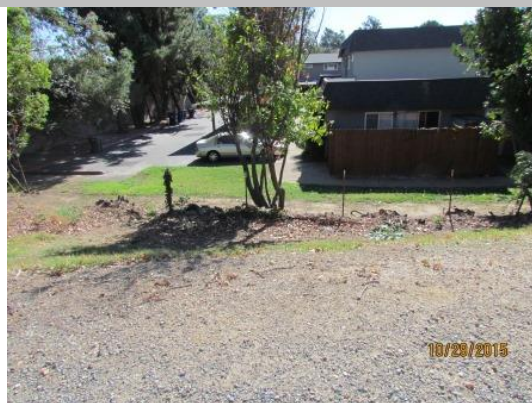
Photo 1 of 1 : FA\_2018\_NA0001\_55\_230\_20180911\_00189.jpg

View of the multiple tree stumps at the landside levee toe.

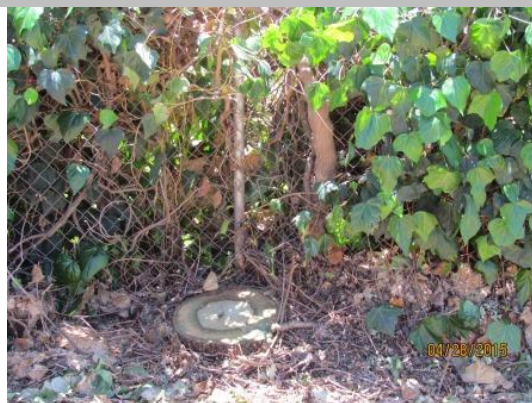
Photo 1 of 1 : FA\_2018\_NA0001\_55\_234\_20180911\_00190.jpg

View of the tree stump at the landside levee toe.

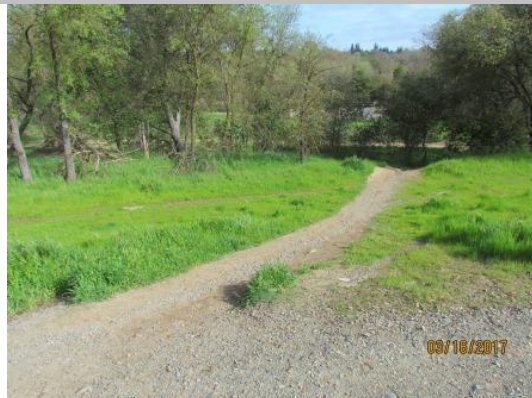
Photo 1 of 1 : FA\_2018\_NA0001\_55\_219\_20180911\_00181.jpg

View of the footpath on the levee slope.

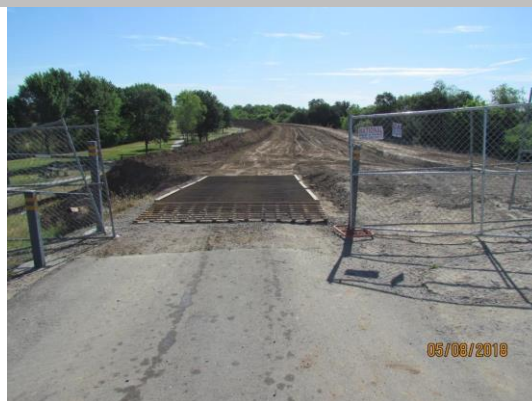
Photo 1 of 1 : FA\_2018\_NA0001\_58\_32\_20180911\_00028.jpg

View looking upstream from Norwood Ave. This Unit is under construction and not accessible. All the issues for Unit 7 will have to be reassessed when construction is complete and turn back over to ARFCD to maintain. Spring 2018.

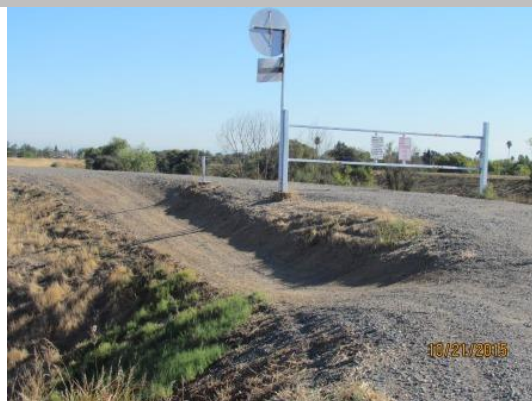
Photo 1 of 1 : FA\_2018\_NA0001\_58\_38\_20180911\_00031.jpg

View of the landside levee slope damaged by motorized traffic.

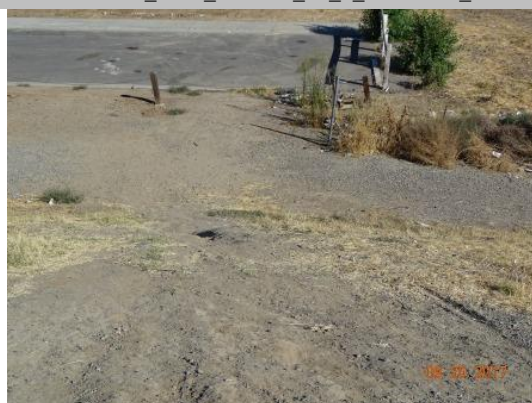
Photo 1 of 1 : FA\_2018\_NA0001\_58\_5\_20180911\_00004.jpg

View of the damaged levee slope.

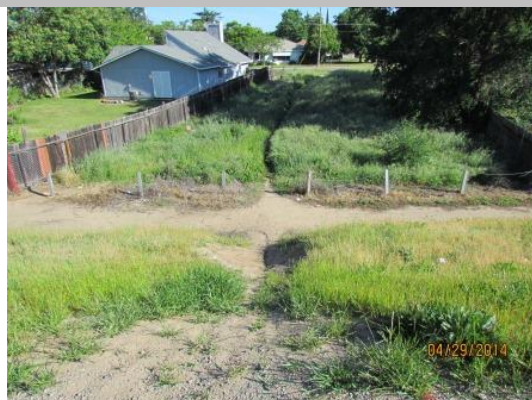
Photo 1 of 1 : FA\_2018\_NA0001\_58\_34\_20180911\_00029.jpg

View of the landside levee slope damaged by foot traffic.

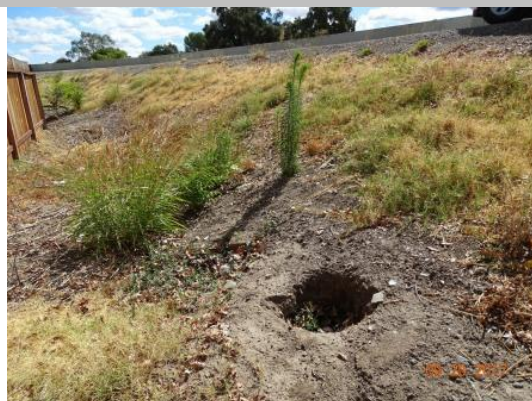
Photo 1 of 1 : FA\_2018\_NA0001\_58\_18\_20180911\_00017.jpg

View of the rodent hole that needs to be backfilled.

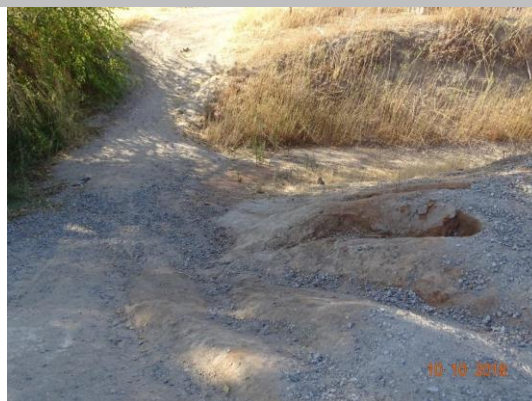
Photo 1 of 1 : FA\_2018\_NA0001\_59\_14\_20181011\_00018.jpg

View of slope damage near gate on an oversized section of levee. Fall 2018

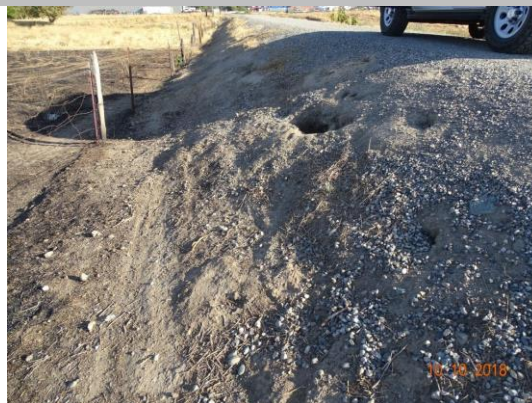
Photo 1 of 1 : FA\_2018\_NA0001\_59\_11\_20181011\_00015.jpg

View of animal holes on levee slope. Fall 2018

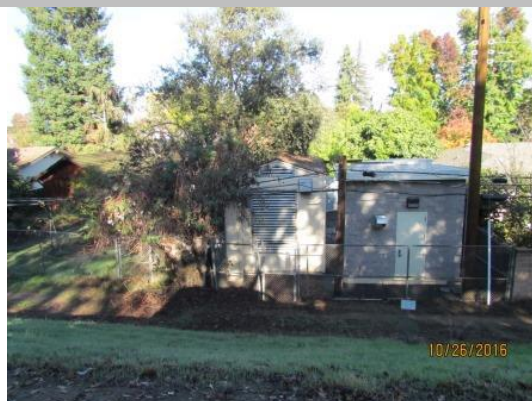
Photo 1 of 1 : FA\_2018\_NA0001\_60\_14\_20180911\_00005.jpg

View of tree trunk at fence line.

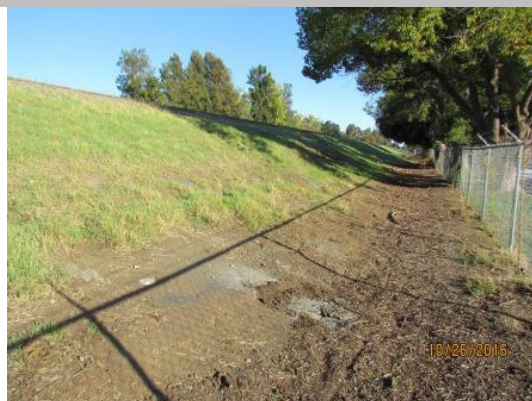
Photo 1 of 2 : FA\_2018\_NA0001\_60\_27\_20180911\_00008.jpg

View of the rodent holes on the landside levee slope.

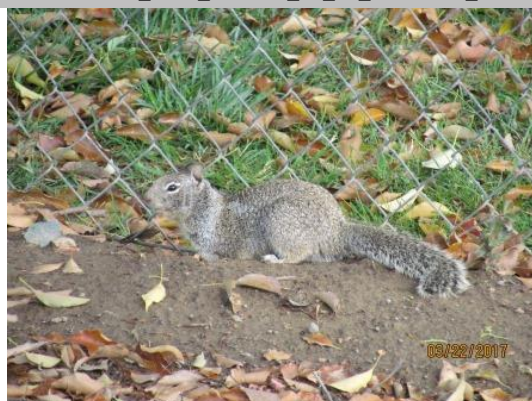
Photo 2 of 2 : FA\_2018\_NA0001\_60\_27\_20180911\_00009.jpg

View of the rodent at the levee toe causing levee damage.

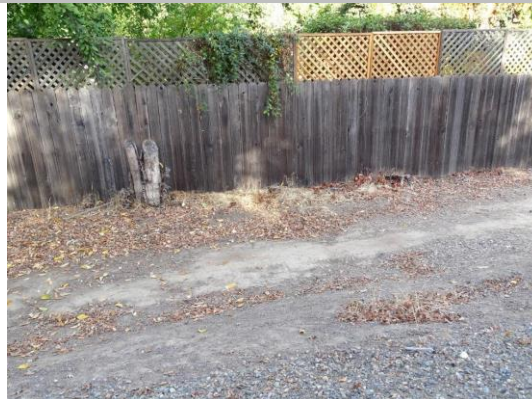
Photo 1 of 1 : FA\_2018\_NA0001\_61\_26\_20181029\_00048.jpg

View of tree stumps on levee easement. Fall 2018

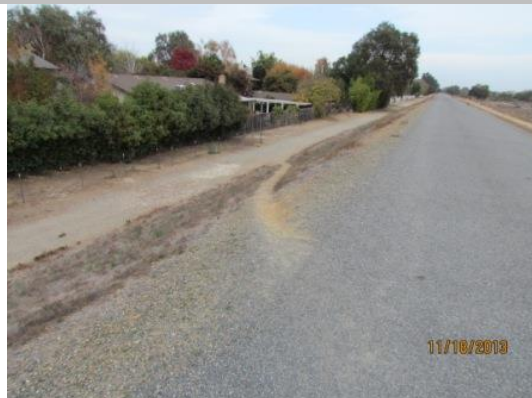
Photo 1 of 1 : FA\_2018\_NA0001\_61\_7\_20180911\_00002.jpg

View of the pathway on the landside levee slope.

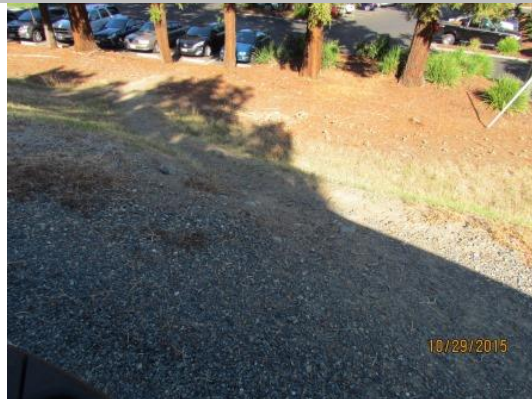
Photo 1 of 1 : FA\_2018\_NA0001\_61\_21\_20180911\_00004.jpg

View of the footpath on the landside levee slope.

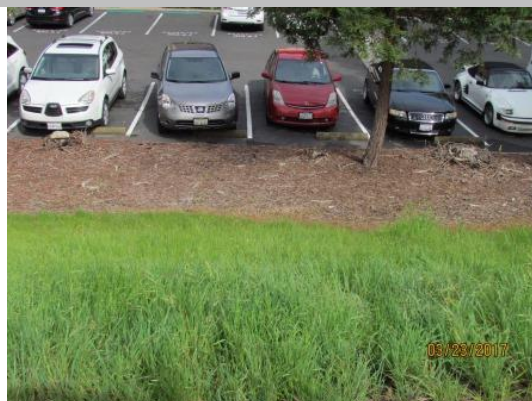
Photo 1 of 1 : FA\_2018\_NA0001\_61\_29\_20180911\_00007.jpg

View of the tree stumps within the levee easement.

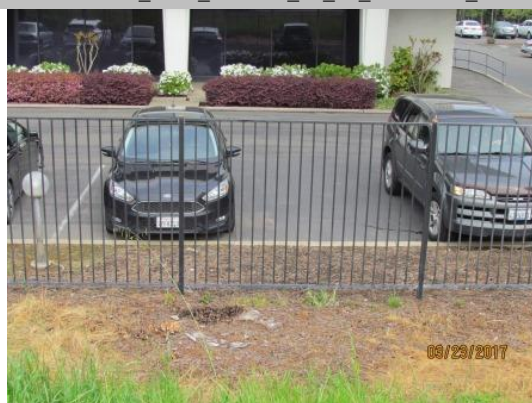
Photo 1 of 1 : FA\_2018\_NA0001\_61\_28\_20180911\_00006.jpg

View of the tree stump at the levee toe.

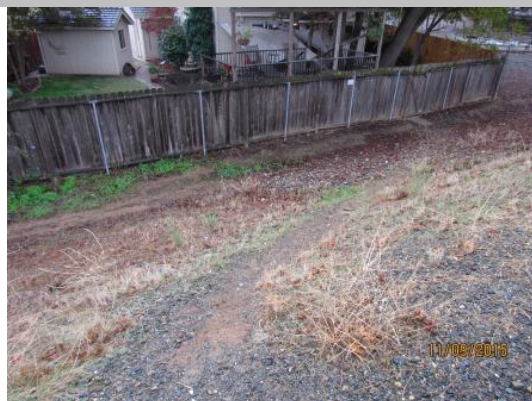
Photo 1 of 1 : FA\_2018\_NA0001\_438\_3\_20180911\_00002.jpg

View of the footpath on the landside levee slope.
