**Flood Control Project Maintenance
Levee Inspections**

Maintenance Issue Types Only, Levee Inspection Report By Mile - Fall 2019

American River Flood Control District

Waterway	Bank	Unit Miles	Inspection Start/End	Inspector
Unit No. 01 Arcade Creek	Left	2.08	11/05/2019 11/05/2019	Luz Dial

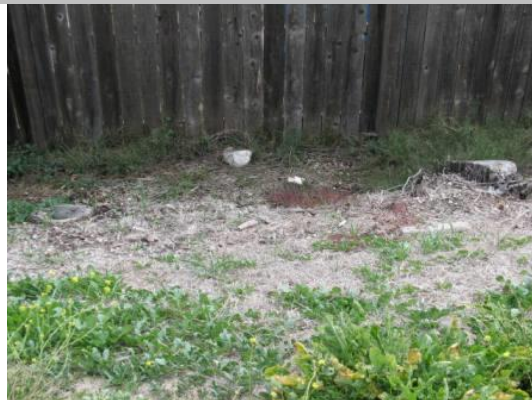
Photo 1 of 1 : FA_2019_NA0001_51_178_20190904_00055.jpg

11/17/2011 Two stumps at levee toe.

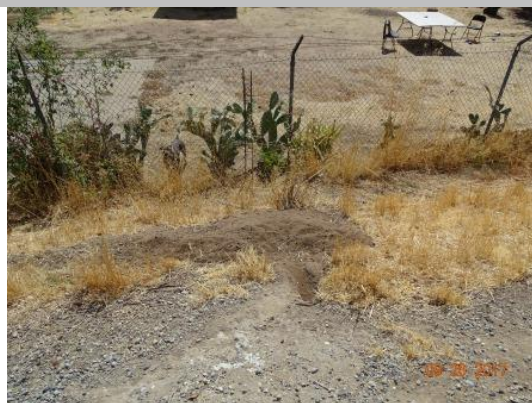
Photo 1 of 1 : FA_2019_NA0001_51_11_20190904_00010.jpg

View of the rodent activity on the levee slope.

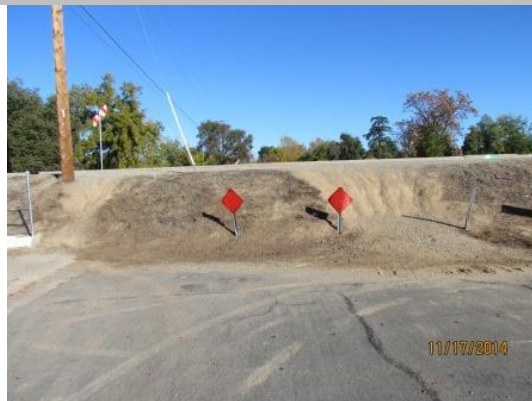
Photo 1 of 1 : FA_2019_NA0001_51_54_20190904_00034.jpg

LM Start	1.58	Rating **	A/W	Issue No.	54
LM End	1.58	Issue Type +	Ma	Location *	LS
Category	Earthen Levee			GPS Latitude/Longitude	
				Start	End
Item	Slope Stability			38.627251 °	38.627251 °
				-121.441460 °	-121.441460 °
DWR ID	DWR_NA0001_01_s_2012_54				
Comment Code					
S2 : Repair the levee slope damaged by foot traffic and prevent access where possible.					
Inspector Comment

Slope stability due to foot traffic needs to be monitored. Fall 2014

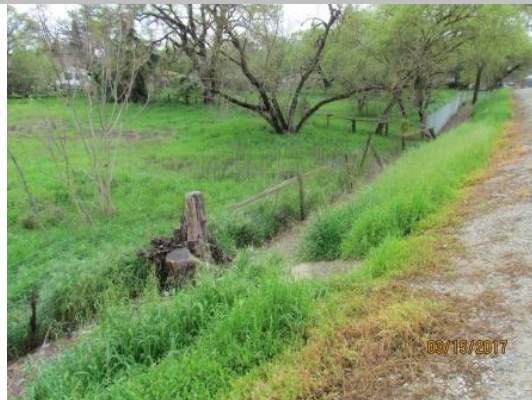
Photo 1 of 1 : FA_2019_NA0001_51_74_20190904_00046.jpg

View of the tree stump at the levee toe.

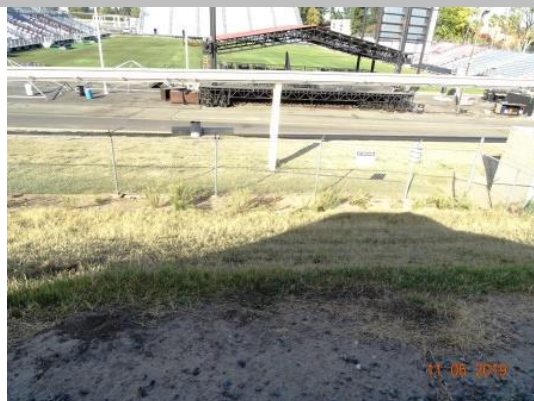
Photo 1 of 1 : FA_2019_NA0001_490_16_20191119_00030.jpg

View of animal holes on the landside shoulder and slope. Fall 2019

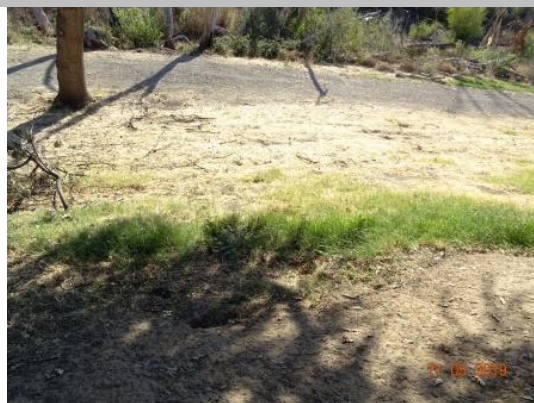
Photo 1 of 1 : FA_2019_NA0001_490_14_20191119_00031.jpg

LM Start	1.25	Rating **	M	Issue No.	14
LM End	1.25	Issue Type +	Ma	Location *	WS
Category	Earthen Levee			GPS Latitude/Longitude	
				Start	End
Item	Animal Control			38.590532 °	38.590532 °
				-121.440153 °	-121.440153 °
DWR ID	DWR_NA0001_03_f_2019_14				
Comment Code					
A3 : No rodents visible, but rodent burrows visible; need to backfill and compact or grout burrows.					
Inspector Comment					
Backfill rodent holes on the slope.

View of an animal hole on the levee slope. Fall 2019

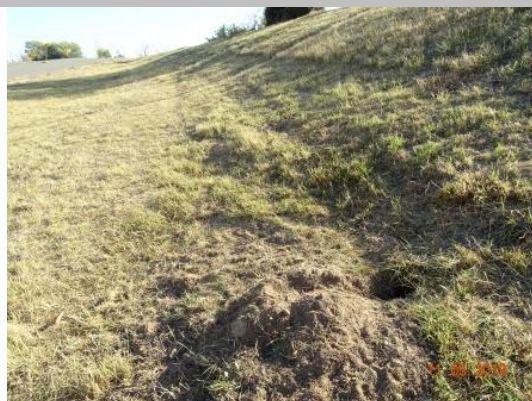
Photo 1 of 1 : FA_2019_NA0001_490_15_20191119_00032.jpg

View of animal holes on the landside slope. Fall 2019

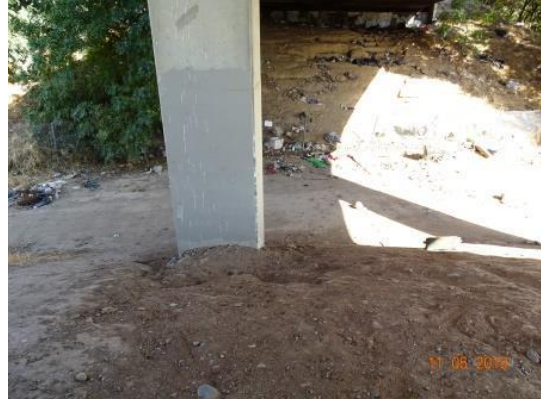
Photo 1 of 1 : FA_2019_NA0001_490_10_20191119_00033.jpg

View of footpaths around column for the overpass. Fall 2019

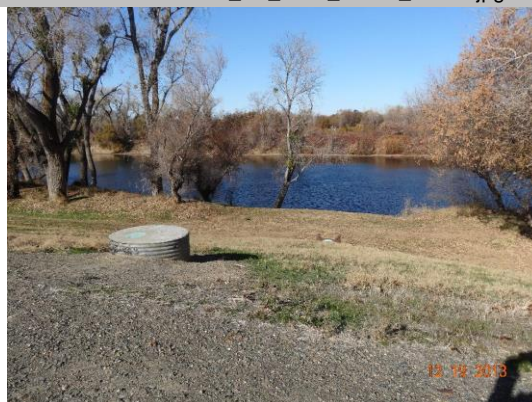
Photo 3 of 3 : UCIP_FA_2019_31249_57210.jpg

View of waterward side--standpipe located on waterward slope.
Standpipe filled with concrete.

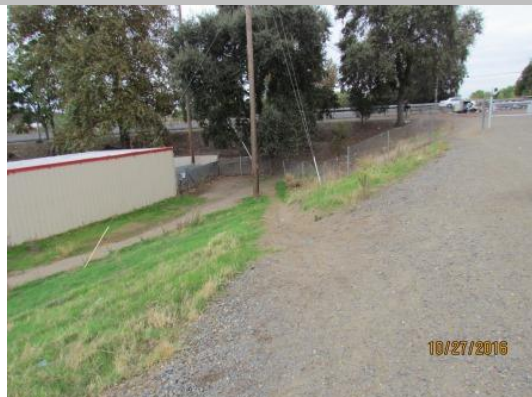
Photo 1 of 1 : FA_2019_NA0001_55_244_20190904_00185.jpg

View of the footpath on the landside levee slope. Fall 2016

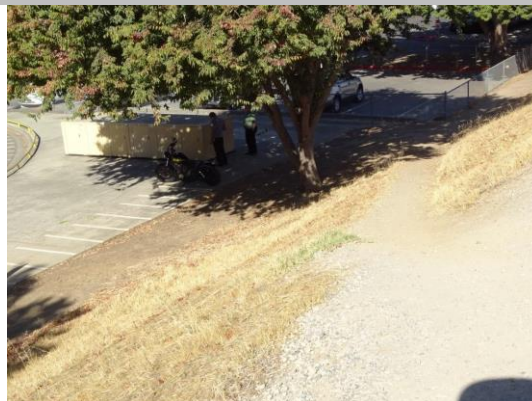
Photo 1 of 1 : FA_2019_NA0001_55_270_20190904_00200.jpg

View of footpath on slope. Fall 2018

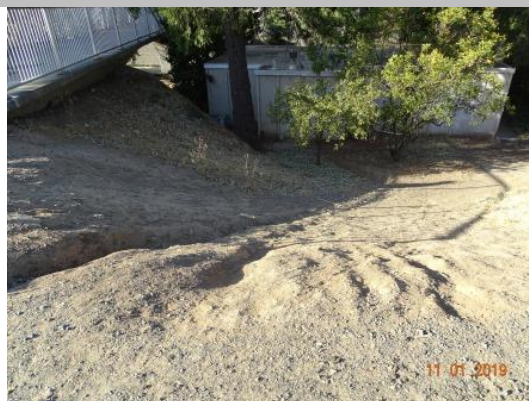
Photo 1 of 1 : FA_2019_NA0001_55_287_20191118_00287.jpg

View of erosion rills downstream of the Guy West Bridge. Fall 2019

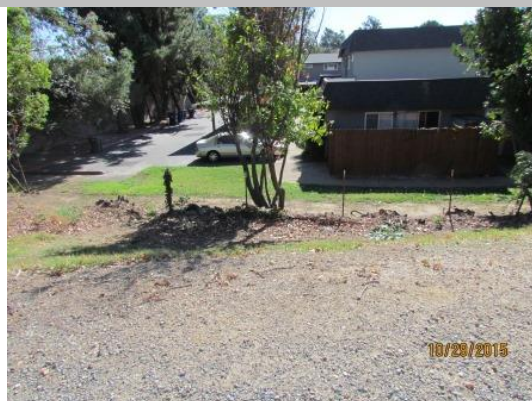
Photo 1 of 1 : FA_2019_NA0001_55_230_20190904_00179.jpg

View of the multiple tree stumps at the landside levee toe.

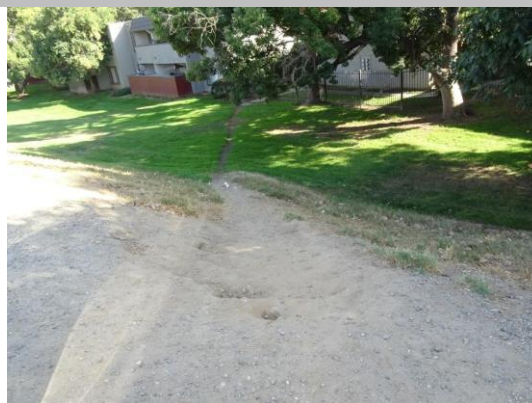
Photo 1 of 1 : FA_2019_NA0001_55_252_20190904_00190.jpg

View of footpath on levee toe. Fall 2018

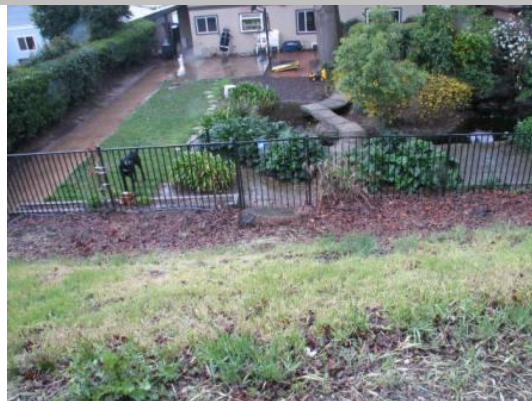
Photo 1 of 1 : FA_2019_NA0001_55_123_20190904_00105.jpg

03/16/2012 Large tree stump at levee toe.

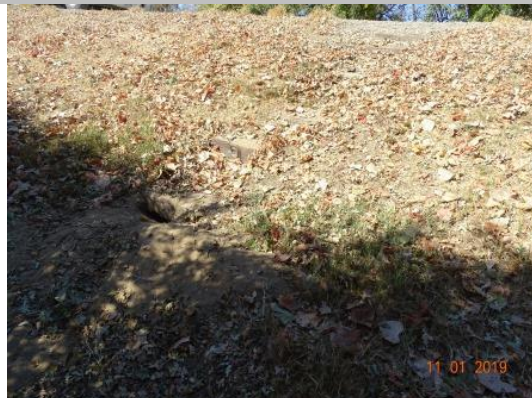
Photo 1 of 1 : FA_2019_NA0001_55_268_20191118_00294.jpg

View of a rodent hole underneath the wooden stairs. Fall 2019

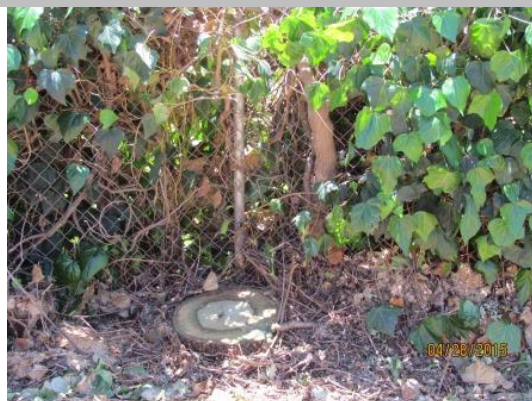
Photo 1 of 1 : FA_2019_NA0001_55_234_20190904_00180.jpg

LM Start	9.72	Rating **	N	Issue No.	234
LM End	9.72	Issue Type +	Ma	Location *	LS
Category	Earthen Levee			GPS Latitude/Longitude	
				Start	End
Item	Trim / Thin Trees			38.567761 °	38.567761 °
				-121.367363 °	-121.367363 °
DWR ID	DWR_NA0001_04_s_2015_234				
Comment Code					
T5 : Tree stumps.					
Inspector Comment

View of the tree stump at the landside levee toe.

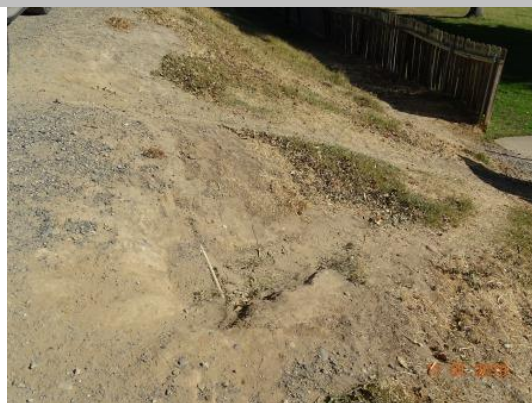
Photo 1 of 2 : FA_2019_NA0001_55_228_20191118_00295.jpg

View of erosion along a footpath. Fall 2019

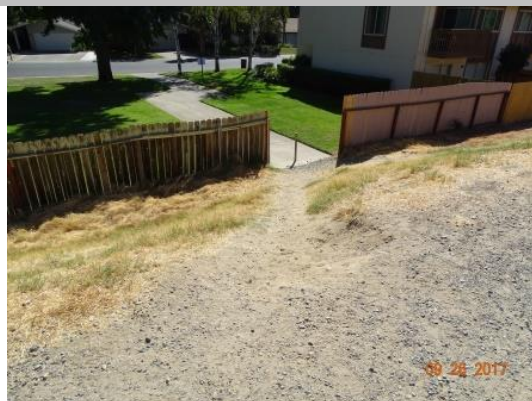
Photo 2 of 2 : FA_2019_NA0001_55_228_20190904_00177.jpg

View of the footpath on the levee slope.

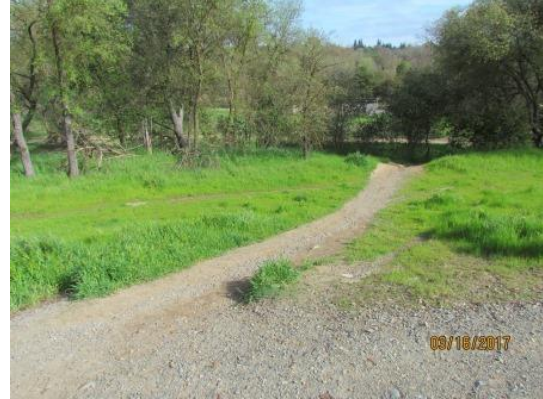
Photo 1 of 1 : FA_2019_NA0001_55_219_20190904_00172.jpg

View of the footpath on the levee slope.

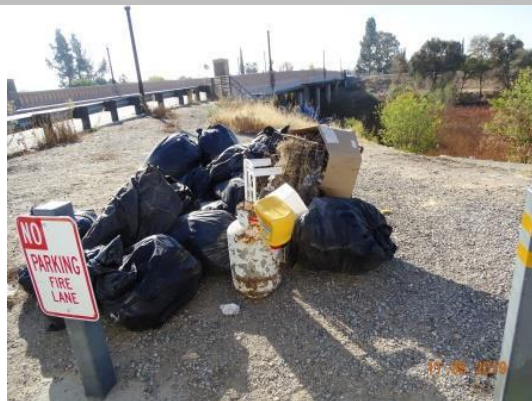
Photo 1 of 1 : FA_2019_NA0001_58_38_20191106_00063.jpg

View of garbage bags located on the levee shoulder. Fall 2019

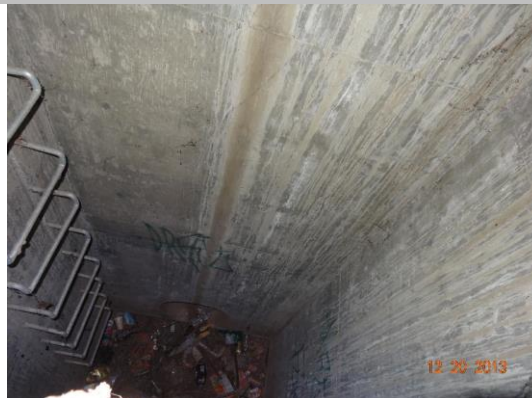
Photo 3 of 3 : UCIP_FA_2019_29326_54320.jpg

Inside view of concrete riser located on waterward shoulder--debris found at the bottom of riser.

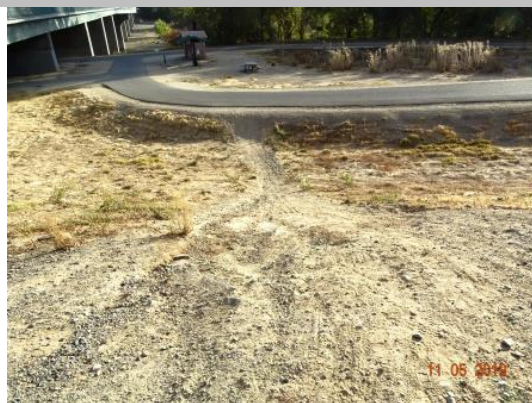
Photo 1 of 1 : FA_2019_NA0001_60_20_20191119_00044.jpg

View of footpath on the waterside slope. Fall 2019

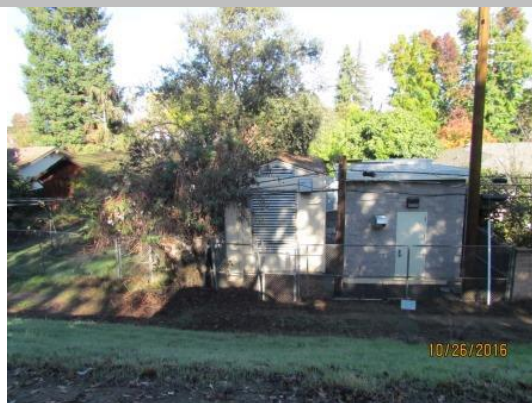
Photo 1 of 1 : FA_2019_NA0001_60_14_20190904_00005.jpg

View of tree trunk at fence line. Fall 2016

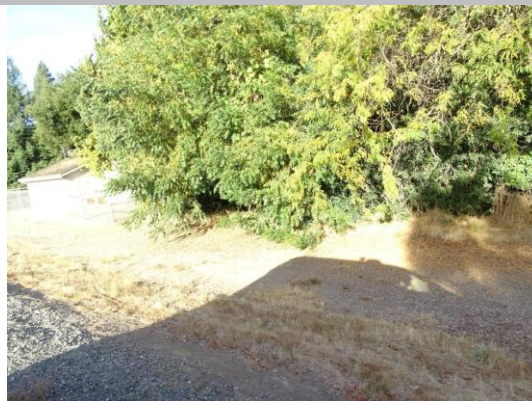
Photo 1 of 1 : FA_2019_NA0001_61_25_20190904_00007.jpg

View of vegetation at landside toe. Fall 2018

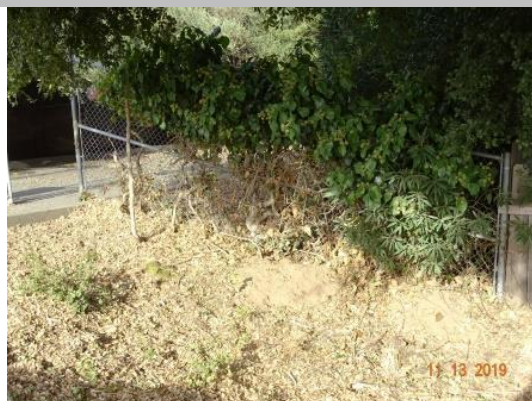
Photo 1 of 1 : FA_2019_NA0001_61_30_20191119_00034.jpg

View of animal hole at the edge of the levee toe easement. Fall 2019

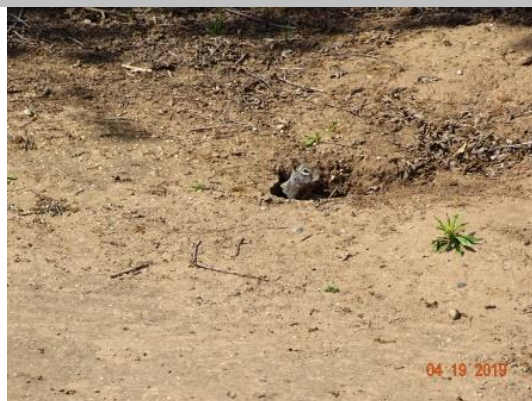
Photo 1 of 2 : FA_2019_NA0001_61_36_20190904_00011.jpg

View of squirrel hole with activity along toe road. Spring 2019

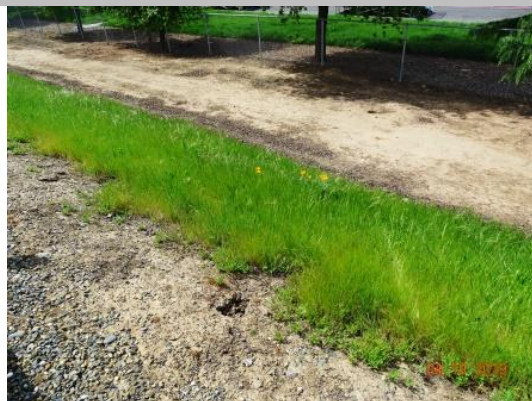
Photo 2 of 2 : FA_2019_NA0001_61_36_20190904_00012.jpg

View of animal holes on levee slope and toe road. Spring 2019

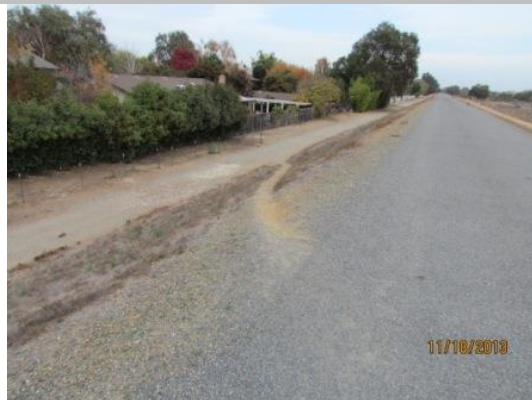
Photo 1 of 1 : FA_2019_NA0001_61_7_20190904_00002.jpg

View of the pathway on the landside levee slope. Fall 2013

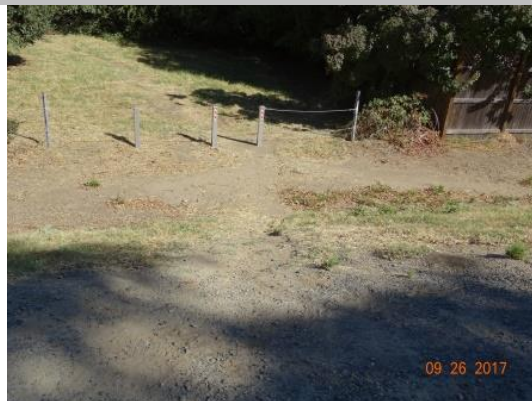
Photo 1 of 1 : FA_2019_NA0001_61_2_20190904_00001.jpg

View of the footpath on the levee slope. Fall 2017

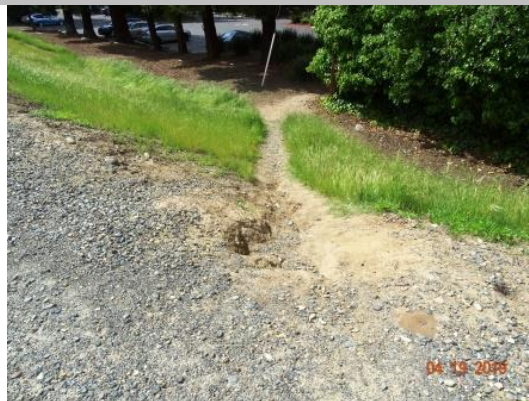
Photo 1 of 1 : FA_2019_NA0001_61_19_20190904_00004.jpg

View of footpath on landside slope. Spring 2019

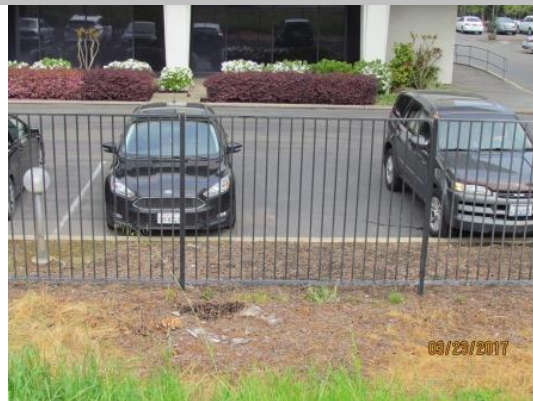
Photo 1 of 1 : FA_2019_NA0001_61_28_20190904_00009.jpg

View of the tree stump at the levee toe. Spring 2017
