**Flood Control Project Maintenance  
Levee Inspections**

**Maintenance Issue Types Only, Levee Inspection Report By Mile - Fall 2020**

**American River Flood Control District**

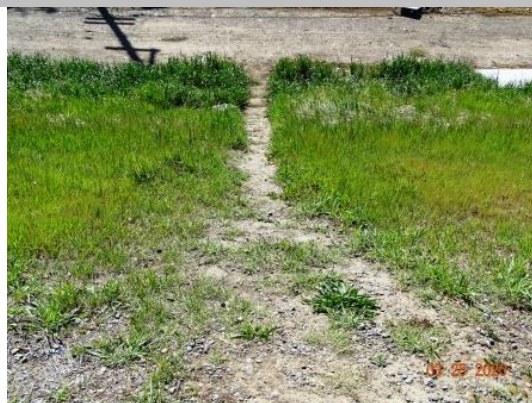
Photo 1 of 1 : FA\_2020\_NA0001\_51\_48\_20200902\_00028.jpg

LM Start	0.48	Rating **	M	Issue No.	48
LM End	0.48	Issue Type +	Ma	Location *	LS
Category	Earthen Levee			GPS Latitude/Longitude	
				Start	End
Item	Slope Stability			38.623177 °	38.623177 °
				-121.460360 °	-121.460360 °
DWR ID	DWR_NA0001_01_s_2020_48				
Comment Code					
S2 : Repair the levee slope damaged by foot traffic and prevent access where possible.					
Inspector Comment					
Steps are cut into the levee.

View of steps dug into the landside levee slope. Spring 2020

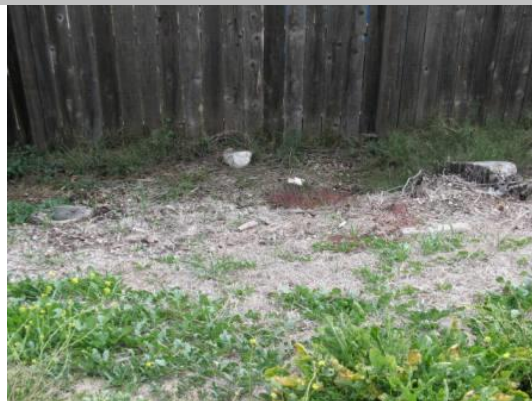
Photo 1 of 1 : FA\_2020\_NA0001\_51\_178\_20200902\_00050.jpg

11/17/2011 Two stumps at levee toe.

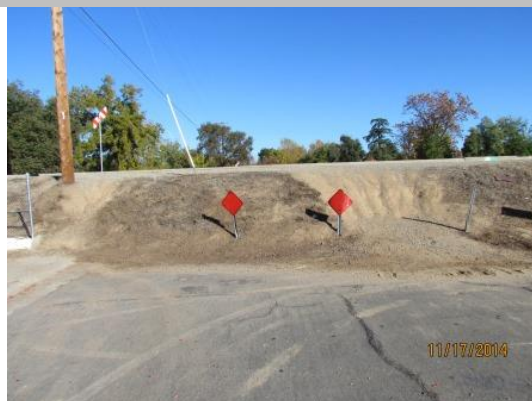
Photo 1 of 1 : FA\_2020\_NA0001\_51\_54\_20200902\_00032.jpg

LM Start	1.58	Rating **	A/W	Issue No.	54
LM End	1.58	Issue Type +	Ma	Location *	LS
Category	Earthen Levee			GPS Latitude/Longitude	
				Start	End
Item	Slope Stability			38.627251 °	38.627251 °
				-121.441460 °	-121.441460 °
DWR ID	DWR_NA0001_01_s_2012_54				
Comment Code					
S2 : Repair the levee slope damaged by foot traffic and prevent access where possible.					
Inspector Comment

Slope stability due to foot traffic needs to be monitored. Fall 2014

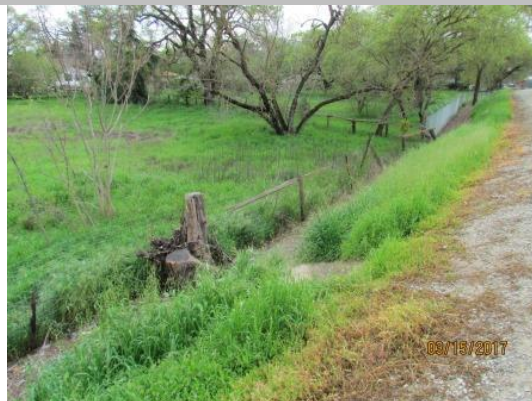
Photo 1 of 1 : FA\_2020\_NA0001\_51\_74\_20200902\_00042.jpg

LM Start	1.69	Rating **	N	Issue No.	74
LM End	1.69	Issue Type +	Ma	Location *	LS
Category	Earthen Levee			GPS Latitude/Longitude	
				Start	End
Item	Trim / Thin Trees			38.627607 °	38.627607 °
				-121.439545 °	-121.439545 °
DWR ID	DWR_NA0001_01_s_2017_74				
Comment Code					
T5 : Tree stumps.					
Inspector Comment					
There is a 24-inch large tree stump at the levee toe.

View of the tree stump at the levee toe.

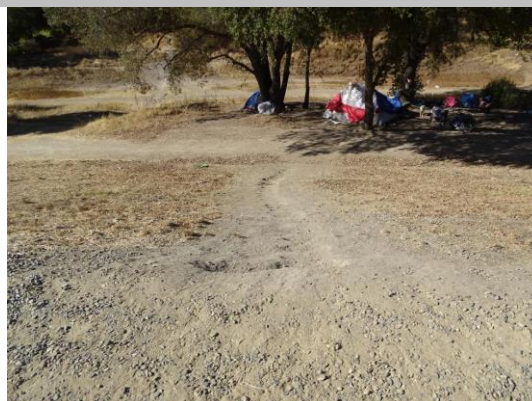
Photo 1 of 1 : FA\_2020\_NA0001\_52\_39\_20200902\_00009.jpg

LM Start	0.17	Rating **	A/W	Issue No.	39
LM End	0.17	Issue Type +	Ma	Location *	WS
Category	Earthen Levee			GPS Latitude/Longitude	
				Start	End
Item	Slope Stability			38.604455 °	38.604455 °
				-121.470417 °	-121.470417 °
DWR ID	DWR_NA0001_02_f_2018_39				
Comment Code					
S2 : Repair the levee slope damaged by foot traffic and prevent access where possible.					
Inspector Comment					
Monitor the footpath on the waterside slope.

View of stair steps dug into levee slope. Fall 2018

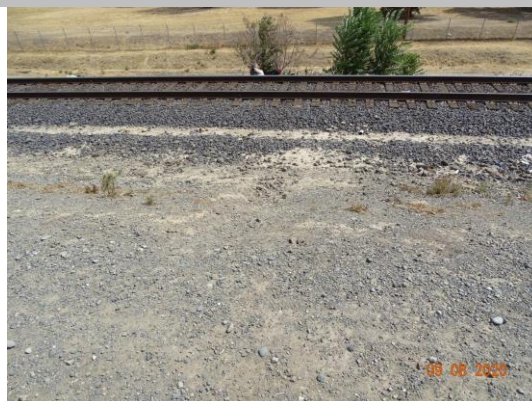
Photo 1 of 1 : FA\_2020\_NA0001\_52\_17\_20200914\_00065.jpg

LM Start	<b>0.92</b>	Rating **	M	Issue No.	<b>17</b>
LM End	<b>0.92</b>	Issue Type +	Ma	Location *	LS
Category	Earthen Levee		GPS Latitude/Longitude		
			Start	End	
Item	Slope Stability		38.614215 °	38.614215 °	
			-121.466682 °	-121.466682 °	
DWR ID	DWR_NA0001_02_s_2020_17				
Comment Code					
S2 : Repair the levee slope damaged by foot traffic and prevent access where possible.					
Inspector Comment

View of footpath on the landside slope. Fall 2020

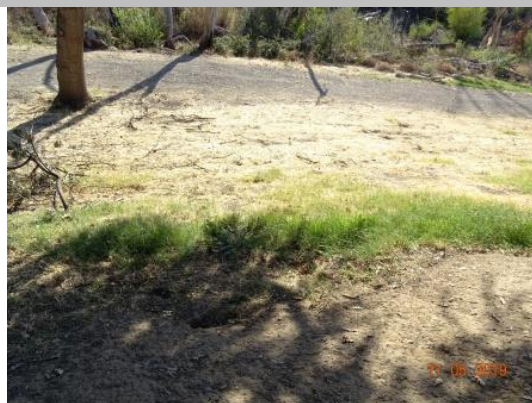
Photo 1 of 1 : FA\_2020\_NA0001\_490\_14\_20200902\_00002.jpg

View of an animal hole on the levee slope. Fall 2019

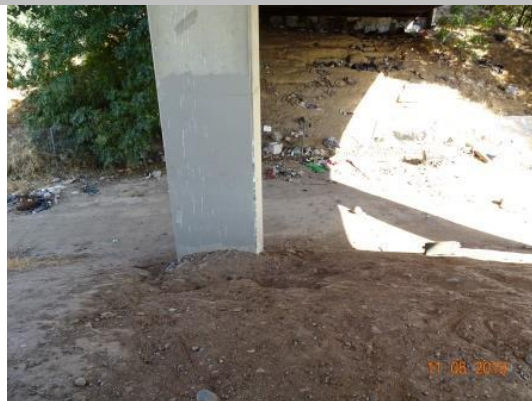
Photo 1 of 1 : FA\_2020\_NA0001\_490\_10\_20200902\_00001.jpg

LM Start	<b>3.17</b>	Rating **	A/W	Issue No.	<b>10</b>
LM End	<b>3.17</b>	Issue Type +	Ma	Location *	LS
Category	Earthen Levee		GPS Latitude/Longitude		
			Start	End	
Item	Slope Stability		38.599172 °	38.599172 °	
			-121.470252 °	-121.470252 °	
DWR ID	DWR_NA0001_03_f_2019_10				
Comment Code					
S2 : Repair the levee slope damaged by foot traffic and prevent access where possible.					
Inspector Comment

View of footpaths around column for the overpass. Fall 2019

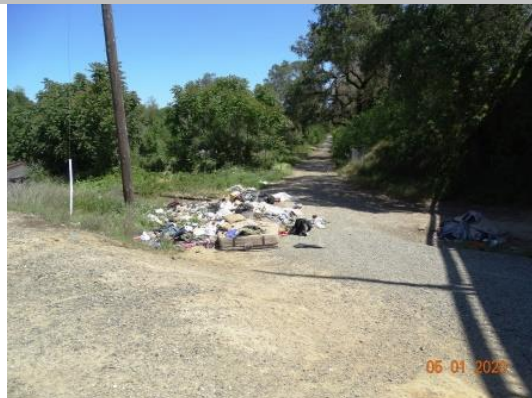
Photo 1 of 1 : FA\_2020\_NA0001\_490\_26\_20200902\_00006.jpg

View of debris on the landside toe. Spring 2020

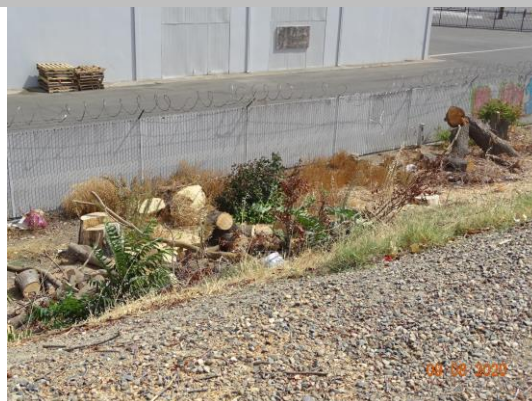
Photo 1 of 1 : FA\_2020\_NA0001\_490\_44\_20200914\_00091.jpg

LM Start	3.38	Rating **	M	Issue No.	44
LM End	3.38	Issue Type +	Ma	Location *	LS
Category	Earthen Levee			GPS Latitude/Longitude	
				Start	End
Item	Encroachments			38.601767 °	38.601767 °
				-121.472215 °	-121.472215 °
DWR ID	DWR_NA0001_03_f_2020_44				
Comment Code					
TR : Tree or limb					
Inspector Comment					
Remove cut tree logs along the landside toe.

View of tree logs at the landside toe. Fall 2020

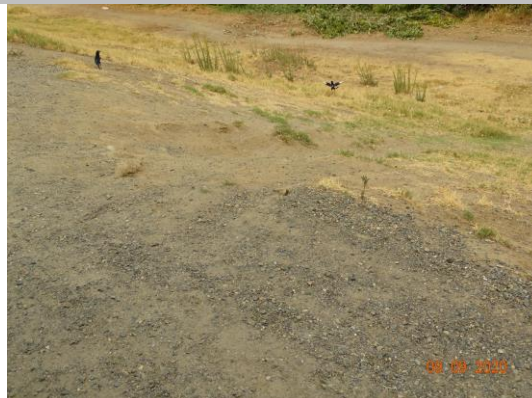
Photo 1 of 1 : FA\_2020\_NA0001\_55\_231\_20200915\_00436.jpg

LM Start	0.02	Rating **	M	Issue No.	231
LM End	0.02	Issue Type +	Ma	Location *	WS
Category	Earthen Levee			GPS Latitude/Longitude	
				Start	End
Item	Slope Stability			38.596780 °	38.596780 °
				-121.506817 °	-121.506817 °
DWR ID	DWR_NA0001_04_f_2019_231				
Comment Code					
S2 : Repair the levee slope damaged by foot traffic and prevent access where possible.					
Inspector Comment

View of footpath on the waterside slope. Fall 2020

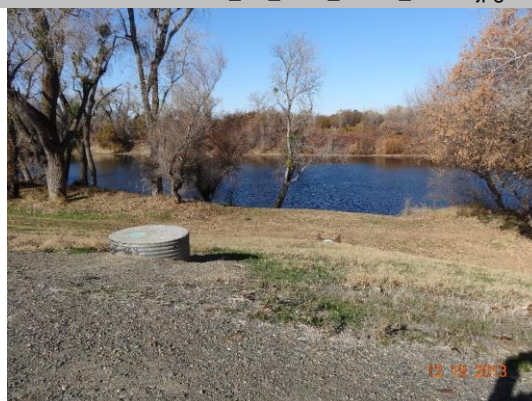
Photo 3 of 3 : UCIP\_FA\_2020\_61222\_57210.jpg

Comment Code						
Inspector Comment						
DS_ID:24303 FS_ID:61222 EP_NO: N/A Repair Type: Non-Urgent EVAL Issue: Geophysical Evaluation (Confirmed) Crossing Status: Found UCIP Comments: 06/25/2020 Crossing evaluated as "Non-Urgent" because pipe was abandoned and there was no permit found authorizing this pipe. Geophysical evaluation found evidence of a pipe at this location. (A. McDonald - DWR UCIP)08/16/2017 DWR Deferred Maintenance Project (DMP), Vince Rodriguez, forwarded email received from Tim Kerr, General Manager of American River Flood Control District (ARFCD) with file "DWR Eligible Pipes Found in ARFCD" from ARFCD that shows the ownership and location of the pipes Tim Kerr investigated. No owner was identified, ARFCD Staff Notes indicate Abandoned (ARFCD/Bill) - No As-builts. (DWR UCIP - O. Magana) 12/19/2013 Non-functional crossing--need additional information about how crossing was abandoned. (DWR UCIP - O. Magana) FIELD_STRUCT_DESC: *ABANDONED* 42-inch corrugated metal drainage pipe through the levee, 16.5 feet below the crown. Gravel filled with both ends welded shut. Flap gate on the waterside (WS) end. Slide gate inside a corrugated metal riser and splash board drain structure on the landside (LS). (No permit has been identified authorizing this structure. No owner has been identified). [Additional Reference(s): DWR Levee Log, 2002 (HLM 0.44). USACE Sacramento O&M Manual Unit 118, Part No. 1, August 1955, (Station 10+00)]. FS Date: 6/25/2020

View of waterward side--standpipe located on waterward slope.  
Standpipe filled with concrete.

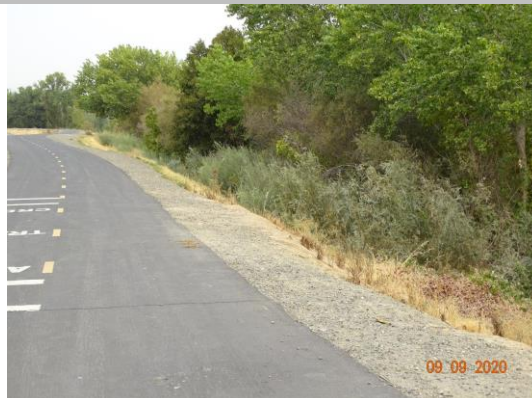
Photo 1 of 1 : FA\_2020\_NA0001\_55\_352\_20200915\_00440.jpg

View of vegetation on the waterside slope. Fall 2020

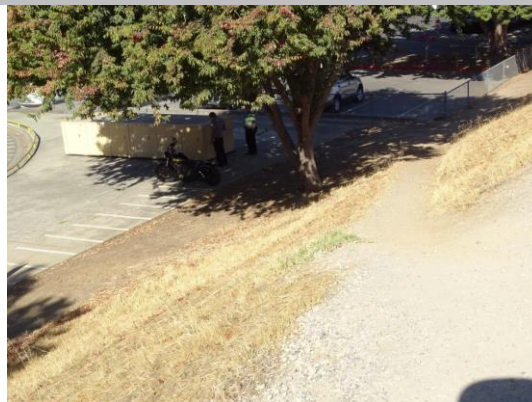
Photo 1 of 1 : FA\_2020\_NA0001\_55\_270\_20200902\_00204.jpg

View of footpath on slope. Fall 2018

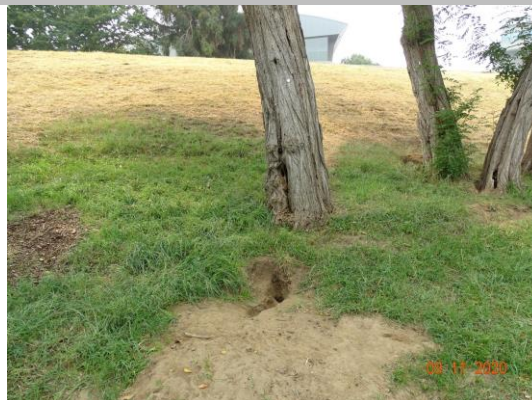
Photo 1 of 1 : FA\_2020\_NA0001\_55\_383\_20200915\_00450.jpg

View of animal holes on the waterside slope. Fall 2020

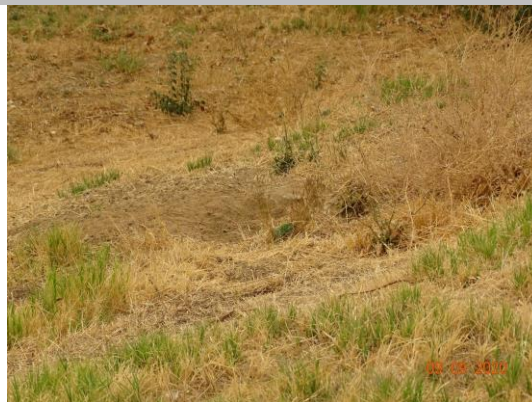
Photo 1 of 1 : FA\_2020\_NA0001\_55\_368\_20200915\_00451.jpg

View of large animal hole on the landside slope within the City Fairbairn Plant. Fall 2020

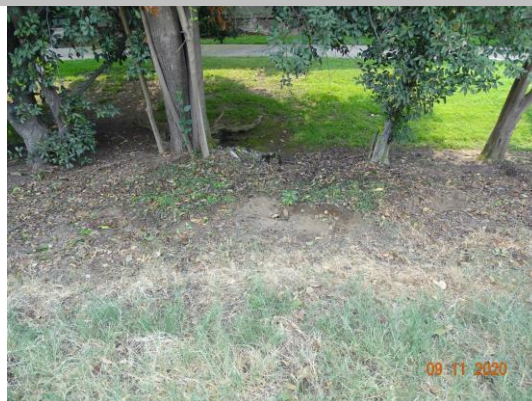
Photo 1 of 1 : FA\_2020\_NA0001\_55\_379\_20200915\_00452.jpg

View of large animal hole at the landside toe. Fall 2020

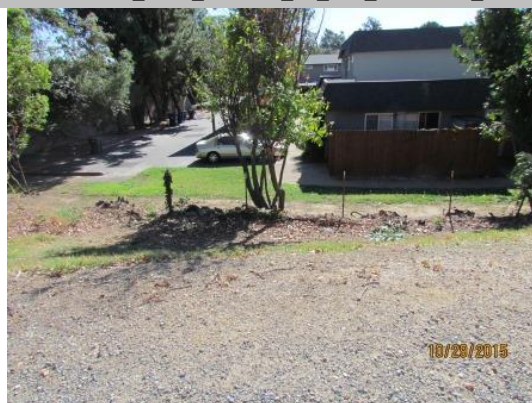
Photo 1 of 1 : FA\_2020\_NA0001\_55\_230\_20200902\_00184.jpg

LM Start	8.83	Rating **	N	Issue No.	230	
LM End	8.83	Issue Type +	Ma	Location *	LS	
Category	Earthen Levee			GPS Latitude/Longitude		
				Start		End
Item	Trim / Thin Trees			38.564929 °		38.564929 °
				-121.383248 °		-121.383248 °
DWR ID	DWR_NA0001_04_f_2015_230					
Comment Code						
T5 : Tree stumps.						
Inspector Comment						
There are five shrub stumps with multiple branches at this location.

View of the multiple tree stumps at the landside levee toe.

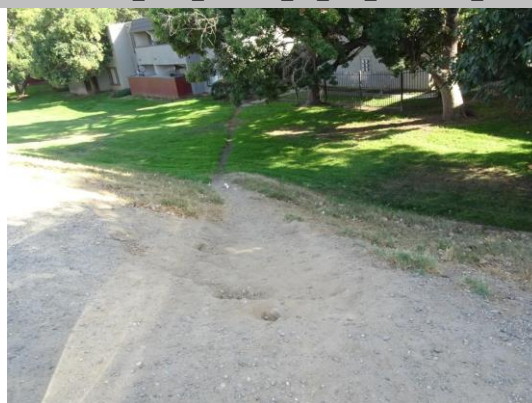
Photo 1 of 1 : FA\_2020\_NA0001\_55\_252\_20200902\_00193.jpg

LM Start	8.95	Rating **	A/W	Issue No.	252
LM End	8.95	Issue Type +	Ma	Location *	LS
Category	Earthen Levee			GPS Latitude/Longitude	
				Start	End
Item	Slope Stability			38.565696 °	38.565696 °
				-121.381141 °	-121.381141 °
DWR ID	DWR_NA0001_04_f_2018_252				
Comment Code					
S2 : Repair the levee slope damaged by foot traffic and prevent access where possible.					
Inspector Comment					
Monitor slope damage from foot traffic.

View of footpath on levee toe. Fall 2018

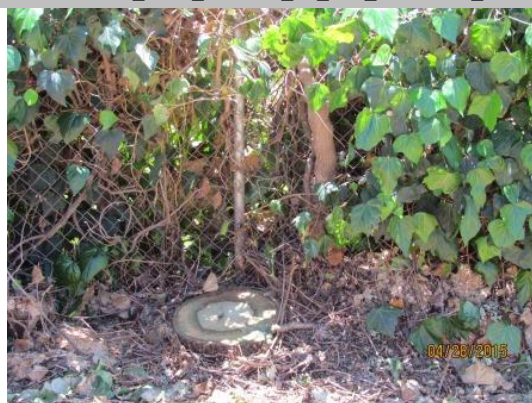
Photo 1 of 1 : FA\_2020\_NA0001\_55\_234\_20200902\_00185.jpg

View of the tree stump at the landside levee toe.

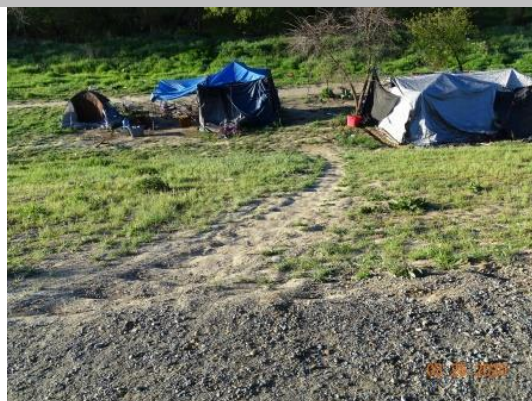
Photo 1 of 1 : FA\_2020\_NA0001\_58\_46\_20200902\_00032.jpg

View of steps dug into the waterside slope. Spring 2020

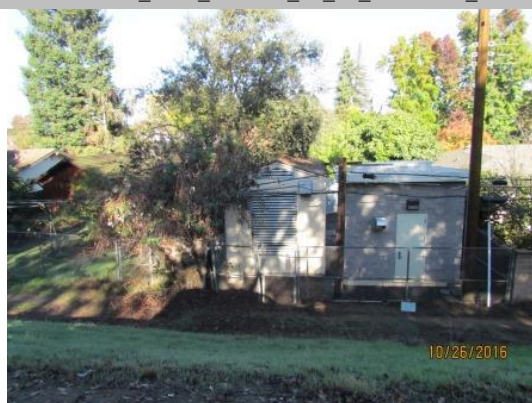
Photo 1 of 1 : FA\_2020\_NA0001\_60\_14\_20200902\_00003.jpg

View of tree trunk at fence line. Fall 2016

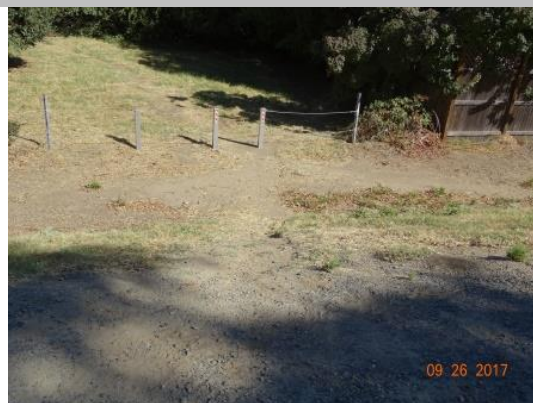
Photo 1 of 1 : FA\_2020\_NA0001\_61\_2\_20200902\_00001.jpg

View of the footpath on the levee slope. Fall 2017

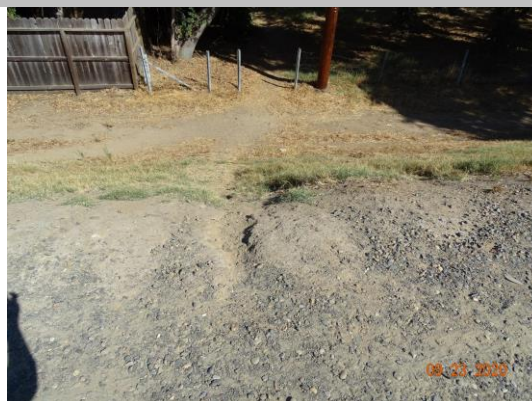
Photo 1 of 1 : FA\_2020\_NA0001\_61\_23\_20200924\_00081.jpg

View of erosion rills on the landside slope. Fall 2020

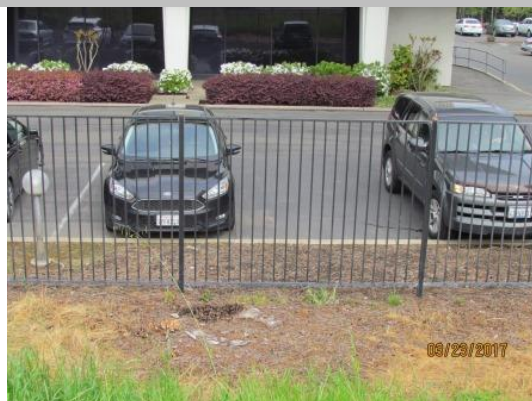
Photo 1 of 1 : FA\_2020\_NA0001\_61\_28\_20200902\_00008.jpg

View of the tree stump at the levee toe. Spring 2017

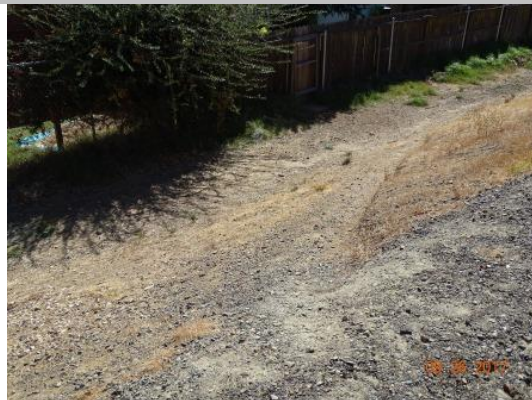
Photo 1 of 1 : FA\_2020\_NA0001\_438\_8\_20200902\_00002.jpg

View of the footpath on the levee slope.

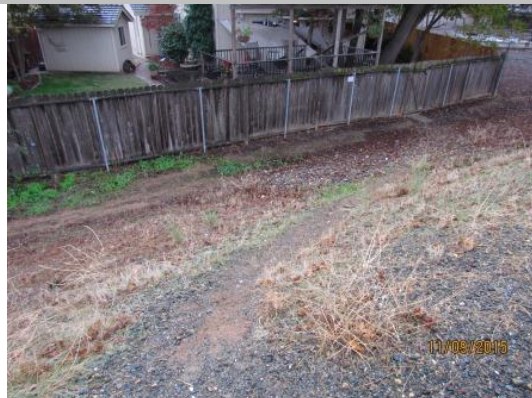
Photo 1 of 1 : FA\_2020\_NA0001\_438\_3\_20200902\_00001.jpg

View of the footpath on the landside levee slope.
