**Flood Control Project Maintenance  
Levee Inspections**

## Maintenance Issue Types Only, Levee Inspection Report By Mile - Fall 2021

### American River Flood Control District

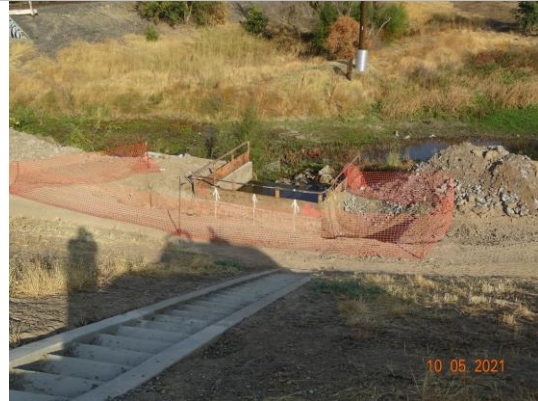
Photo 1 of 1 : FA\_2021\_NA0001\_51\_99\_20211007\_00128.jpg

Construction on the WS outfall. Fall 2021

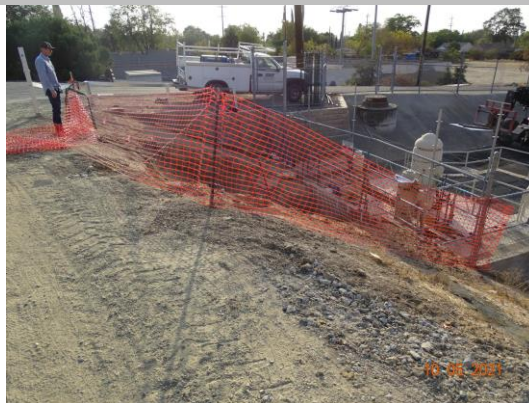
Photo 1 of 1 : FA\_2021\_NA0001\_51\_95\_20211007\_00141.jpg

Construction on the LS slope for outfall pipe repair. Fall 2021

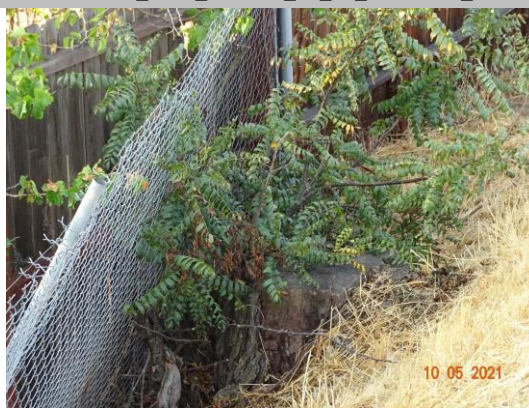
Photo 1 of 1 : FA\_2021\_NA0001\_51\_94\_20211007\_00144.jpg

Stump on the LS toe. Fall 2021

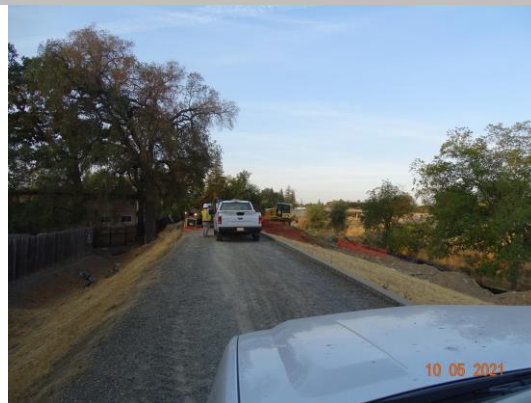
Photo 1 of 1 : FA\_2021\_NA0001\_51\_93\_20211007\_00151.jpg

| Permit 19129 to replace a 24" RCP pipe and outfall. | | | | | |

Construction of new outfall and pipe in the levee. Fall 2021

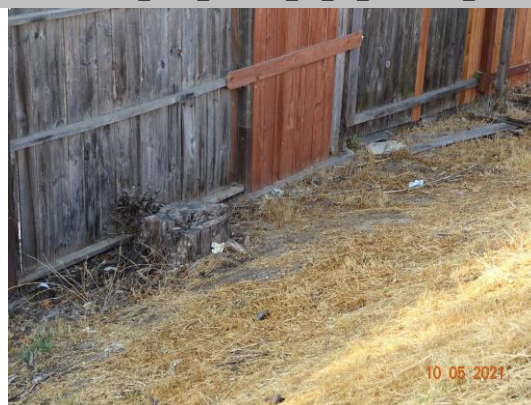
Photo 1 of 1 : FA\_2021\_NA0001\_51\_72\_20211007\_00152.jpg

Stumps on the LS toe. Fall 2021

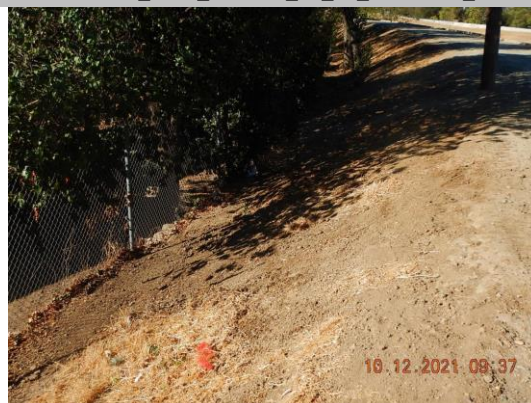
Photo 1 of 1 : FA\_2021\_NA0001\_51\_92\_20211012\_00183.jpg

Repaired burrows on the LS slope. Fall 2021

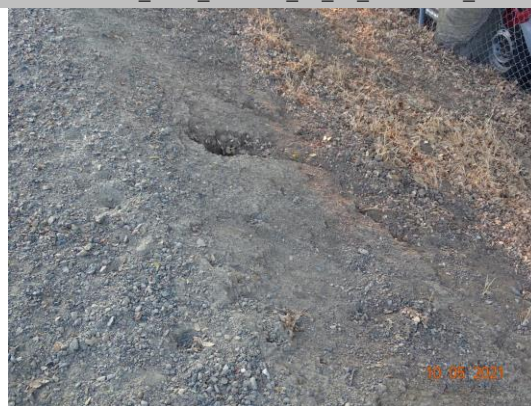
Photo 1 of 1 : FA\_2021\_NA0001\_51\_91\_20211007\_00161.jpg

Burrows in the LS crown. Fall 2021

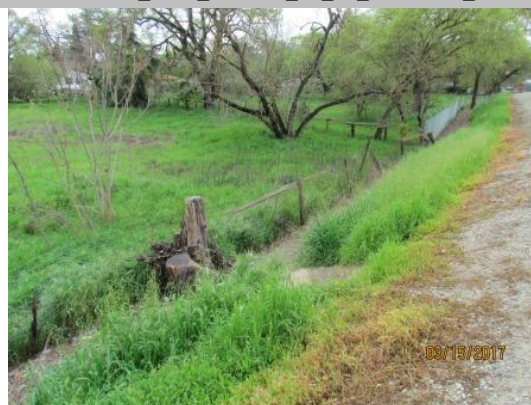
Photo 1 of 1 : FA\_2021\_NA0001\_51\_74\_20210823\_00038.jpg

View of the tree stump at the levee toe.

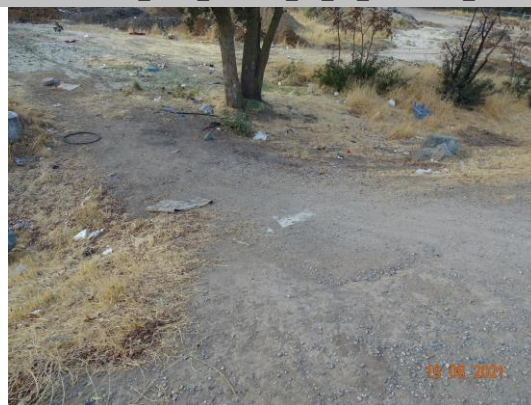
Photo 1 of 1 : FA\_2021\_NA0001\_51\_89\_20211007\_00165.jpg

Vehicle and footpath on the LS slope. Fall 2021

| S1 : Repair slope instability. | | | | | |

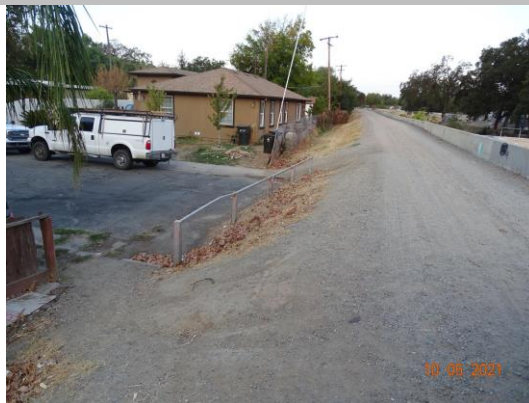
Photo 1 of 1 : FA\_2021\_NA0001\_51\_86\_20211007\_00179.jpg

Two footpaths on the LS slope. Fall 2021

| S2 : Repair the levee slope damaged by foot traffic and prevent access where possible. | | | | | | |

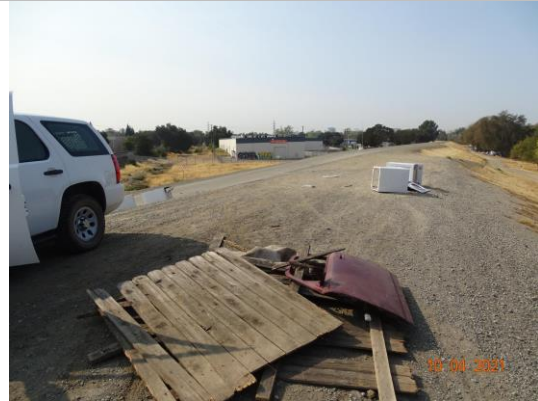
Photo 1 of 1 : FA\_2021\_NA0001\_52\_26\_20211006\_00059.jpg

Debris on the crown. Fall 2021

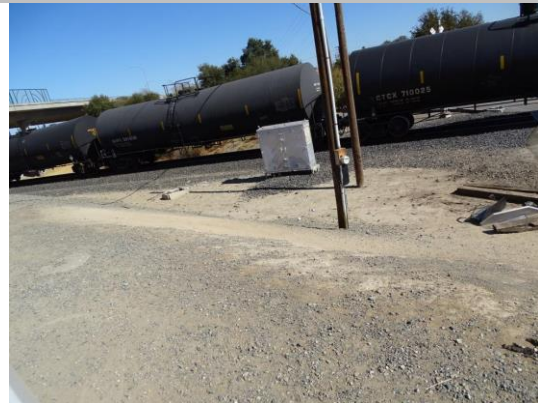
Photo 1 of 1 : FA\_2021\_NA0001\_52\_23\_20210823\_00004.jpg

View of footpath on levee slope. Fall 2018

| S2 : Repair the levee slope damaged by foot traffic and prevent access where possible. | | | | | |

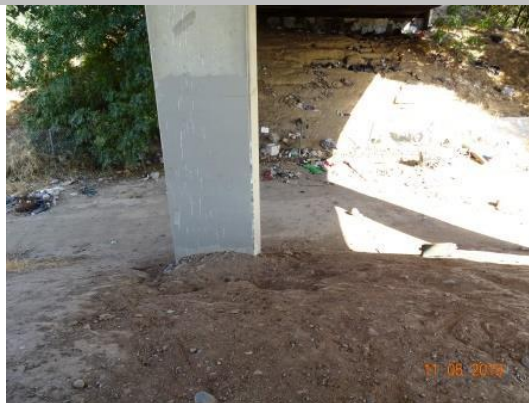
Photo 1 of 1 : FA\_2021\_NA0001\_490\_10\_20210823\_00001.jpg

View of footpaths around column for the overpass. Fall 2019

| S2 : Repair the levee slope damaged by foot traffic and prevent access where possible. | | | | | |

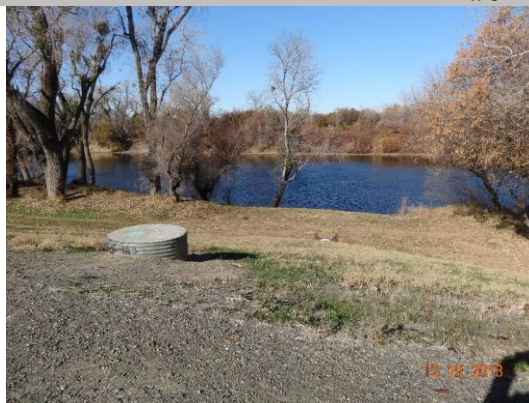
Photo 3 of 3 : UCIP\_FA\_2021\_69301\_57210.jpg

View of waterward side--standpipe located on waterward slope.  
Standpipe filled with concrete.

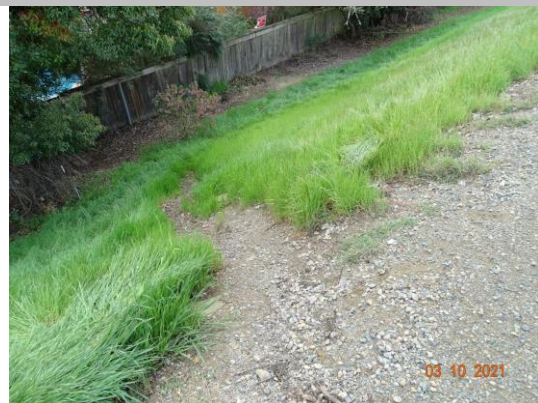
Photo 1 of 1 : FA\_2021\_NA0001\_55\_333\_20210823\_00207.jpg

View of the footpath going down the LS levee slope. Spring 2021.

| S2 : Repair the levee slope damaged by foot traffic and prevent access where possible. | | | | | |

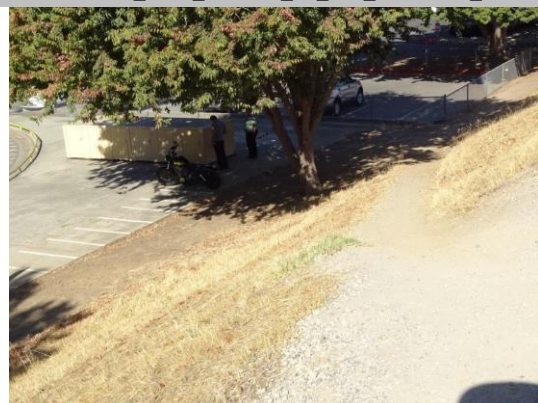
Photo 1 of 1 : FA\_2021\_NA0001\_55\_270\_20210823\_00193.jpg

View of footpath on slope. Fall 2018

| S2 : Repair the levee slope damaged by foot traffic and prevent access where possible. | | | | | |

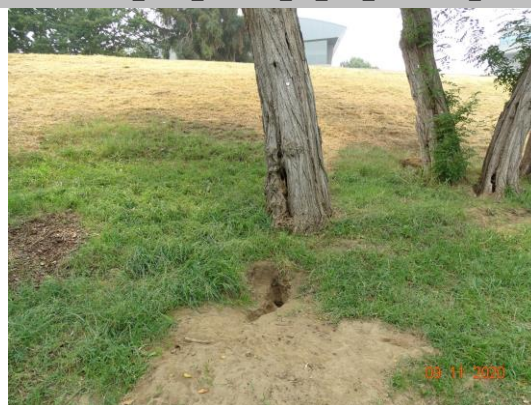
Photo 1 of 1 : FA\_2021\_NA0001\_55\_383\_20210823\_00218.jpg

View of animal holes on the waterside slope. Fall 2020

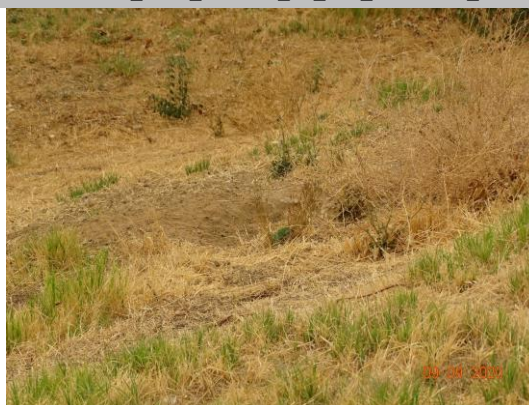
Photo 1 of 1 : FA\_2021\_NA0001\_55\_368\_20210823\_00216.jpg

View of large animal hole on the landside slope within the City Fairbairn Plant. Fall 2020

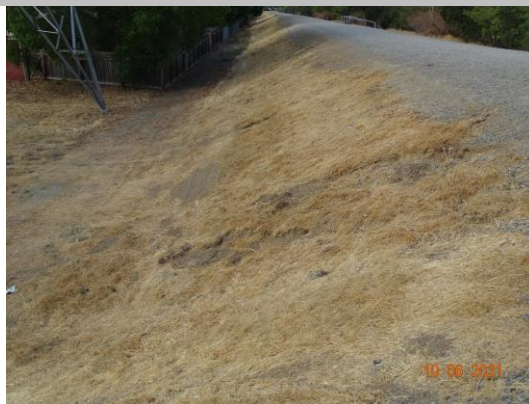
Photo 1 of 1 : FA\_2021\_NA0001\_55\_315\_20211011\_00444.jpg

Rutting on the LS slope. Fall 2021

| S3 : Repair the levee slope damaged by vehicle traffic and prevent access where possible. | | | | | |
| Repair rutting from vehicles driving up slope. | | | | | |

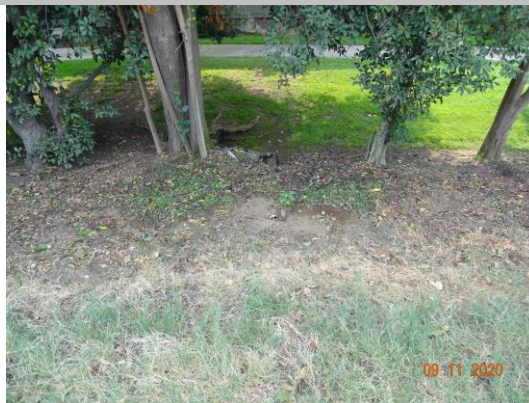
Photo 1 of 1 : FA\_2021\_NA0001\_55\_379\_20210823\_00217.jpg

View of large animal hole at the landside toe. Fall 2020

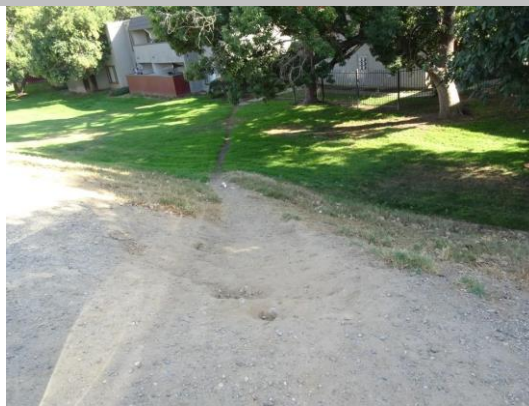
Photo 1 of 1 : FA\_2021\_NA0001\_55\_252\_20210823\_00184.jpg

View of footpath on levee toe. Fall 2018

| S2 : Repair the levee slope damaged by foot traffic and prevent access where possible. | | | | | |
| Monitor slope damage from foot traffic. | | | | | |

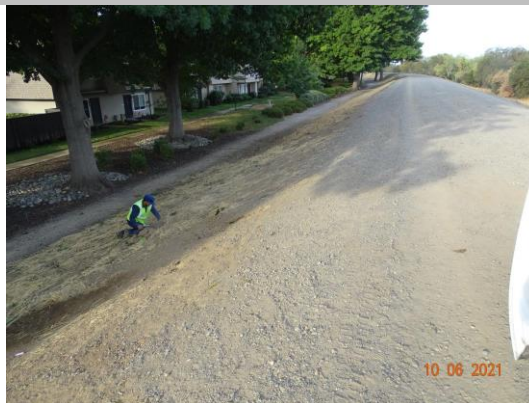
Photo 1 of 1 : FA\_2021\_NA0001\_55\_314\_20211011\_00445.jpg

Rodent holes being grouted. Fall 2021

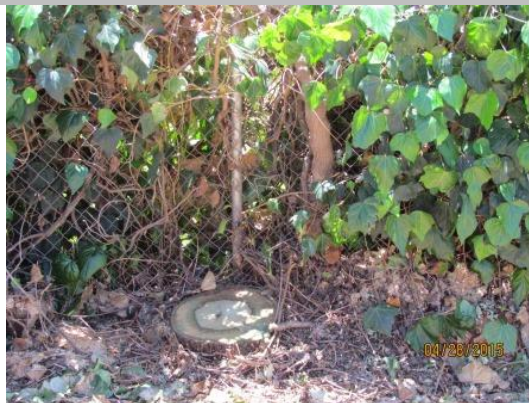
Photo 1 of 1 : FA\_2021\_NA0001\_55\_234\_20210823\_00176.jpg

View of the tree stump at the landside levee toe.

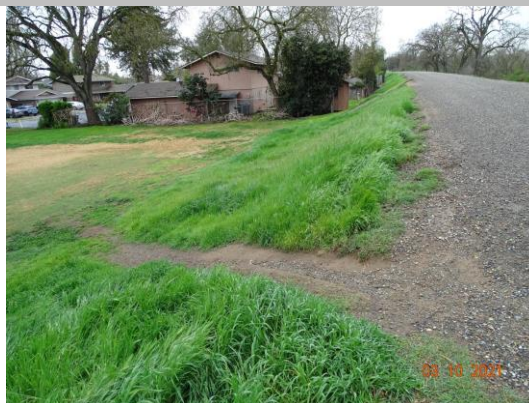
Photo 1 of 1 : FA\_2021\_NA0001\_55\_141\_20210823\_00107.jpg

View of one of the two footpaths going down the LS levee slope. Spring 2021.

| S2 : Repair the levee slope damaged by foot traffic and prevent access where possible. | | | | | |

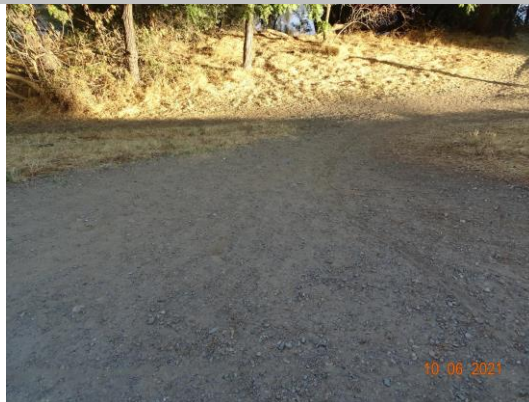
Photo 1 of 1 : FA\_2021\_NA0001\_55\_311\_20211011\_00449.jpg

Footpath on the LS slope. Fall 2021

| S2 : Repair the levee slope damaged by foot traffic and prevent access where possible. | | | | | |

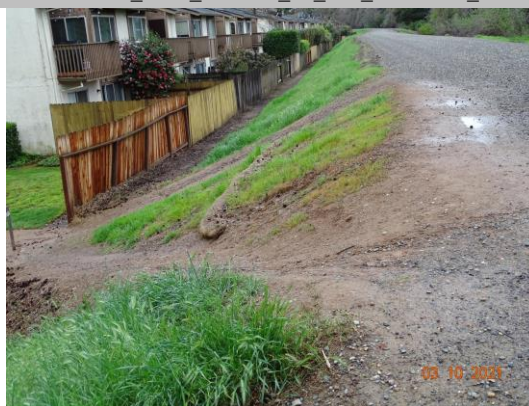
Photo 1 of 1 : FA\_2021\_NA0001\_55\_329\_20210823\_00204.jpg

View of the footpaths going the the LS levee slope. Spring 2021.

| S2 : Repair the levee slope damaged by foot traffic and prevent access where possible. | | | | | |

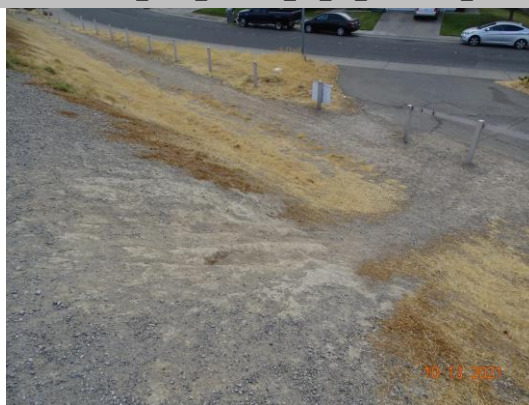
Photo 1 of 1 : FA\_2021\_NA0001\_57\_15\_20211013\_00045.jpg

Footpath on the LS shoulder. Fall 2021

| S2 : Repair the levee slope damaged by foot traffic and prevent access where possible. | | | | | |

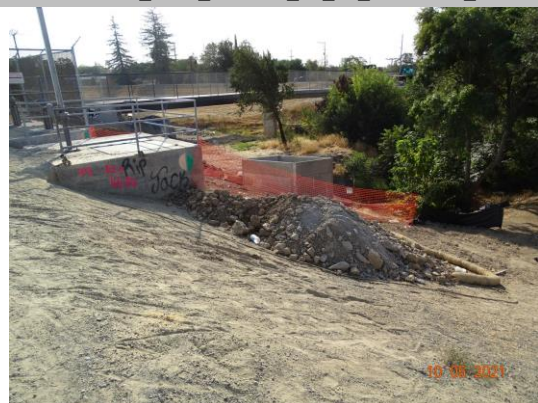
Photo 1 of 1 : FA\_2021\_NA0001\_58\_57\_20211007\_00093.jpg

Construction on the outfall. Fall 2021

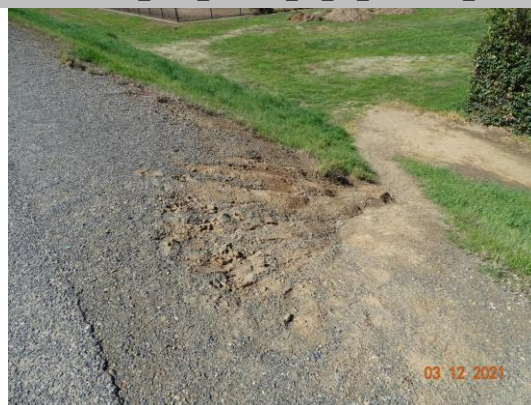
Photo 1 of 1 : FA\_2021\_NA0001\_60\_39\_20210823\_00005.jpg

View of the footpath and rills on the LS levee slope. Spring 2021.

| S2 : Repair the levee slope damaged by foot traffic and prevent access where possible. | | | | | |

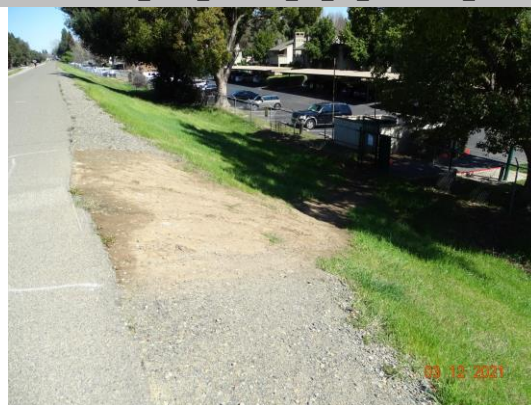
Photo 1 of 1 : FA\_2021\_NA0001\_60\_18\_20210823\_00004.jpg

View of the footpath on the LS levee slope. Spring 2021.

| S2 : Repair the levee slope damaged by foot traffic and prevent access where possible. | | | | | |

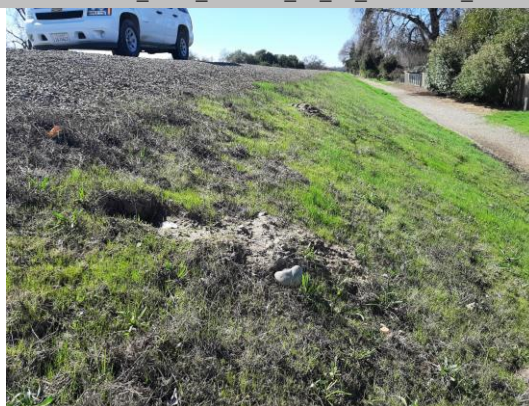
Photo 1 of 1 : FA\_2021\_NA0001\_61\_24\_20210823\_00005.jpg

View of the two inactive rodent holes on the LS slope. No rodents were present. Spring 2021.

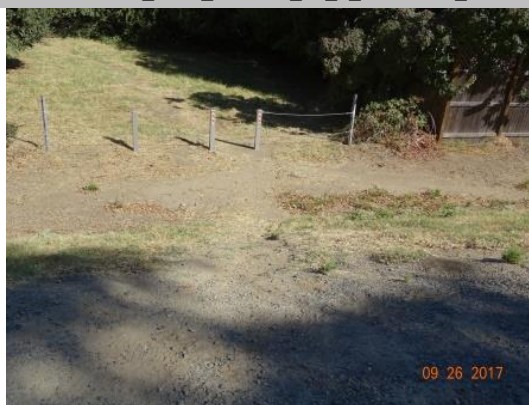
Photo 1 of 1 : FA\_2021\_NA0001\_61\_2\_20210823\_00001.jpg

View of the footpath on the levee slope. Fall 2017

| S2 : Repair the levee slope damaged by foot traffic and prevent access where possible. | | | | | |

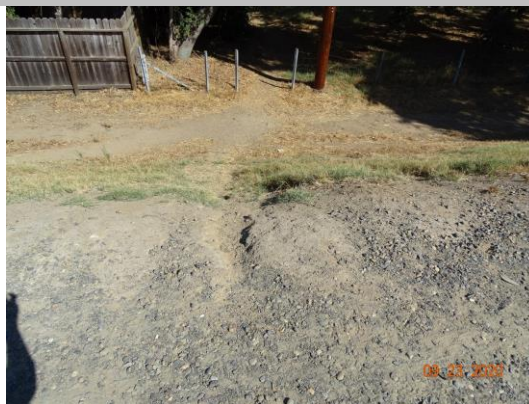
Photo 1 of 1 : FA\_2021\_NA0001\_61\_23\_20210823\_00004.jpg

View of erosion rills on the landside slope. Fall 2020

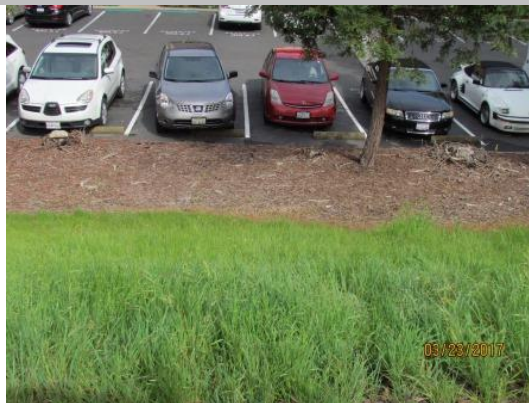
Photo 1 of 1 : FA\_2021\_NA0001\_61\_29\_20210823\_00007.jpg

View of the tree stumps within the levee easement. Spring 2017

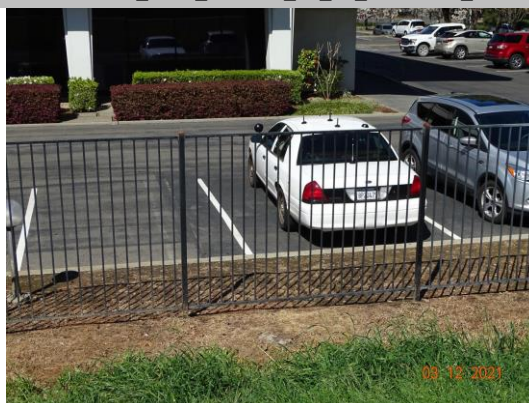
Photo 1 of 1 : FA\_2021\_NA0001\_61\_28\_20210823\_00006.jpg

View of the tree stump on the LS levee toe. Spring 2021.

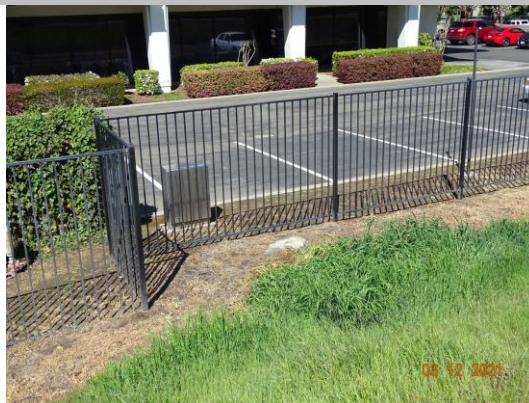
Photo 1 of 1 : FA\_2021\_NA0001\_61\_31\_20210823\_00008.jpg

View of the tree stump on the LS levee toe. Spring 2021.

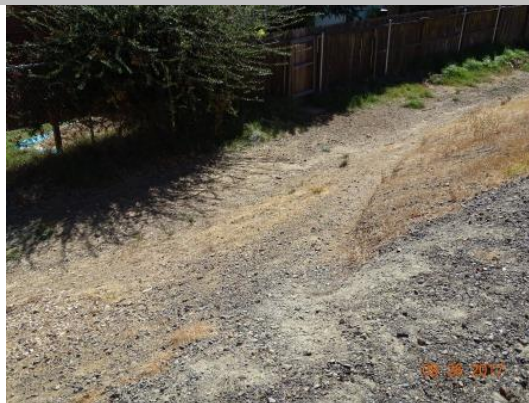
Photo 1 of 1 : FA\_2021\_NA0001\_438\_8\_20210823\_00003.jpg

View of the footpath on the levee slope.

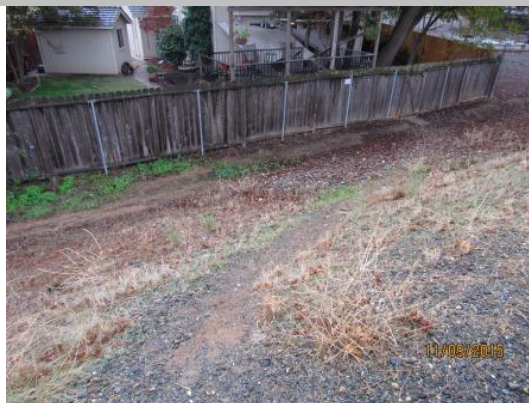
Photo 1 of 1 : FA\_2021\_NA0001\_438\_3\_20210823\_00002.jpg

View of the footpath on the landside levee slope.
