**Flood Control Project Maintenance  
Levee Inspections**

**Maintenance Issue Types Only, Levee Inspection Report By Mile - Fall 2022**

**American River Flood Control District**

Waterway	Bank	Unit Miles	Inspection Start/End	Inspector
Unit No. 01 Arcade Creek	Left	2.08	11/08/2022 11/08/2022	Marvin Marshall

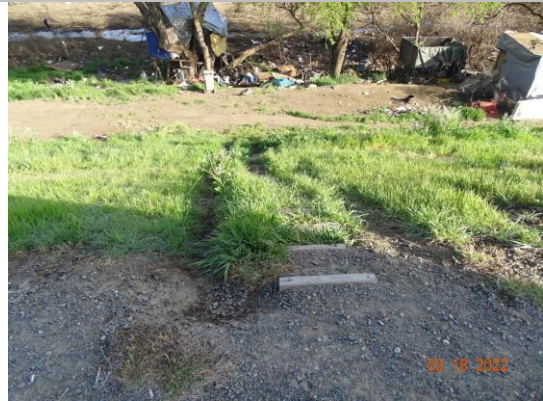
Photo 1 of 2 : FA\_2022\_NA0001\_51\_82\_20220822\_00048.jpg

LM Start	0.54	Rating **	M	Issue No.	82
LM End	0.54	Issue Type +	Ma	Location *	WS
Category	Earthen Levee			GPS Latitude/Longitude	
				Start	End
Item	Encroachments			38.623573 °	38.623573 °
				-121.459281 °	-121.459281 °
DWR ID	DWR_NA0001_01_s_2020_82				
Comment Code					
CA : Campers					
Inspector Comment					
Remove wooden steps and repair footpath erosion at two locations.

Wooden stairway on the water side slope. Spring 2022

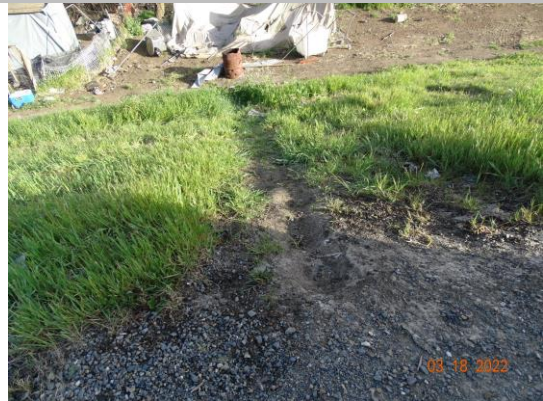
Photo 2 of 2 : FA\_2022\_NA0001\_51\_82\_20220822\_00049.jpg

Second stairway site on the waterside slope. Spring 2022

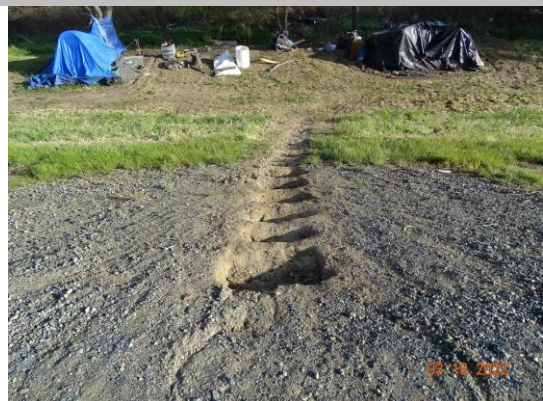
Photo 1 of 1 : FA\_2022\_NA0001\_51\_85\_20220822\_00051.jpg

LM Start	0.62	Rating **	M	Issue No.	85
LM End	0.62	Issue Type +	Ma	Location *	WS
Category	Earthen Levee			GPS Latitude/Longitude	
				Start	End
Item	Erosion / Foot Traffic			38.623684 °	38.623684 °
				-121.457936 °	-121.457936 °
DWR ID	DWR_NA0001_01_s_2022_85				
Comment Code					
E3 : Repair the levee slope damaged by foot traffic and prevent access where possible.					
Inspector Comment					
Repair slope damage from stairway digging.

Stairway dug into the water side slope. Spring 2022

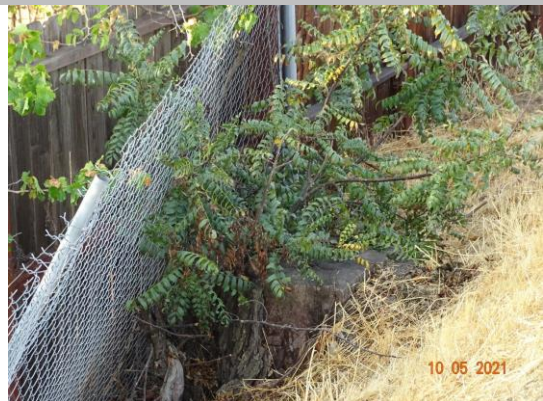
Photo 1 of 1 : FA\_2022\_NA0001\_51\_94\_20220822\_00057.jpg

Stump on the LS toe. Fall 2021

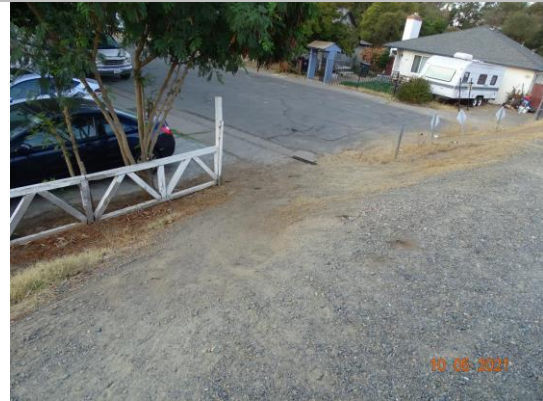
Photo 1 of 1 : FA\_2022\_NA0001\_51\_90\_20220822\_00054.jpg

LM Start	1.57	Rating **	A/W	Issue No.	90
LM End	1.57	Issue Type +	Ma	Location *	LS
Category	Earthen Levee			GPS Latitude/Longitude	
				Start	End
Item	Erosion / Foot Traffic			38.627264 °	38.627264 °
				-121.441585 °	-121.441585 °
DWR ID	DWR_NA0001_01_f_2021_90				
Comment Code					
E3 : Repair the levee slope damaged by foot traffic and prevent access where possible.					
Inspector Comment					
Monitor footpath for further erosion.

Footpath on the LS slope. Fall 2021

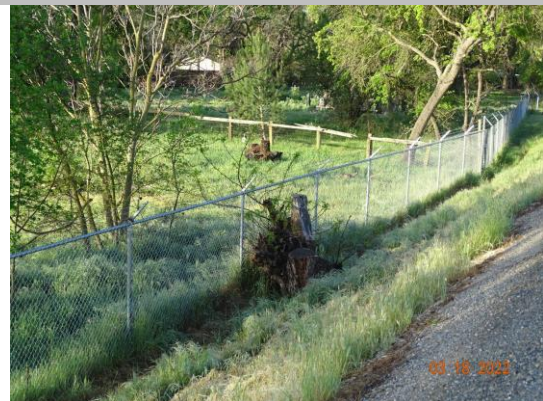
Photo 1 of 1 : FA\_2022\_NA0001\_51\_74\_20220822\_00043.jpg

LM Start	1.69	Rating **	N	Issue No.	74
LM End	1.69	Issue Type +	Ma	Location *	LS
Category	Earthen Levee			GPS Latitude/Longitude	
				Start	End
Item	Trim / Thin Trees			38.627607 °	38.627607 °
				-121.439545 °	-121.439545 °
DWR ID	DWR_NA0001_01_s_2017_74				
Comment Code					
T5 : Tree stumps.					
Inspector Comment					
Remove large tree stump at the levee toe.

Large stump at the land side toe. Spring 2022

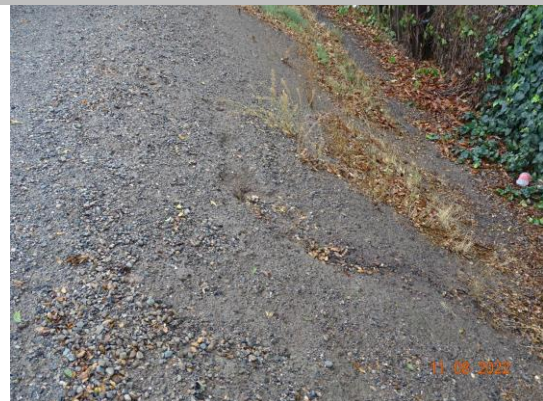
Photo 1 of 1 : FA\_2022\_NA0001\_51\_71\_20221109\_00137.jpg

LM Start	1.71	Rating **	M	Issue No.	71	
LM End	1.71	Issue Type +	Ma	Location *	LS	
Category	Earthen Levee			GPS Latitude/Longitude		
				Start		End
Item	Erosion / Foot Traffic			38.627739 °		38.627739 °
				-121.439175 °		-121.439175 °
DWR ID	DWR_NA0001_01_f_2022_71					
Comment Code						
E3 : Repair the levee slope damaged by foot traffic and prevent access where possible.						
Inspector Comment						
Repair stairs dug into the LS slope.

Stair dug into the LS slope. Fall 2022

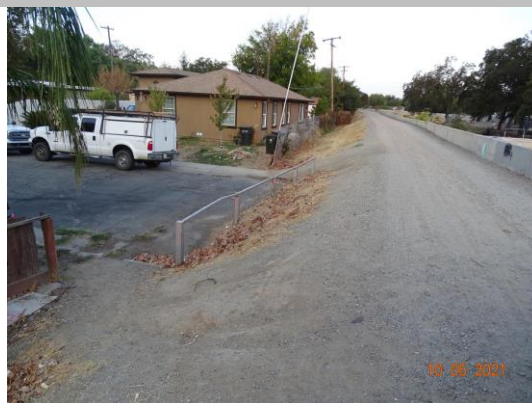
Photo 1 of 1 : FA\_2022\_NA0001\_51\_86\_20220822\_00052.jpg

LM Start	1.96	Rating **	A/W	Issue No.	86	
LM End	1.96	Issue Type +	Ma	Location *	LS	
Category	Earthen Levee			GPS Latitude/Longitude		
				Start		End
Item	Erosion / Foot Traffic			38.627556 °		38.627556 °
				-121.434766 °		-121.434766 °
DWR ID	DWR_NA0001_01_f_2021_86					
Comment Code						
E3 : Repair the levee slope damaged by foot traffic and prevent access where possible.						
Inspector Comment						
Monito two footpaths at the street end for further erosion.

Two footpaths on the LS slope. Fall 2021

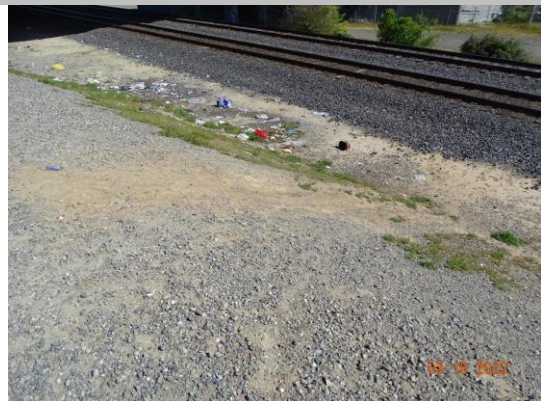
Photo 1 of 1 : FA\_2022\_NA0001\_52\_31\_20220929\_00010.jpg

LM Start	2.78	Rating **	M	Issue No.	31
LM End	2.78	Issue Type +	Ma	Location *	LS
Category	Earthen Levee			GPS Latitude/Longitude	
				Start	End
Item	Erosion / Foot Traffic			38.640828 °	38.640828 °
				-121.471778 °	-121.471778 °
DWR ID	DWR_NA0001_02_s_2020_31				
Comment Code					
E3 : Repair the levee slope damaged by foot traffic and prevent access where possible.					
Inspector Comment					
Repair the steps dug into the LS slope.

Steps on the landside slope. Spring 2022

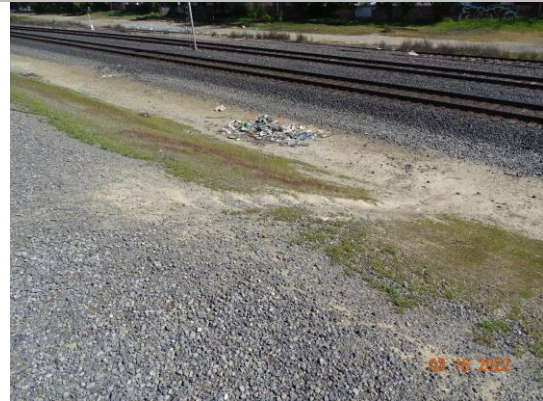
Photo 1 of 1 : FA\_2022\_NA0001\_52\_28\_20220929\_00008.jpg

LM Start	3.69	Rating **	M	Issue No.	28
LM End	3.69	Issue Type +	Ma	Location *	LS
Category	Earthen Levee			GPS Latitude/Longitude	
				Start	End
Item	Erosion / Foot Traffic			38.653880 °	38.653880 °
				-121.474253 °	-121.474253 °
DWR ID	DWR_NA0001_02_s _ 2020_28				
Comment Code					
E3 : Repair the levee slope damaged by foot traffic and prevent access where possible.					
Inspector Comment					
Repair steps dug into the LS slope.

Steps dug in the land side slope. Spring 2022

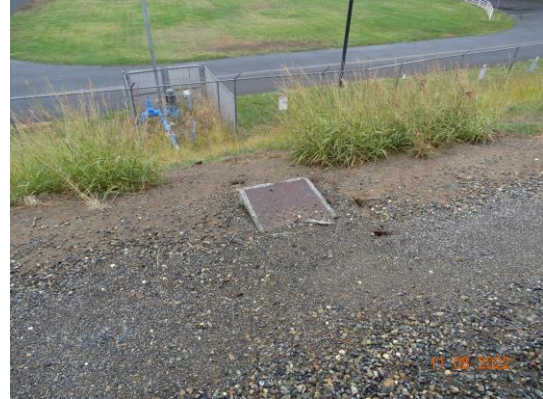
Photo 1 of 1 : FA\_2022\_NA0001\_490\_35\_20221109\_00089.jpg

Rodent holes in the LS shoulder. Fall 2022

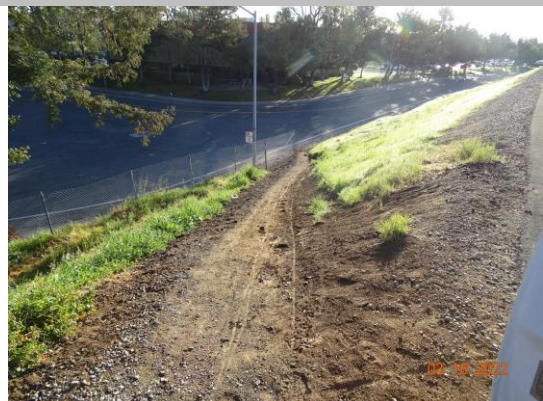
Photo 1 of 1 : FA\_2022\_NA0001\_490\_42\_20220822\_00008.jpg

LM Start	1.82	Rating **	A/W	Issue No.	42
LM End	1.82	Issue Type +	Ma	Location *	LS
Category	Earthen Levee			GPS Latitude/Longitude	
				Start	End
Item	Erosion / Foot Traffic			38.595699 °	38.595699 °
				-121.448246 °	-121.448246 °
DWR ID	DWR_NA0001_03_s_2022_42				
Comment Code					
E3 : Repair the levee slope damaged by foot traffic and prevent access where possible.					
Inspector Comment					
Monitor for future erosion.

Footpath on the landside slope. Spring 2022

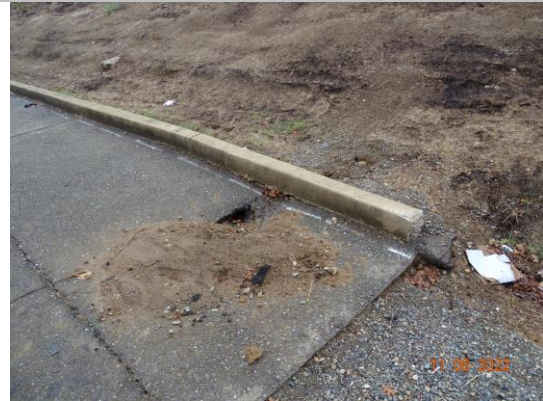
Photo 1 of 1 : FA\_2022\_NA0001\_490\_40\_20221109\_00091.jpg

LM Start	2.35	Rating **	M	Issue No.	40
LM End	2.35	Issue Type +	Ma	Location *	LS
Category	Earthen Levee			GPS Latitude/Longitude	
				Start	End
Item	Erosion / Bank Caving			38.595869 °	38.595869 °
				-121.457801 °	-121.457801 °
DWR ID	DWR_NA0001_03_s_2022_40				
Comment Code					
E2 : Schedule repair of erosion site prior to the next inspection.					
Inspector Comment					
Repair pothole in the asphalt at the LS toe. The hole was probed to be 6"-8"

Pothole on the landside toe. Fall 2022

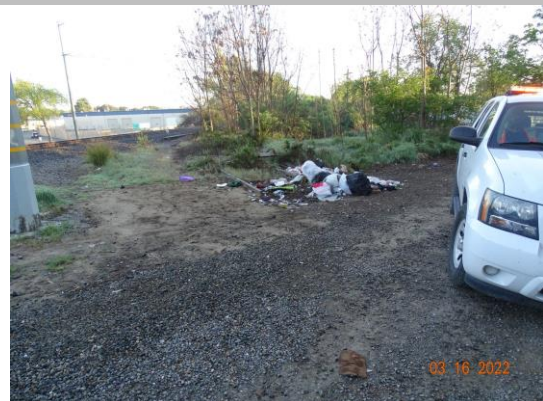
Photo 1 of 1 : FA\_2022\_NA0001\_490\_26\_20220822\_00002.jpg

Debris pile near the landside easement. Spring 2022

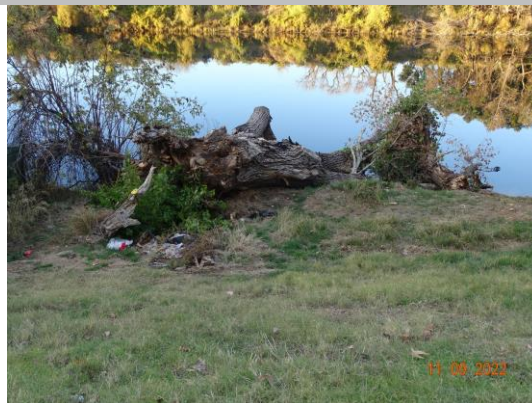
Photo 1 of 1 : FA\_2022\_NA0001\_55\_287\_20221110\_00468.jpg

Fallen tree in channel. Fall 2022

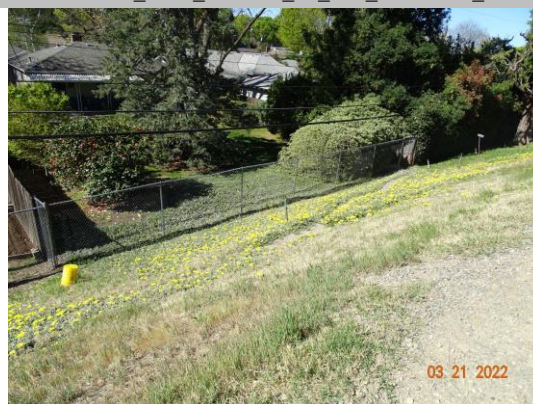
Photo 1 of 1 : FA\_2022\_NA0001\_55\_283\_20220822\_00202.jpg

LM Start	4.29	Rating **	A/W	Issue No.	283
LM End	4.29	Issue Type +	Ma	Location *	LS
Category	Earthen Levee			GPS Latitude/Longitude	
				Start	End
Item	Erosion / Foot Traffic			38.582640 °	38.582640 °
				-121.442064 °	-121.442064 °
DWR ID	DWR_NA0001_04_f_2018_283				
Comment Code					
E3 : Repair the levee slope damaged by foot traffic and prevent access where possible.					
Inspector Comment					
Monitor footpath on the land side slope for erosion.

Dirt footpath on the land side slope. Spring 2022

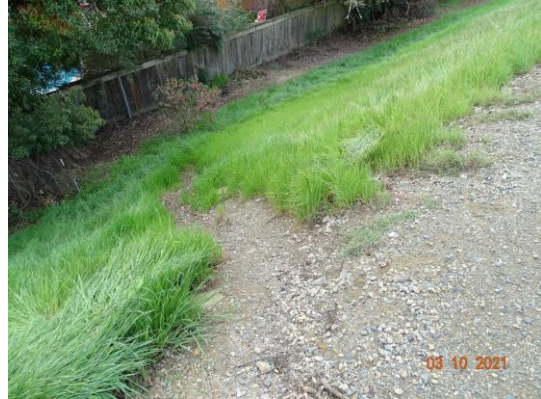
Photo 1 of 1 : FA\_2022\_NA0001\_55\_333\_20220822\_00240.jpg

LM Start	4.65	Rating **	A/W	Issue No.	333
LM End	4.65	Issue Type +	Ma	Location *	LS
Category	Earthen Levee			GPS Latitude/Longitude	
				Start	End
Item	Erosion / Foot Traffic			38.580961 °	38.580961 °
				-121.435765 °	-121.435765 °
DWR ID	DWR_NA0001_04_s_2021_333				
Comment Code					
E3 : Repair the levee slope damaged by foot traffic and prevent access where possible.					
Inspector Comment					
Monitor footpath for further erosion.

View of the footpath going down the LS levee slope. Spring 2021.

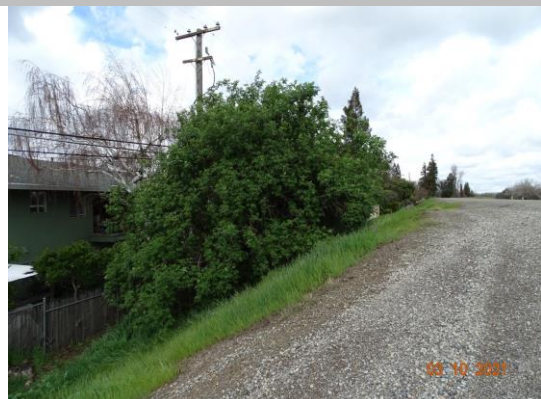
Photo 1 of 1 : FA\_2022\_NA0001\_55\_296\_20220822\_00209.jpg

View of the trees on the LS levee slope with utility lines going through them. Spring 2021.

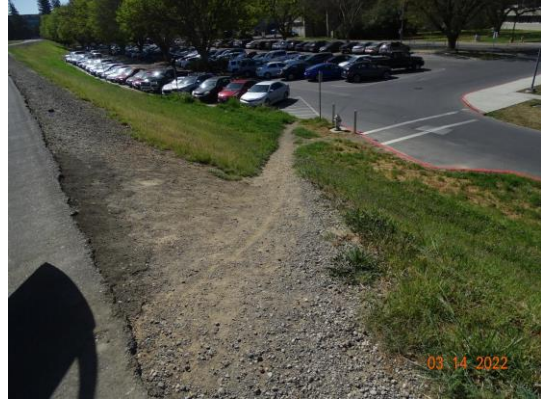
Photo 1 of 1 : FA\_2022\_NA0001\_55\_270\_20220822\_00196.jpg

LM Start	6.34	Rating **	A/W	Issue No.	270
LM End	6.34	Issue Type +	Ma	Location *	LS
Category	Earthen Levee			GPS Latitude/Longitude	
				Start	End
Item	Erosion / Foot Traffic			38.564833 °	38.564833 °
				-121.422947 °	-121.422947 °
DWR ID	DWR_NA0001_04_f _ 2018_270				
Comment Code					
E3 : Repair the levee slope damaged by foot traffic and prevent access where possible.					
Inspector Comment					
Monitor footpath for erosion.

Footpath on the land side slope. Spring 2022

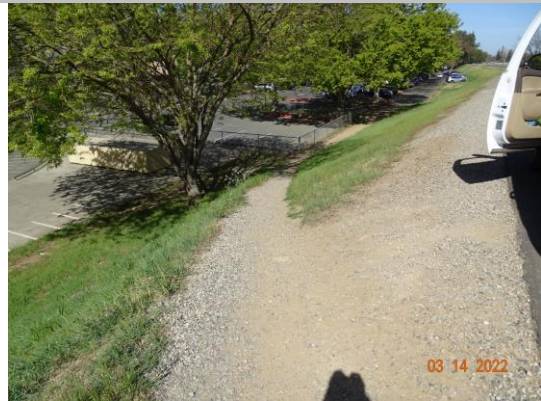
Photo 1 of 1 : FA\_2022\_NA0001\_55\_288\_20220822\_00204.jpg

LM Start	6.45	Rating **	A/W	Issue No.	288
LM End	6.45	Issue Type +	Ma	Location *	LS
Category	Earthen Levee			GPS Latitude/Longitude	
				Start	End
Item	Erosion / Foot Traffic			38.563243 °	38.563243 °
				-121.422423 °	-121.422423 °
DWR ID	DWR_NA0001_04_s_2019_288				
Comment Code					
E3 : Repair the levee slope damaged by foot traffic and prevent access where possible.					
Inspector Comment					
Monitor footpath for erosion.

Foot path on the land side slope. Spring 2022

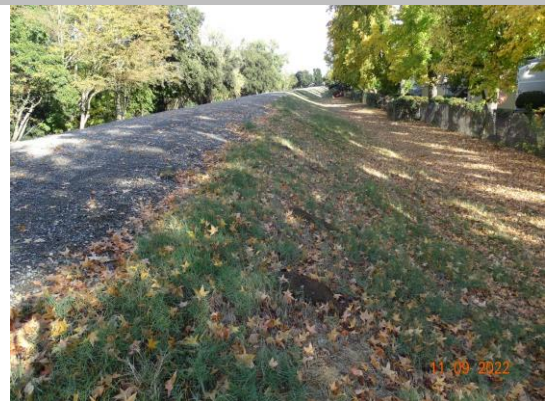
Photo 1 of 1 : FA\_2022\_NA0001\_55\_277\_20221110\_00474.jpg

Filled burrows on the LS slope. Fall 2022

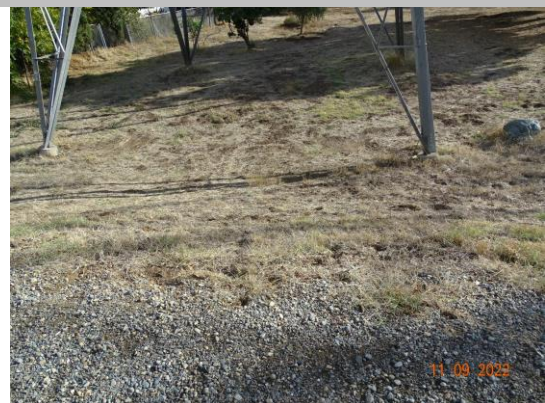
Photo 1 of 1 : FA\_2022\_NA0001\_55\_315\_20221110\_00475.jpg

Slope repair from vehicle traffic. Fall 2022

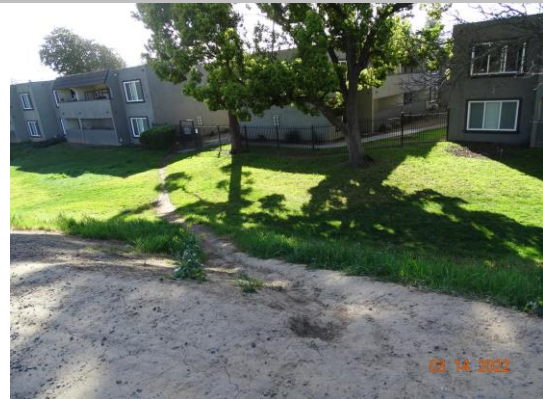
Photo 1 of 1 : FA\_2022\_NA0001\_55\_252\_20220822\_00183.jpg

Foot path on the land side slope. Spring 2022

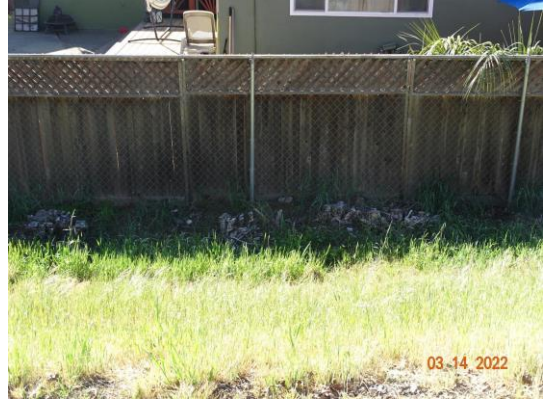
Photo 1 of 1 : FA\_2022\_NA0001\_55\_320\_20220822\_00228.jpg

Stumps at the land side toe. Spring 2022

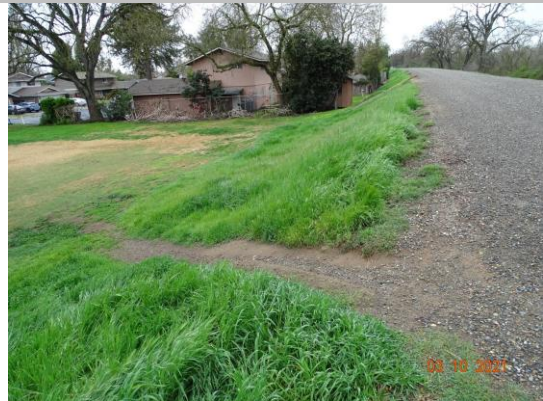
Photo 1 of 1 : FA\_2022\_NA0001\_55\_141\_20220822\_00105.jpg

View of one of the two footpaths going down the LS levee slope. Spring 2021.

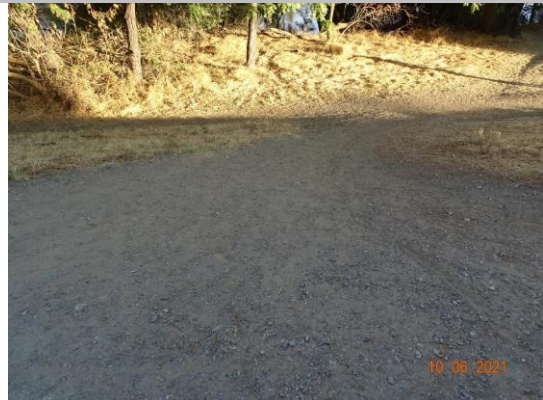
Photo 1 of 1 : FA\_2022\_NA0001\_55\_311\_20220822\_00223.jpg

Footpath on the LS slope. Fall 2021

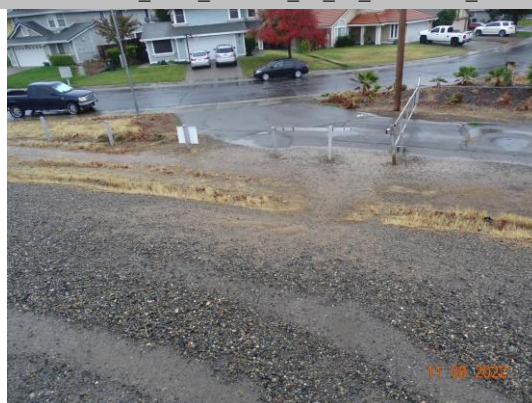
Photo 1 of 1 : FA\_2022\_NA0001\_57\_15\_20221109\_00042.jpg

Footpath is located on the landside slope. Fall 2022

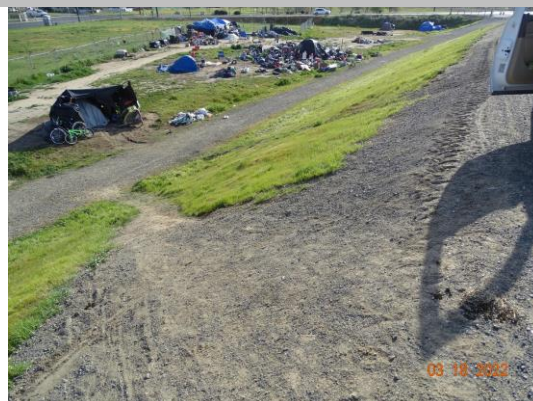
Photo 1 of 1 : FA\_2022\_NA0001\_58\_65\_20220822\_00040.jpg

Footpath on the landside slope. Spring 2022

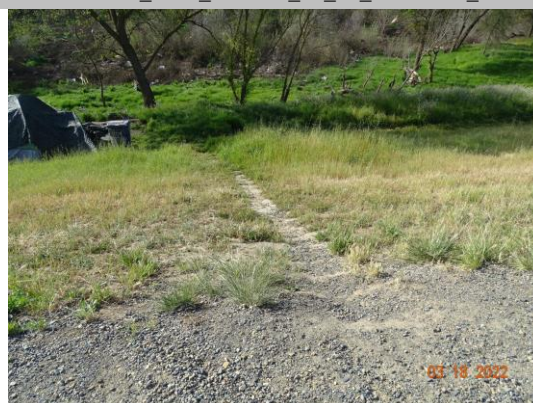
Photo 1 of 1 : FA\_2022\_NA0001\_58\_50\_20220822\_00033.jpg

Steps dug into the waterside slope. Spring 2022

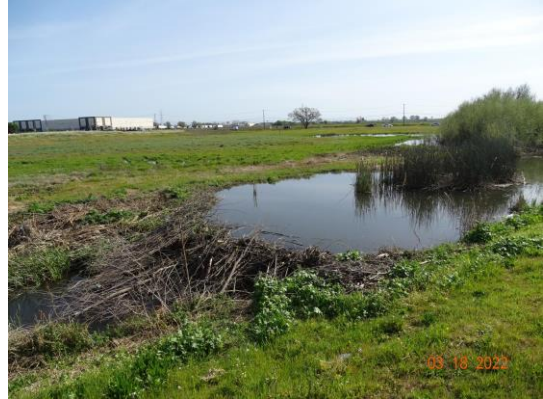
Photo 1 of 1 : FA\_2022\_NA0001\_59\_25\_20220822\_00012.jpg

Beaver dam and channel flooding caused by dam. Spring 2022

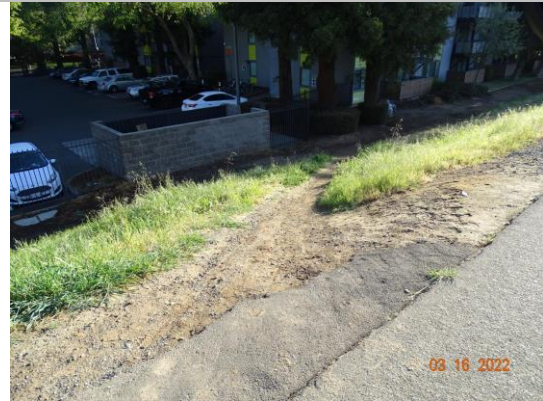
Photo 1 of 1 : FA\_2022\_NA0001\_60\_36\_20220822\_00004.jpg

Footpath on the landside slope. Spring 2022

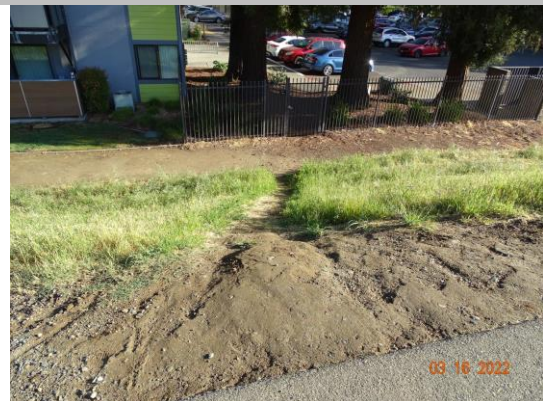
Photo 1 of 1 : FA\_2022\_NA0001\_60\_37\_20220822\_00005.jpg

Rilling and a footpath on the landside slope. Spring 2022

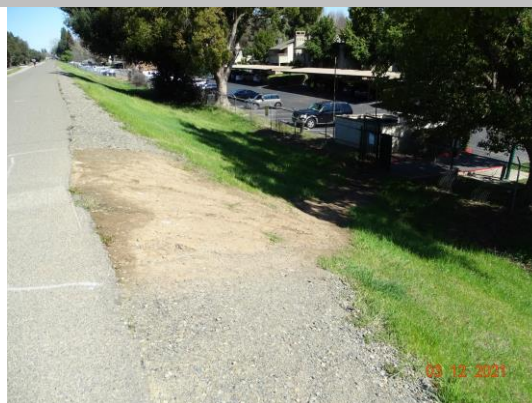
Photo 1 of 1 : FA\_2022\_NA0001\_60\_18\_20220822\_00003.jpg

View of the footpath on the LS levee slope. Spring 2021.

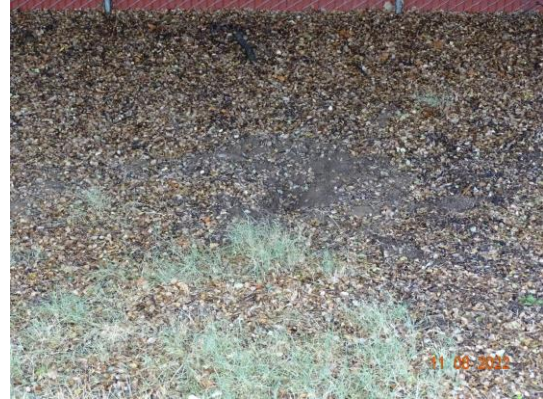
Photo 1 of 1 : FA\_2022\_NA0001\_60\_32\_20221109\_00080.jpg

Rodent hole in the LS easement. Fall 2022

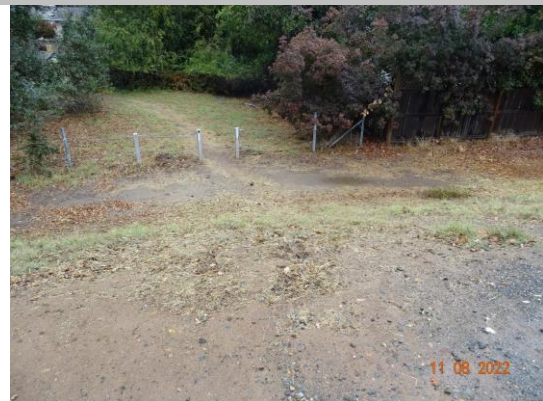
Photo 1 of 1 : FA\_2022\_NA0001\_61\_2\_20221110\_00077.jpg

Footpaths on the landside slope. Fall 2022

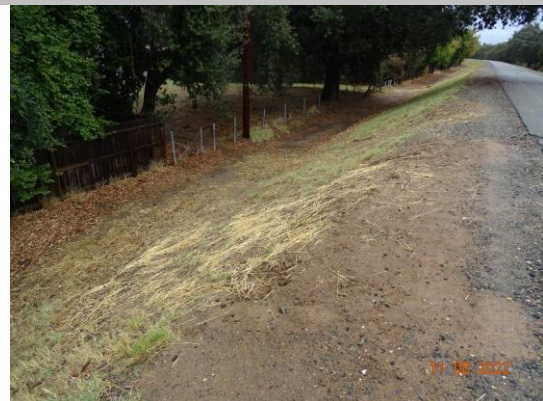
Photo 1 of 1 : FA\_2022\_NA0001\_61\_23\_20221110\_00078.jpg

Repaired footpath. Fall 2022

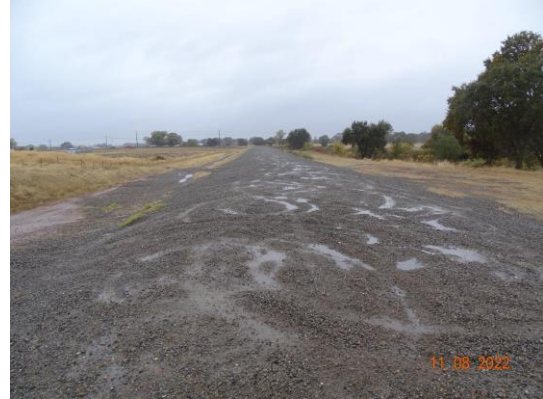
Photo 1 of 1 : FA\_2022\_NA0001\_436\_5\_20221110\_00015.jpg

Rutting from ATC use on crown. Fall 2022

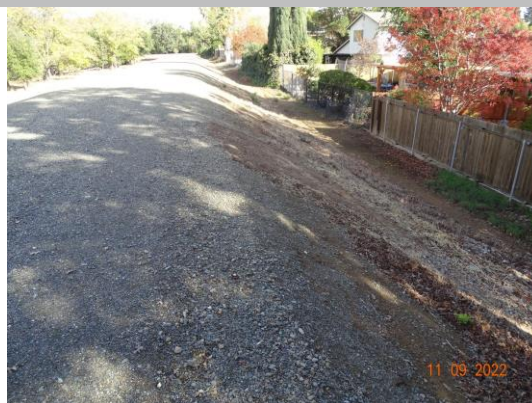
Photo 1 of 1 : FA\_2022\_NA0001\_438\_3\_20221110\_00014.jpg

Footpath on the LS slope. Fall 2022
