**Flood Control Project Maintenance
Levee Inspections**

Maintenance Issue Types Only, Levee Inspection Report By Mile - Fall 2023

American River Flood Control District

Waterway	Bank	Unit Miles	Inspection Start/End	Inspector
Unit No. 01 Arcade Creek	Left	2.08	09/19/2023 09/19/2023	Marvin Marshall

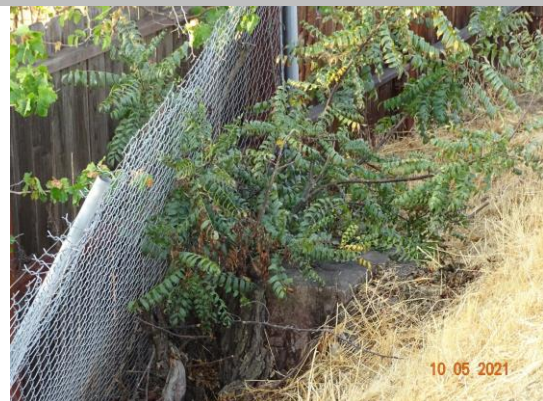
Photo 1 of 1 : FA_2023_NA0001_51_94_20230905_00056.jpg

LM Start	1.34	Rating **	N	Issue No.	94
LM End	1.34	Issue Type +	Ma	Location *	LS
Category	Earthen Levee			GPS Latitude/Longitude	
				Start	End
Item	Trim / Thin Trees			38.625935°	38.625935°
				-121.445364°	-121.445364°
DWR ID	DWR_NA0001_01_f_2021_94				
Comment Code					
T5 : Tree stumps.					
Inspector Comment					
Remove 24" stump.

Stump on the LS toe. Fall 2021

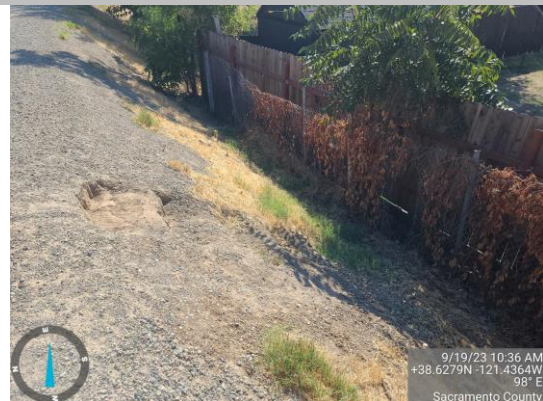
Photo 1 of 1 : FA_2023_NA0001_51_17_20230920_00071.jpg

LM Start	1.86	Rating **	M	Issue No.	17
LM End	1.86	Issue Type +	Ma	Location *	LS
Category	Earthen Levee			GPS Latitude/Longitude	
				Start	End
Item	Erosion / Foot Traffic			38.627900°	38.627900°
				-121.436400°	-121.436400°
DWR ID	DWR_NA0001_01_f_2023_17				
Comment Code					
E3 : Repair the levee slope damaged by foot traffic and prevent access where possible.					
Inspector Comment					
Repair steps on the LS slope.

Steps on the LS slope. Fall 2023

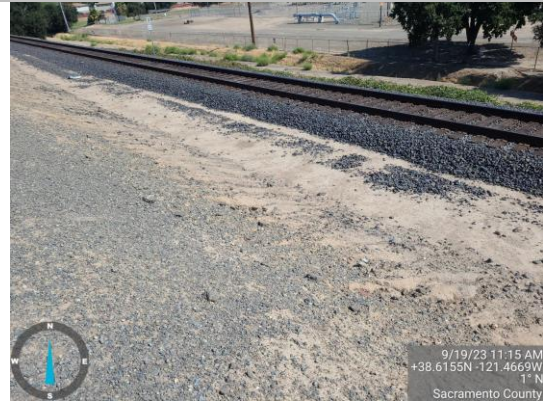
Photo 1 of 1 : FA_2023_NA0001_52_4_20230920_00010.jpg

LM Start	1.01	Rating **	M	Issue No.	4
LM End	1.01	Issue Type +	Ma	Location *	LS
Category	Earthen Levee			GPS Latitude/Longitude	
				Start	End
Item	Erosion / Rills			38.615500°	38.615500°
				-121.466900°	-121.466900°
DWR ID	DWR_NA0001_02_f_2023_4				
Comment Code					
E5 : Schedule repair of rills prior to the next inspection.					
Inspector Comment					
Repair rilling on lower half of LS slope.

Rilling on the LS slope. Fall 2023

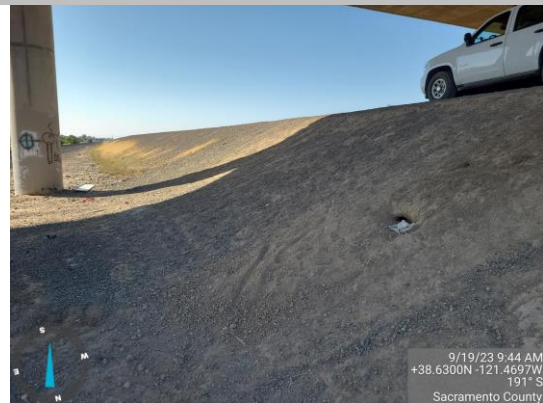
Photo 1 of 1 : FA_2023_NA0001_52_3_20230920_00011.jpg

LM Start	2.02	Rating **	M	Issue No.	3
LM End	2.02	Issue Type +	Ma	Location *	LS
Category	Earthen Levee			GPS Latitude/Longitude	
				Start	End
Item	Animal Control			38.630000°	38.630000°
				-121.469700°	-121.469700°
DWR ID	DWR_NA0001_02_f_2023_3				
Comment Code					
A3 : No rodents visible, but rodent burrows visible; need to backfill and compact or grout burrows.					
Inspector Comment					
Repair rodent holes on the LS slope.

Rodent holes on the LS slope. Fall 2023

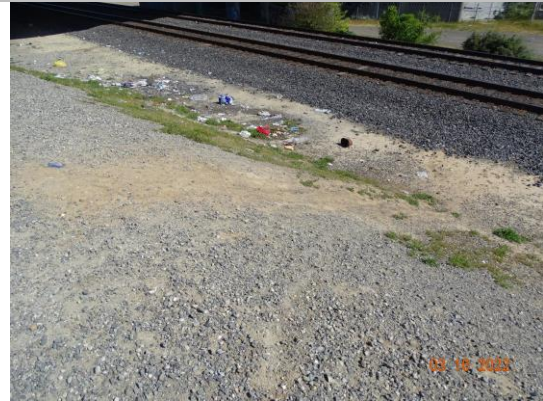
Photo 1 of 1 : FA_2023_NA0001_52_31_20230905_00006.jpg

LM Start	2.78	Rating **	M	Issue No.	31
LM End	2.78	Issue Type +	Ma	Location *	LS
Category	Earthen Levee			GPS Latitude/Longitude	
				Start	End
Item	Erosion / Foot Traffic			38.640828°	38.640828°
				-121.471778°	-121.471778°
DWR ID	DWR_NA0001_02_s_2020_31				
Comment Code					
E3 : Repair the levee slope damaged by foot traffic and prevent access where possible.					
Inspector Comment					
Repair the steps dug into the LS slope.

Steps on the landside slope. Spring 2022

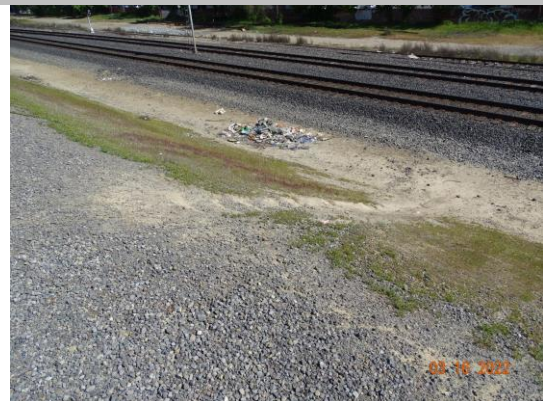
Photo 1 of 1 : FA_2023_NA0001_52_28_20230905_00004.jpg

LM Start	3.69	Rating **	M	Issue No.	28
LM End	3.69	Issue Type +	Ma	Location *	LS
Category	Earthen Levee			GPS Latitude/Longitude	
				Start	End
Item	Erosion / Foot Traffic			38.653880°	38.653880°
				-121.474253°	-121.474253°
DWR ID	DWR_NA0001_02_s_2020_28				
Comment Code					
E3 : Repair the levee slope damaged by foot traffic and prevent access where possible.					
Inspector Comment					
Repair steps dug into the LS slope.

Steps dug in the landside slope. Spring 2022

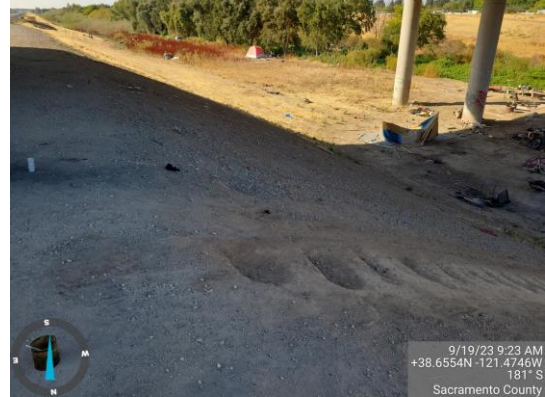
Photo 1 of 1 : FA_2023_NA0001_52_2_20230920_00012.jpg

LM Start	3.79	Rating **	M	Issue No.	2
LM End	3.79	Issue Type +	Ma	Location *	WS
Category	Earthen Levee			GPS Latitude/Longitude	
				Start	End
Item	Erosion / Foot Traffic			38.655400°	38.655400°
				-121.474600°	-121.474600°
DWR ID	DWR_NA0001_02_f_2023_2				
Comment Code					
E3 : Repair the levee slope damaged by foot traffic and prevent access where possible.					
Inspector Comment					
Repair steps in the WS slope.

Steps in the WS slope. Fall 2023

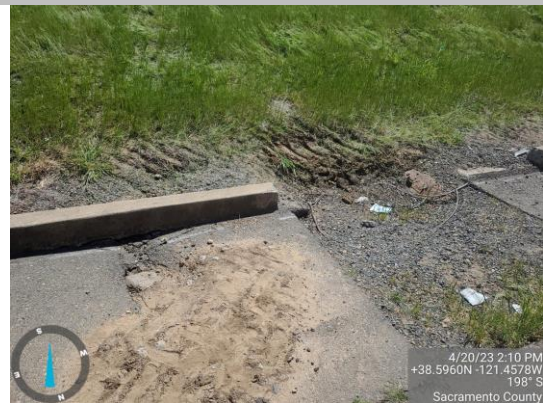
Photo 1 of 1 : FA_2023_NA0001_490_40_20230905_00002.jpg

LM Start	2.35	Rating **	M	Issue No.	40
LM End	2.35	Issue Type +	Ma	Location *	LS
Category	Earthen Levee			GPS Latitude/Longitude	
				Start	End
Item	Erosion / Bank Caving			38.595869°	38.595869°
				-121.457801°	-121.457801°
DWR ID	DWR_NA0001_03_s_2022_40				
Comment Code					
E2 : Schedule repair of erosion site prior to the next inspection.					
Inspector Comment					
Repair pothole in the asphalt at the LS toe. The hole was probed to be 6"-8"

Erosion/pothole on the LS toe. Spring 2023

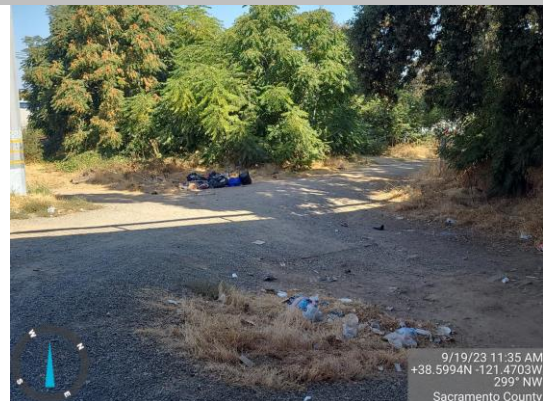
Photo 1 of 1 : FA_2023_NA0001_490_26_20230920_00008.jpg

LM Start	3.19	Rating **	M	Issue No.	26
LM End	3.19	Issue Type +	Ma	Location *	LS
Category	Earthen Levee			GPS Latitude/Longitude	
				Start	End
Item	Encroachments			38.599442°	38.599442°
				-121.470435°	-121.470435°
DWR ID	DWR_NA0001_03_s_2020_26				
Comment Code					
DE : Debris					
Inspector Comment					
Known debris dumping site. Monitor the site and remove debris as necessary.

Debris pile near the landside easement. Fall 2023

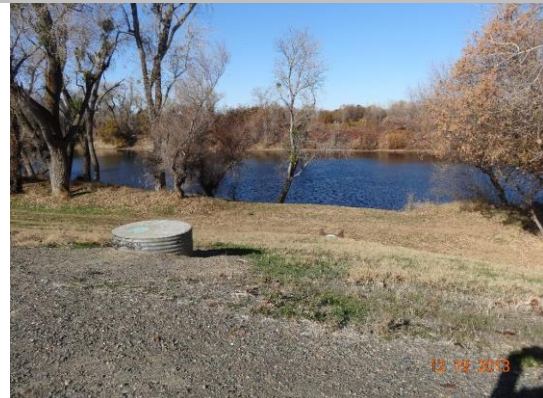
Photo 3 of 3 : UCIP_FA_2023_69301_57210.jpg

Comment Code					
Inspector Comment					
DS_ID:24303 FS_ID:69301 EP_NO: N/A Repair Type: Non-Urgent EVAL Issue: Crossing Status: Found UCIP Comments: 06/25/2020 Crossing evaluated as "Non-Urgent" because pipe looks abandoned and there was no permit found authorizing this pipe. Geophysical evaluation found evidence of a pipe at this location. (A. McDonald - DWR UCIP)08/16/2017 DWR Deferred Maintenance Project (DMP), Vince Rodriguez, forwarded email received from Tim Kerr, General Manager of American River Flood Control District (ARFCD) with file "DWR Eligible Pipes Found in ARFCD" from ARFCD that shows the ownership and location of the pipes Tim Kerr investigated. No owner was identified, ARFCD Staff Notes indicate Abandoned (ARFCD/Bill) - No As-builts. (DWR UCIP - O. Magana) 12/19/2013 Non-functional crossing--need additional information about how crossing was abandoned. (DWR UCIP - O. Magana) FIELD_STRUCT_DESC: 42-inch corrugated metal (CM) drainage pipe through the levee, 16.5 feet below the crown. Gravel filled with both ends welded shut. Flap gate on the waterside (WS) end. Slide gate inside a CM riser and splash board drain structure on the landside (LS). (No permit found authorizing this structure. Owner unknown). [Additional Reference(s): DWR Levee Log, 2002 (HLM 0.44). USACE Sacramento O&M Manual Unit 118, Part No. 1, August 1955, (Station 10+00). USACE As-Built Drawing No. 50-10-2792, Sheet 2792/1, (Station 10+00), March 1951]. FS Date: 6/25/2020

View of waterward side--standpipe located on waterward slope.
Standpipe filled with concrete.

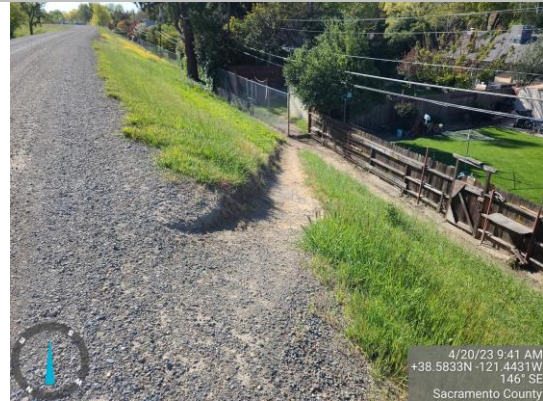
Photo 1 of 1 : FA_2023_NA0001_55_56_20230905_00045.jpg

LM Start	4.21	Rating **	M	Issue No.	56
LM End	4.21	Issue Type +	Ma	Location *	LS
Category	Earthen Levee			GPS Latitude/Longitude	
				Start	End
Item	Erosion / Foot Traffic			38.583362°	38.583362°
				-121.443100°	-121.443100°
DWR ID	DWR_NA0001_04_s_2023_56				
Comment Code					
E3 : Repair the levee slope damaged by foot traffic and prevent access where possible.					
Inspector Comment					
Repair footpath on the LS slope.

Footpath on the LS slope. Spring 2023

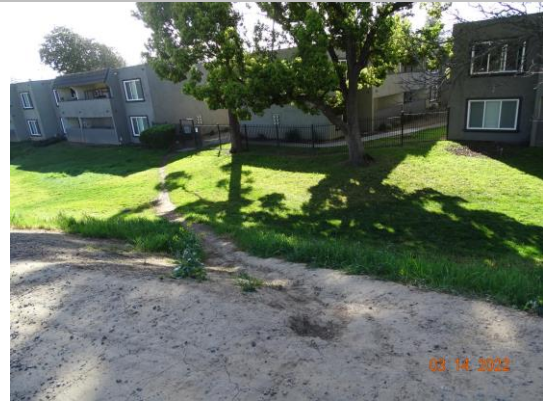
Photo 1 of 1 : FA_2023_NA0001_55_252_20230905_00190.jpg

Footpath on the landside slope. Spring 2022

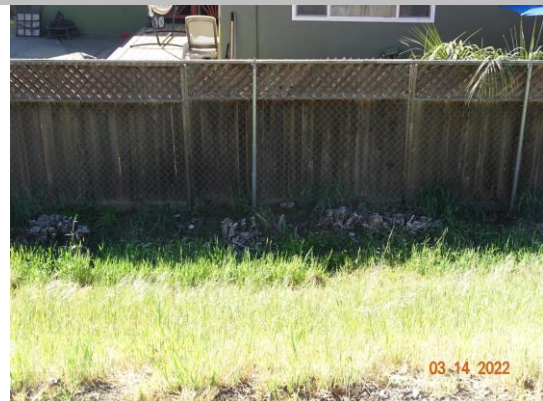
Photo 1 of 1 : FA_2023_NA0001_55_320_20230905_00237.jpg

Stumps at the landside toe. Spring 2022

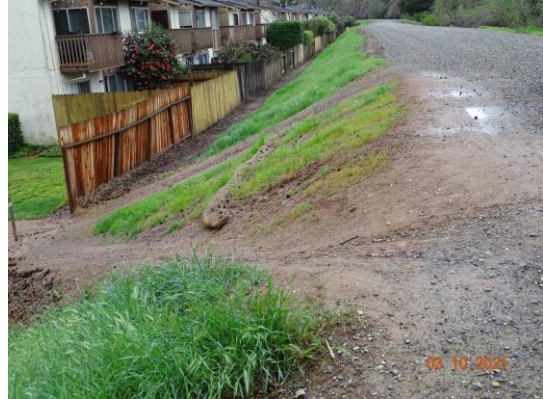
Photo 1 of 1 : FA_2023_NA0001_55_329_20230905_00244.jpg

View of the footpaths going down the LS levee slope. Spring 2021.

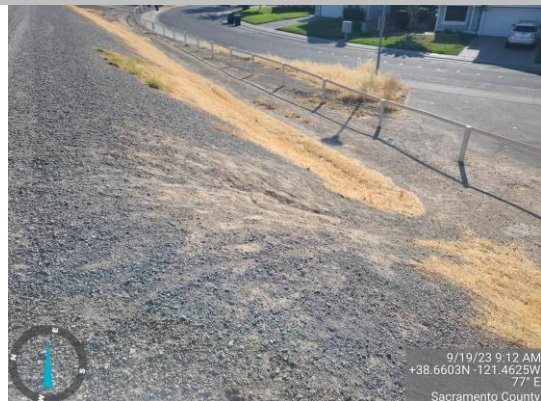
Photo 1 of 1 : FA_2023_NA0001_57_15_20230920_00013.jpg

A footpath is located on the landside slope. Fall 2023

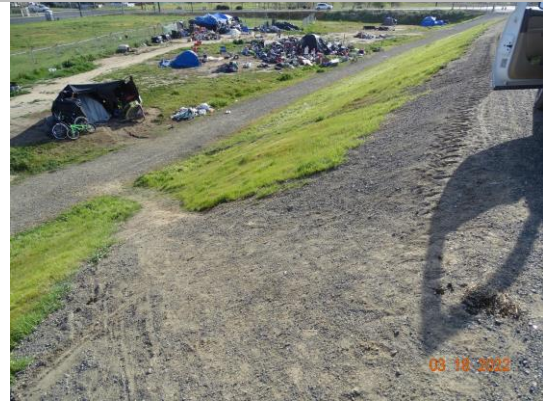
Photo 1 of 1 : FA_2023_NA0001_58_65_20230905_00038.jpg

Footpath on the landside slope. Spring 2022

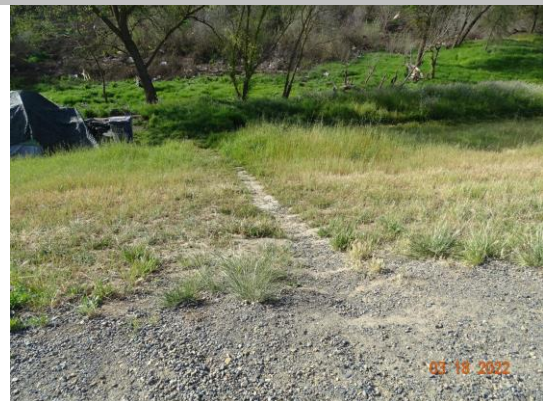
Photo 1 of 1 : FA_2023_NA0001_58_50_20230905_00034.jpg

Steps dug into the waterside slope. Spring 2022

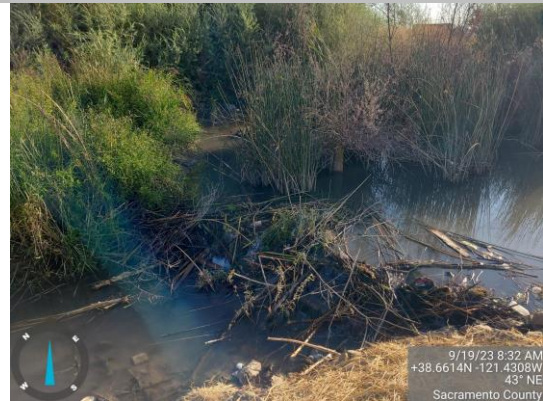
Photo 1 of 1 : FA_2023_NA0001_59_4_20230920_00018.jpg

Beaver dam in the channel. Fall 2023

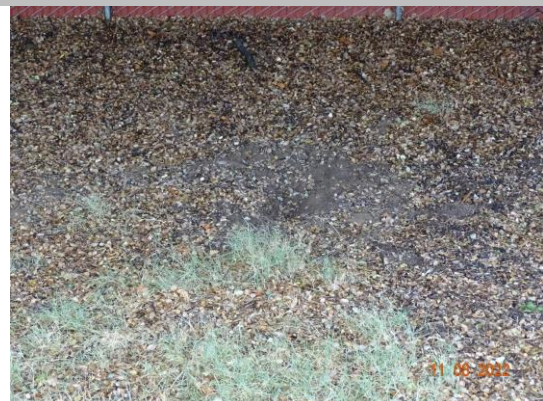
Photo 1 of 1 : FA_2023_NA0001_60_32_20230905_00005.jpg

Rodent hole in the LS easement. Fall 2022

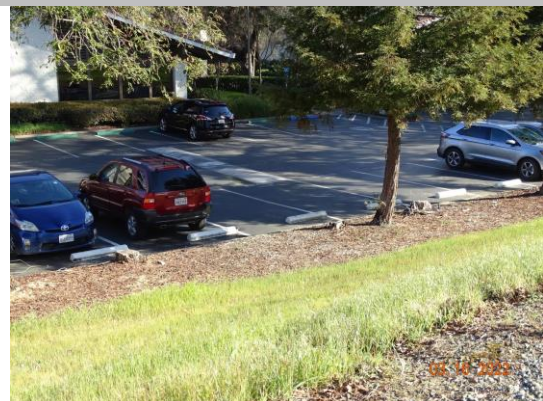
Photo 1 of 1 : FA_2023_NA0001_61_29_20230905_00004.jpg

Stumps in the easement. Spring 2022

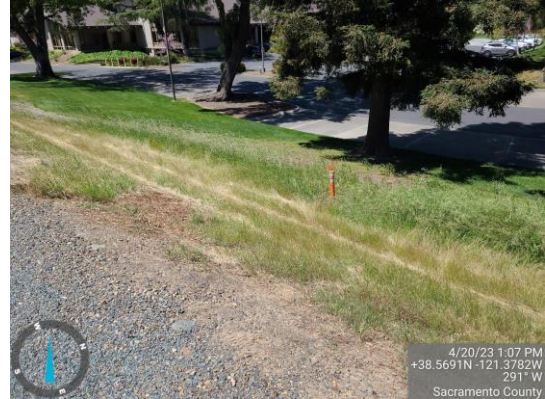
Photo 1 of 1 : FA_2023_NA0001_61_32_20230905_00005.jpg

Abandoned well on the LS slope. Spring 2023

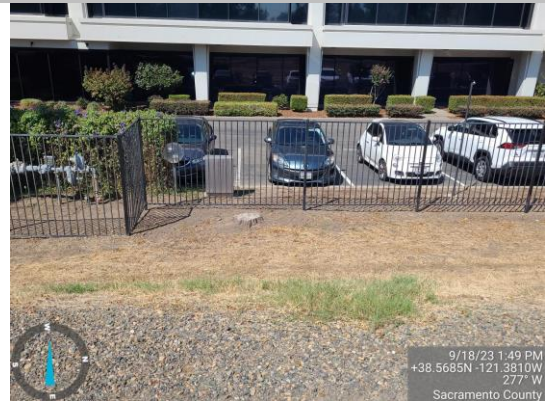
Photo 1 of 1 : FA_2023_NA0001_61_28_20230920_00012.jpg

Stump in the LS easement. Fall 2023
