**Flood Control Project Maintenance  
Levee Inspections****Maintenance Issue Types Only, Levee Inspection Report By Mile - Fall 2024****American River Flood Control District**

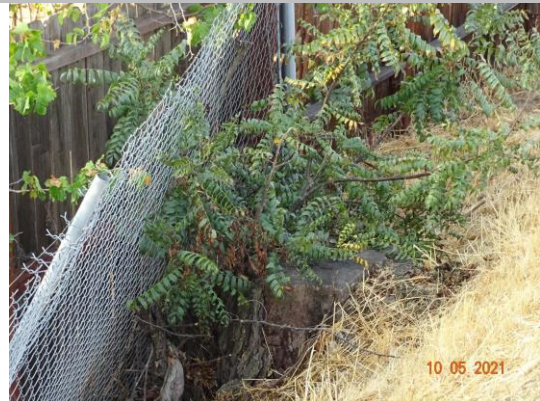
Photo 1 of 1 : FA\_2024\_NA0001\_51\_94\_20240911\_00049.jpg

Stump on the LS toe. Fall 2021

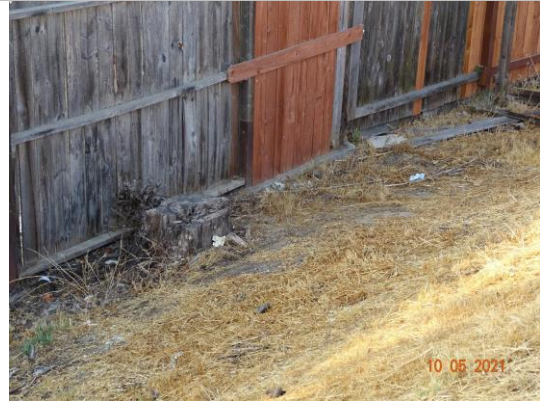
Photo 1 of 1 : FA\_2024\_NA0001\_51\_72\_20240911\_00041.jpg

Stumps on the LS toe. Fall 2021

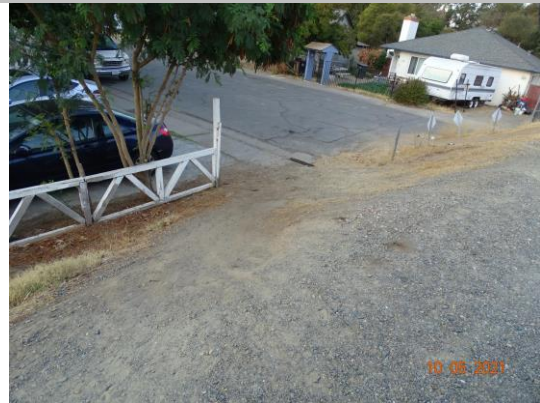
Photo 1 of 1 : FA\_2024\_NA0001\_51\_90\_20240911\_00048.jpg

Footpath on the LS slope. Fall 2021

| E3 : Repair the levee slope damaged by foot traffic and prevent access where possible. | | | | | |

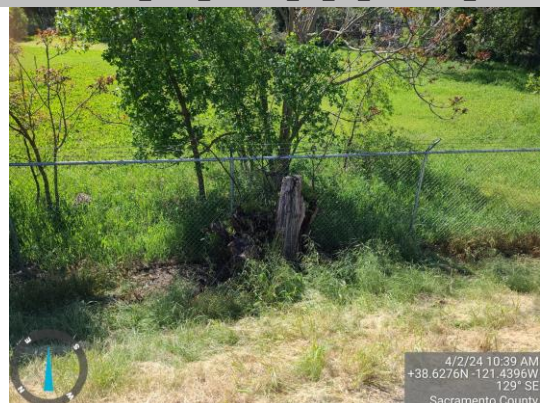
Photo 1 of 1 : FA\_2024\_NA0001\_51\_74\_20240911\_00043.jpg

Stump at the landside toe. Spring 2024

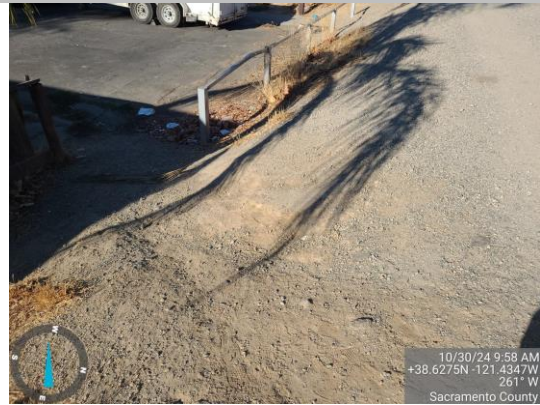
Photo 1 of 1 : FA\_2024\_NA0001\_51\_31\_20241031\_00071.jpg

Footpath on the LS slope. Fall 2024

| E3 : Repair the levee slope damaged by foot traffic and prevent access where possible. | | | | | |

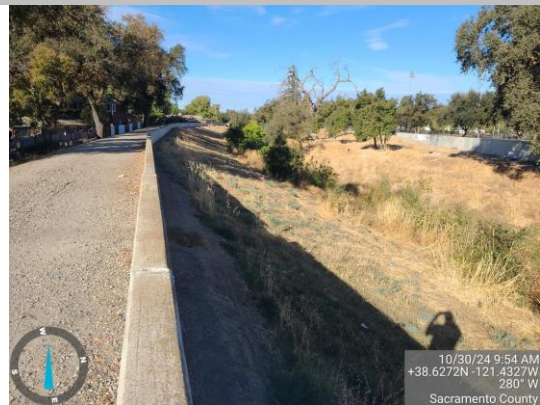
Photo 1 of 1 : FA\_2024\_NA0001\_51\_26\_20241031\_00070.jpg

View of well maintained vegetation on the WS slope. Fall 2024

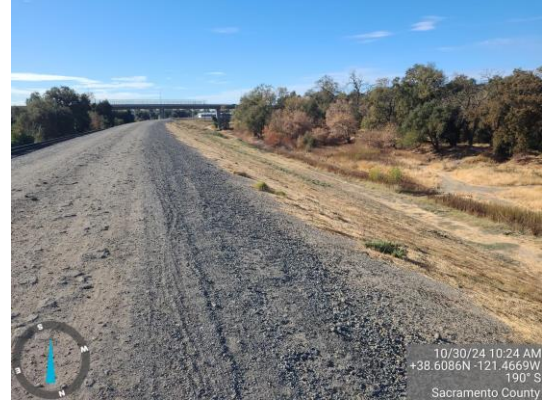
Photo 1 of 1 : FA\_2024\_NA0001\_52\_5\_20241031\_00011.jpg

Acceptable vegetation on the WS slope. Fall 2024

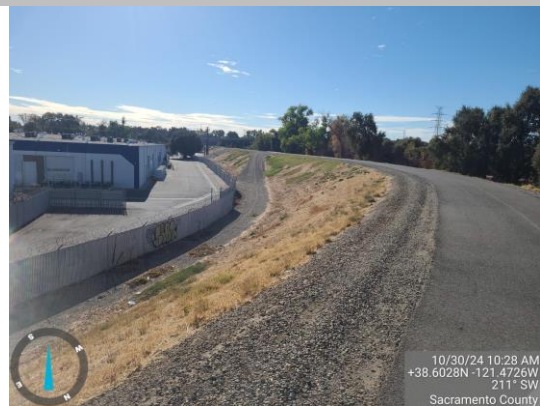
Photo 1 of 1 : FA\_2024\_NA0001\_490\_2\_20241031\_00008.jpg

Acceptable vegetation on the LS slope. Fall 2024

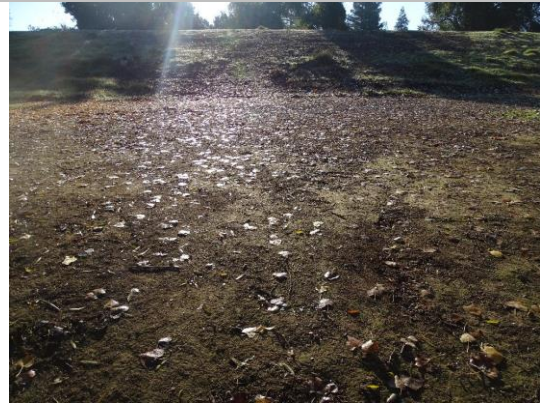
Photo 3 of 3 : UCIP\_FA\_2024\_84752\_121743.jpg

View of WS slope and toe from riverbank. No evidence of pipe.

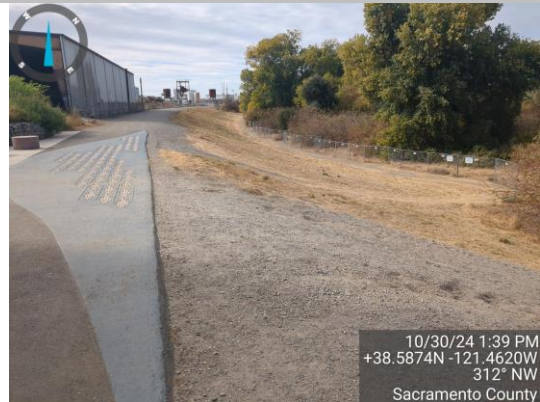
Photo 1 of 1 : FA\_2024\_NA0001\_55\_45\_20241031\_00272.jpg

Acceptable vegetation on the WS slope. Fall 2024

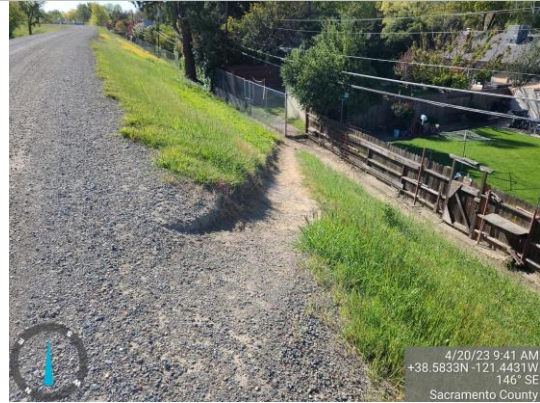
Photo 1 of 1 : FA\_2024\_NA0001\_55\_56\_20240911\_00047.jpg

Footpath on the LS slope. Spring 2023

| Repair footpath on the LS slope. | | | | | |

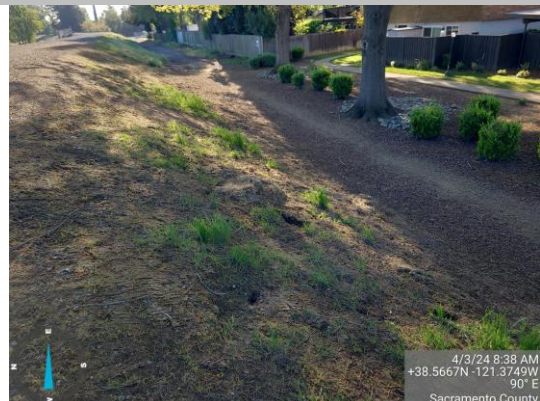
Photo 1 of 1 : FA\_2024\_NA0001\_55\_314\_20240911\_00229.jpg

Burrows in the LS slope. Spring 2024

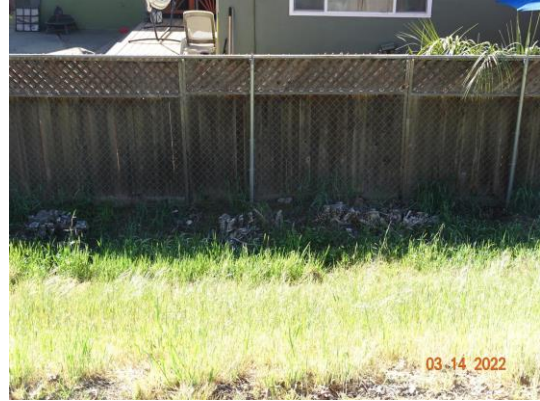
Photo 1 of 1 : FA\_2024\_NA0001\_55\_320\_20240911\_00231.jpg

Stumps at the landside toe. Spring 2022

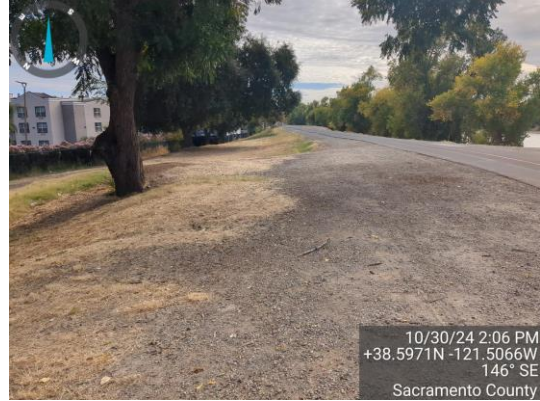
Photo 1 of 1 : FA\_2024\_NA0001\_56\_3\_20241031\_00002.jpg

Acceptable vegetation on the LS slope. Fall 2024

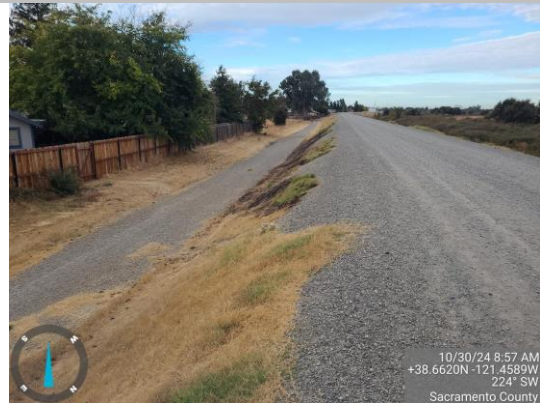
Photo 1 of 1 : FA\_2024\_NA0001\_57\_4\_20241031\_00011.jpg

Acceptable vegetation on the LS slope. Fall 2024

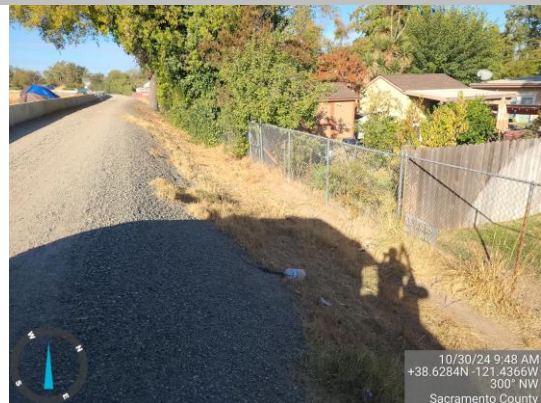
Photo 1 of 1 : FA\_2024\_NA0001\_58\_17\_20241031\_00048.jpg

Acceptable vegetation on the LS slope. Fall 2024

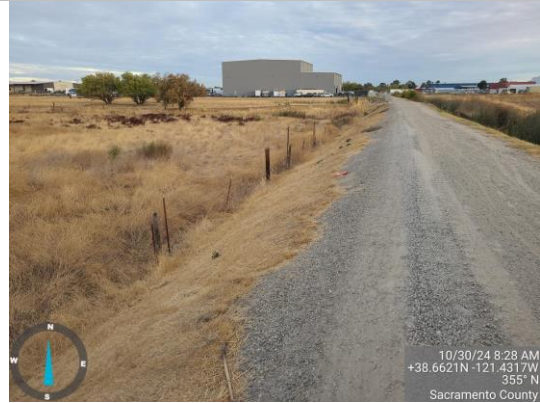
Photo 1 of 1 : FA\_2024\_NA0001\_59\_4\_20241031\_00017.jpg

Acceptable vegetation on the LS slope. Fall 2024

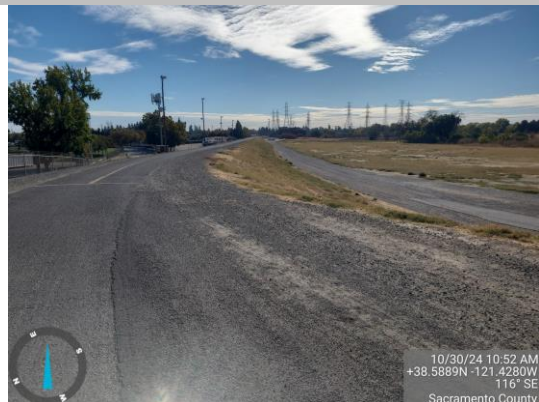
Photo 1 of 1 : FA\_2024\_NA0001\_60\_11\_20241031\_00026.jpg

Acceptable vegetation on the WS slope. Fall 2024

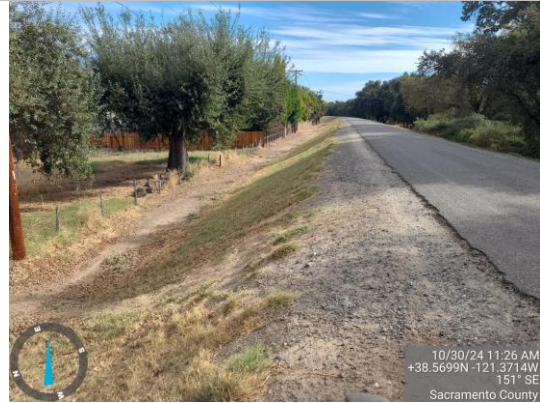
Photo 1 of 1 : FA\_2024\_NA0001\_61\_4\_20241031\_00011.jpg

Acceptable vegetation on the LS slope. Fall 2024

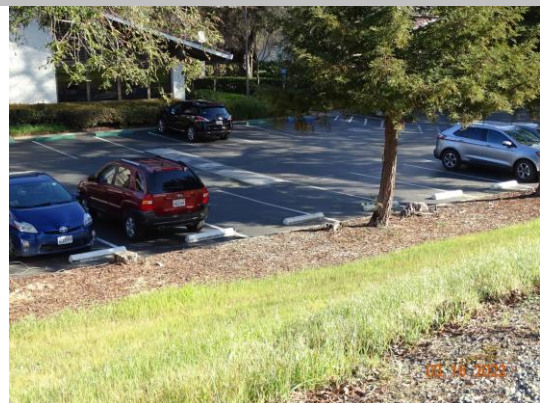
Photo 1 of 1 : FA\_2024\_NA0001\_61\_29\_20240911\_00005.jpg

Stumps in the easement. Spring 2022

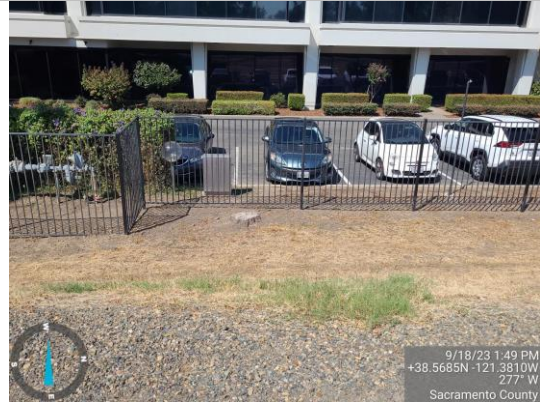
Photo 1 of 1 : FA\_2024\_NA0001\_61\_28\_20240911\_00004.jpg

Stump in the LS easement. Fall 2023

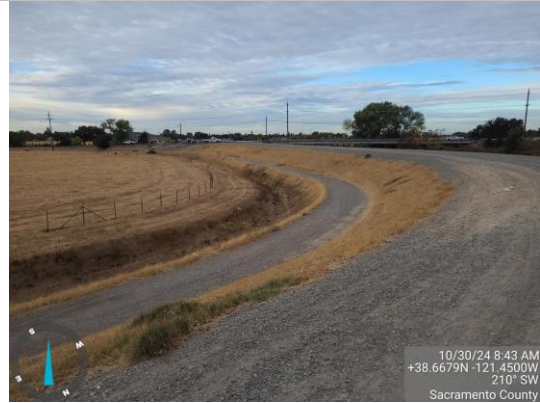
Photo 1 of 1 : FA\_2024\_NA0001\_436\_1\_20241031\_00003.jpg

Acceptable vegetation on the LS slope. Fall 2024

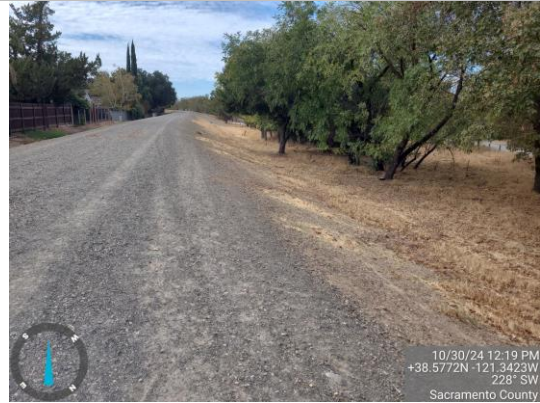
Photo 1 of 1 : FA\_2024\_NA0001\_438\_5\_20241031\_00011.jpg

Acceptable vegetation on the WS slope. Fall 2024
