**Flood Control Project Maintenance
Levee Inspections**

Fall 2008 Levee Maintenance Deficiency Summary Report

Brannan Andrus Levee Maintenance District

Levee Inspection Report By Mile - Fall 2008

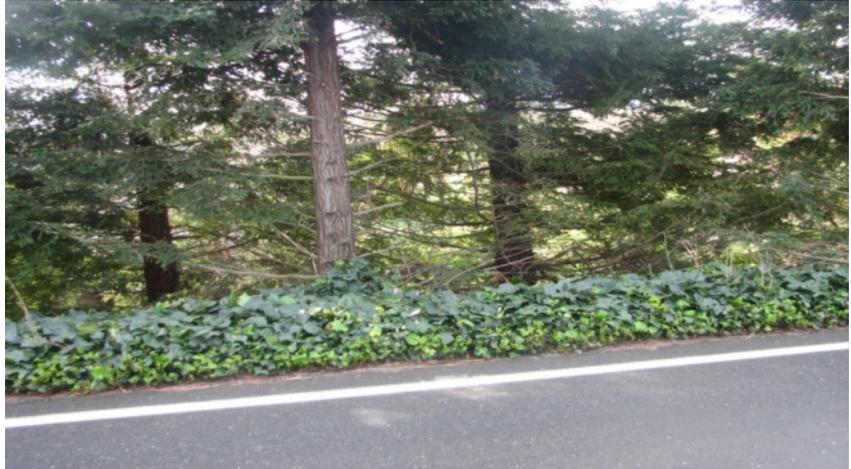
Levee Mile Report Line	2
Start Levee Mile	0.81
End Levee Mile	0.83
Location	
Category	Earthen Levee
Item	Encroachments
Landscaping on landside slope blocking view of slope from LM .81 to 0.83

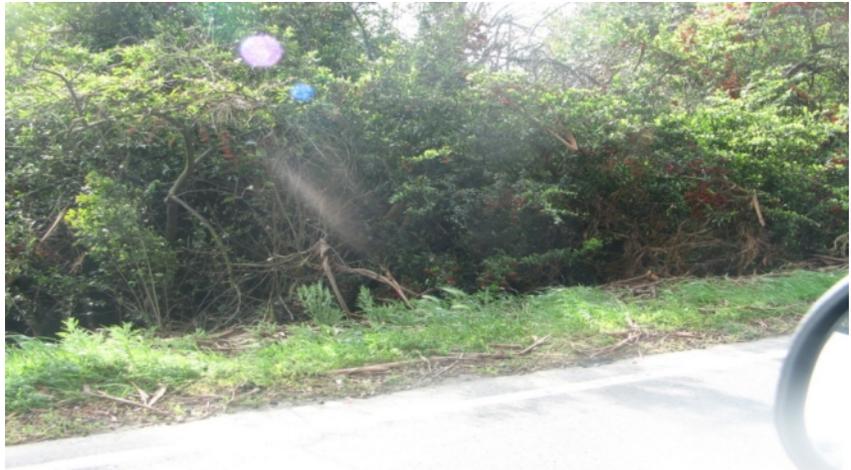
Levee Mile Report Line	4
Start Levee Mile	1.91
End Levee Mile	1.95
Location	
Category	Earthen Levee
Item	Encroachments
Landscaping on landside slope blocking view of slope from LM 1.91 to 1.95

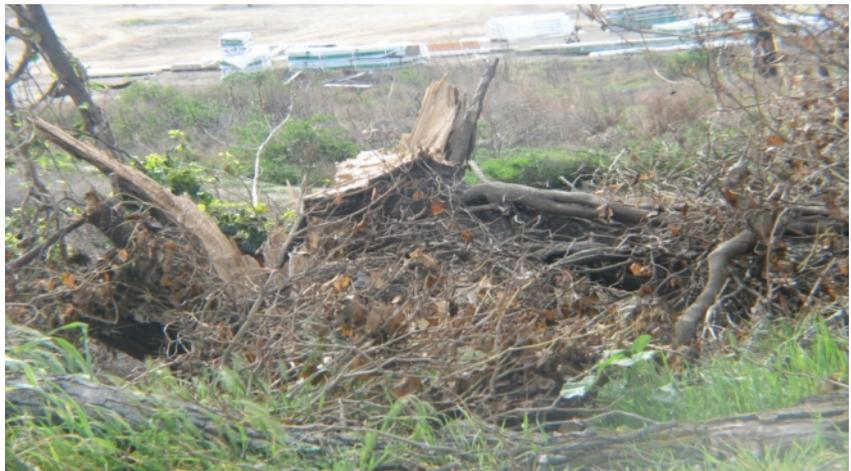
Levee Mile Report Line	7
Start Levee Mile	2.77
End Levee Mile	2.77
Location	
Category	Earthen Levee
Item	Encroachments
Tree limbs at landside slope at LM 2.77

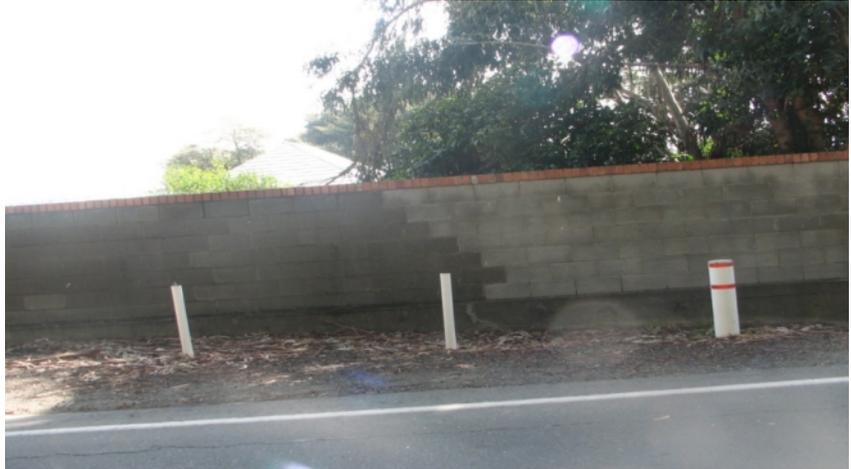
Levee Mile Report Line	24
Start Levee Mile	6.82
End Levee Mile	6.82
Location	
Category	Earthen Levee
Item	Encroachments
Brick wall on landside shoulder at LM 6.82
