**Flood Control Project Maintenance
Levee Inspections**

Fall 2009 Levee Maintenance Deficiency Summary Report

Sacramento River Basin

Brannan Andrus Levee Maintenance District

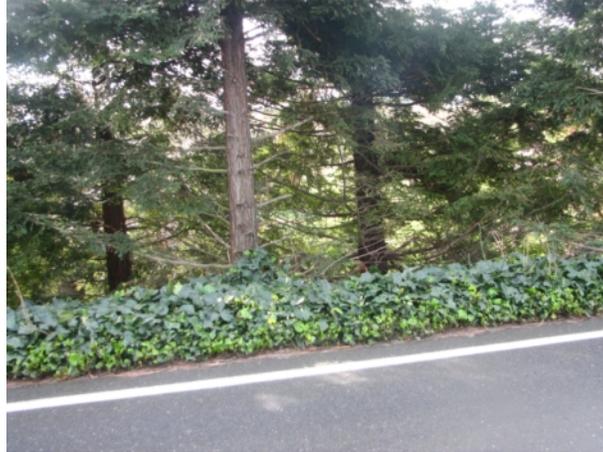
Levee Mile Report Line	2
Start Levee Mile	0.81
End Levee Mile	0.83
Location	Land Side
Category	Earthen Levee
Item	Encroachments
Landscaping on landside slope blocking view of slope from LM .81 to 0.83	
richard_20091210_123.jpg

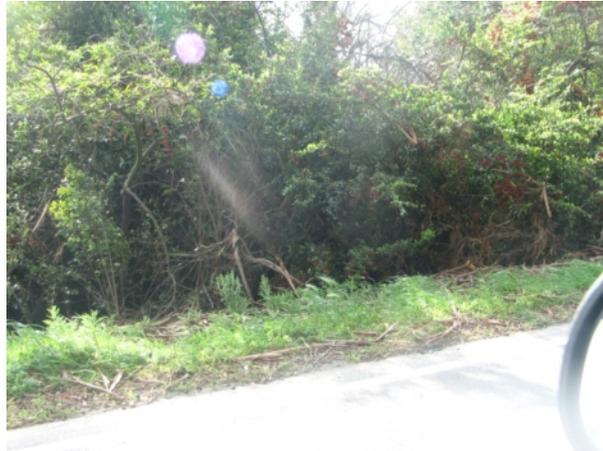
Levee Mile Report Line	4
Start Levee Mile	1.91
End Levee Mile	1.95
Location	Land Side
Category	Earthen Levee
Item	Encroachments
Landscaping on landside slope blocking view of slope from LM 1.91 to 1.95	
richard_20091210_124.jpg

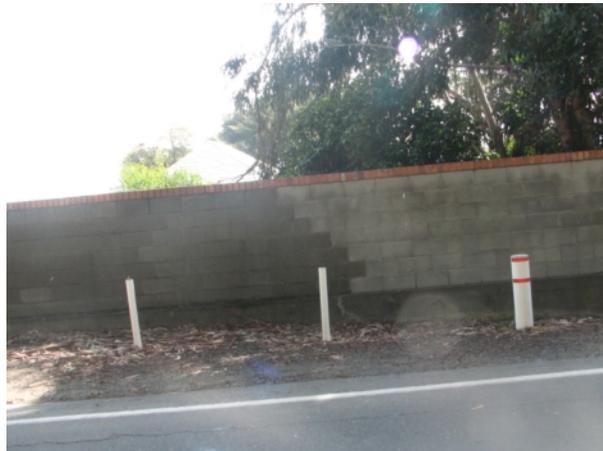
Levee Mile Report Line	18
Start Levee Mile	6.82
End Levee Mile	6.82
Location	Land Side
Category	Earthen Levee
Item	Encroachments
Brick wall on landside shoulder at LM 6.82	
richard_20091210_126.jpg
