**Flood Control Project Maintenance
Levee Inspections
LMA District Cover Sheet
Spring 2008 Levee Inspection Results**

Brannan Andrus Levee Maintenance District

Levee Inspection Report By Mile - Spring 2008

Waterway						Bank	Unit Miles	Inspection Date		Inspector	
Unit No. 01 Georgiana Slough						Right	6.00	03/19/2008		Richard Willoughby	
LMR Line	Levee Mile		Category	Item	Location *	Rating **	Action/Comment	GPS Latitude/Longitude		Photo	Issue
	Start	End						Start	End		
1	0.00	6.02	Earthen Levee	Vegetation	LS	M	Control annual grass and weeds on the levee slopes and easements.	38.186455 ° -121.562575 °	38.129528 ° -121.578458 °		1
2	0.00	6.02	Earthen Levee	Vegetation	WS	M	Control annual grass and weeds on the levee slopes and easements.	38.186458 ° -121.562575 °	38.129527 ° -121.578457 °		2
3	0.27	0.75	Earthen Levee	Vegetation	LS	U	Remove the wild growth other than native grasses from the levee slopes. Inspector Comments: wild grapevines at toe of levee	38.184577 ° -121.567063 °	38.182212 ° -121.574998 °		24
4	0.84	0.88	Earthen Levee	Encroachments	WS	M	Prunings	38.182052 ° -121.576620 °	38.181857 ° -121.577387 °		23

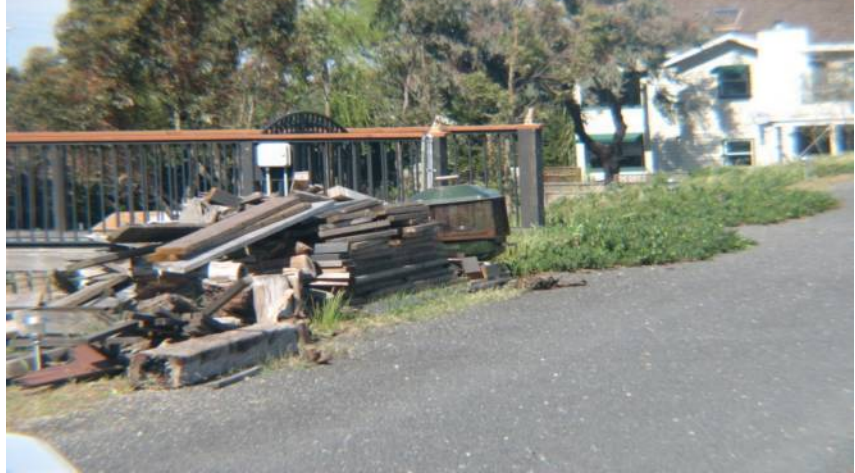
Levee Mile Report Line	21
Start Levee Mile	4.78
End Levee Mile	4.78
Location	
Category	Earthen Levee
Item	Encroachments
Firewood, lumber and garbage at landward should at LM 4.78

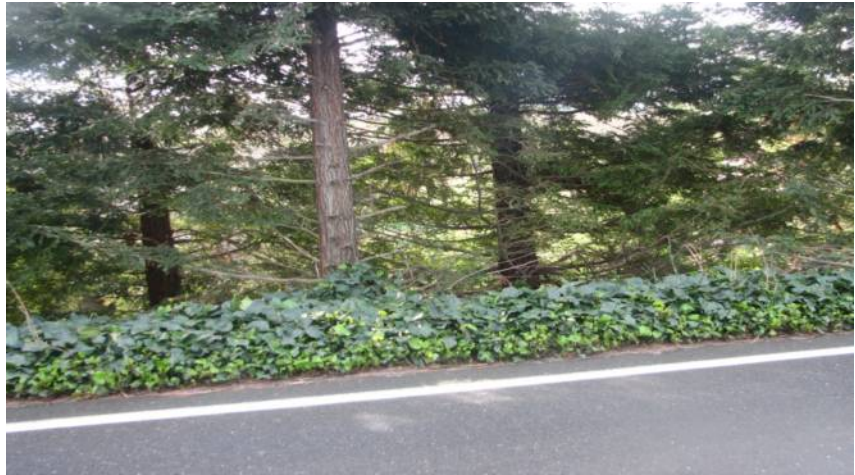
Levee Mile Report Line	8
Start Levee Mile	0.81
End Levee Mile	0.83
Location	
Category	Earthen Levee
Item	Encroachments
Landscaping on landside slope blocking view of slope from LM .81 to 0.83

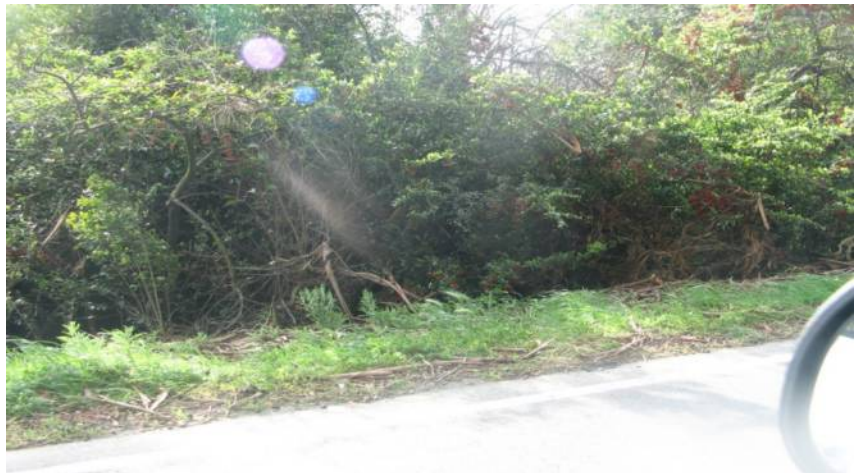
Levee Mile Report Line	12
Start Levee Mile	1.91
End Levee Mile	1.95
Location	
Category	Earthen Levee
Item	Encroachments
Landscaping on landside slope blocking view of slope from LM 1.91 to 1.95

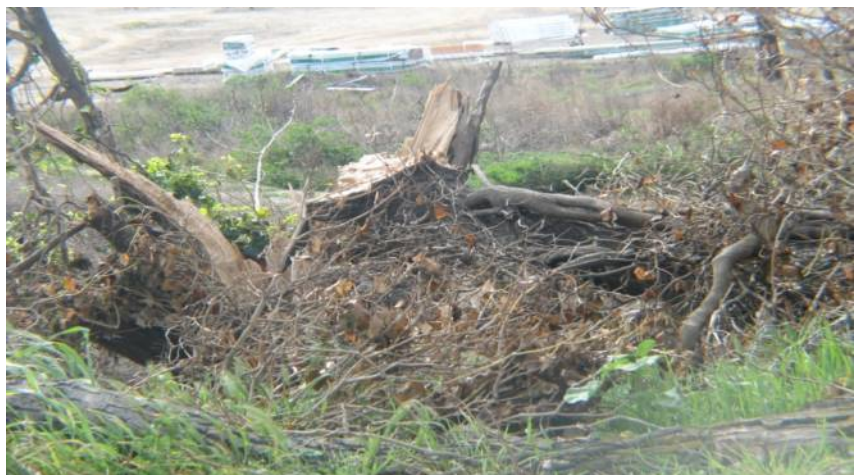
Levee Mile Report Line	17
Start Levee Mile	2.77
End Levee Mile	2.77
Location	
Category	Earthen Levee
Item	Encroachments
Tree limbs at landside slope at LM 2.77

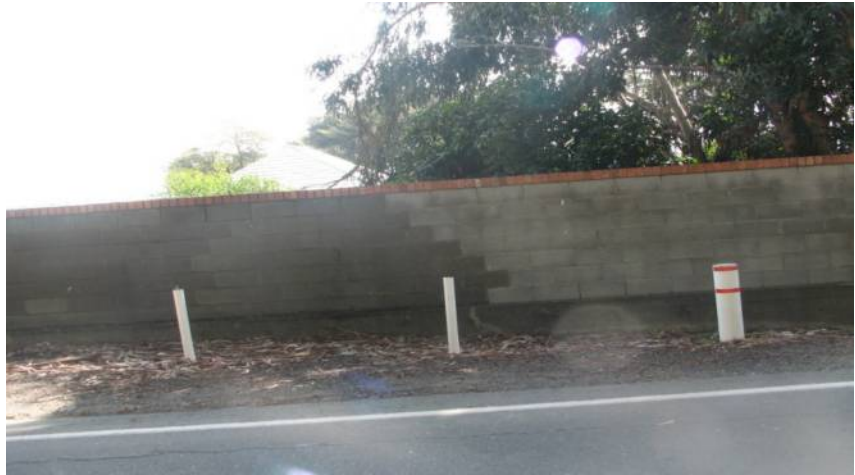
Levee Mile Report Line	42
Start Levee Mile	6.82
End Levee Mile	6.82
Location	
Category	Earthen Levee
Item	Encroachments

Brick wall on landside shoulder at LM 6.82
